Final Reclamation Inspection

Operator: KERR MCGEE OIL & GAS ONSHORE LP #47120

Location ID: 332954

Inspection Photos
Location Name: SHUR VIEW #23-3
Location ID: 332954

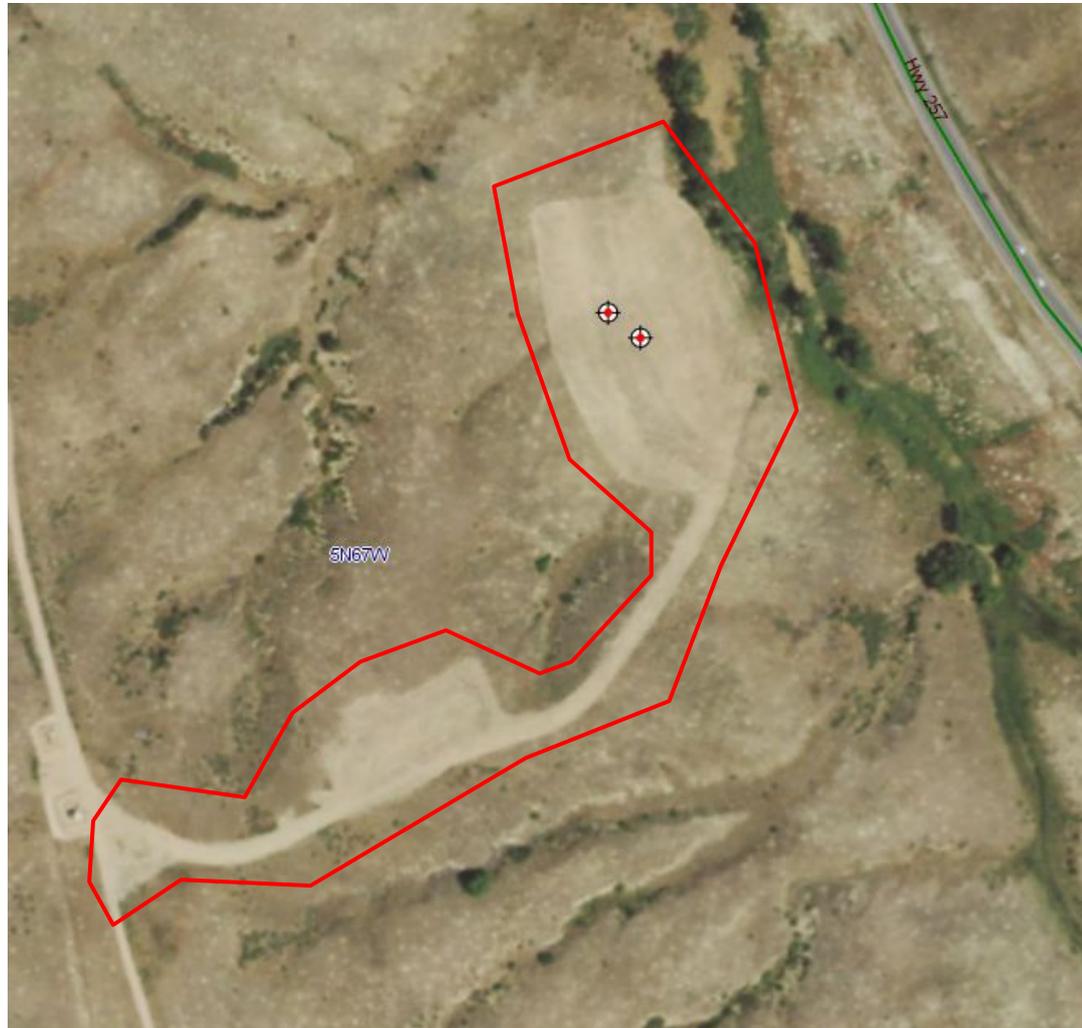
Photo 1. COGCC GISOnline aerial imagery from 2019 illustrates the well location (red circle), access road and associated tank battery.

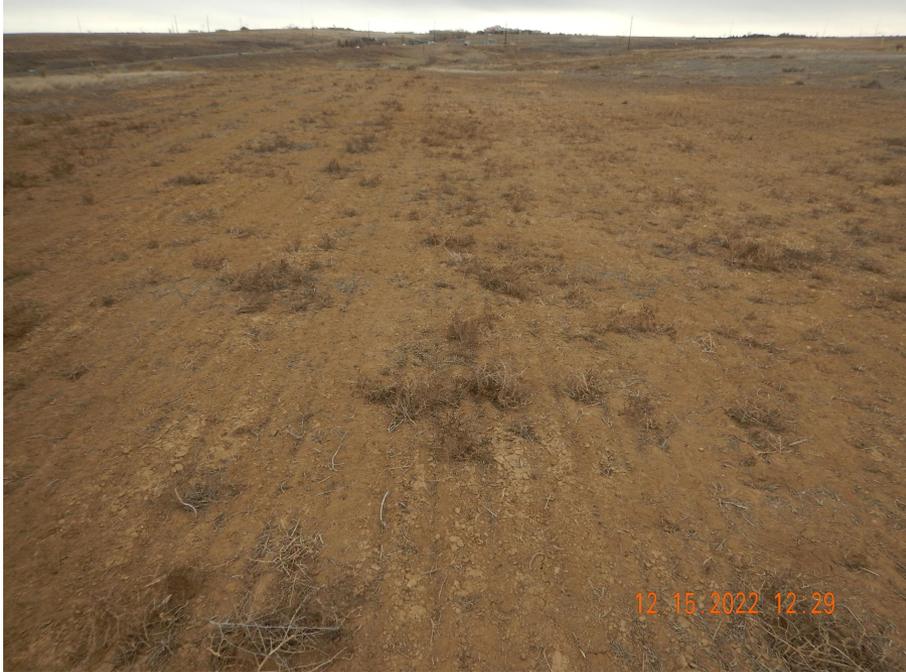
Photo 2. Photo taken from the western disturbance near the active tank battery, facing Southeast. Photo illustrates the limited establishment of grass species observed and it is predominately bare ground.

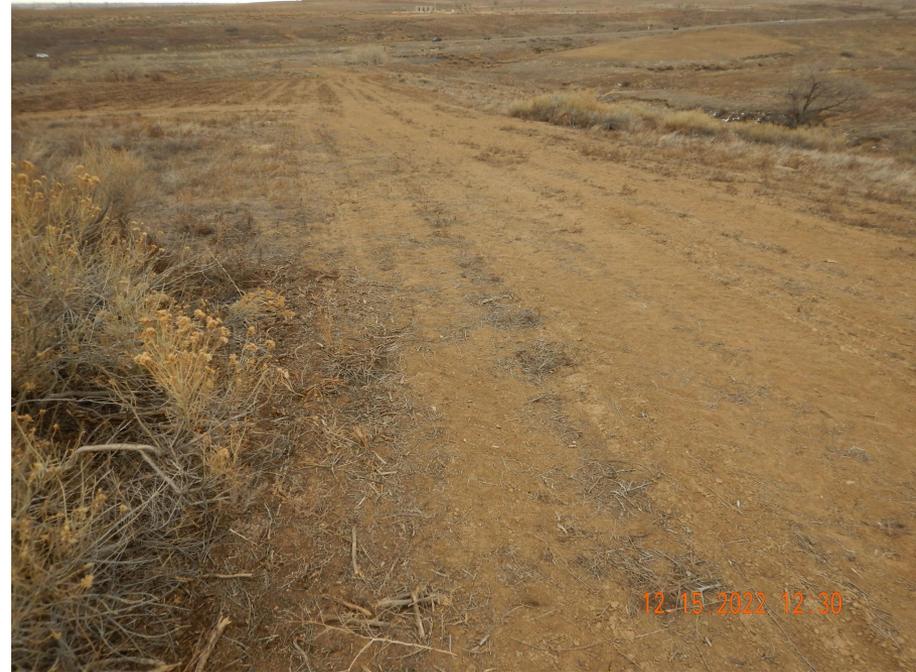
Photo 3. Photo taken from a portion of the western access road, facing East. See comments under Photo 2.

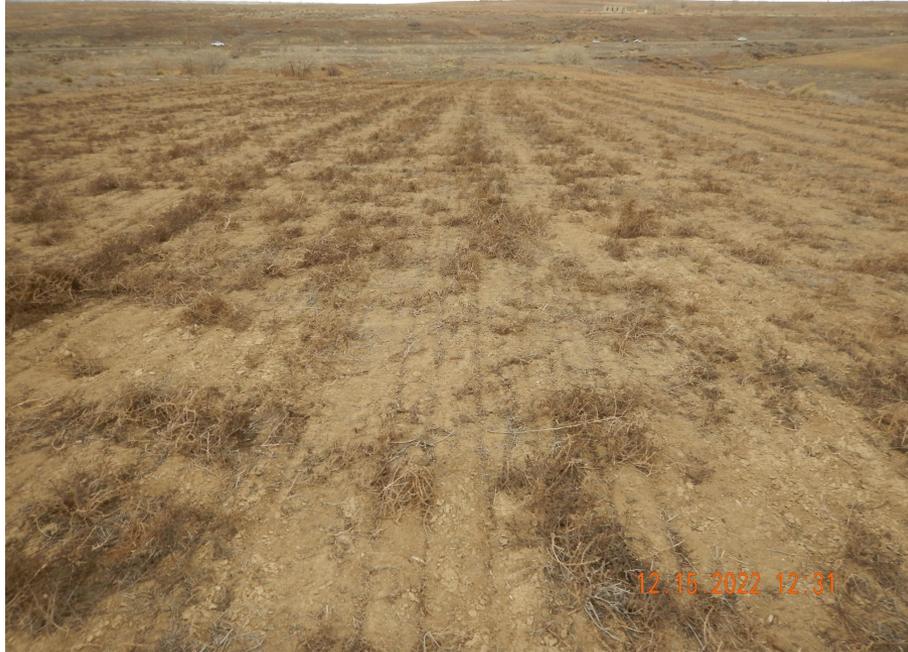
Photo 4. Photo taken from the associated tank battery, facing East. See comments under Photo 2.

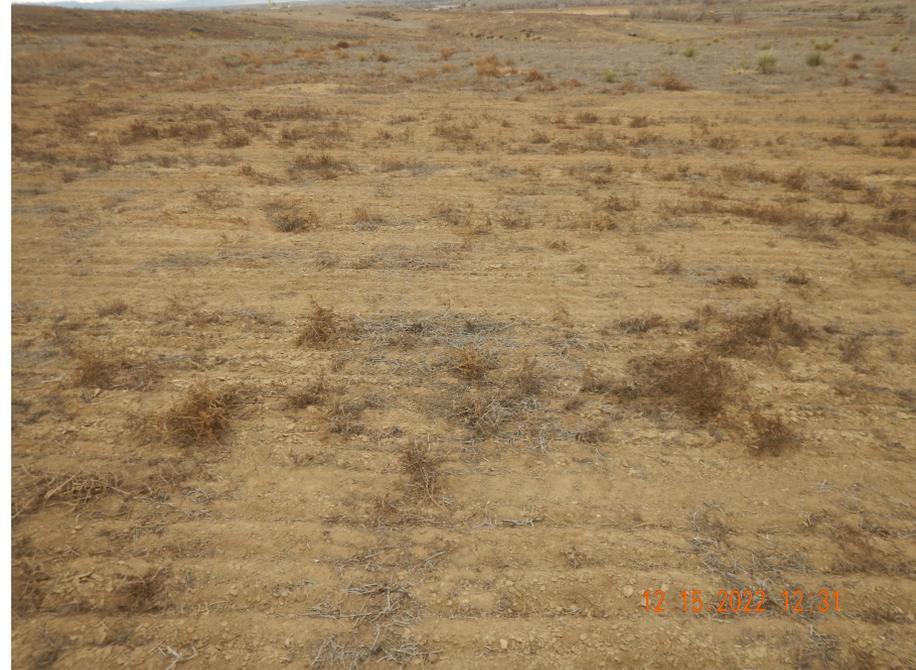
Photo 5. Photo taken from the associated tank battery, facing North. See comments under Photo 2.

Note- Operator should have seeded perpendicular to the slope to minimize potential erosion.

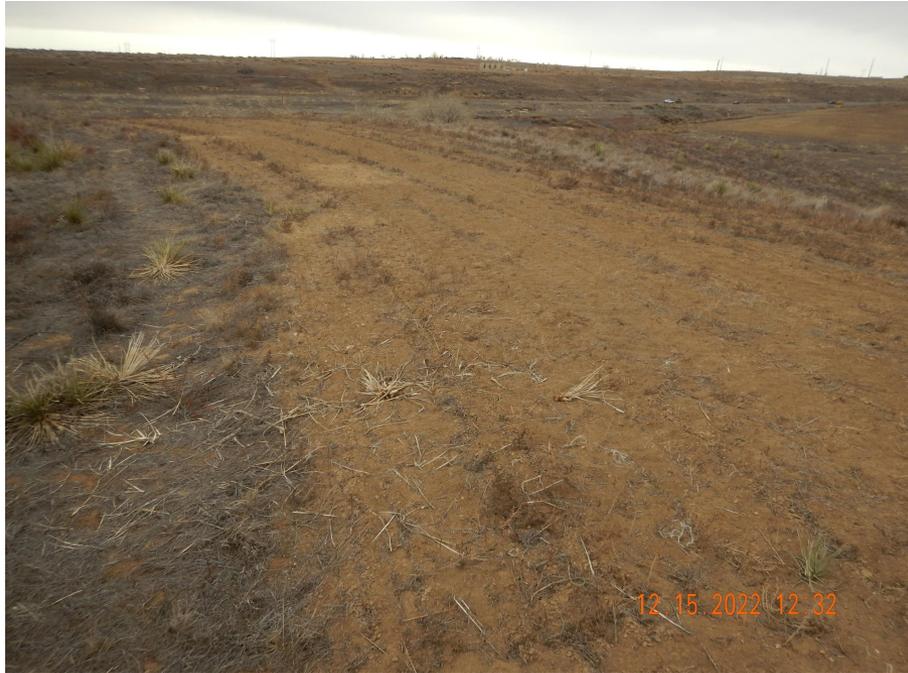
Photo 6. Photo taken from a portion of the eastern access road, facing East. See comments under Photo 2.

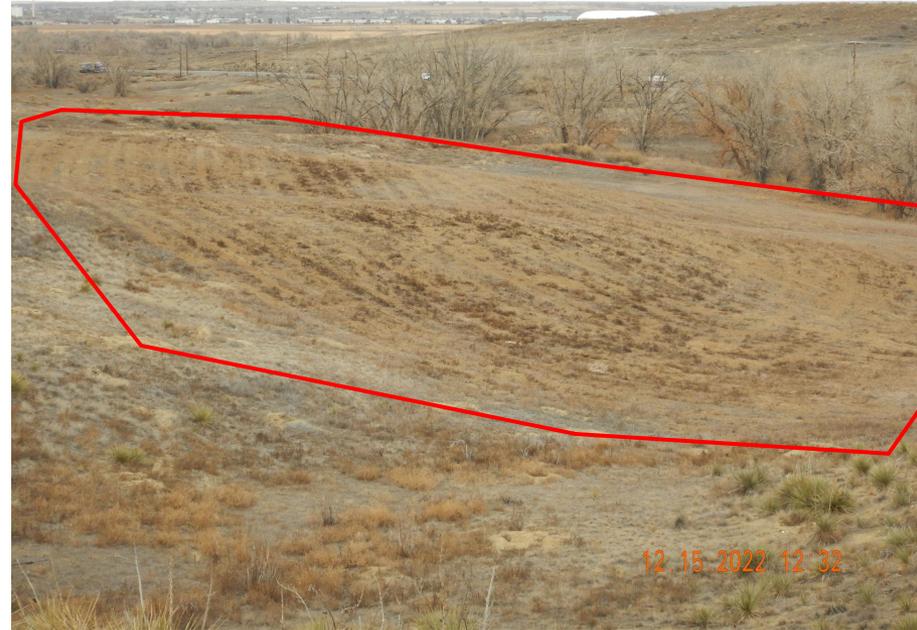
Photo 7. Photo taken south of the well location, facing North. Photo illustrates the well location. See comments under Photo 2.

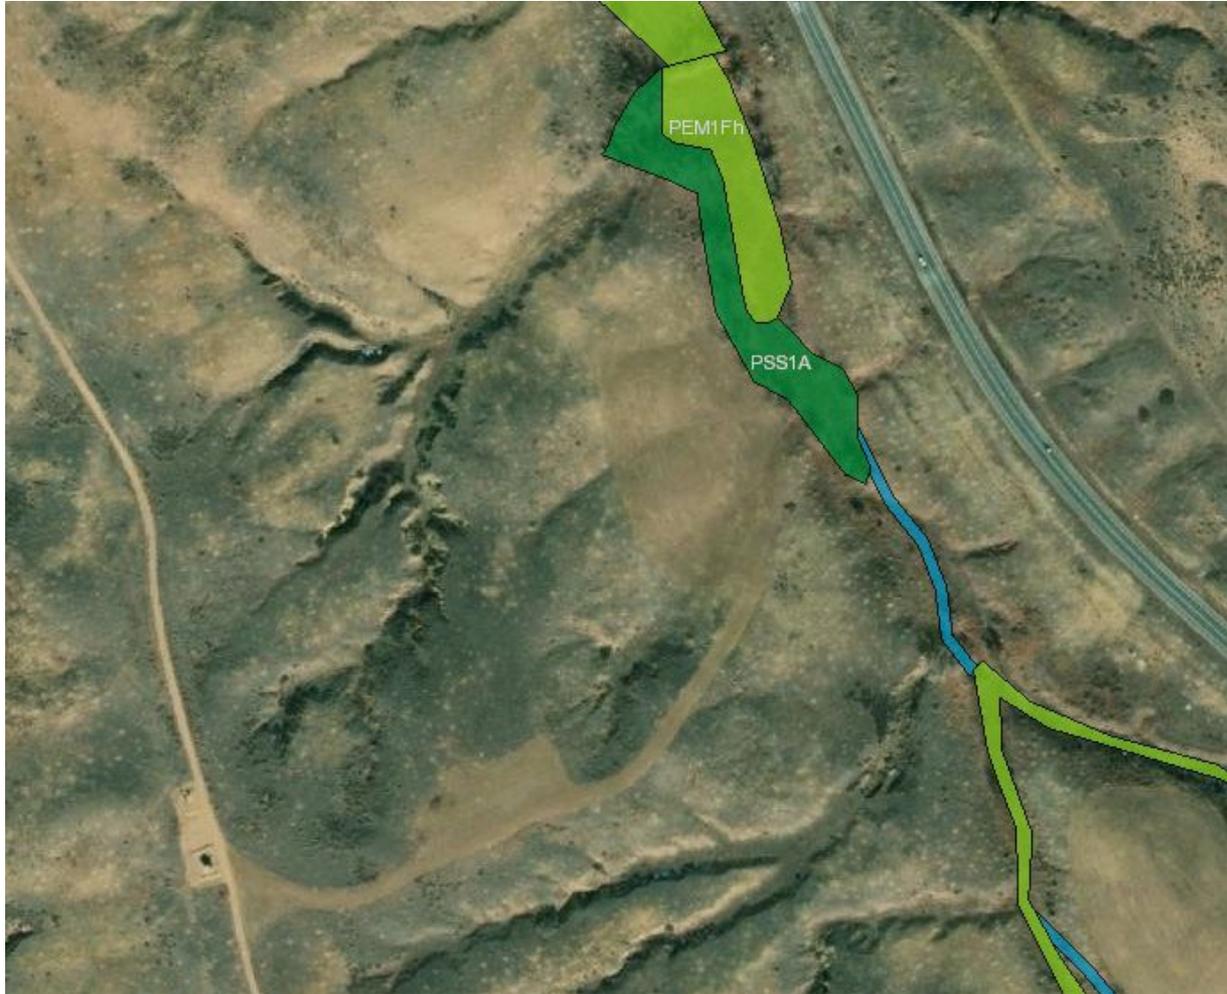
Photo 8. National Wetlands Inventory aerial illustrates Riverine habitat, Freshwater Emergent and Freshwater Forested/Shrub wetland downgradient of location.
