# Final Reclamation Inspection

Operator: SNYDER OIL CORP - 80530

Location ID: 409212

Inspection Photos  
Location Name: CONNELL #4-1114  
Location ID: 409212

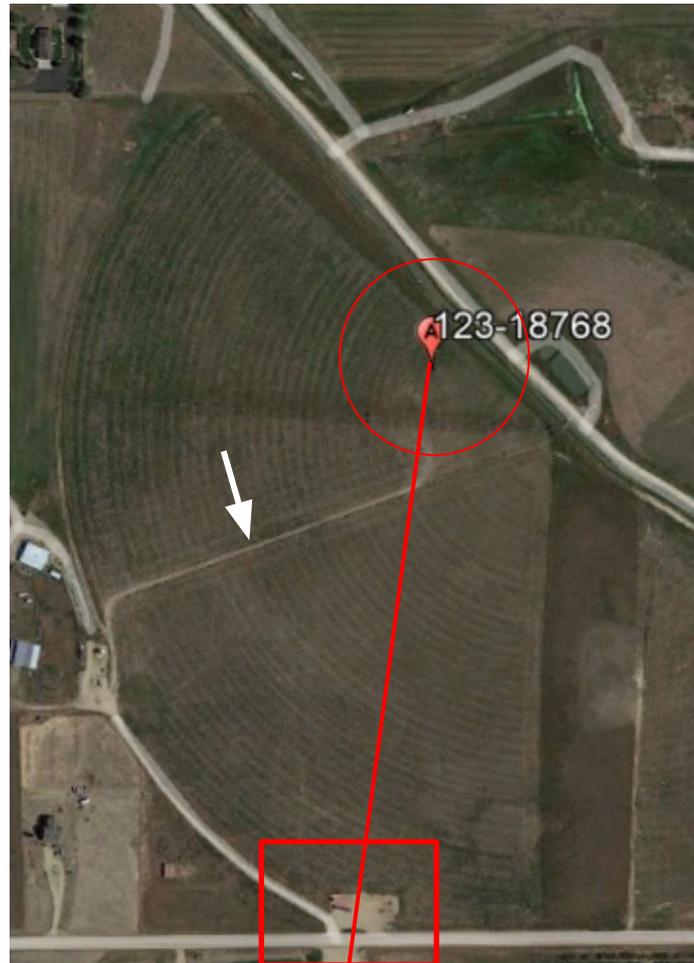
**Photo 1.** Google Earth aerial imagery taken 7/2019 during active operations. Photo illustrates the well location (red circle), tank battery (red rectangle), and access road (white arrow).

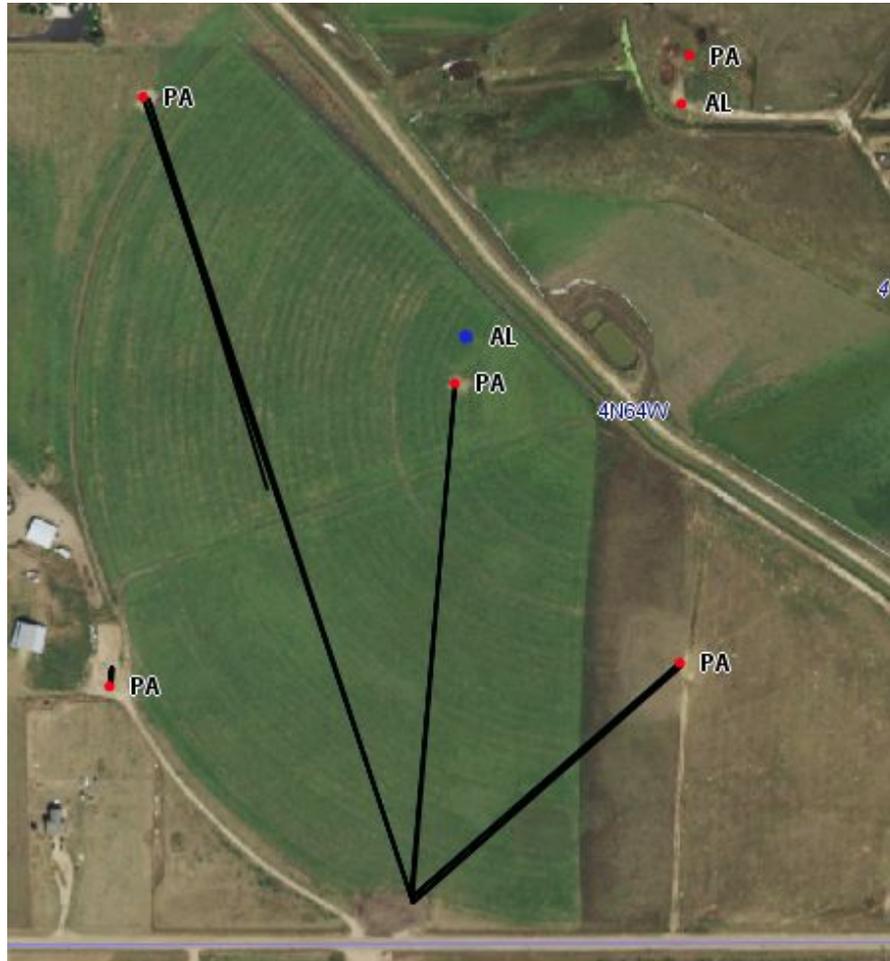
**Photo 2.** COGCC Online Map aerial imagery 2019 with subject well (blue dot), related wells (red dots), tank battery (south center) and flowlines (black lines).

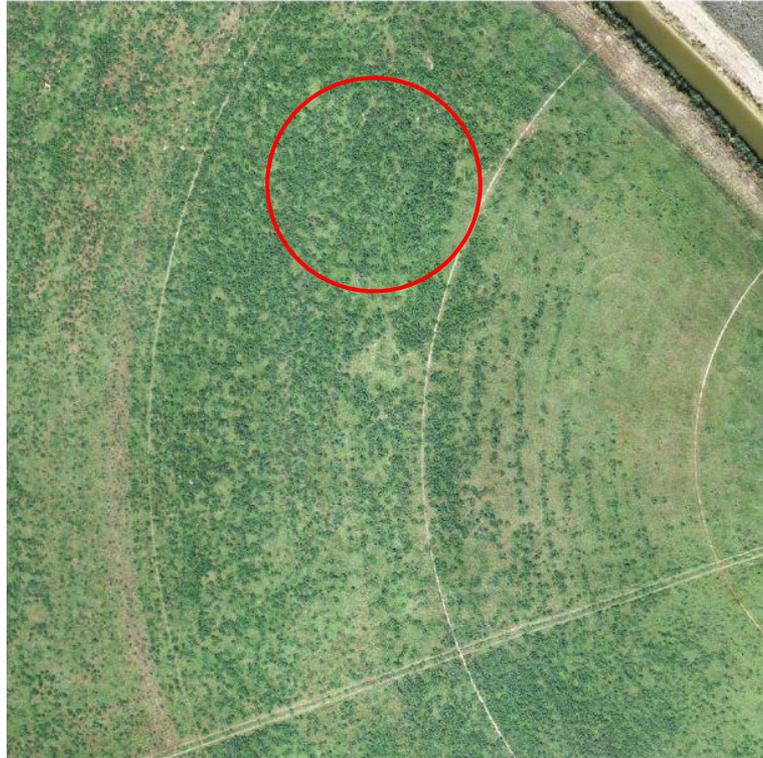
**Photo 3.** Orthomosaic drone aerial imagery taken from 200 ft (Sept. 2022). Illustrates growth on and around the well location (red circle). Tank Battery is addressed in Location 319183 report.

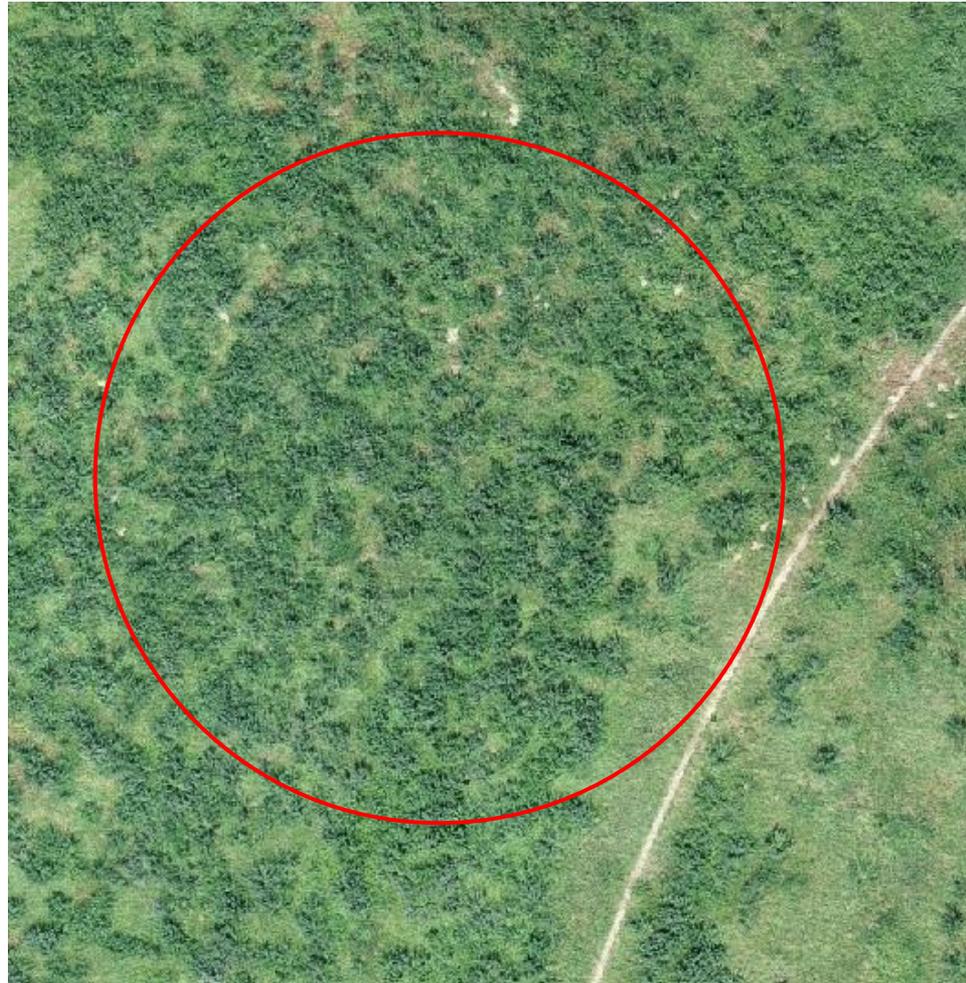
**Photo 4.** Zoomed in Orthomosaic drone aerial imagery taken from 200 ft (Sept. 2022). Illustrates good growth on and around the well location (red circle). Appears similar to rest of area, however crop height cannot be fully evaluated. Another inspection is required when crop is actively growing.
