# Final Reclamation Inspection

Operator: NOBLE ENERGY INC- 100322

Location ID: 330145

Inspection Photos  
Location Name: HSR-LDS #6-17  
Location ID: 330145

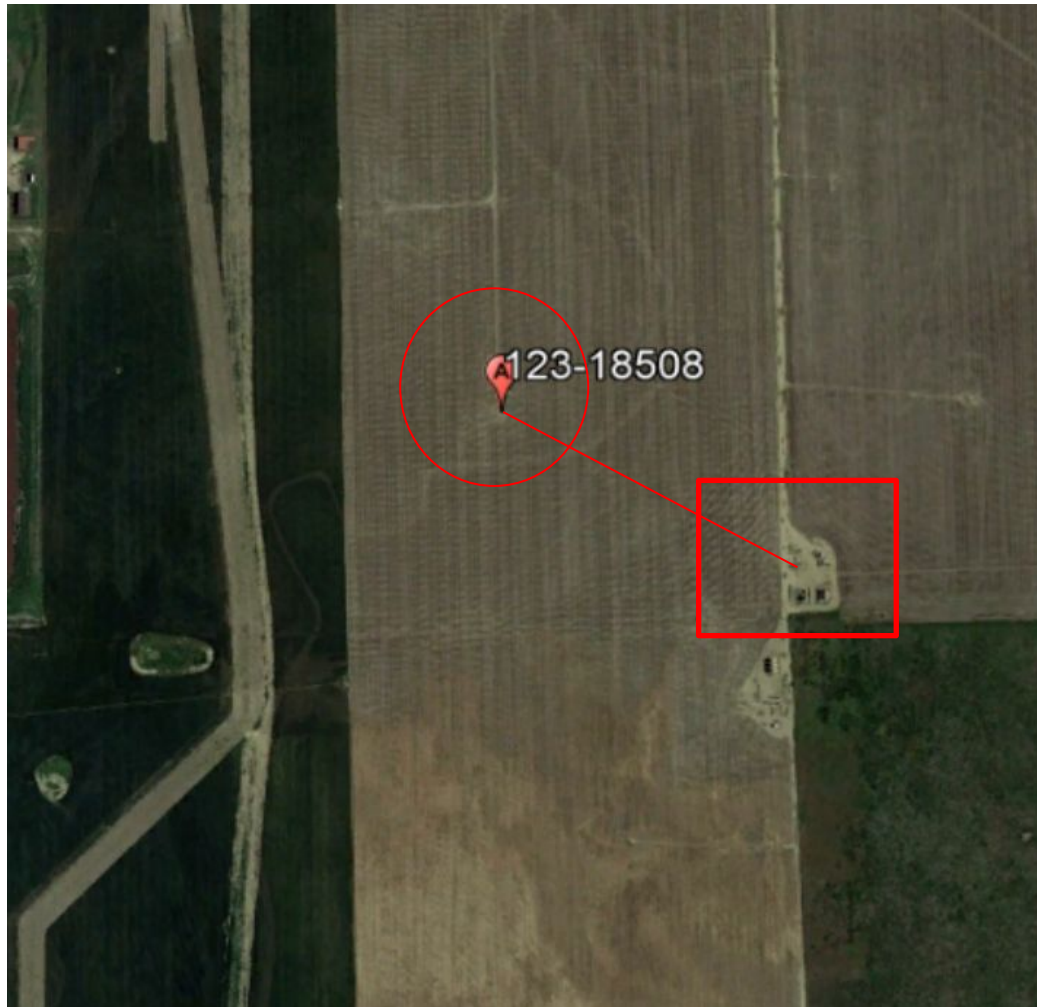
**Photo 1.** Google Earth aerial imagery taken 8/2018 during active operations. Photo illustrates the well location (red circle), tank battery (red rectangle), and approximate flowlines (red line).

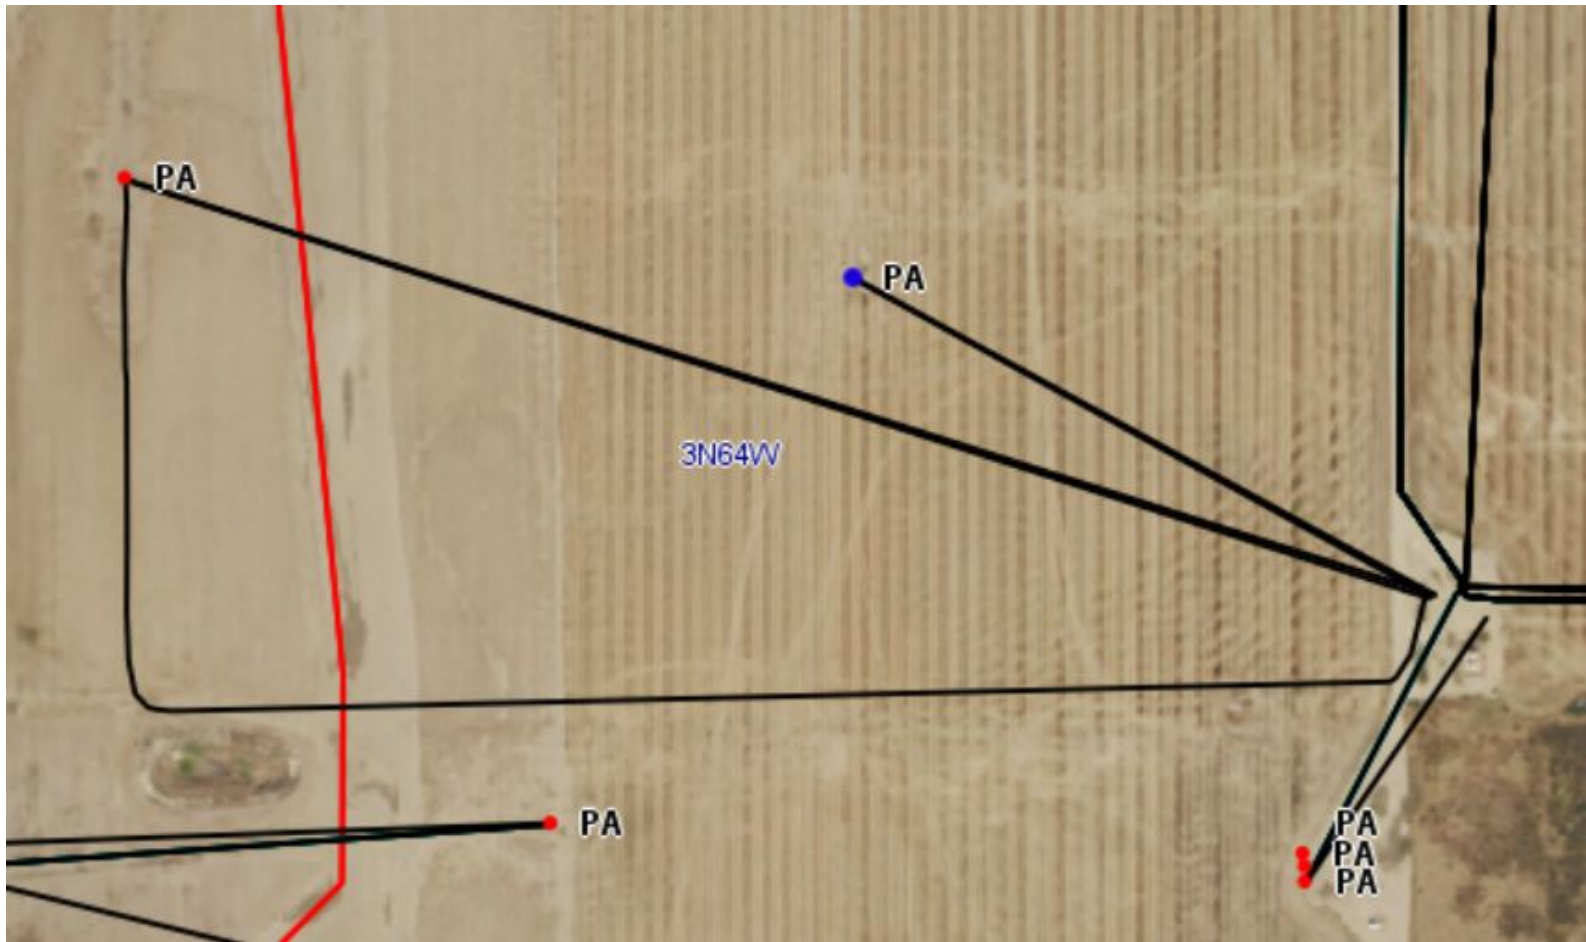
**Photo 2.** COGCC Online Map aerial imagery 2019 with subject well (blue dot), related wells (red dot), tank battery (east center) and flowlines (black lines). Flowline abandonment form has not been submitted.

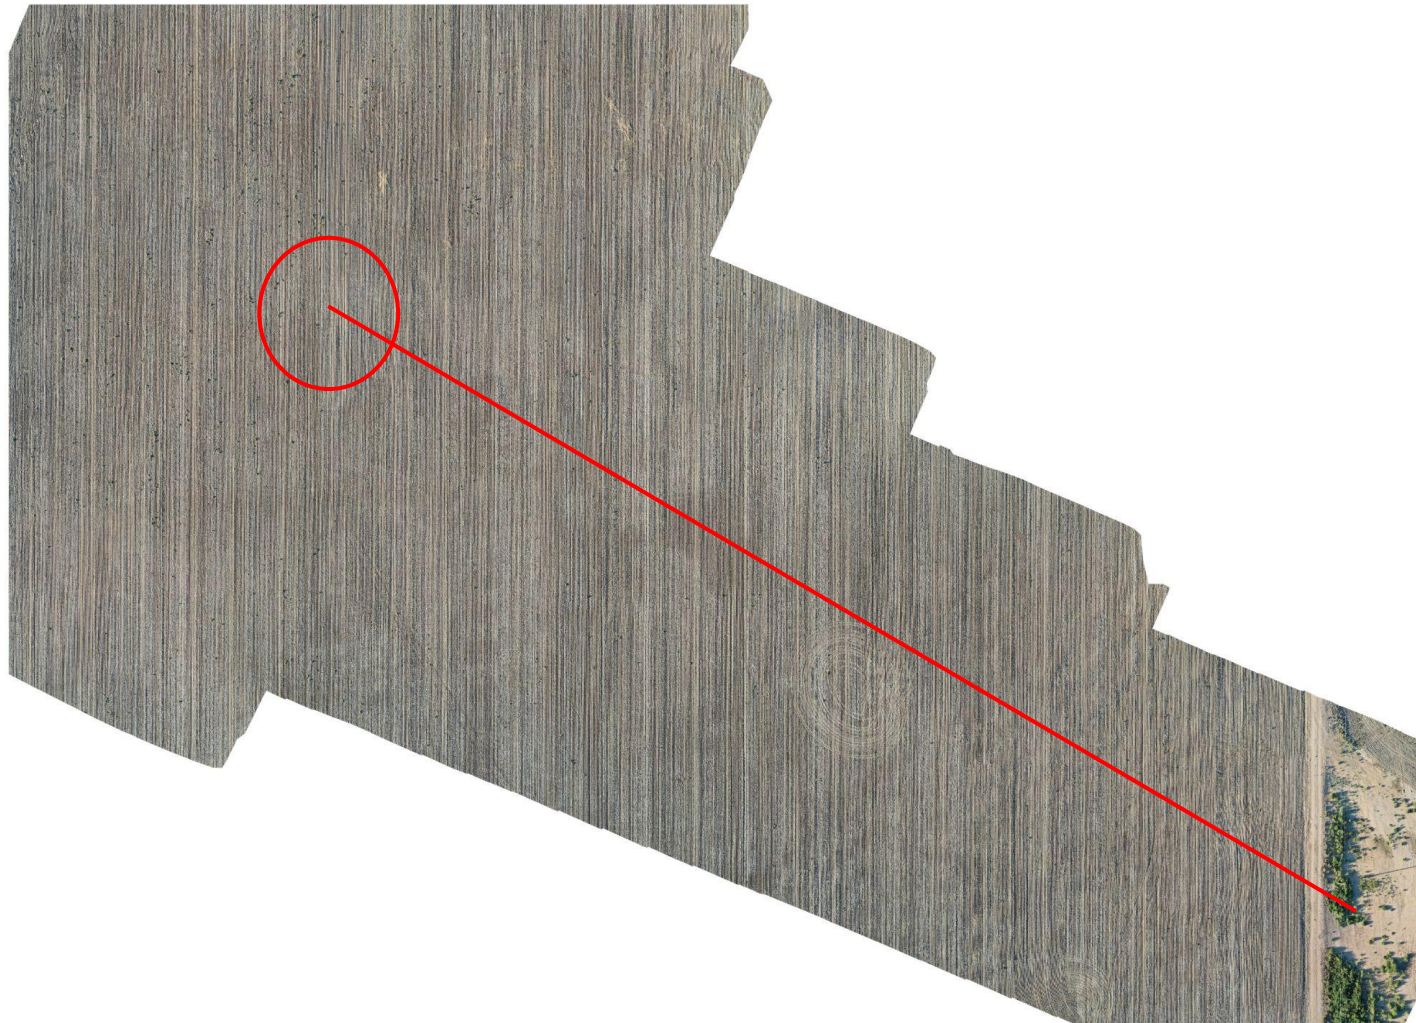
**Photo 3.** Orthomosaic drone aerial imagery taken from 200 ft (Sept. 2022). Illustrates growth on and around the well location (red circle) and flowline (red line). Tank Battery is addressed in Location 428321 report.

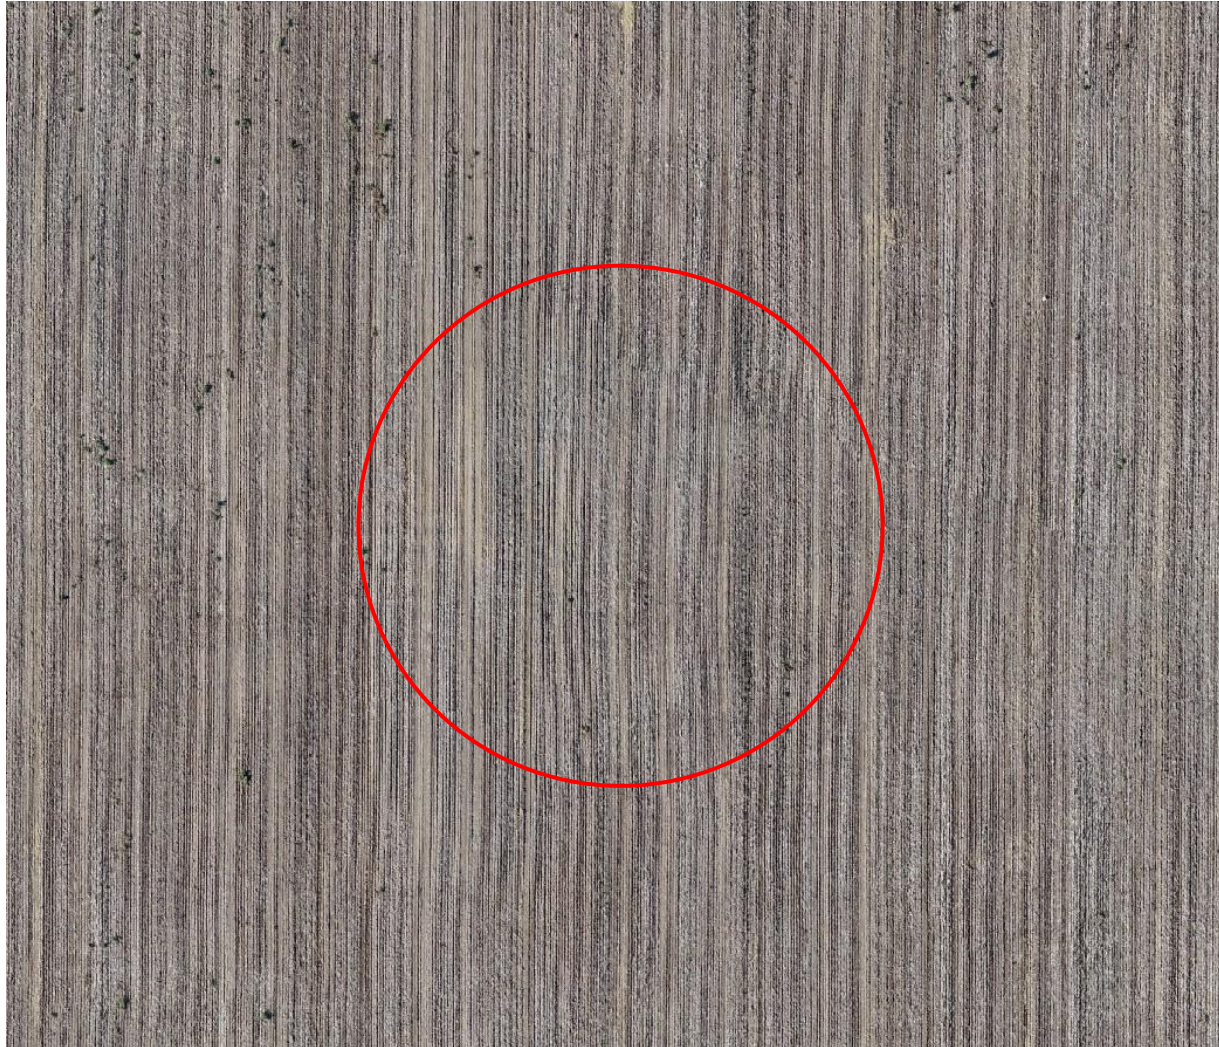
**Photo 4.** Zoomed in Orthomosaic drone aerial imagery taken from 200 ft (Sept. 2022). Photo illustrates growth on and around the well location (red circle). Appears similar to rest of area, however crop height cannot be fully evaluated. Another inspection is required when crop is actively growing.
