Final Reclamation Inspection

Operator: NOBLE ENERGY INC- 100322

Location ID: 406226

Inspection Photos
Location Name: JOHN CROISSANT UNIT 1
Location ID: 406226

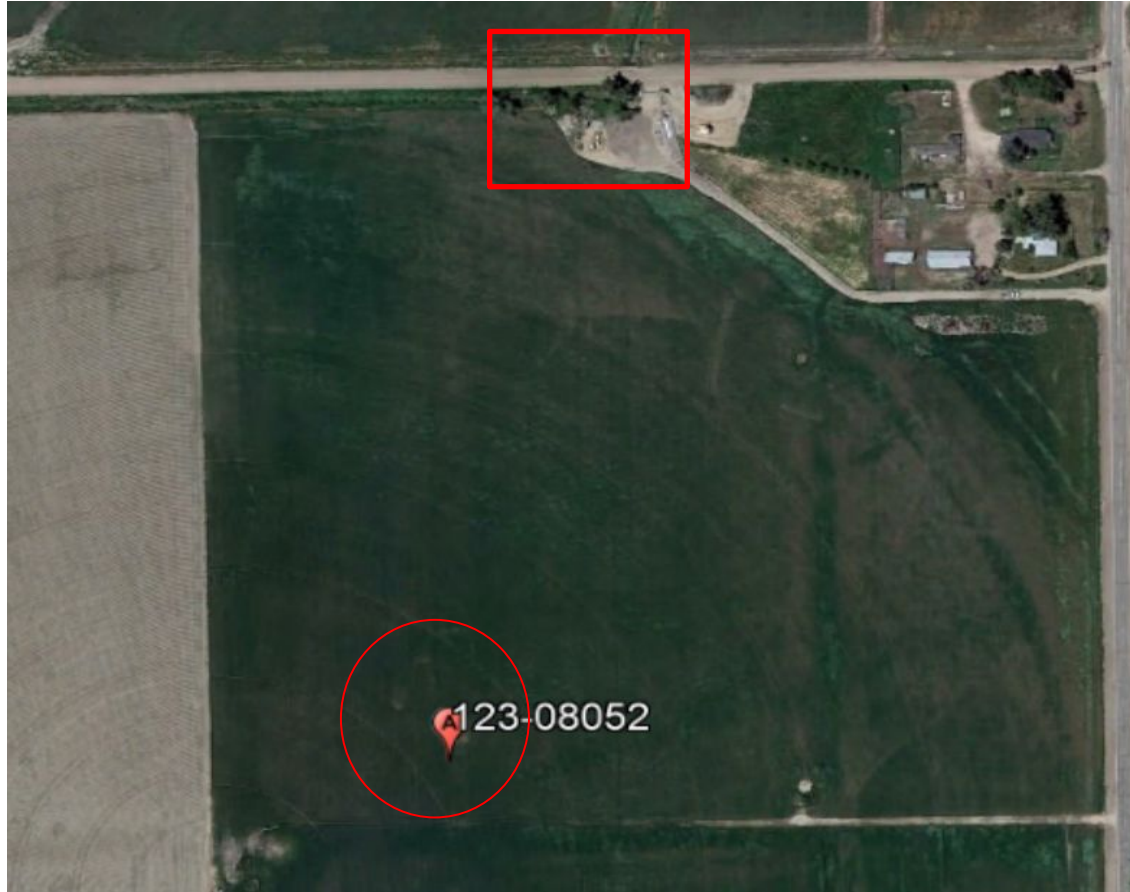
Photo 1. Google Earth aerial imagery taken 7/2019 during active operations. Photo illustrates the well location (red circle), tank battery (red square), and well location access road (white arrow).

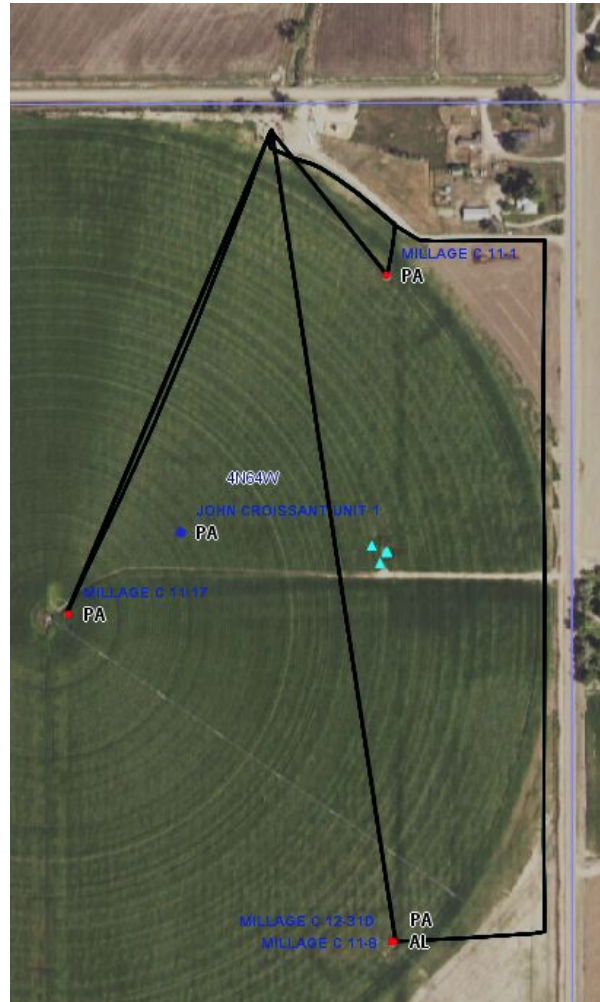
Photo 2. COGCC Online Map aerial imagery 2019 with subject well (blue dot), related wells (red dots), tank battery (north center) and flowlines (black lines).

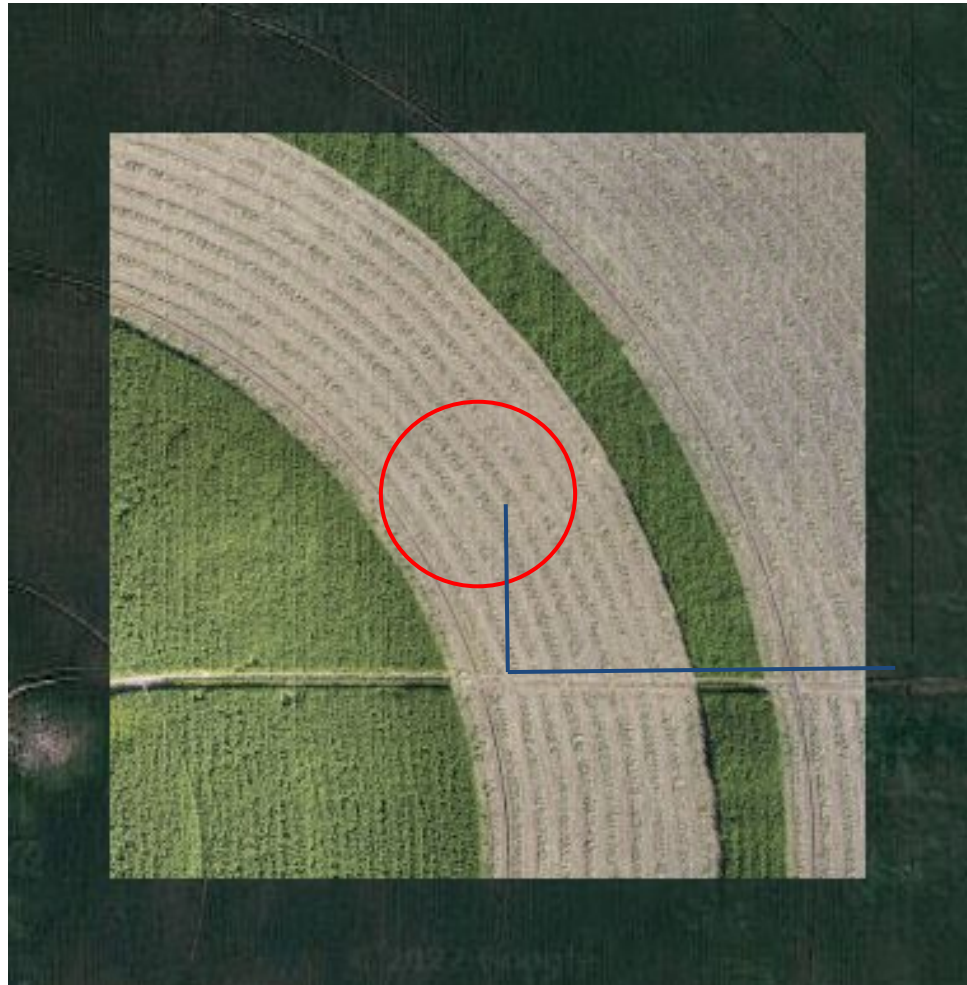
Photo 3. Orthomosaic drone aerial imagery taken from 200 ft (Oct. 2022). Illustrates harvested crop on and around the well location (red circle) and access road (blue line). Access road is shared with active agriculture. Tank Battery is addressed in Location 305601 report.

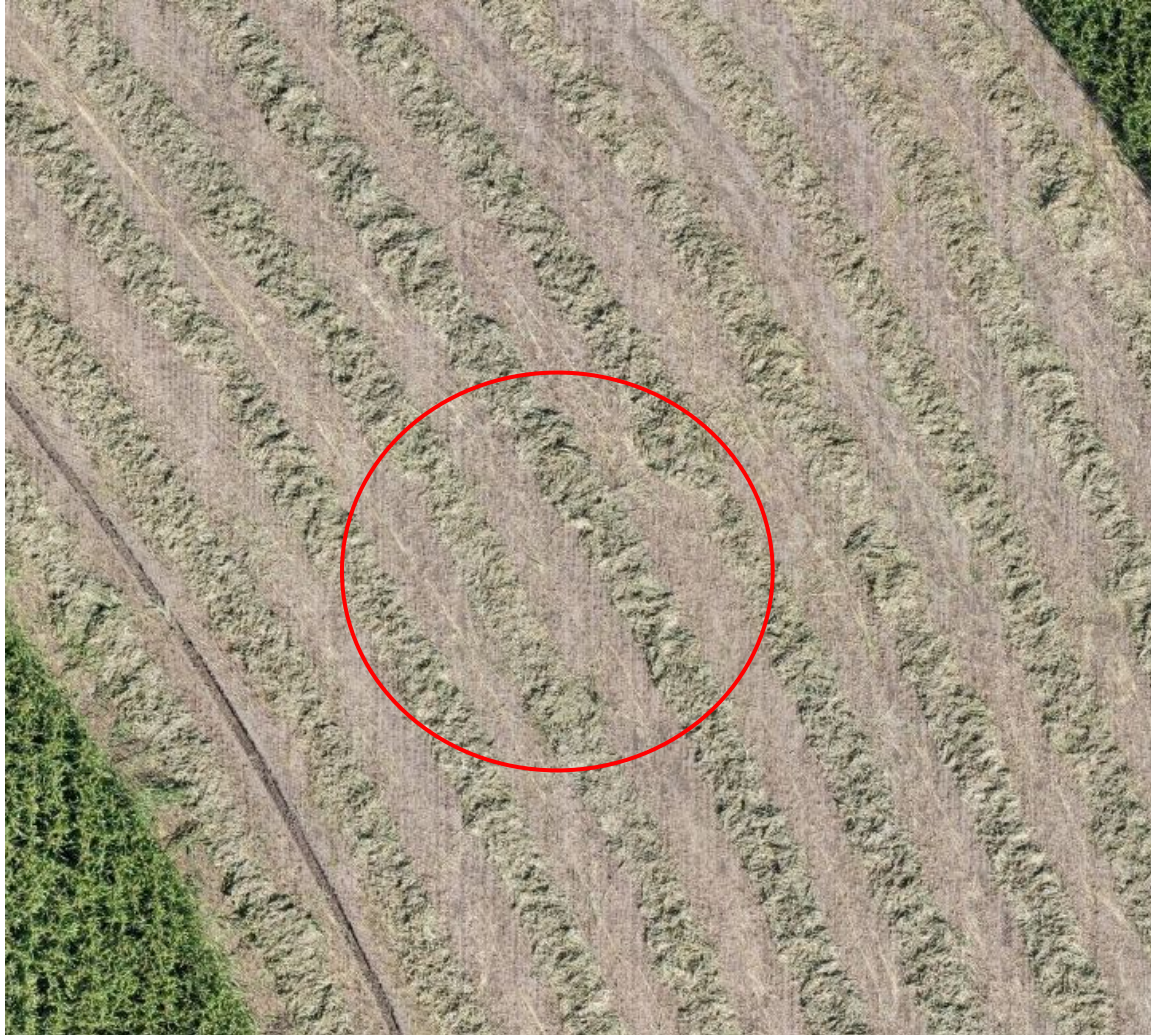
Photo 4. Zoomed in Orthomosaic taken from 200 ft (Oct. 2022). Illustrates harvested crop on and around the well location (red circle). Appears similar to rest of area, however crop height cannot be fully evaluated. Another inspection is required when crop is actively growing.
