Final Reclamation Inspection

Operator: NOBLE ENERGY INC- 100322

Location ID: 332009

Inspection Photos
Location Name: HOSHIKO B *35-23
Location ID: 332009

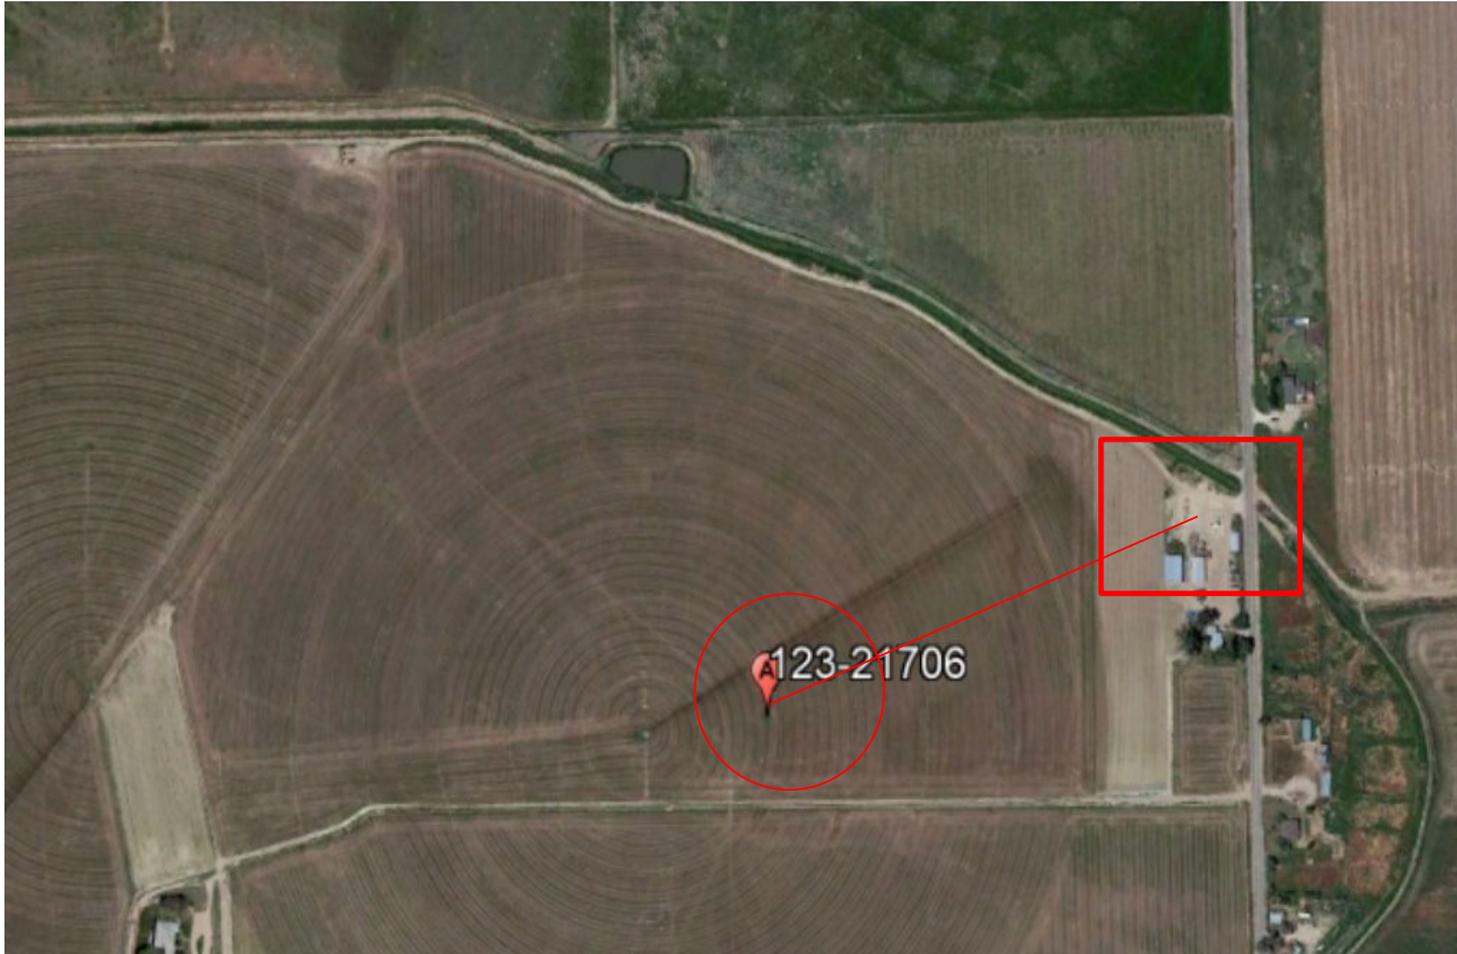
Photo 1. Google Earth aerial imagery taken 6/2016 during active operations. Photo illustrates the well location (red circle), tank battery (red square), and flowline (red line).

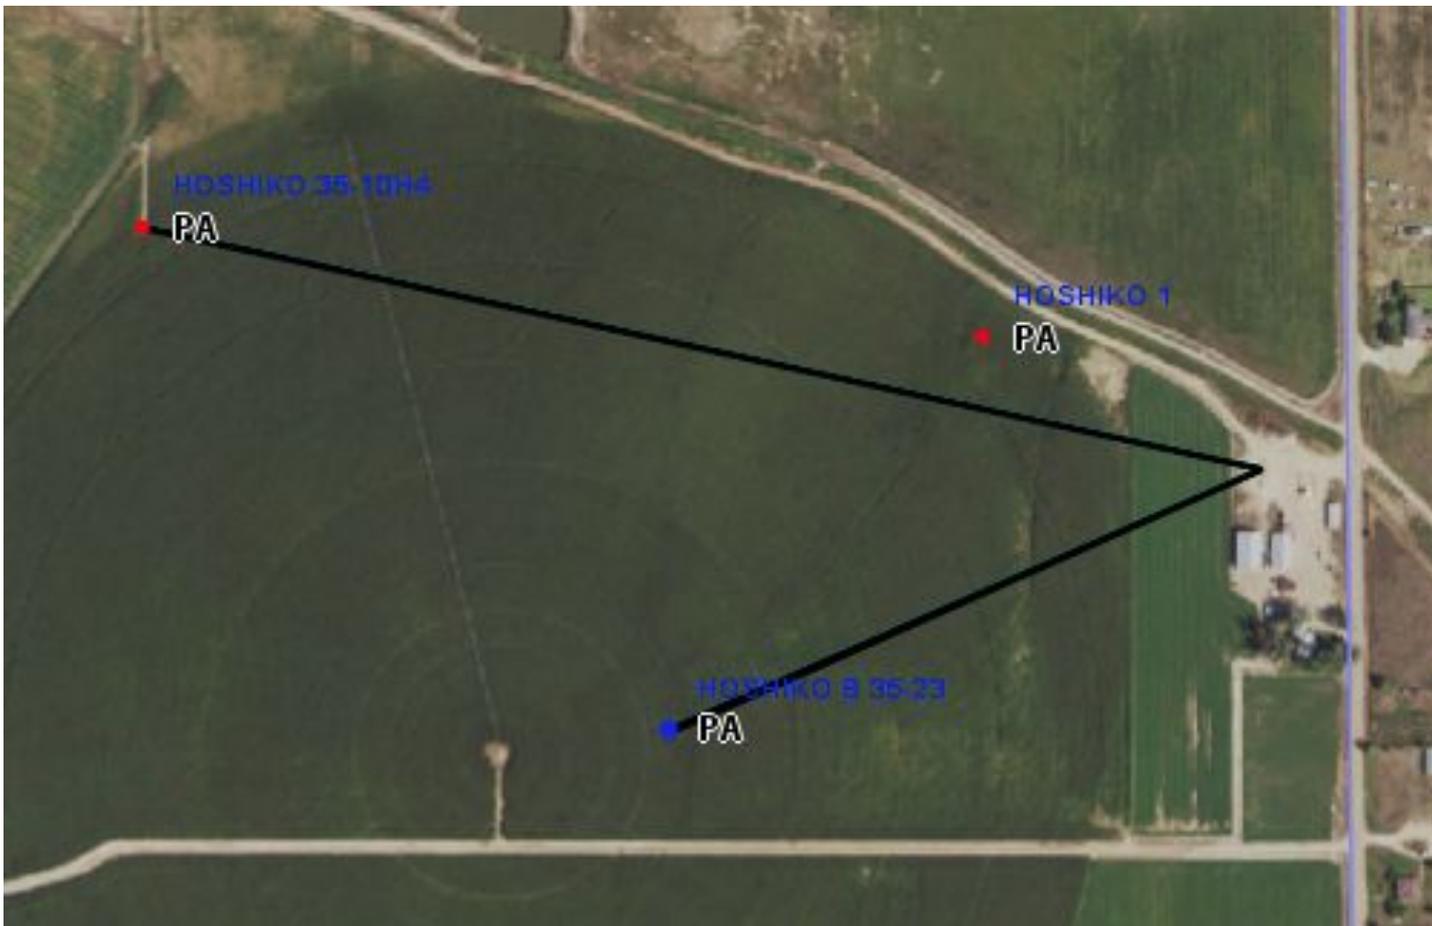
Photo 2. COGCC Online Map aerial imagery 2019 with subject well (blue dot), related wells (red dots), tank battery (northwest) and flowlines (black lines).

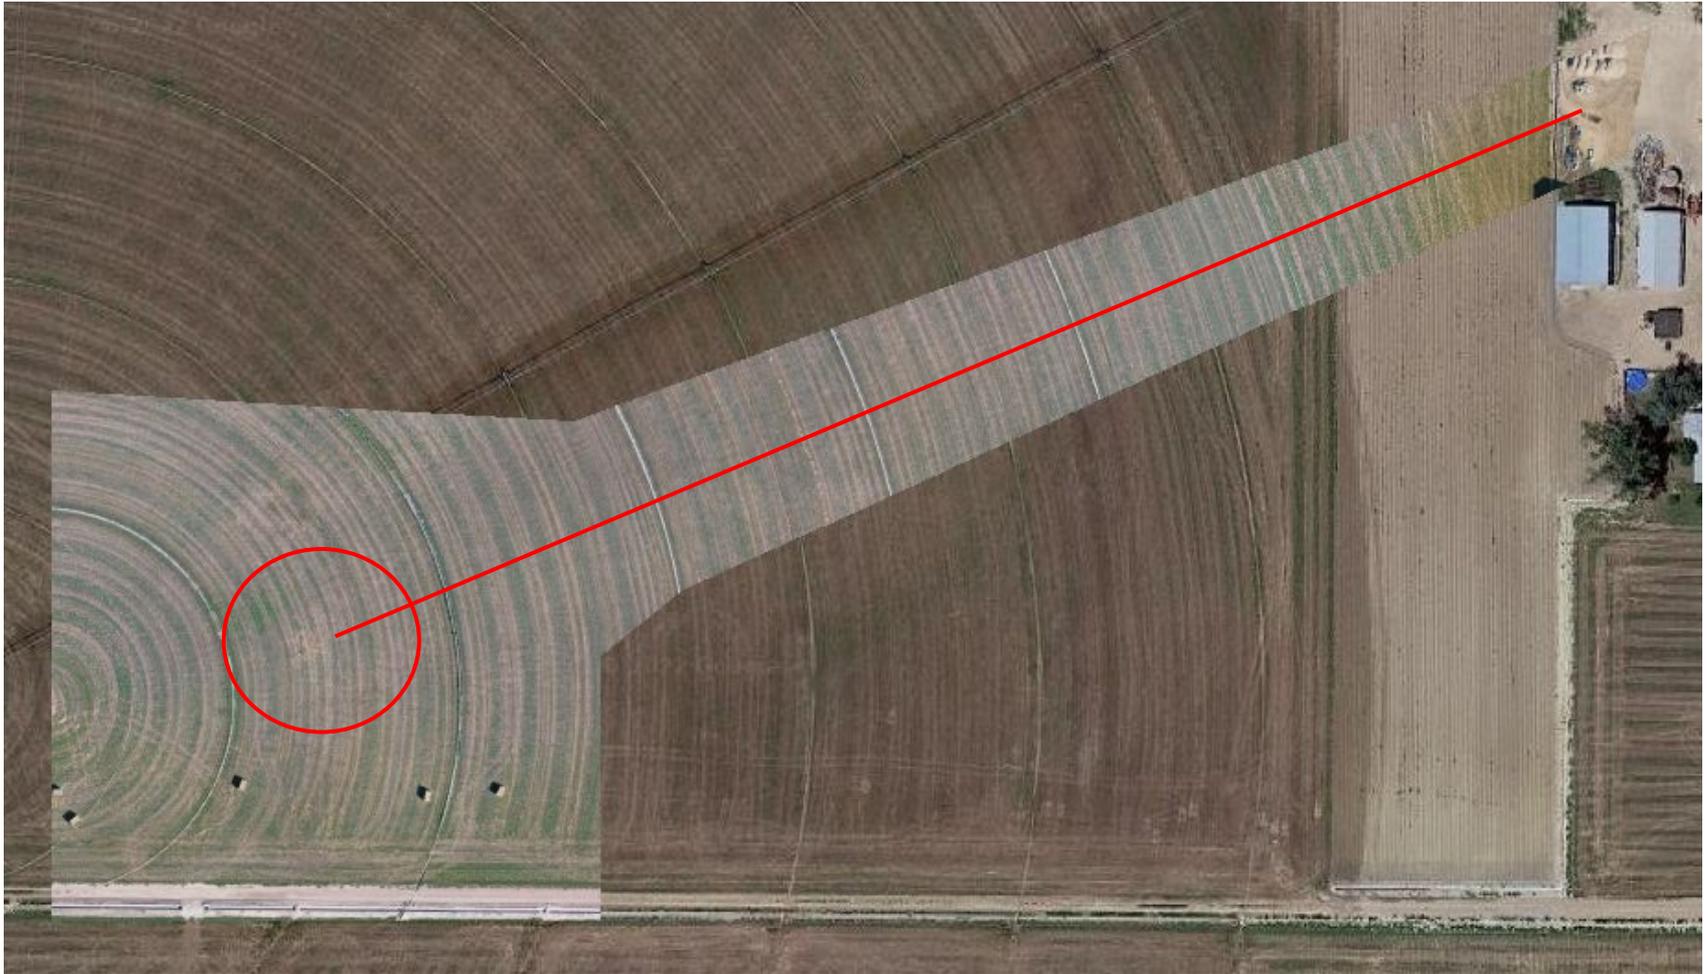
Photo 3. Orthomosaic drone aerial imagery taken from 200 ft (Oct. 2022). Illustrates harvested crop on and around the well location (red circle) and flowline (red line). No access road visible. Tank Battery is addressed in Location 329723 report.

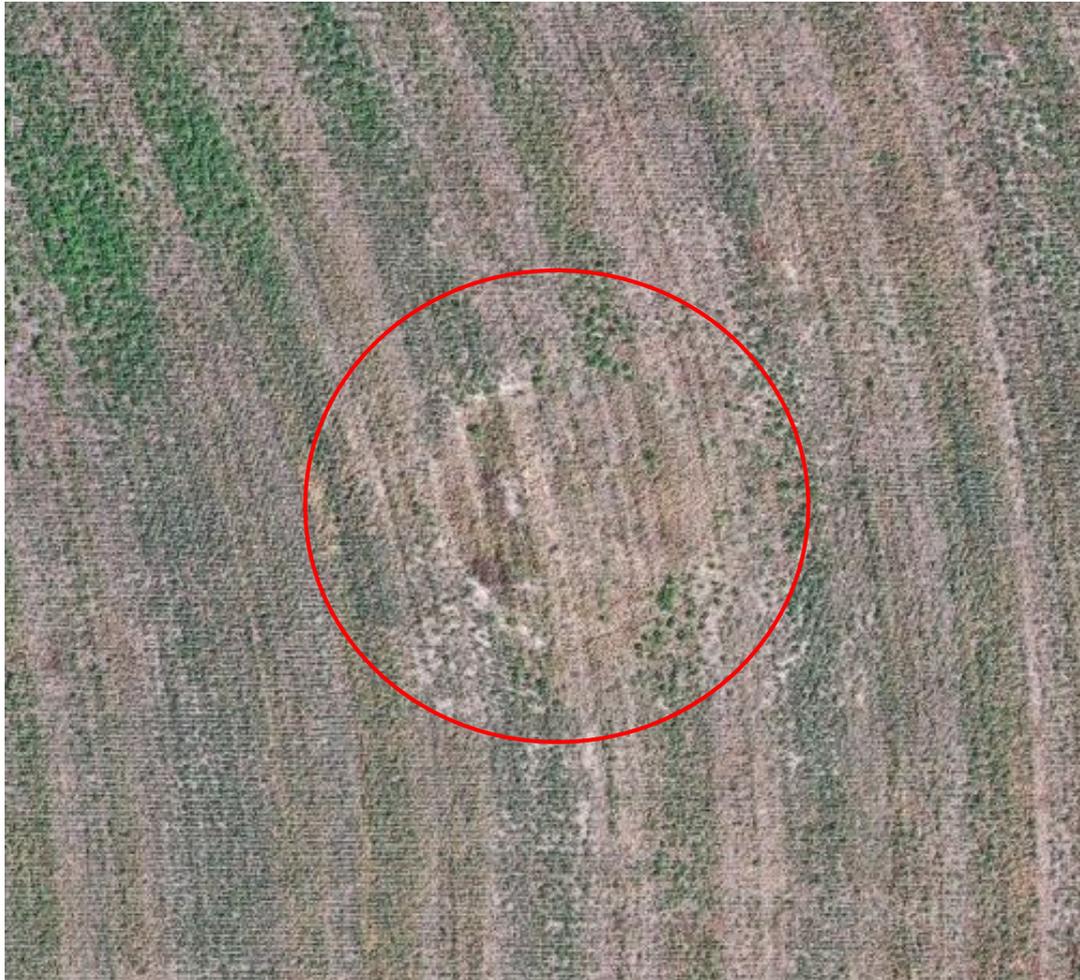
Photo 4. Zoomed in Orthomosaic taken from 200 ft (Oct. 2022). Illustrates harvested crop on and around the well location (red circle). Well scar is minimally visible; however crop height cannot be fully evaluated. Another inspection is required when crop is actively growing.
