# Final Reclamation Inspection

Operator: NOBLE ENERGY INC- 100322

Location ID: 329195

Inspection Photos  
Location Name: STINAR \*14-8  
Location ID: 329195

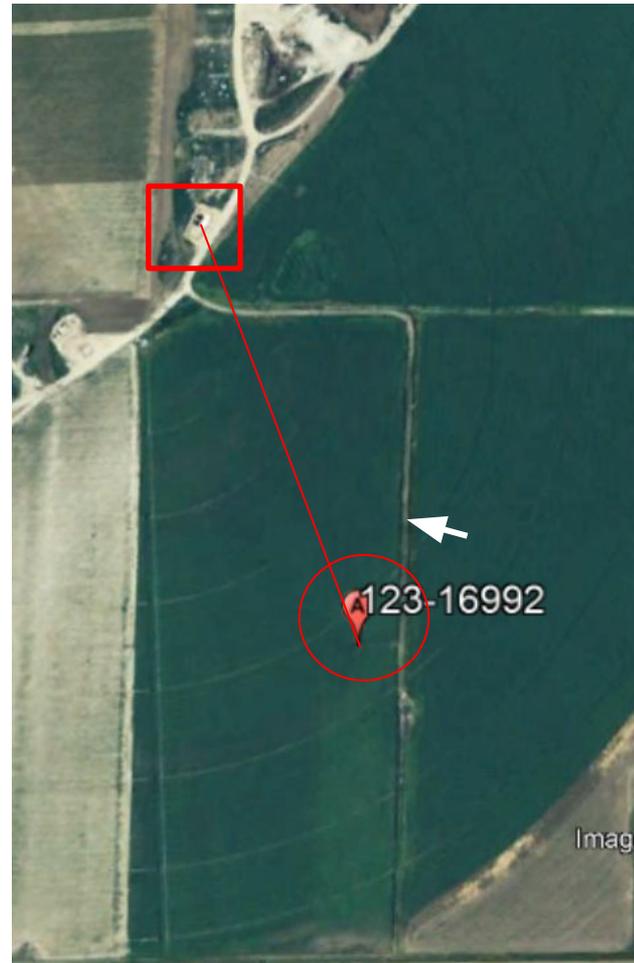
**Photo 1.** Google Earth aerial imagery taken 8/2011 during active operations. Photo illustrates the well location (red circle), tank battery (red square), flowline (red line), and well location access road (white arrow).

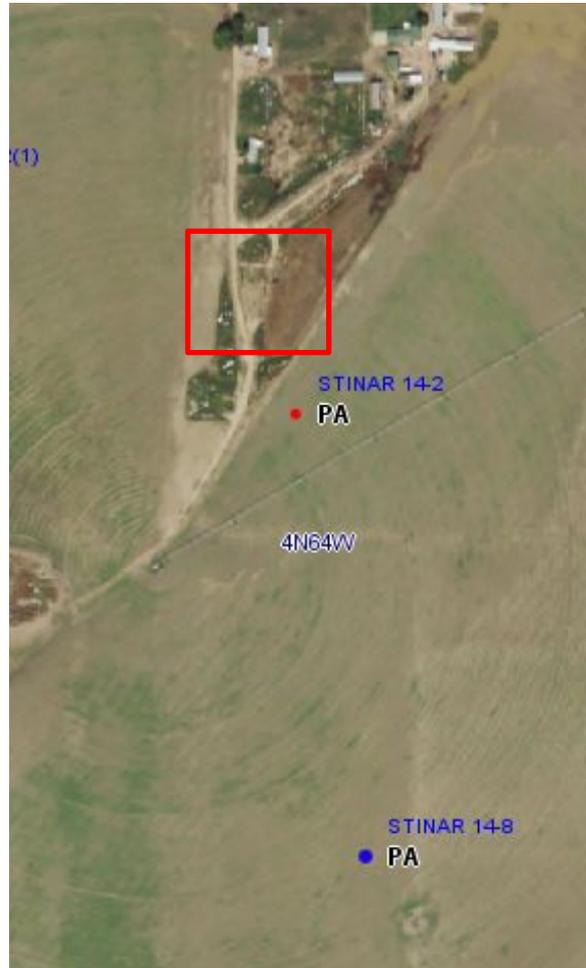
**Photo 2.** COGCC Online Map aerial imagery 2019 with subject well (blue dot), related wells (red dots), tank battery (red rectangle) and flowlines (black lines).

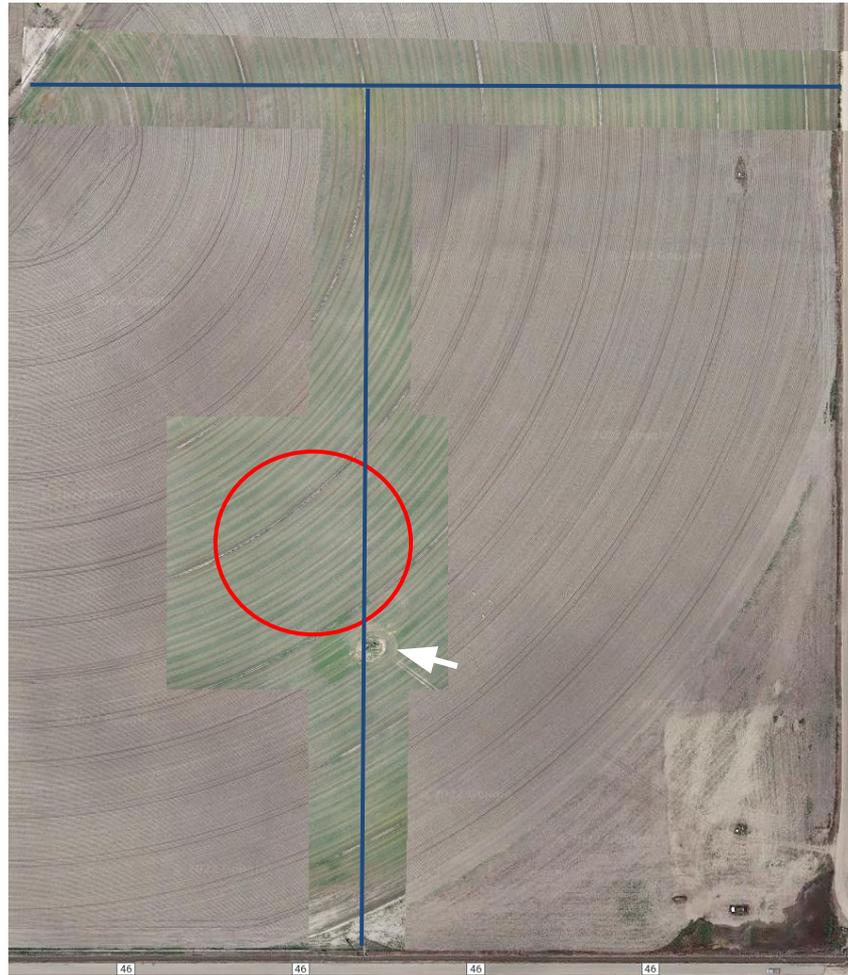
**Photo 3.** Orthomosaic drone aerial imagery taken from 200 ft (Oct. 2022). Illustrates harvested crop on and around the well location (red circle) and access road (blue line). Tank Battery is addressed in Location 323230 report. Agriculture irrigation well near site (white arrow)

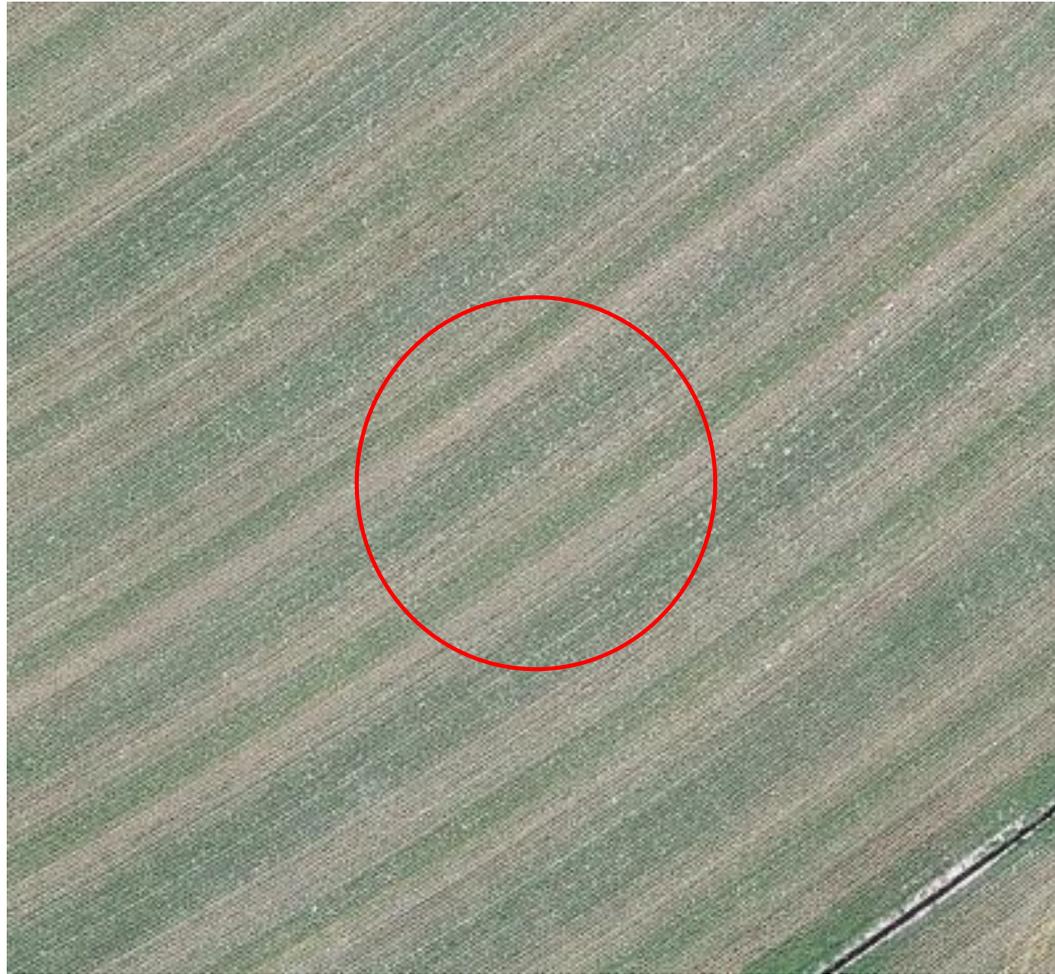
**Photo 4.** Zoomed in Orthomosaic taken from 200 ft (Oct. 2022). Illustrates harvested crop on and around the well location (red circle). Appears similar to rest of area, however crop height cannot be fully evaluated. Another inspection is required when crop is actively growing.

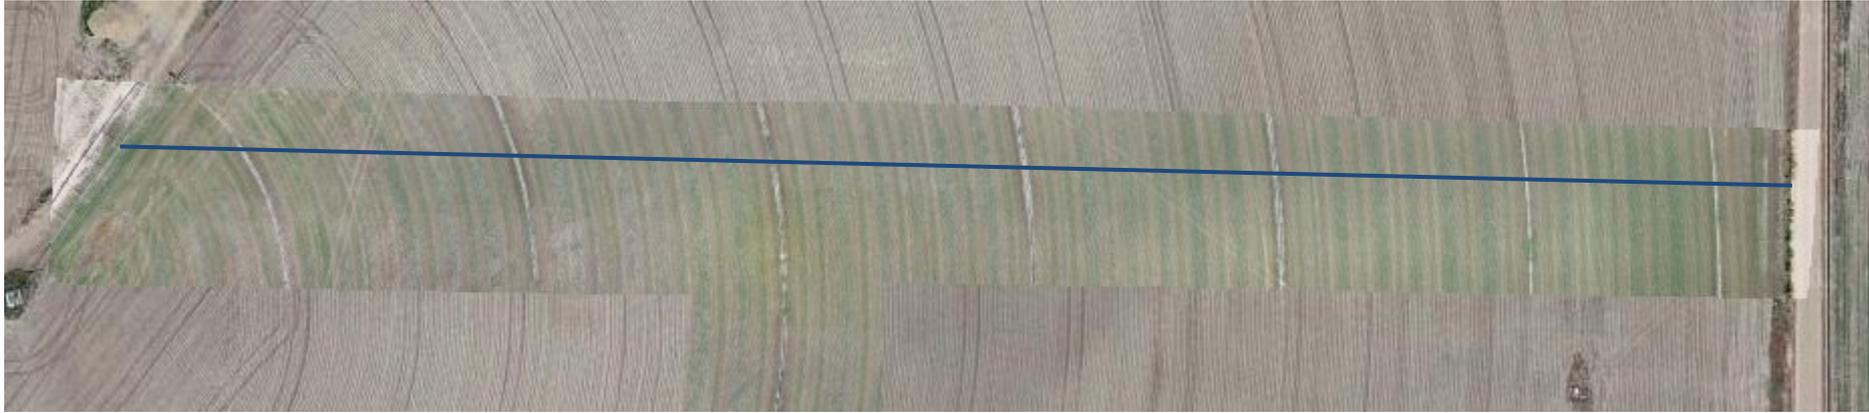
**Photo 5.** Zoomed in Orthomosaic taken from 200 ft (Oct. 2022). Illustrates harvested crop on and around access road. Road does not appear to be present and has been reclaimed (area below blue line). Appears similar to rest of area, however crop height cannot be fully evaluated. Another inspection is required when crop is actively growing.

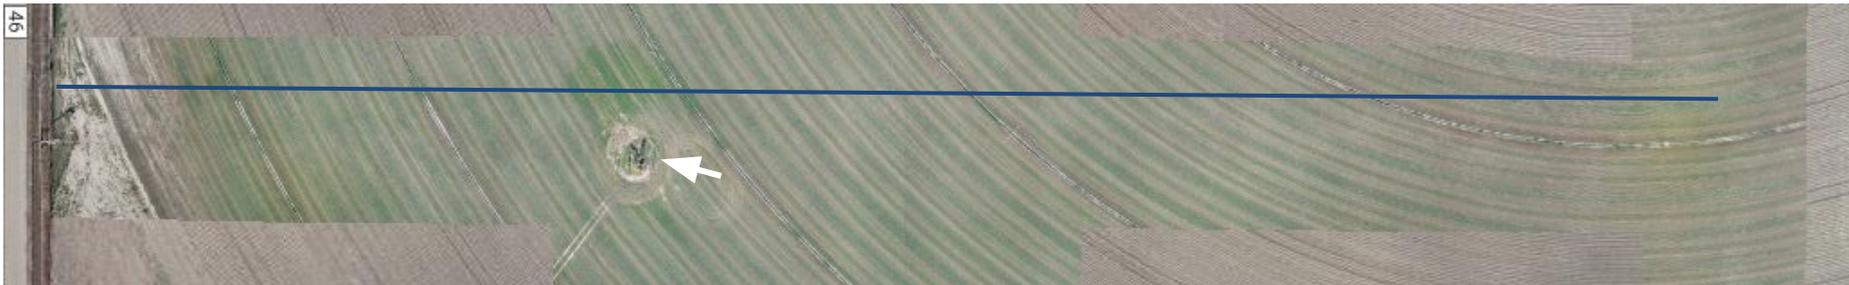
**Photo 6.** Zoomed in Orthomosaic taken from 200 ft (Oct. 2022). Illustrates harvested crop on and around access road. Road does not appear to be present and has been reclaimed (area below blue line). Agriculture irrigation well (white arrow).
