Final Reclamation Inspection

Operator: KERR MCGEE OIL & GAS ONSHORE LP -
47120

Location ID: 305817

Inspection Photos
Location Name: B & M *31-5
Location ID: 305817

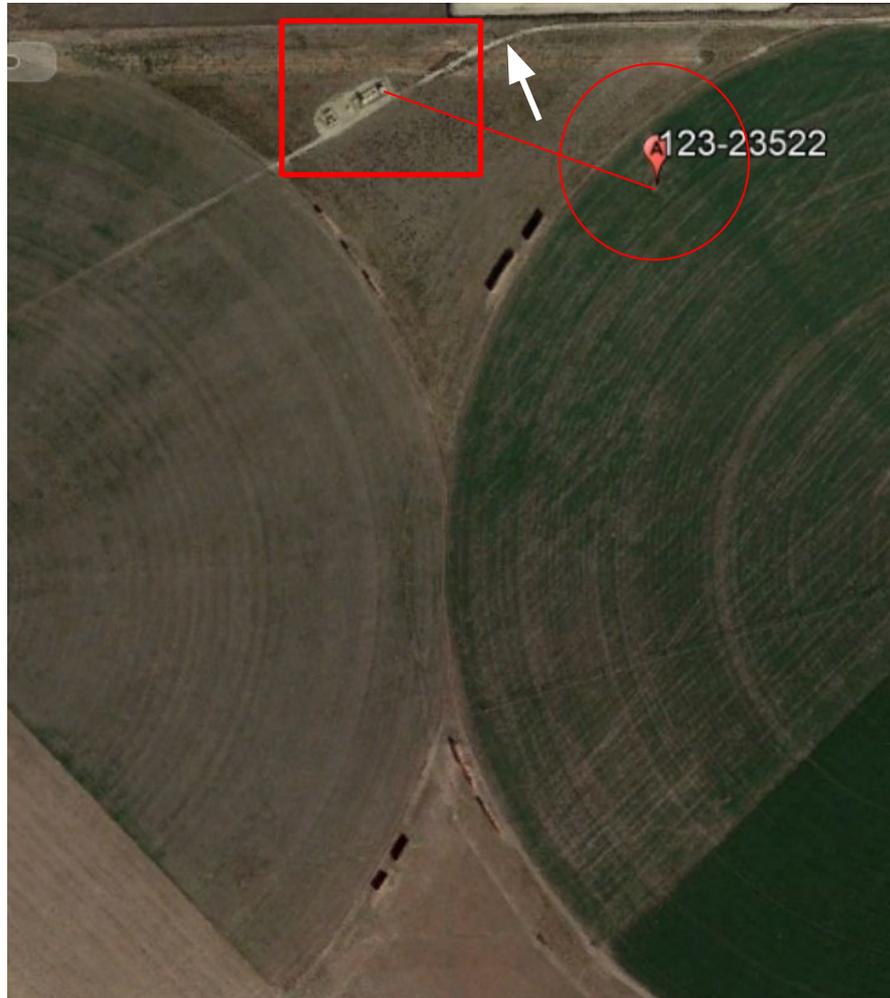
Photo 1. Google Earth aerial imagery taken 10/2015 during active operations. Photo illustrates the well location (red circle), tank battery (red square), and well location access road (white arrow).

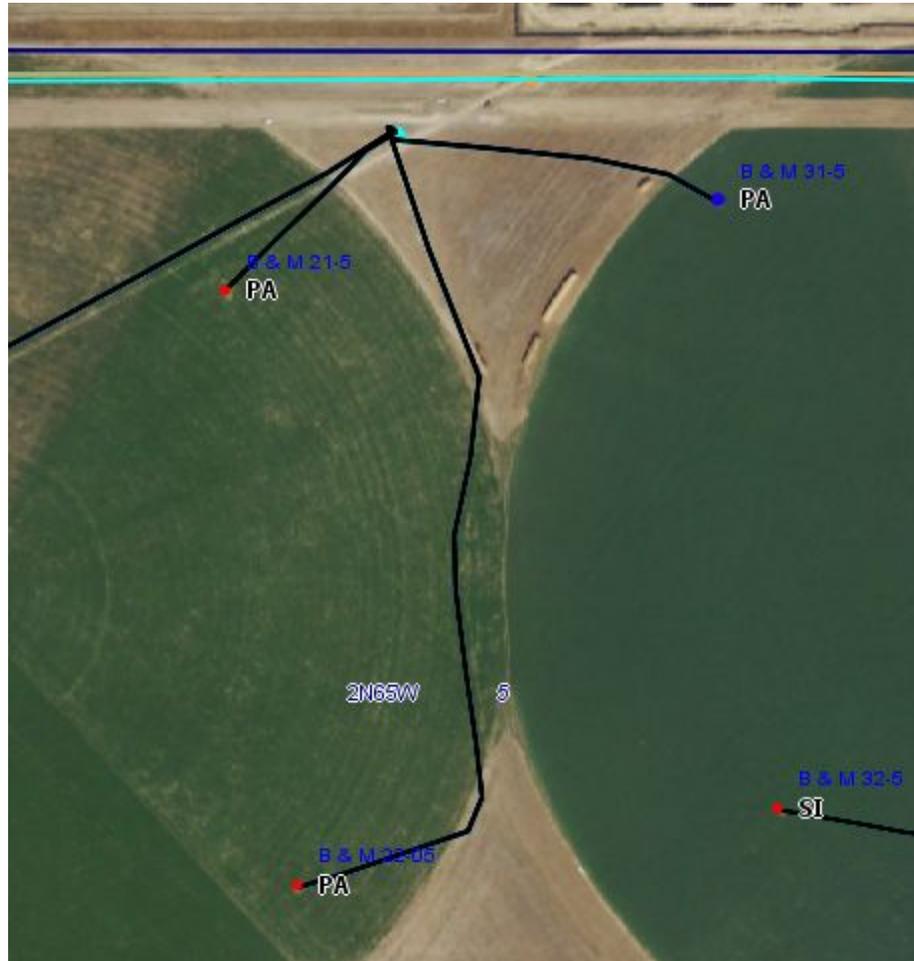
Photo 2. COGCC Online Map aerial imagery 2019 with subject well (blue dot), related wells (red dots), tank battery (north center) and flowlines (black lines).

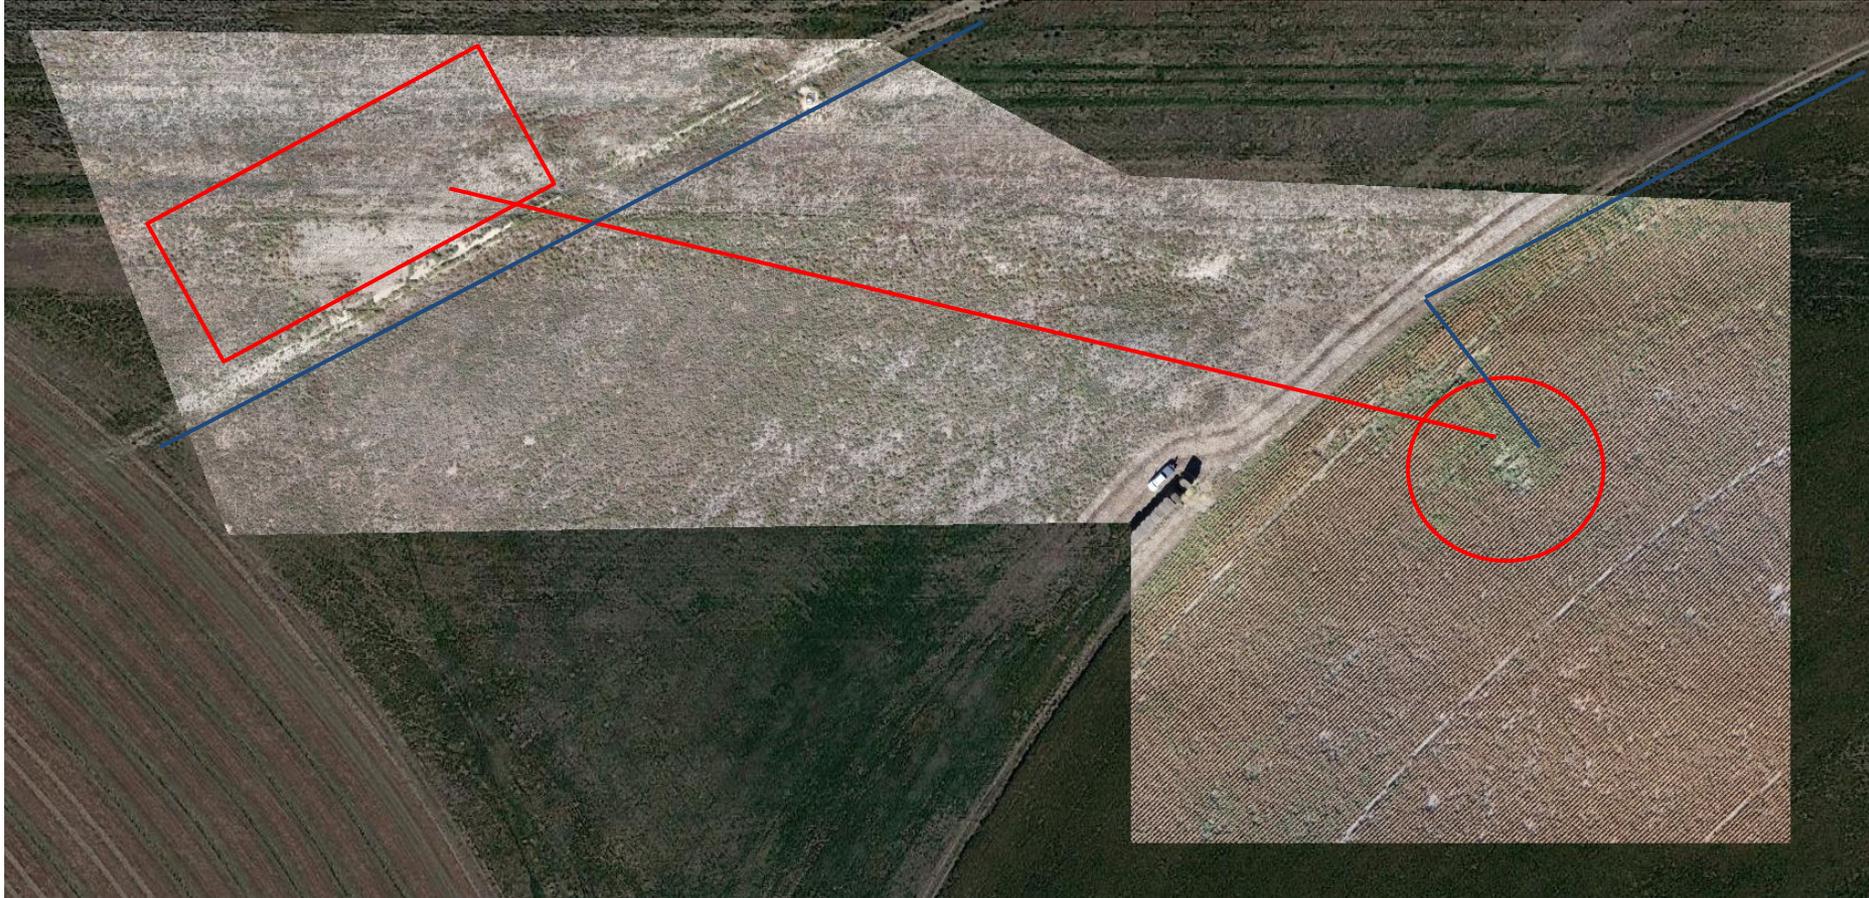
Photo 3. Orthomosaic drone aerial imagery taken from 200 ft (Oct. 2022). Illustrates mature crop (ready to harvest) on and around the well location (red circle), road (blue line) and flowline. Tank battery (red rectangle) and most of access road are between two fields in the corners, rangeland.

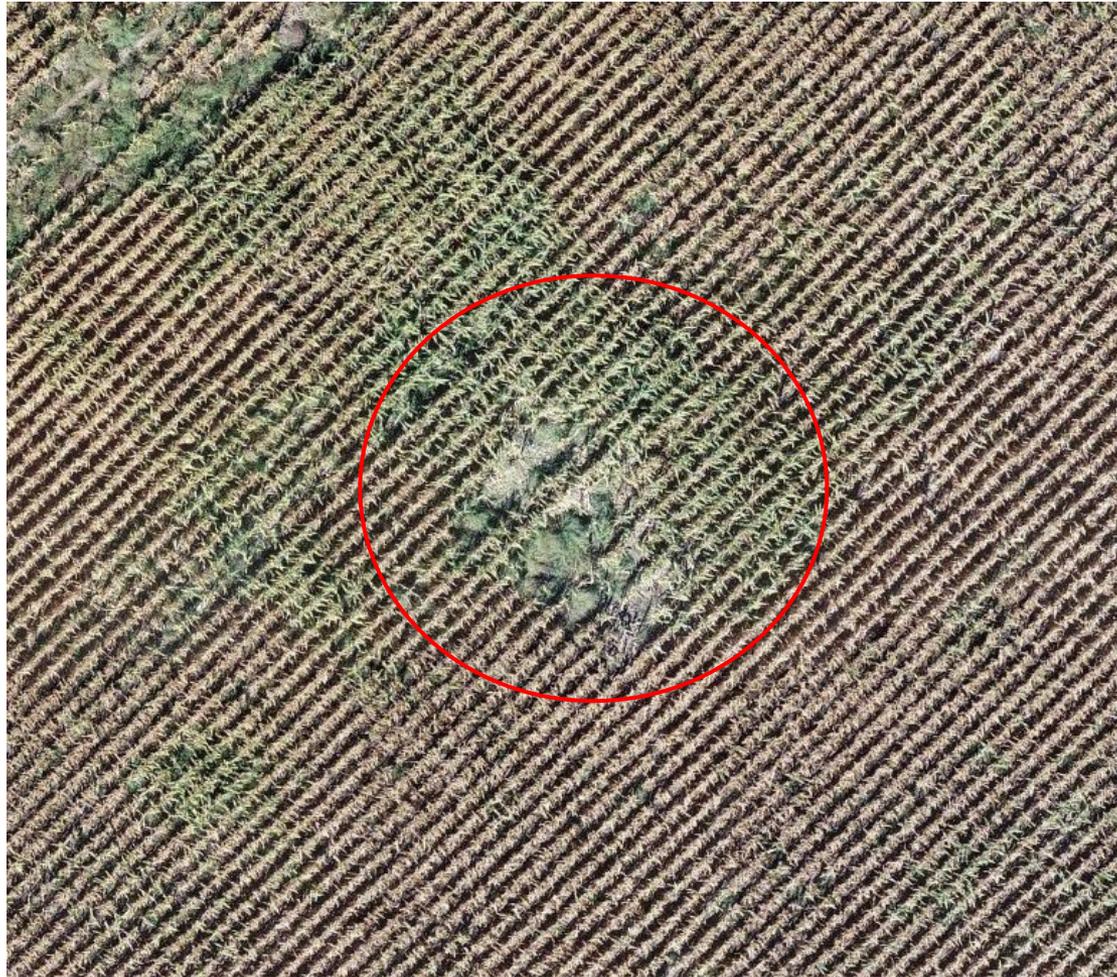
Photo 4. Zoomed in Orthomosaic taken from 200 ft (Oct. 2022). Illustrates mature crop (ready to harvest) on and around the well location (red circle). At well location undesirable plants are more prevalent than crops.

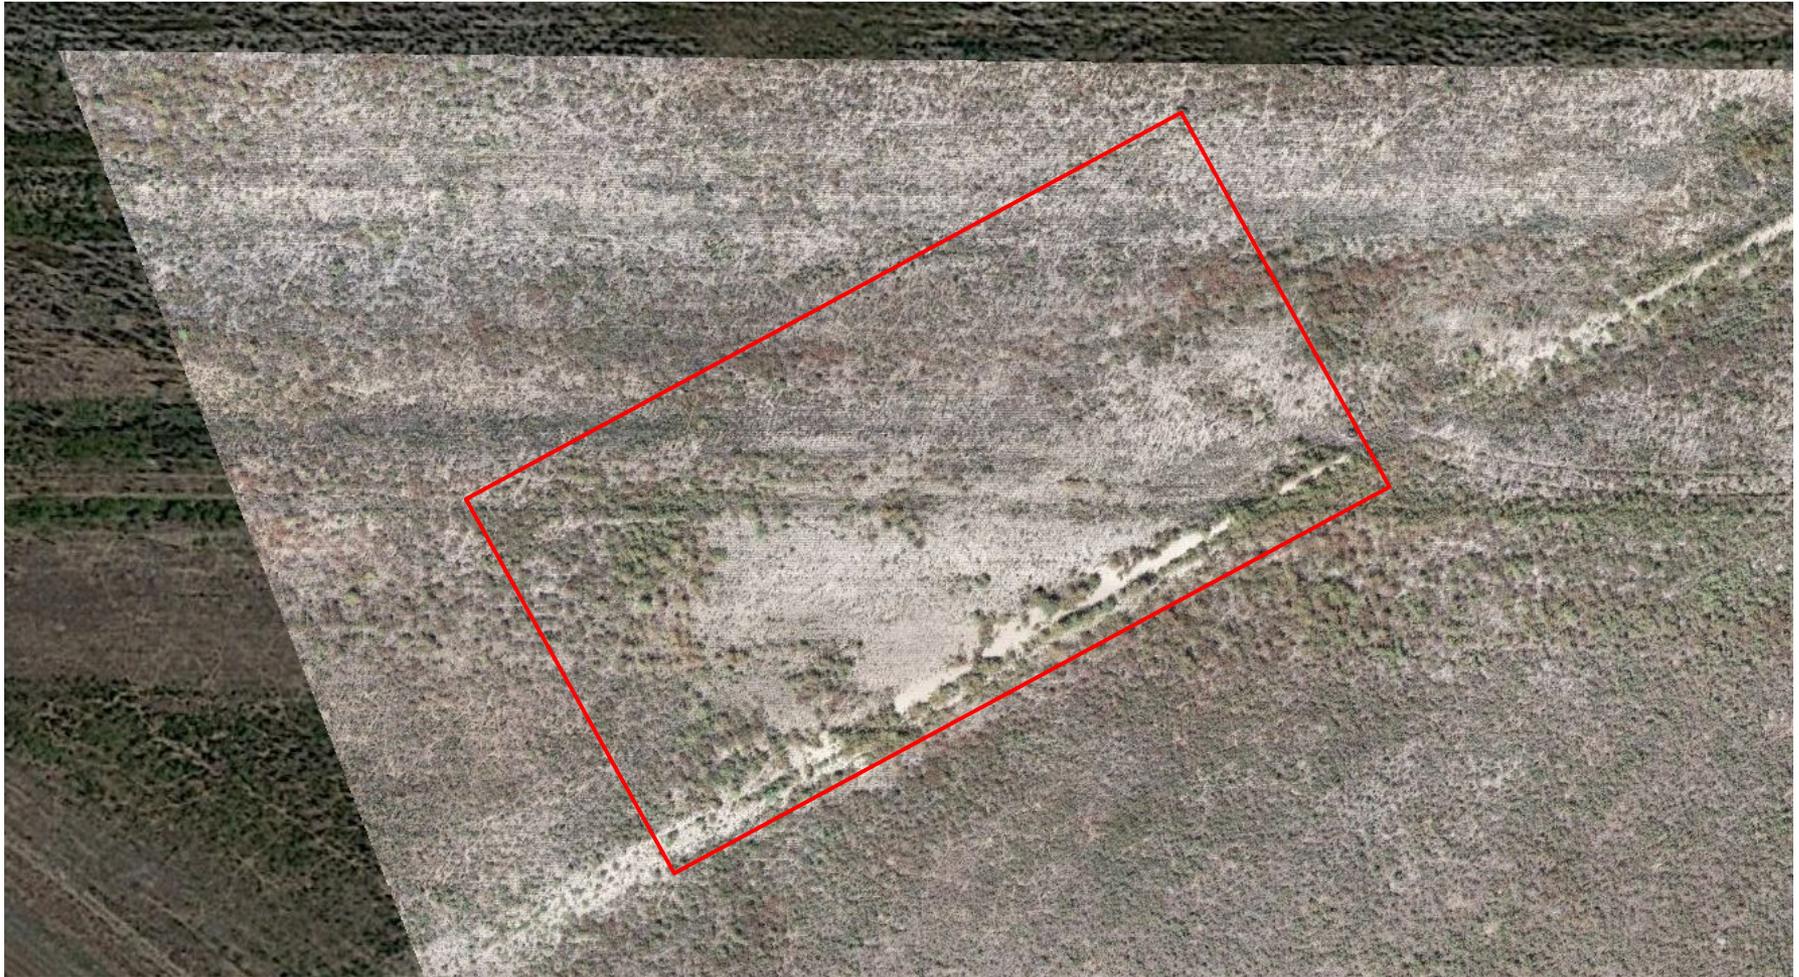
Photo 5. Zoomed in Orthomosaic taken from 200 ft (Oct. 2022). Illustrates some growth on and around the tank battery (red rectangle) but bare dirt prevalent.
