Final Reclamation Inspection

Operator: KERR MCGEE OIL & GAS ONSHORE LP -
47120

Location ID: 305704

Inspection Photos
Location Name: B & M *22-05
Location ID: 305704

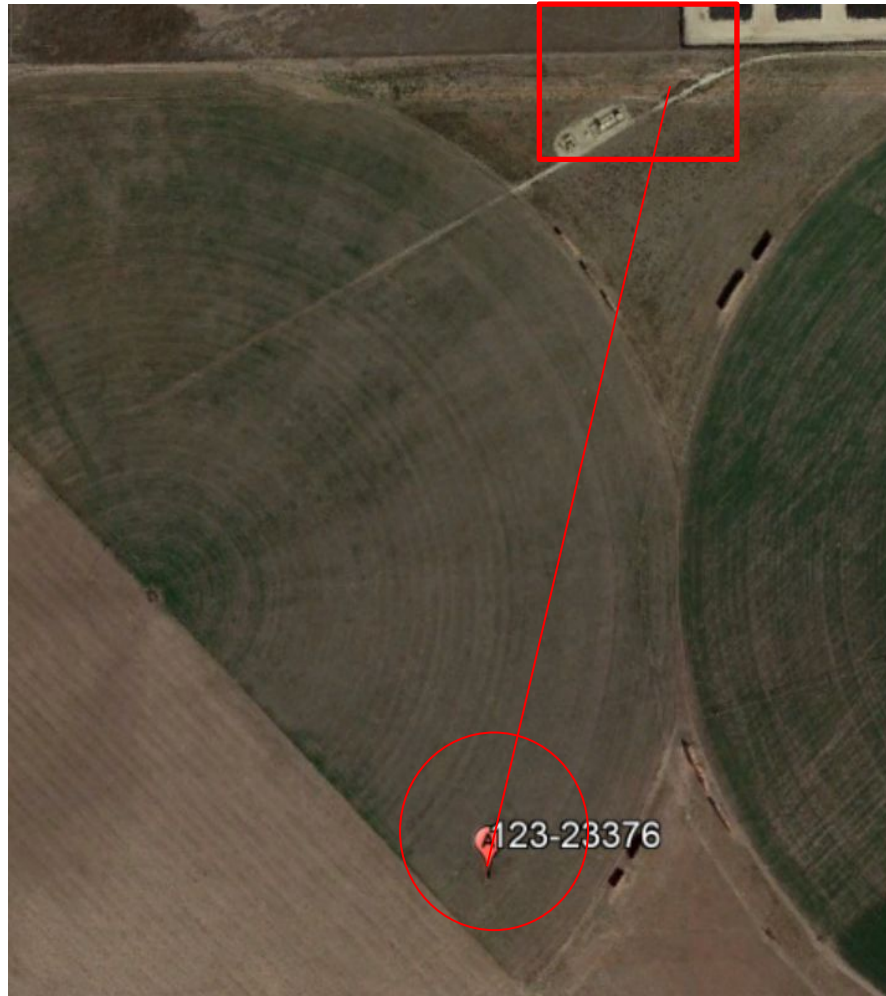
Photo 1. Google Earth aerial imagery taken 10/2015 during active operations. Photo illustrates the well location (red circle), tank battery (red square), and flowline (red line).

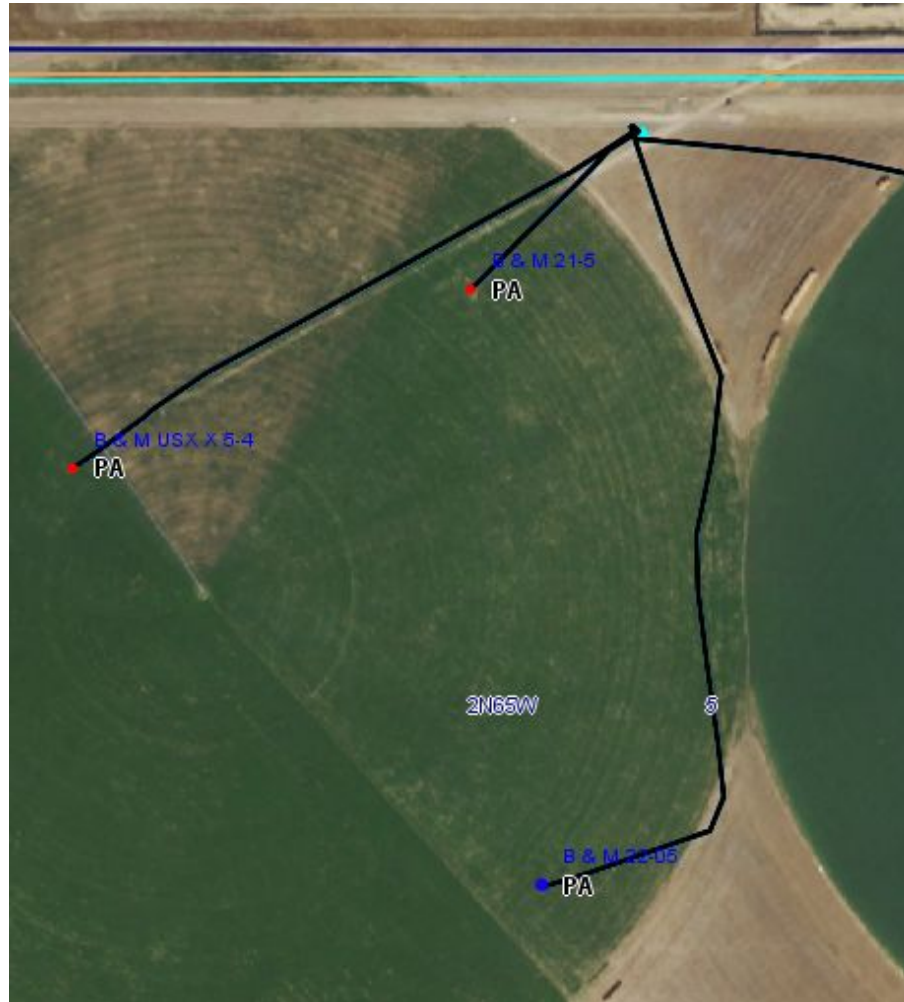
Photo 2. COGCC Online Map aerial imagery 2019 with related wells (red dots), subject well (blue dot), tank battery (near northeast corner) and flowlines (black lines).

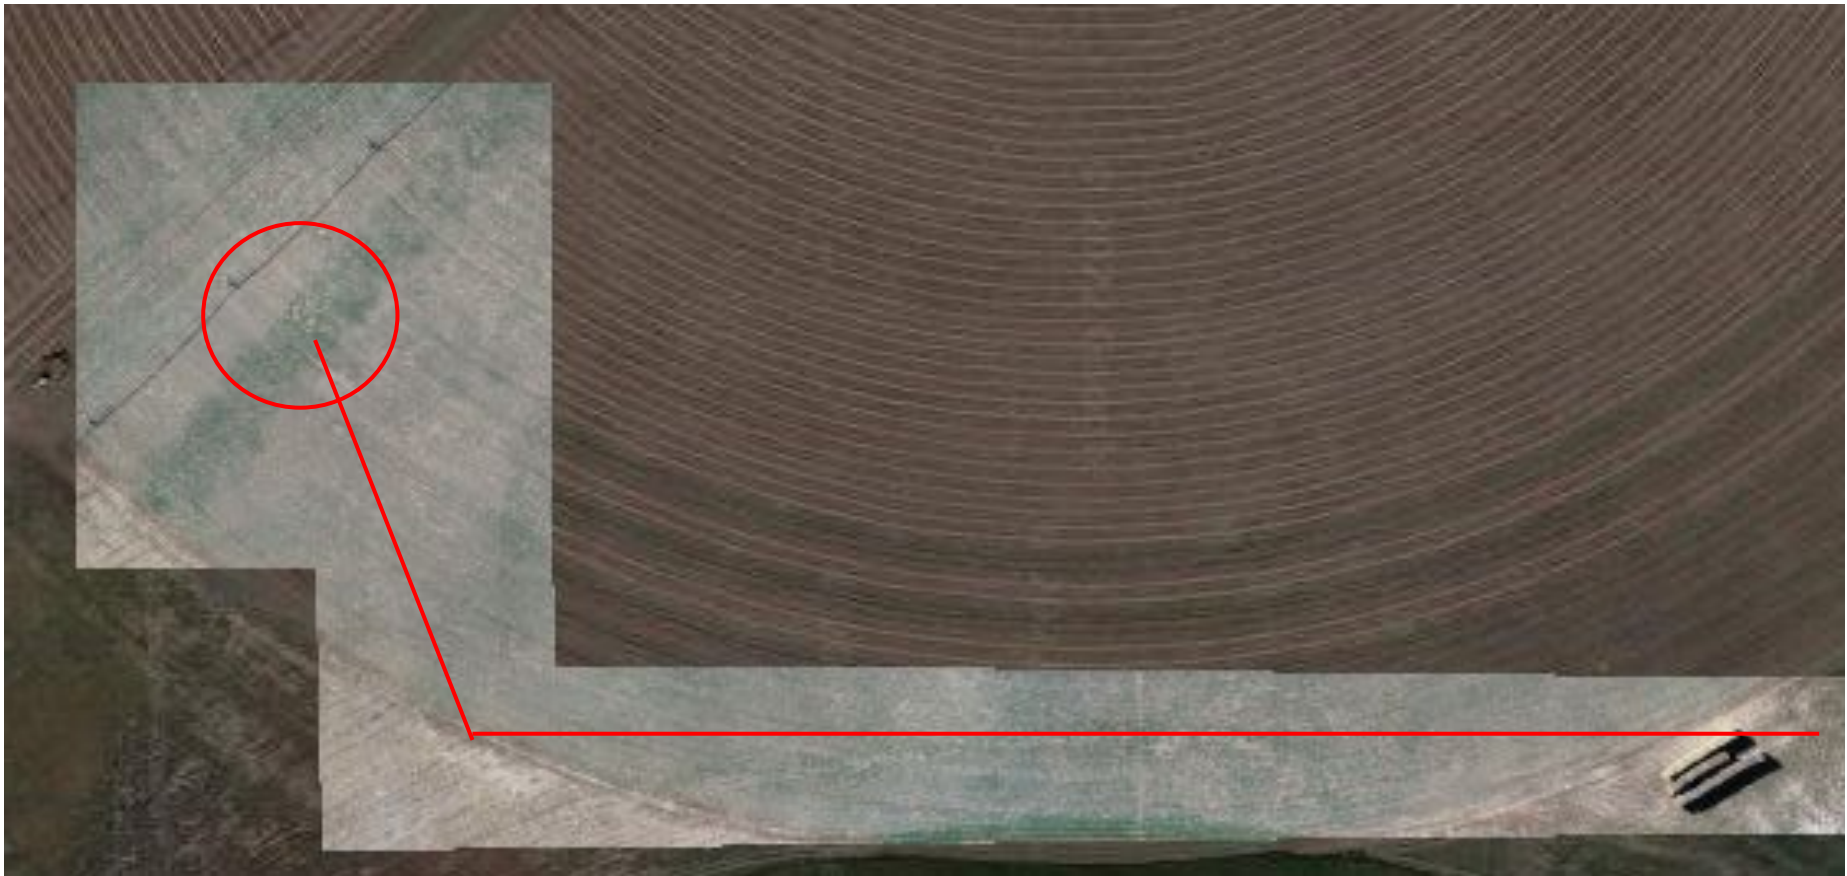
Photo 3. Orthomosaic drone aerial imagery taken from 200 ft (Oct. 2022). Illustrates growth on and around the well location (red circle) and flowline (red line). No access road visible. Tank Battery is addressed in Location 305817 report.

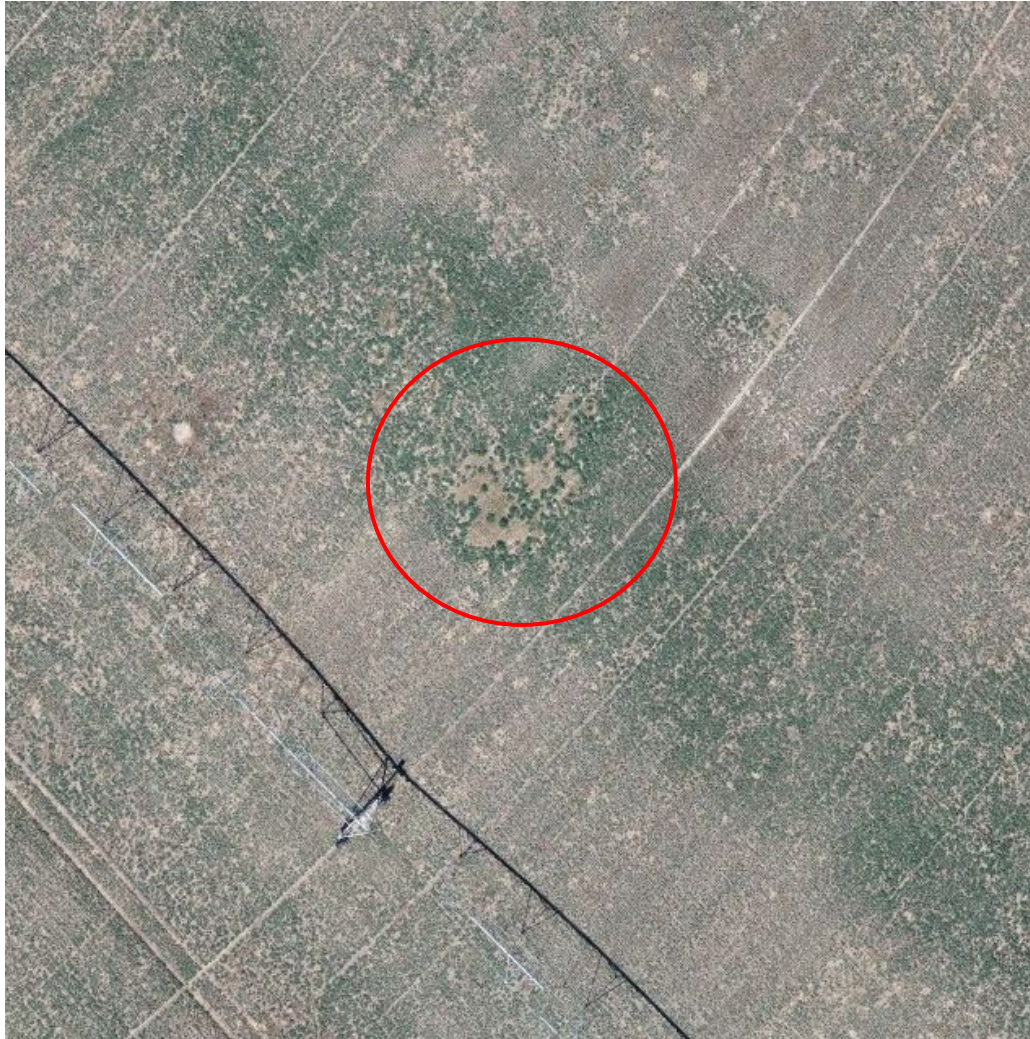
Photo 4. Zoomed in Orthomosaic taken from 200 ft (Oct. 2022). Illustrates harvested crop on and around the well location (red circle). Shows signs of sparse crop coverage and undesirable plants are more prevalent.

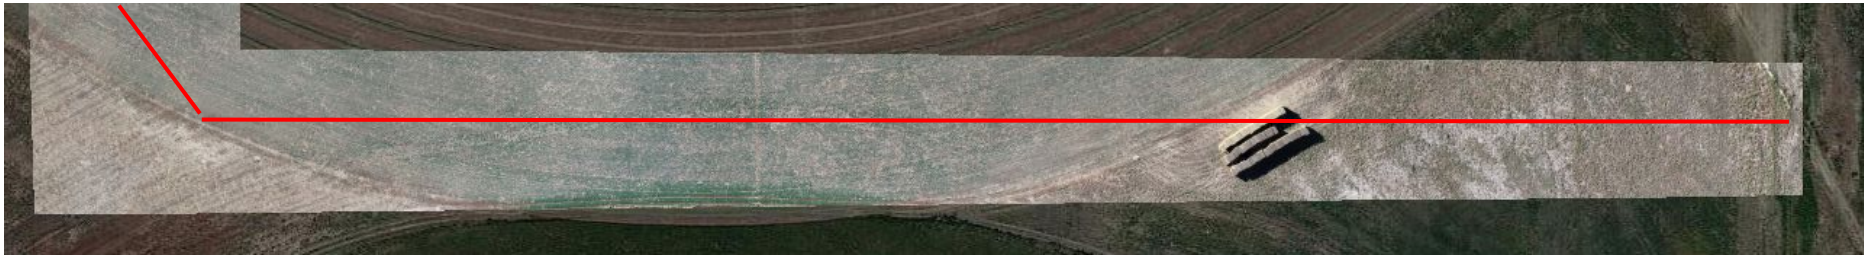
Photo 5. Zoomed in Orthomosaic taken from 200 ft (Oct. 2022). Illustrates harvested crop growth along flowline (red line). Appears similar to rest of area, however crop height cannot be fully evaluated. Another inspection is required when crop is actively growing.
