Interim Reclamation and Stormwater Inspection

Operator: UPLAND EXPLORATION LLC- #10701

Location ID: 462908

Location Name: Little Lady 21/North Well Pad

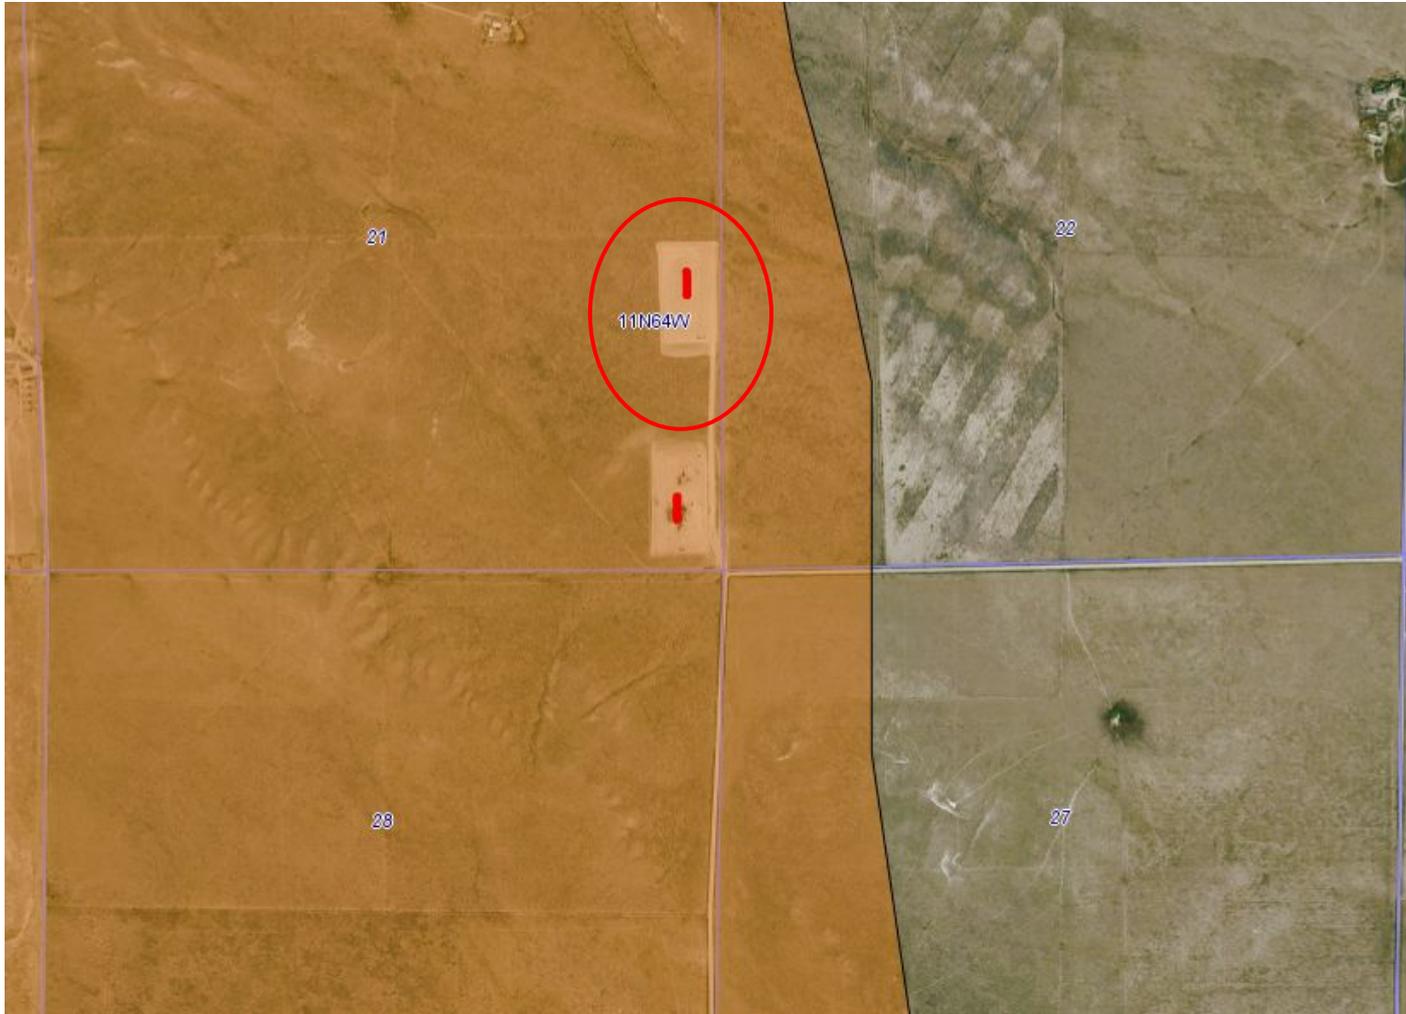
Photo 1. Photo illustrates the access road and location of the Little Lady locations are within a Pronghorn Winter Concentration area.

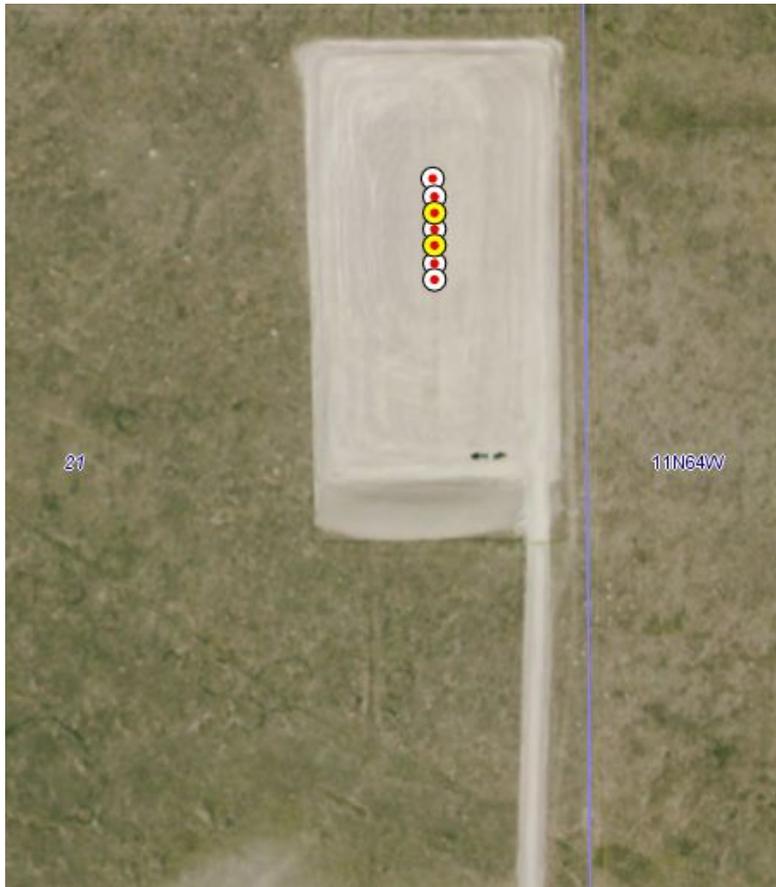
Photo 2. COGCC GISOnline aerial imagery from 2019 illustrates the location. At the time of this inspection, the location remains the same size and interim reclamation has not been performed- refer to Photos 4-5.

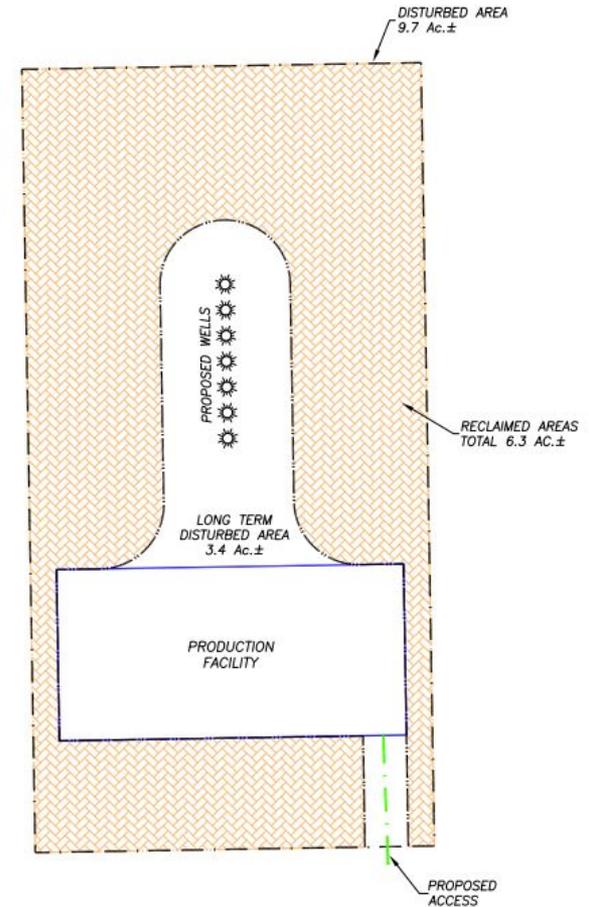
Photo 3. The image is from the Operator's Construction Layout Drawing illustrating the proposed interim reclamation plan, which has failed to be performed.

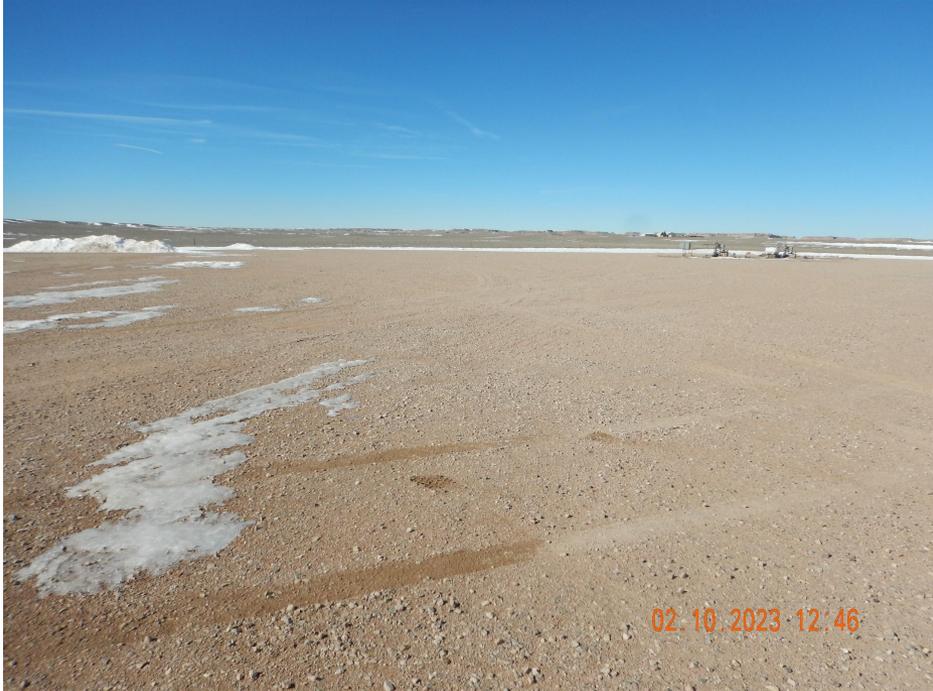
Photo 4. Photo taken from the southern location, facing West. Photo illustrates interim reclamation has not been performed.

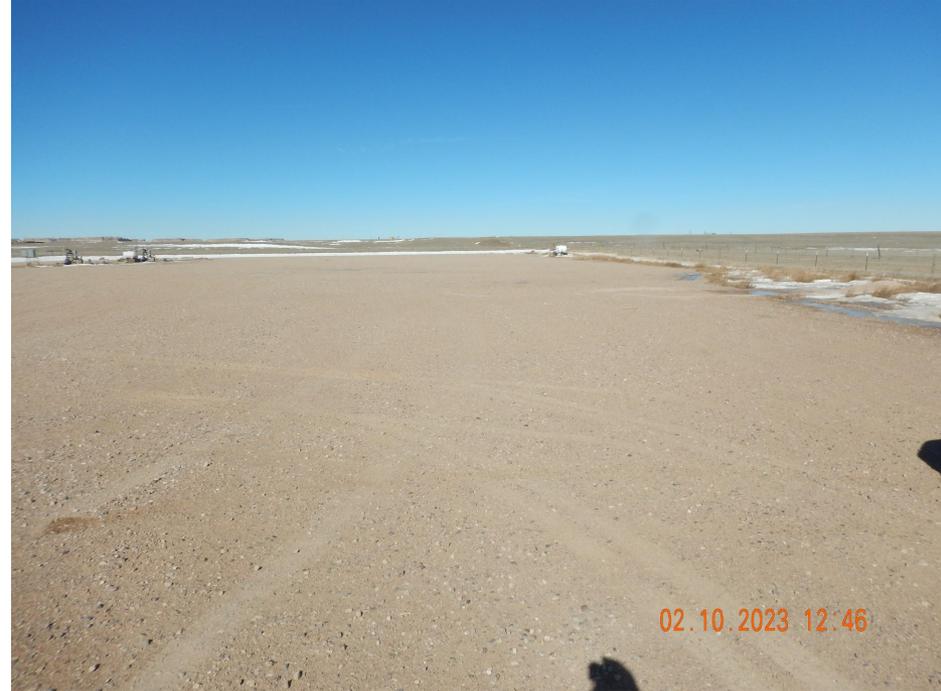
Photo 5. Photo taken from the southern location, facing North. See comments under Photo 4.

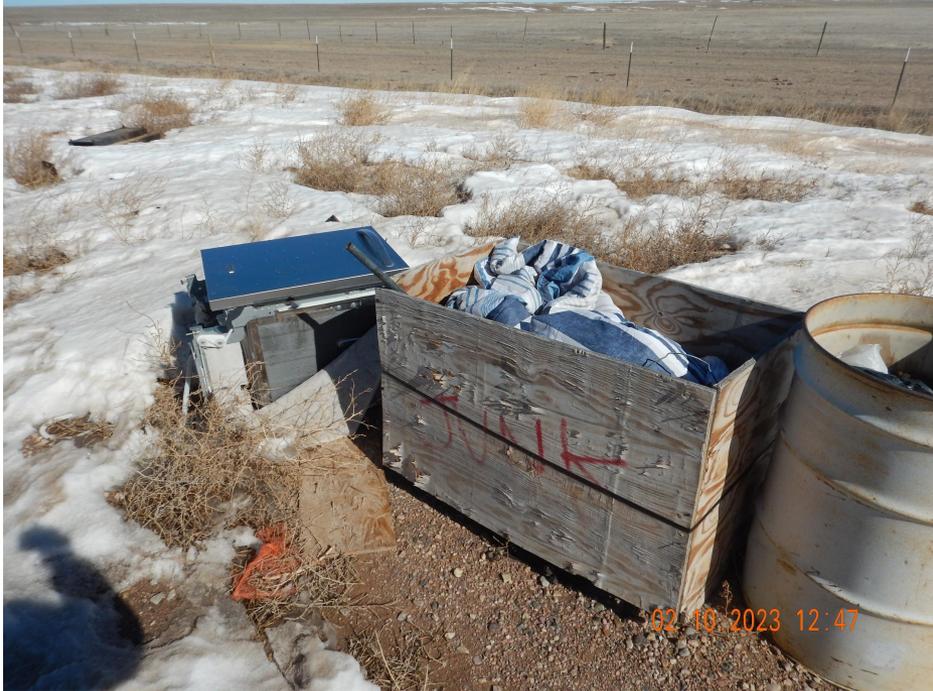
Photo 6. Photo taken from the southeastern location, facing East. Photo illustrates trash being stored on location.

Note- weeds were observed along the eastern perimeter of location.

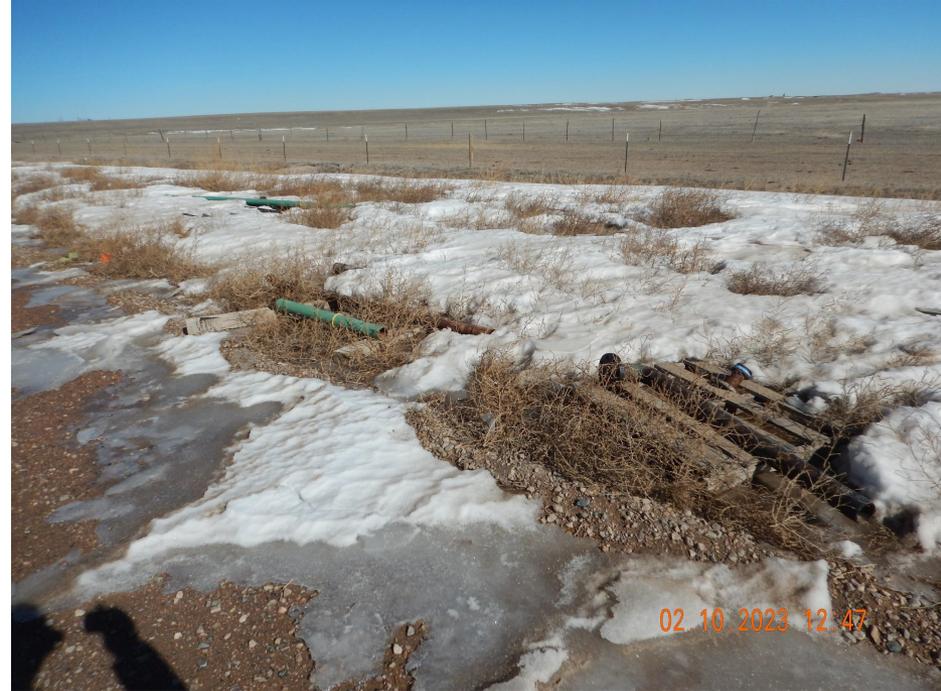
Photo 7. Photo taken from the southeastern location, facing Northeast. Photo illustrates debris and equipment being stored on location.

Note- weeds were observed along the eastern perimeter of location.

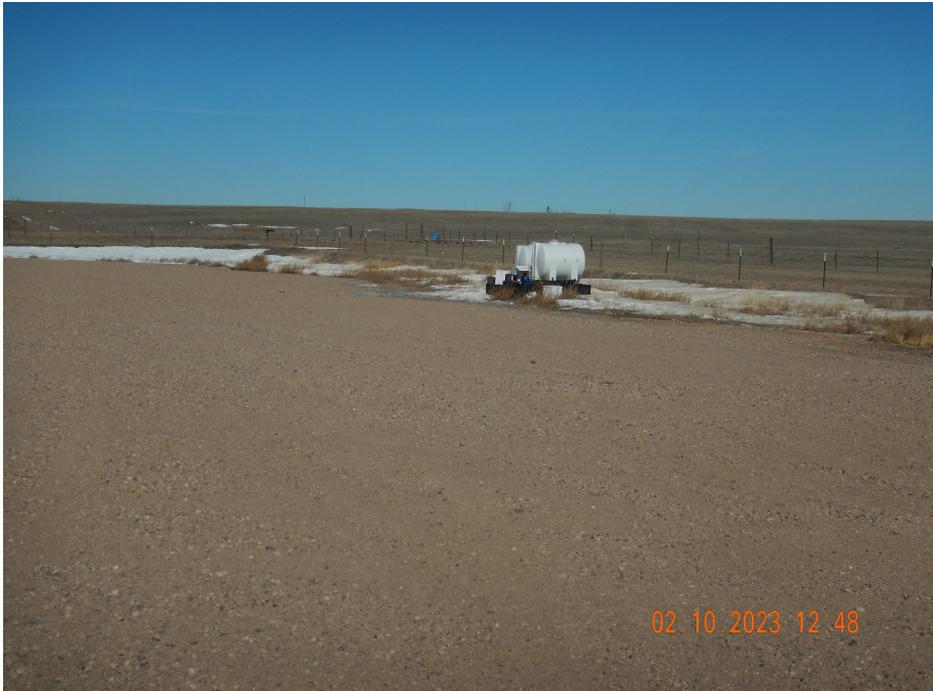
Photo 8. Photo taken from the northeastern location, facing Northeast. Photo illustrates chemicals being stored on location.

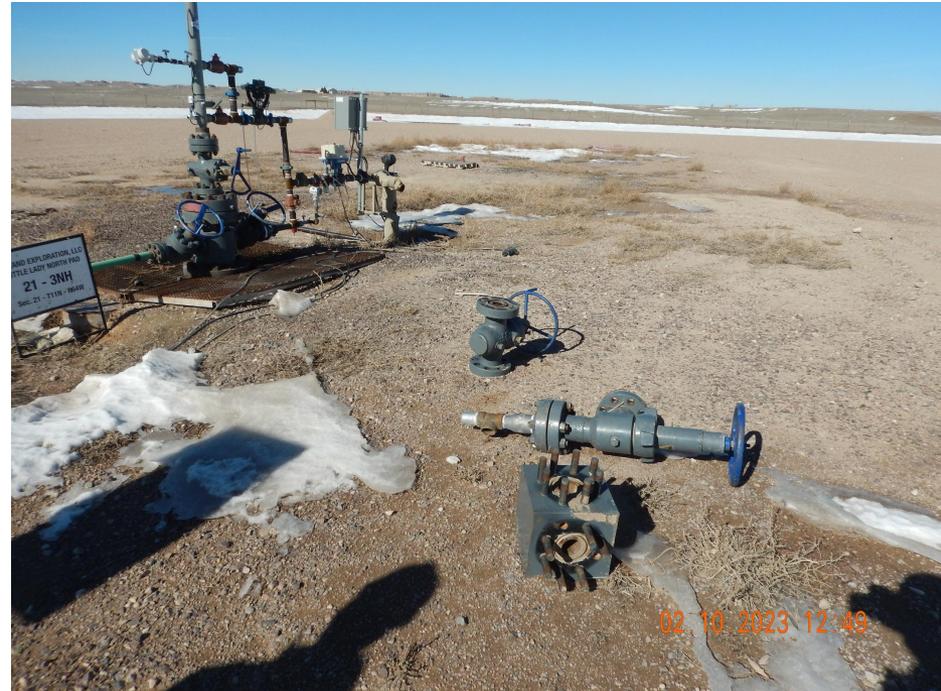
Photo 9. Photo taken from the wellheads, facing North. See comments under Photos 6 & 7.

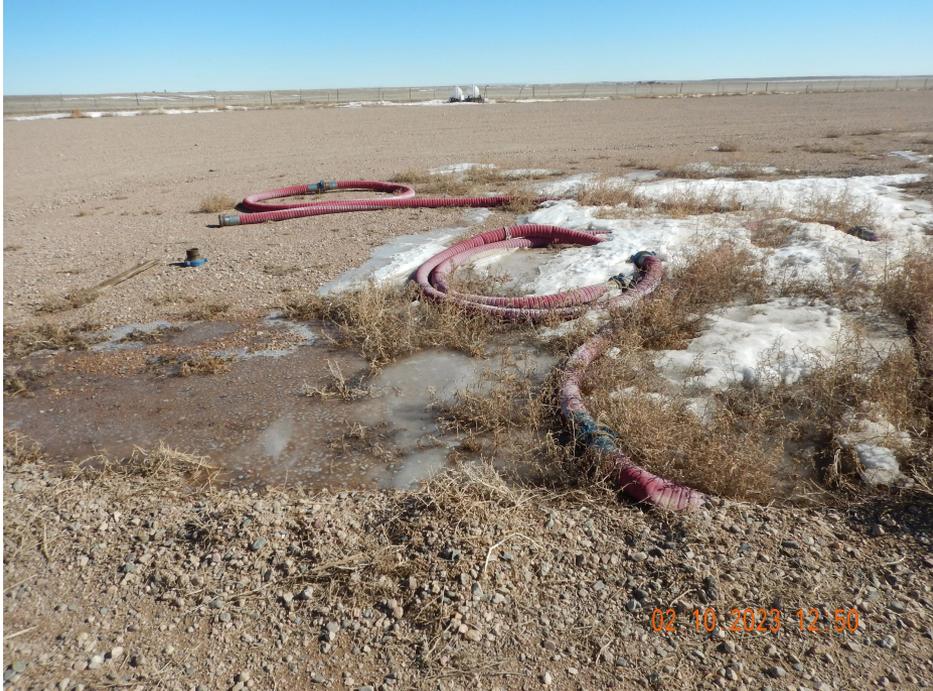
Photo 10. Photo taken from the wellheads, facing East. See comments under Photos 6 & 7.

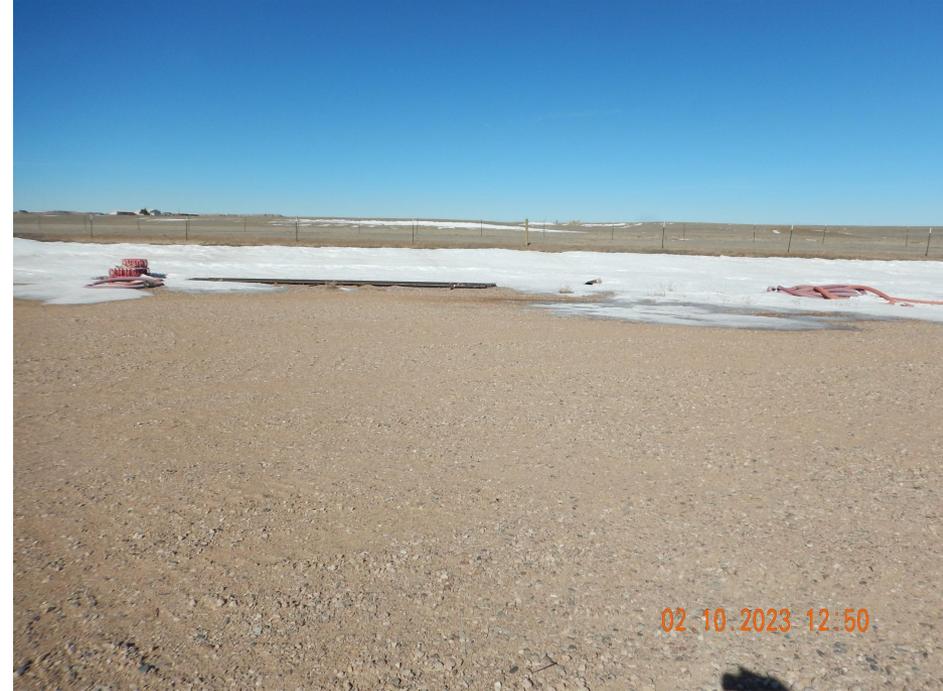
Photo 11. Photo taken from the northwestern location, facing North. See comments under Photos 6 & 7.

Note- weeds were observed around the wellhead area.

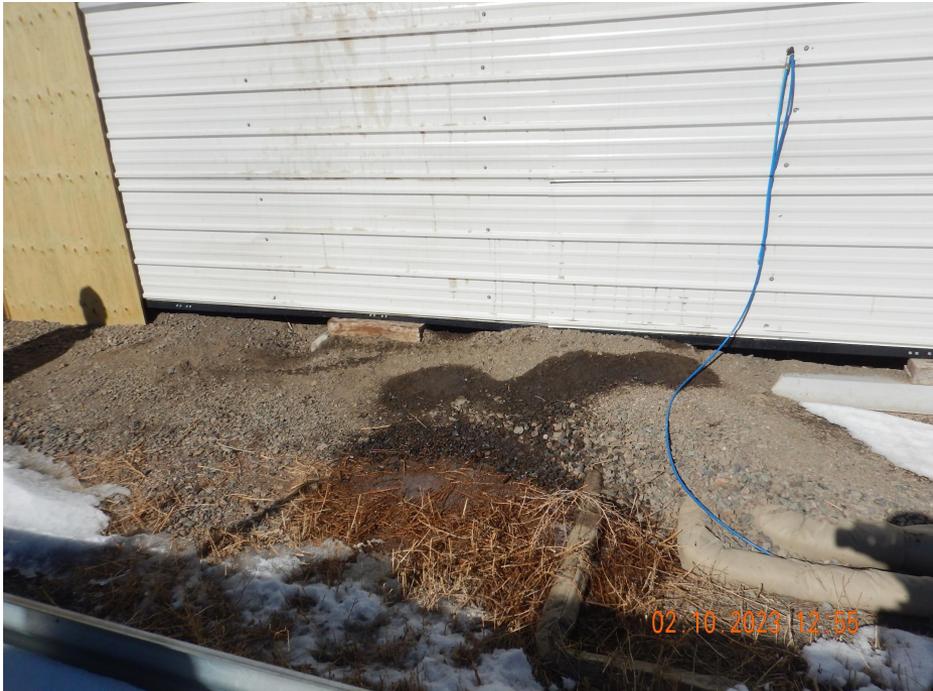
Photo 12. Photo taken from the western location. Photo illustrates stained soil/spill related to the compressor.

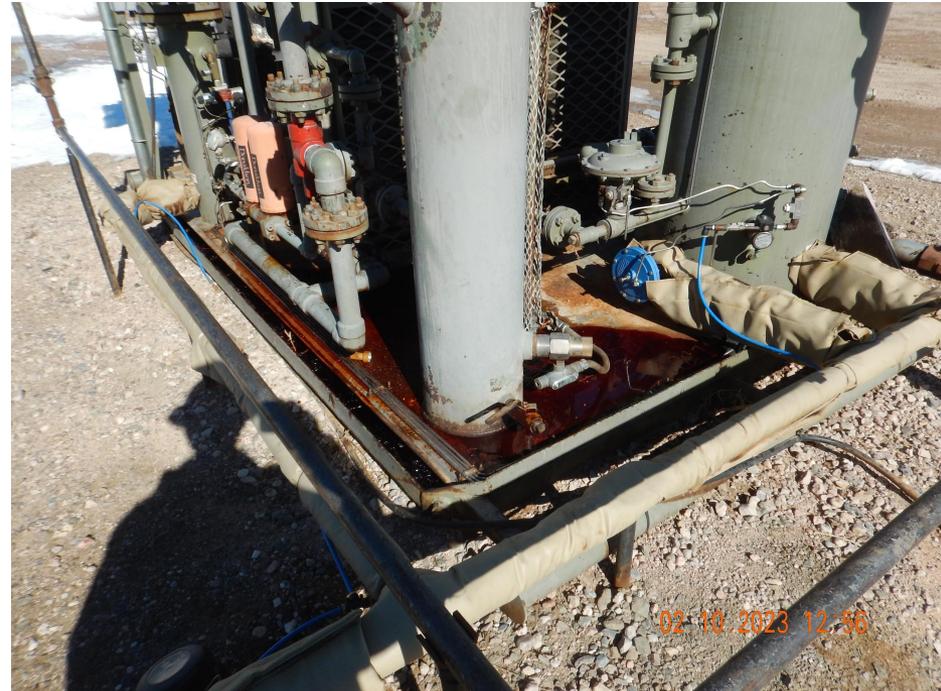
Photo 13. Photo taken from the western location. Photo illustrates spills within secondary containment. Remove and properly dispose fluids from within the secondary containment.

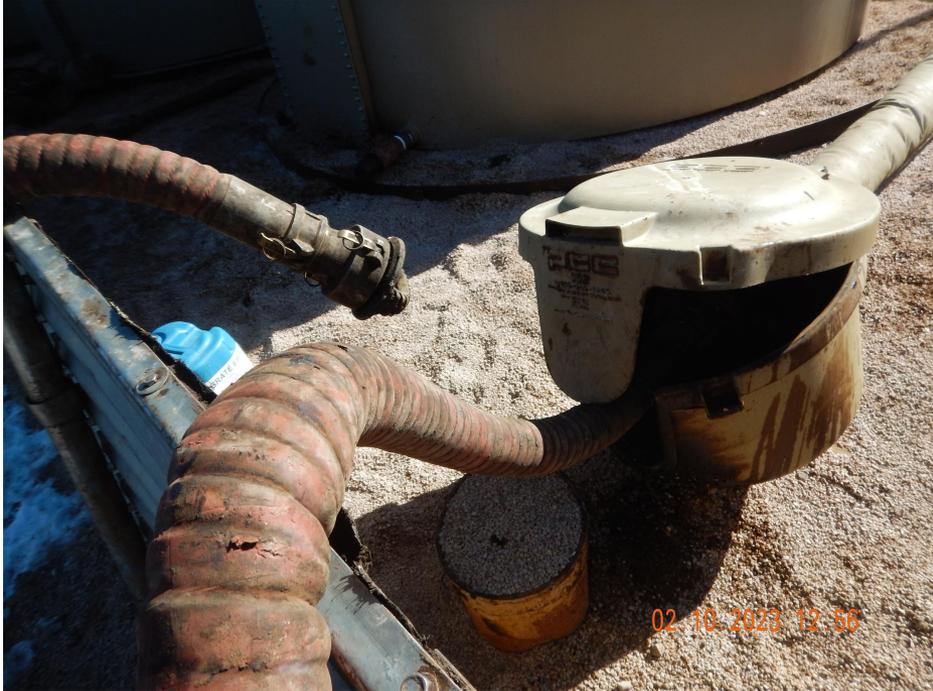
Photo 14. Photo taken from the western location. Photo illustrates a hose left hooked up which could contribute to a potential spill.

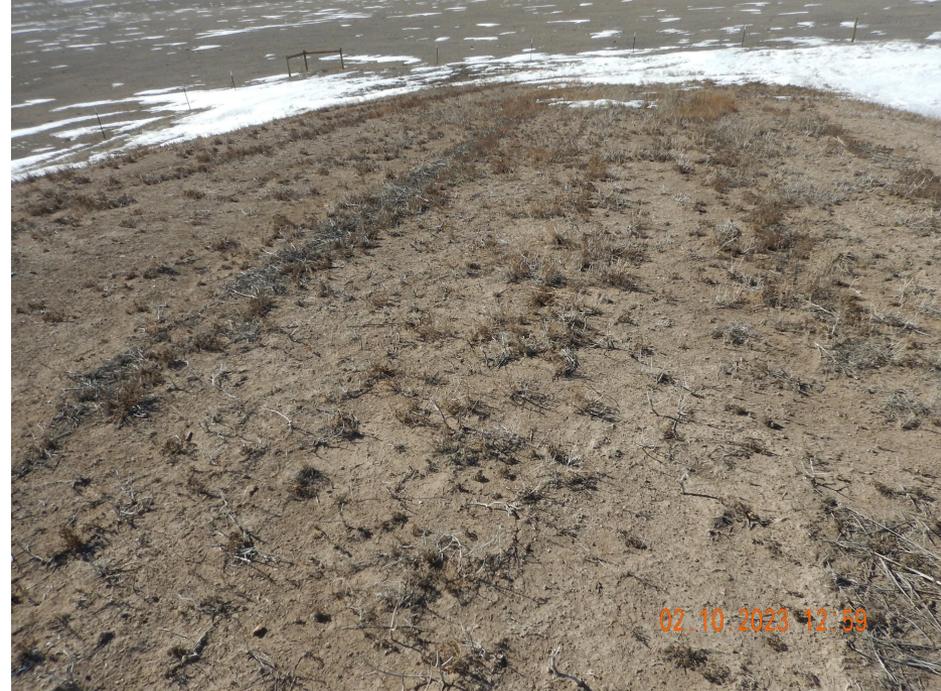
Photo 15. Photo taken from the southern location, facing West. Photo illustrates the topsoil stockpile which is primarily bare or has weedy, annual vegetation with minimal perennial vegetation that would not meet the standard.
