**Operator: HIGHPOINT OPERATING CORPORATION**

**Location Name: Pappenheim 6-62-23 Pad**

**Inspection: 696305499**

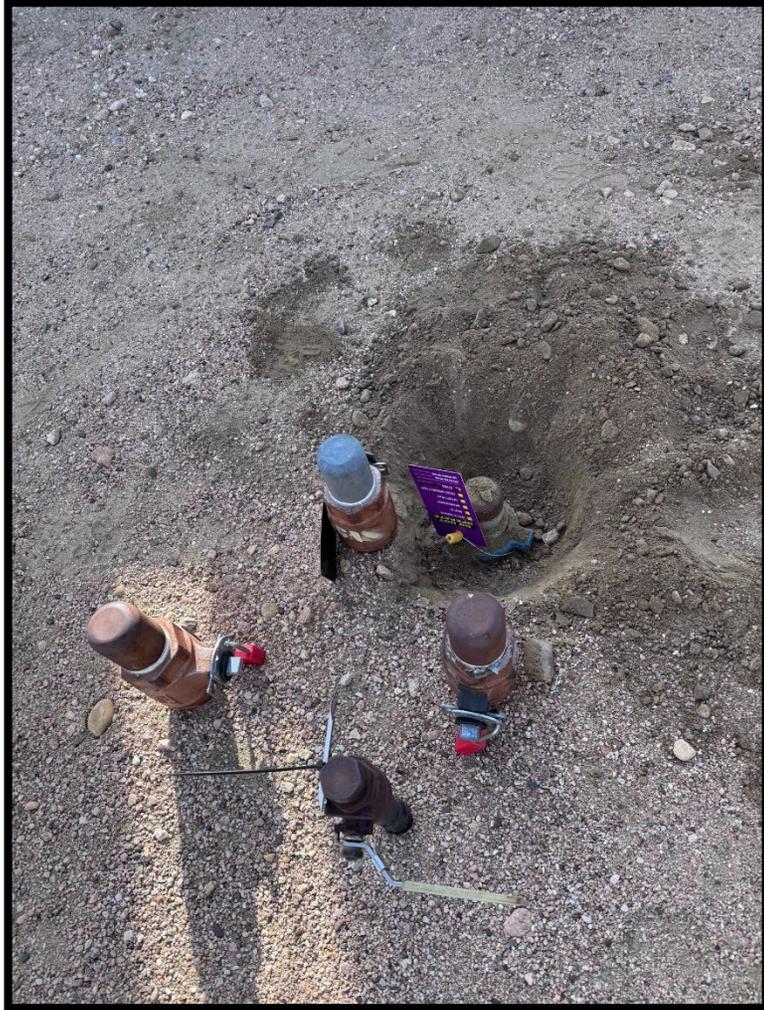
Exhibit A

**CA:** Unmarked OOSLAT Risers at various Locations on Pad - 2" Risers west of Pumping Unit, 1" Risers at VRU, 2" buried Bull Plugs at Heater Treater. See photos. Complete flowline and crude oil transfer line abandonments to comply with Rule 1105.

**CA Resolution:** Operator has appropriately marked identified risers and exposed bull plugs at Heater Treater to comply with Rule 1105.
