**Operator: CIVITAS NORTH**  
**Location Name: Hunt Fed 8-60 19 Pad**  
**Loc ID: 454749**  
**Inspection: 708200771**

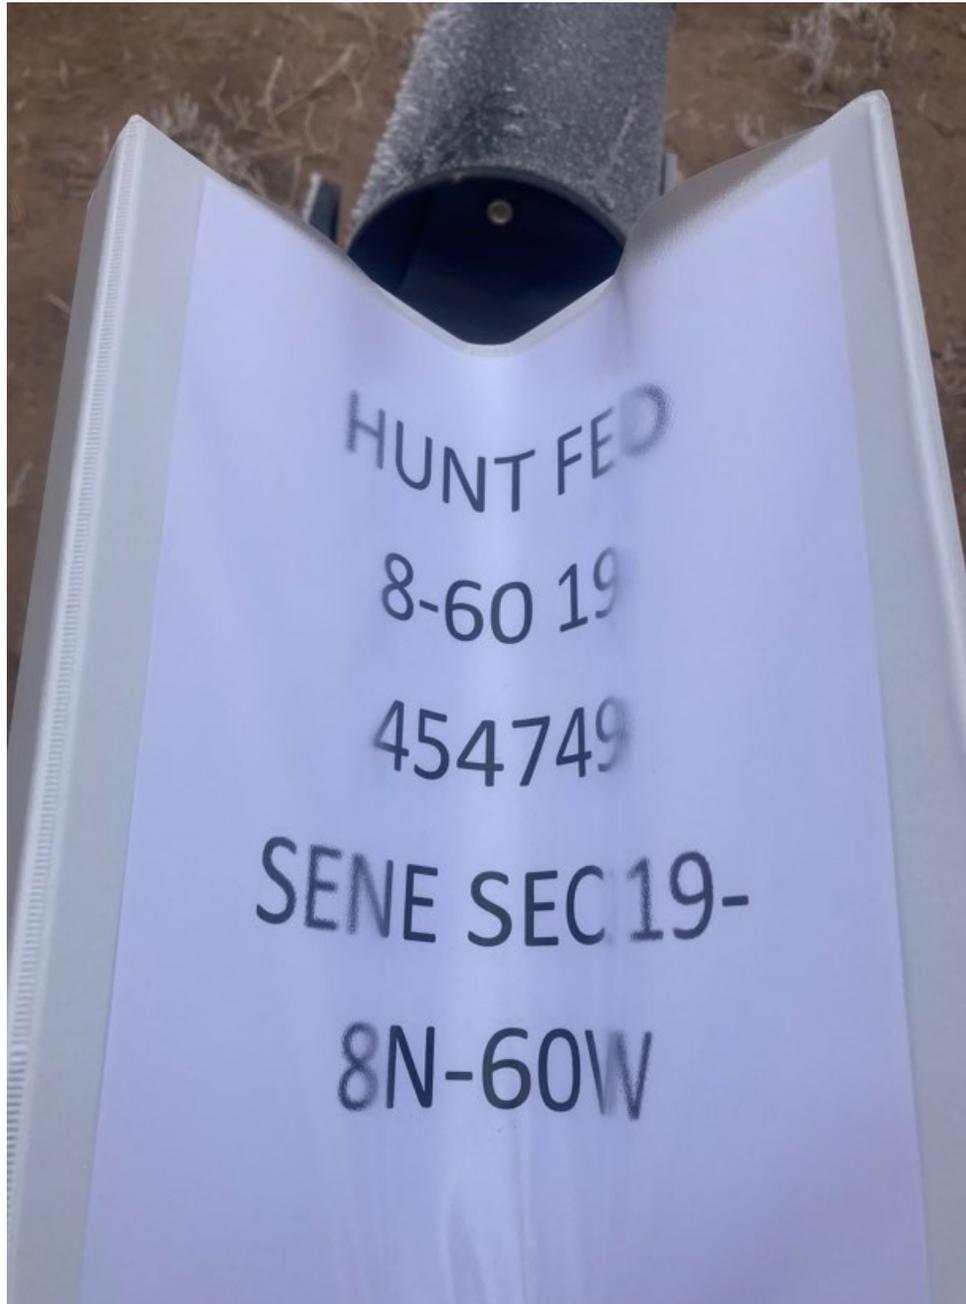
Exhibit A

**CA:** This location does not comply with Rule 406.c. At the time of this inspection, Staff was unable to locate a copy of the approved Form 2A while on location. A mailbox at the location entrance contained only a Weld County grading permit; no other permit materials were found within the mailbox, or elsewhere on location. Refer to the attached inspection photos. Comply with Rule 406.c. The location will remain out of compliance until the corrective action has been resolved.

**CA Resolution:** Form 2A has been placed in mailbox onsite to comply with Rule 406.c.

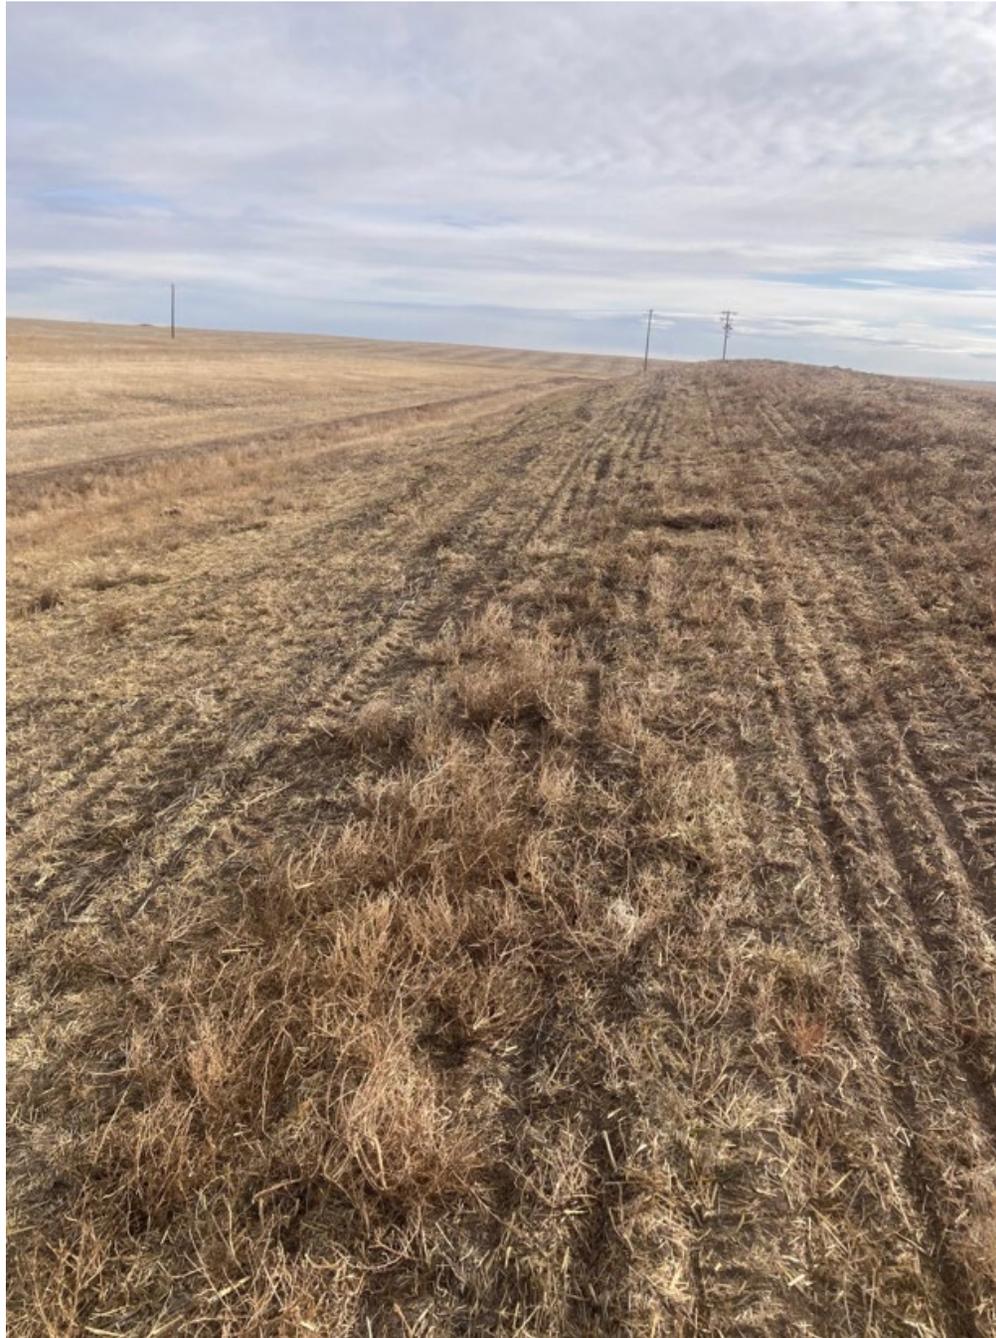
**Exhibit A**

**CA:** This location does not comply with Rule 1002.c. It appears that the topsoil stockpile has been previously seeded/mulched. However, during this inspection, the stockpile was predominantly bare/exposed soil with evidence of undesirable vegetation (e.g. Russian thistle and kochia). Earthen berms around the stormwater detention area are also experiencing bare/exposed soils. Refer to attached inspection photos. Per Rule 1002.c., all stockpiles shall be protected from degradation due to contamination, compaction and, to the extent practicable, from wind and water erosion during drilling and production operations. Per Rule 1002.c., BMPs to prevent weed establishment and to Rule 1002.c. The location will remain out of compliance until the corrective Date action has been resolved.

**CA Resolution:** BMP's to prevent weed establishment have been implemented to comply with Rule 1002.c.
