SUNDRY NOTICE

As requested, the Terracon Engineer visited the subject site and made measurements and observations on February 17 and 23, 2012 and reviewed construction reports of the subject ponds/liners in preparation of this report. The purpose of our review was to determine the conditions of the liner compliance with the attached COGCC Form 15 approval as follows for each pit:

WILLIAMS PRODUCTION RMT
PARACHUTE WATER HANDLING FACILITY

GRAND VALLEY WATER TREATMENT FACILITY HYDRO-TEST EXHIBIT POND 1

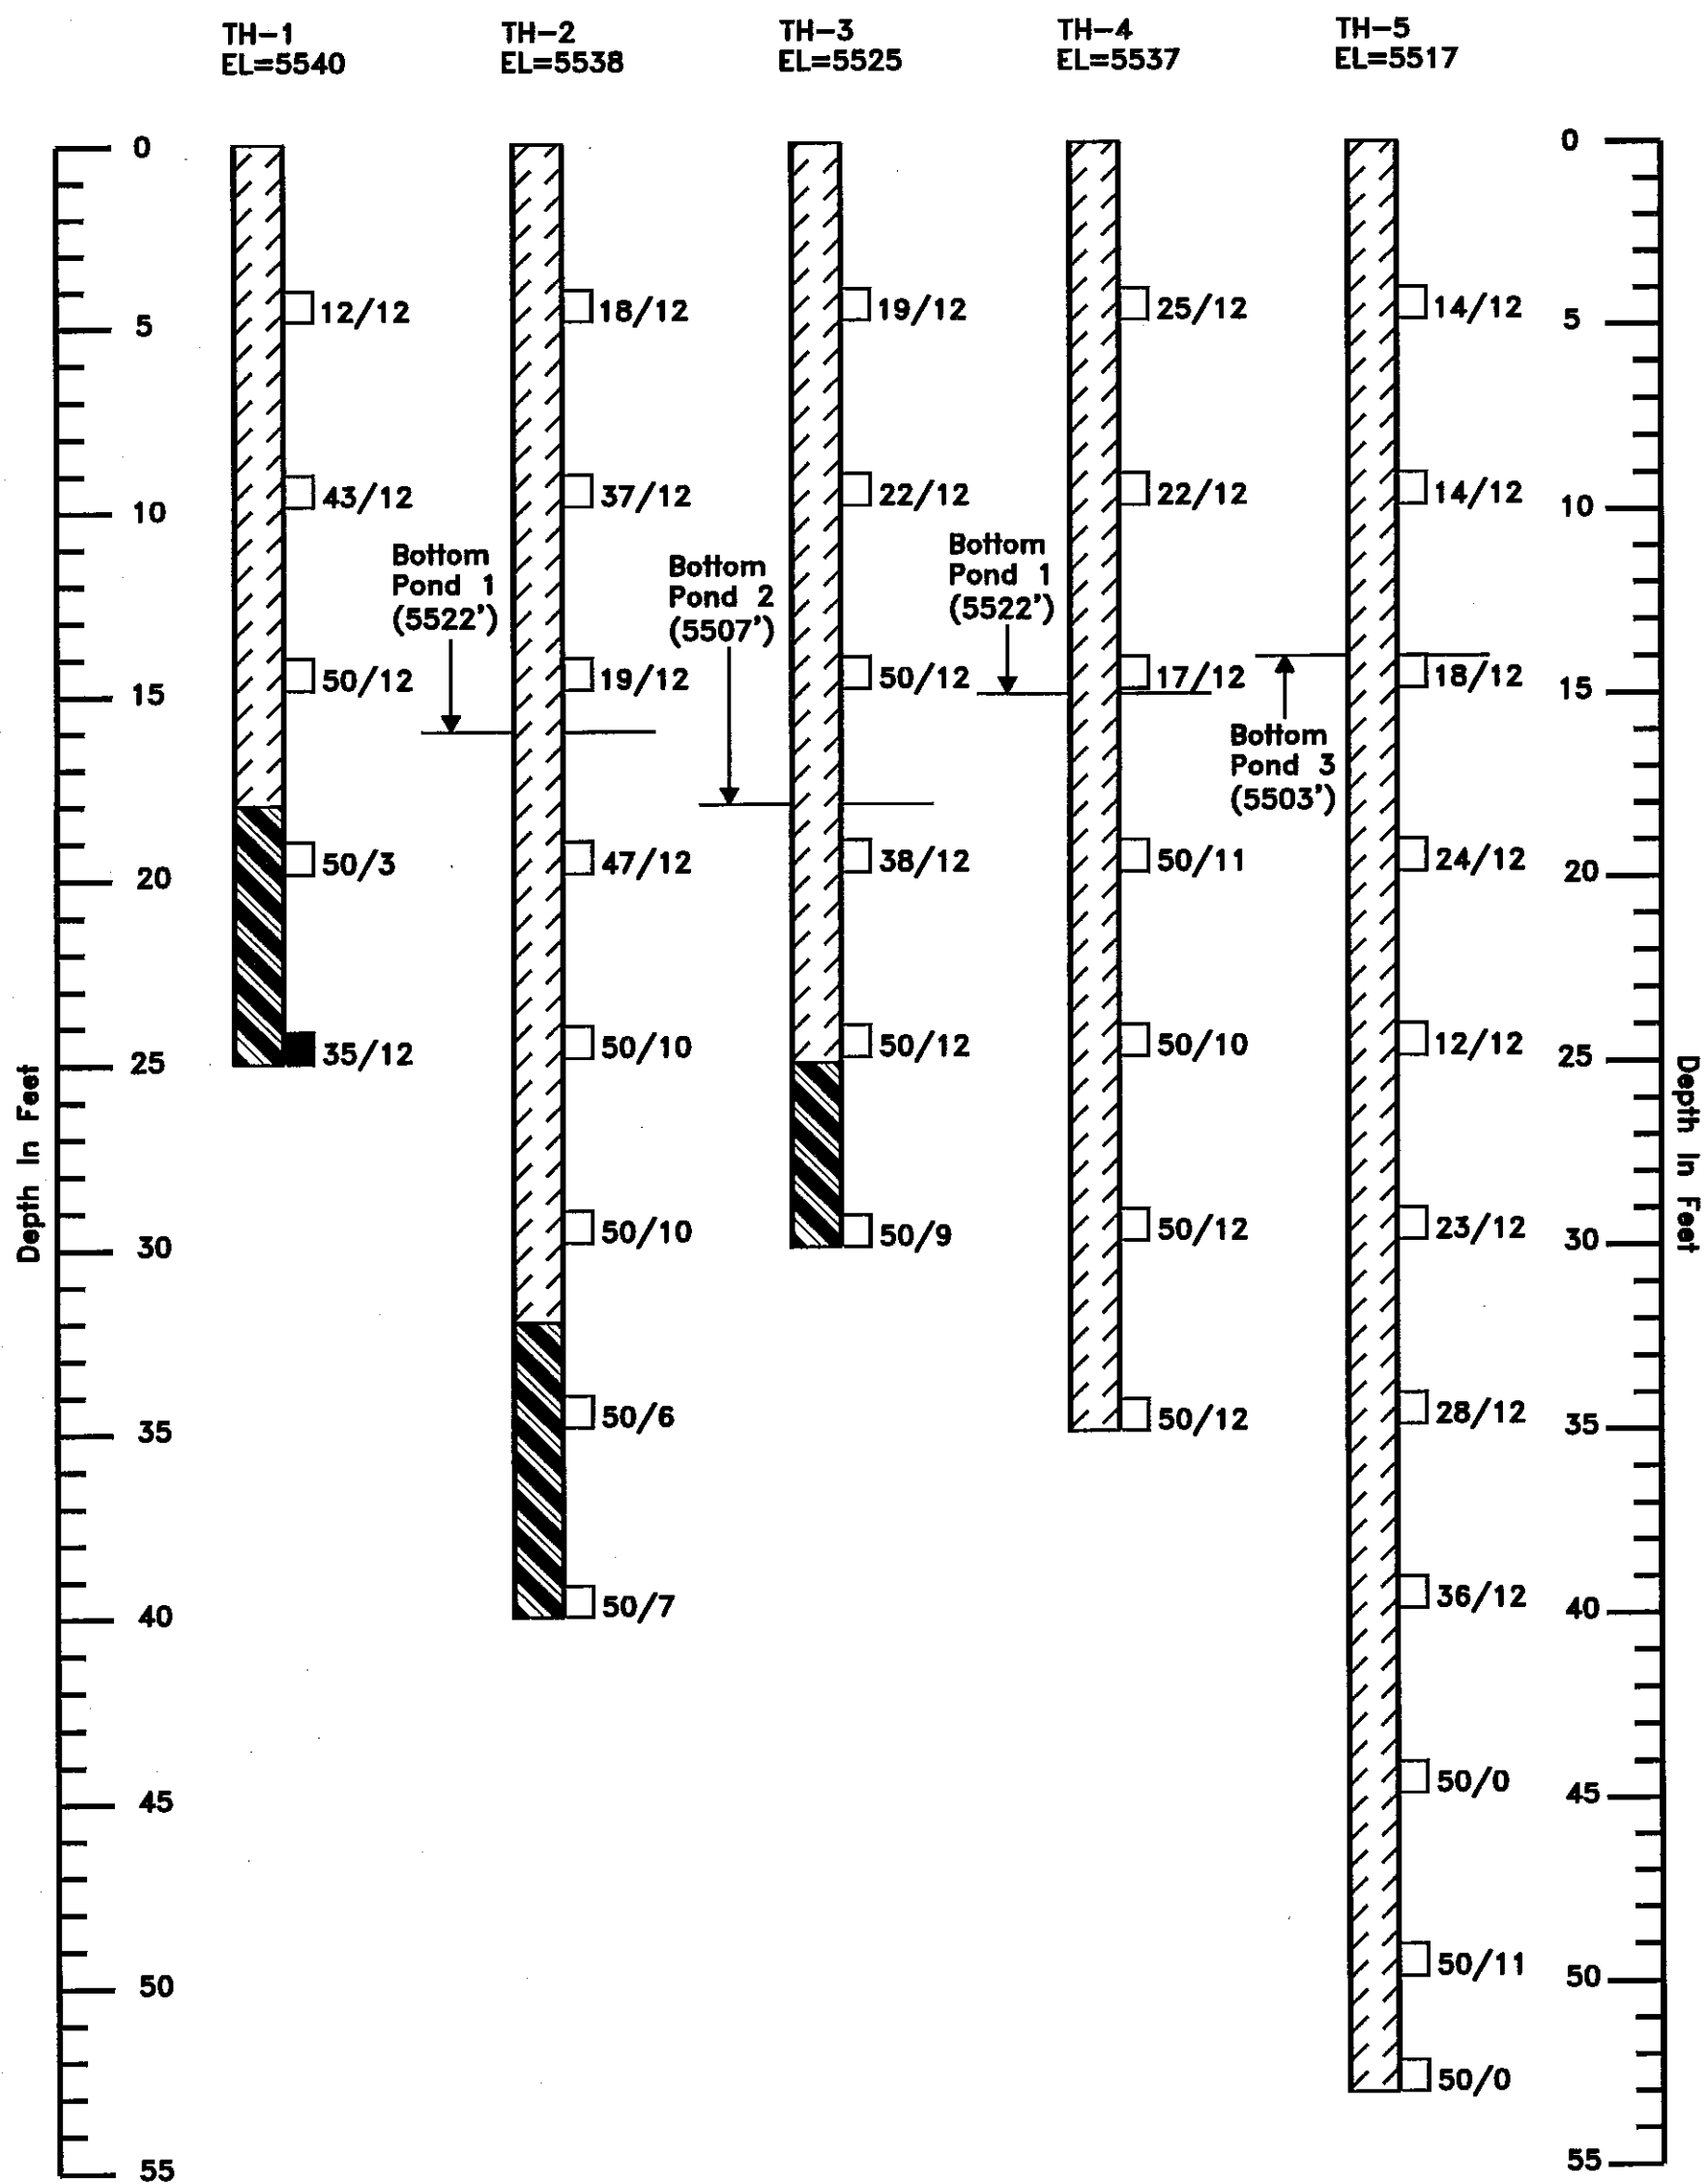
SUMMARY LOGS OF EXPLORATORY BORINGS

1. Exploratory borings were drilled on February 23 and 24, 2010 with 4-inch diameter, continuous-flight solid-stem auger and an track-mounted drill rig.
2. Locations and elevations of exploratory borings are approximate.
3. No free ground water was found in our exploratory borings at the time of drilling.
4. These exploratory borings are subject to the explanations, limitations and conclusions as contained in this report.

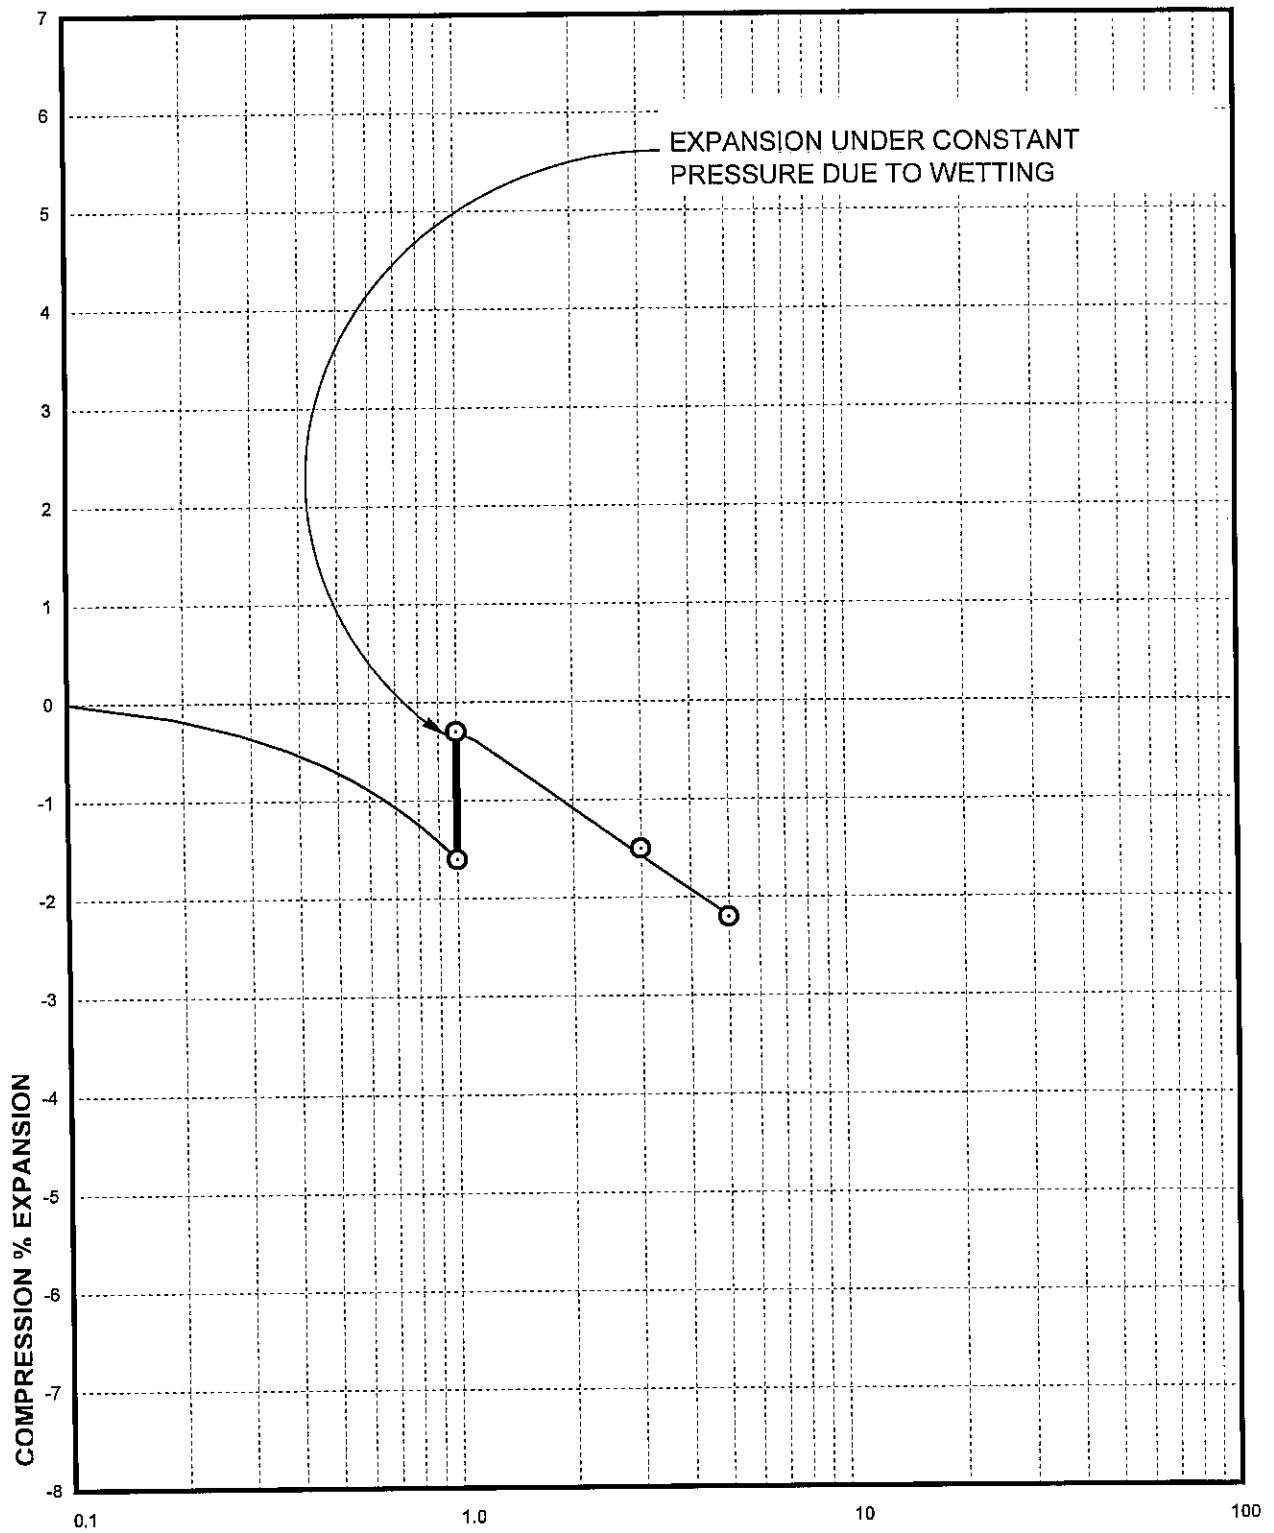
Swell Consolidation Test Results

APPLIED PRESSURE - KSF
Sample of CLAY, SLIGHTLY GRAVELLY (CL)
From TH-1 AT 14 FEET

DRY UNIT WEIGHT= 122 PCF
MOISTURE CONTENT= 7.2 %

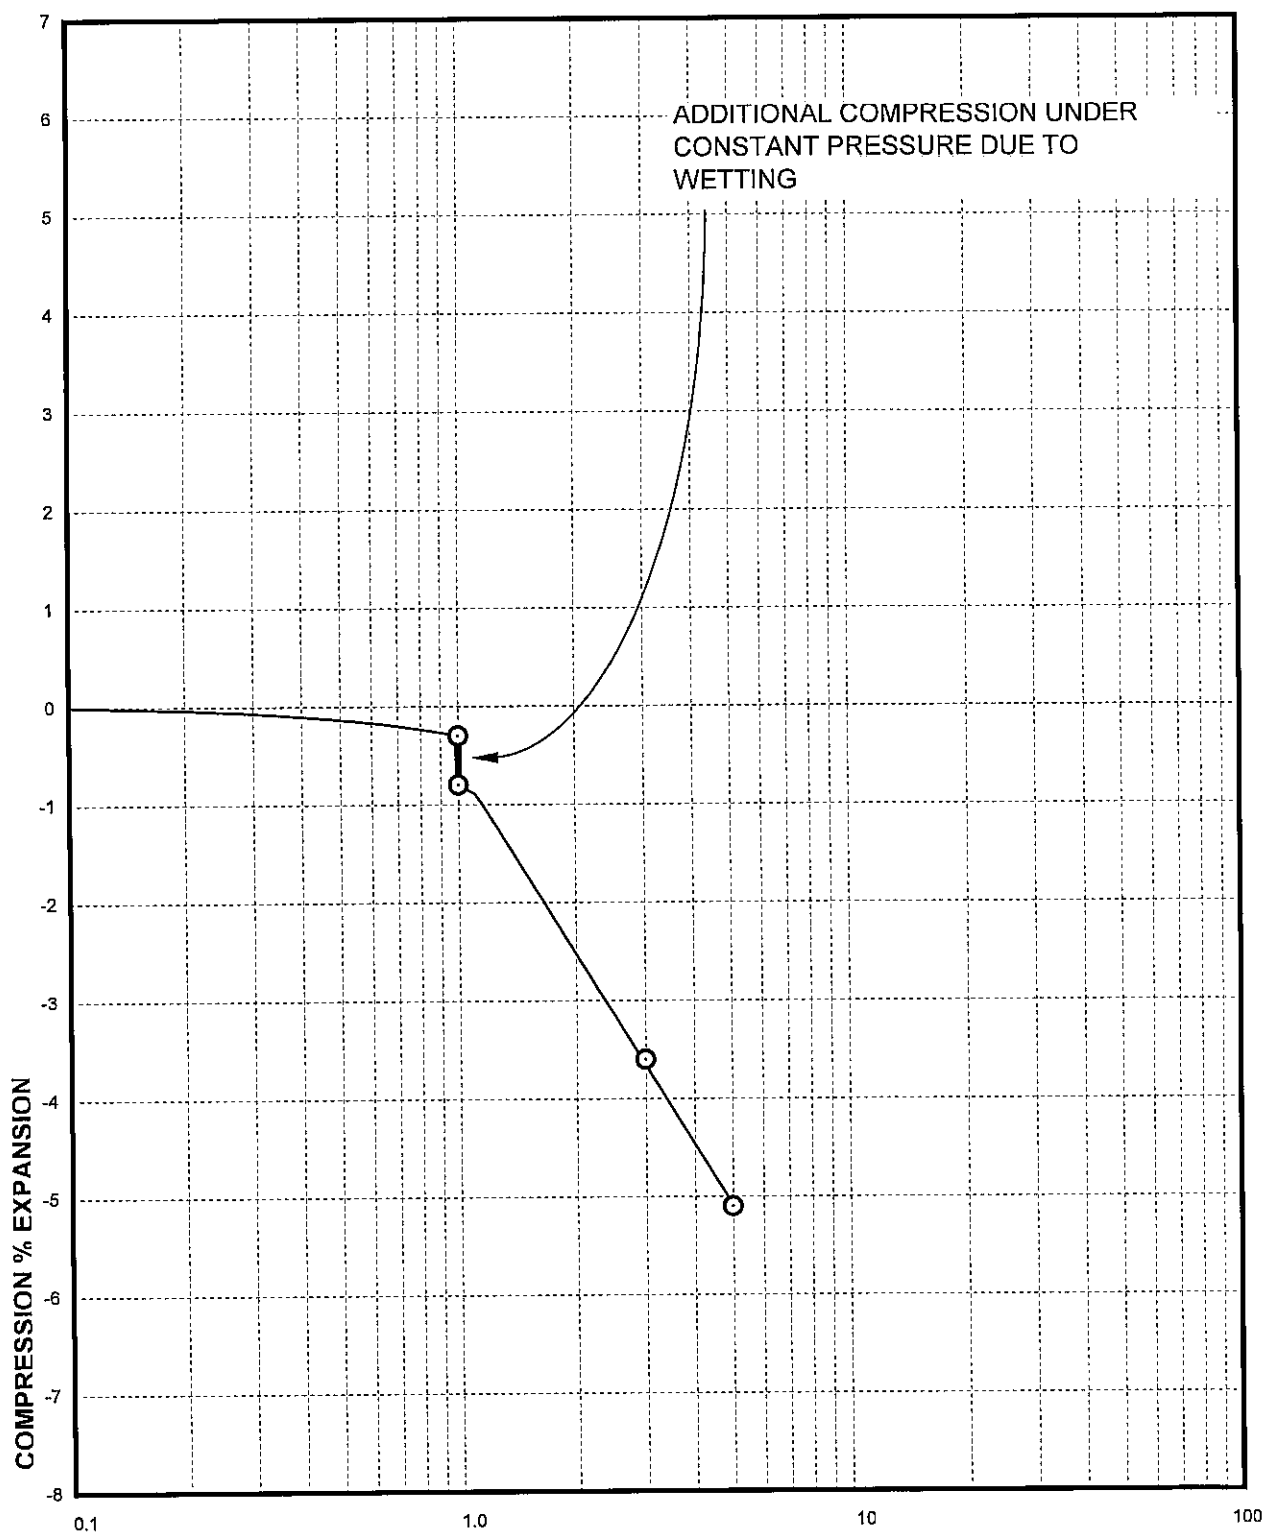
Swell Consolidation Test Results

Sample of SAND, CLAYEY (SC)
From TH-2 AT 9 FEET

DRY UNIT WEIGHT= 113 PCF
MOISTURE CONTENT= 5.8 %

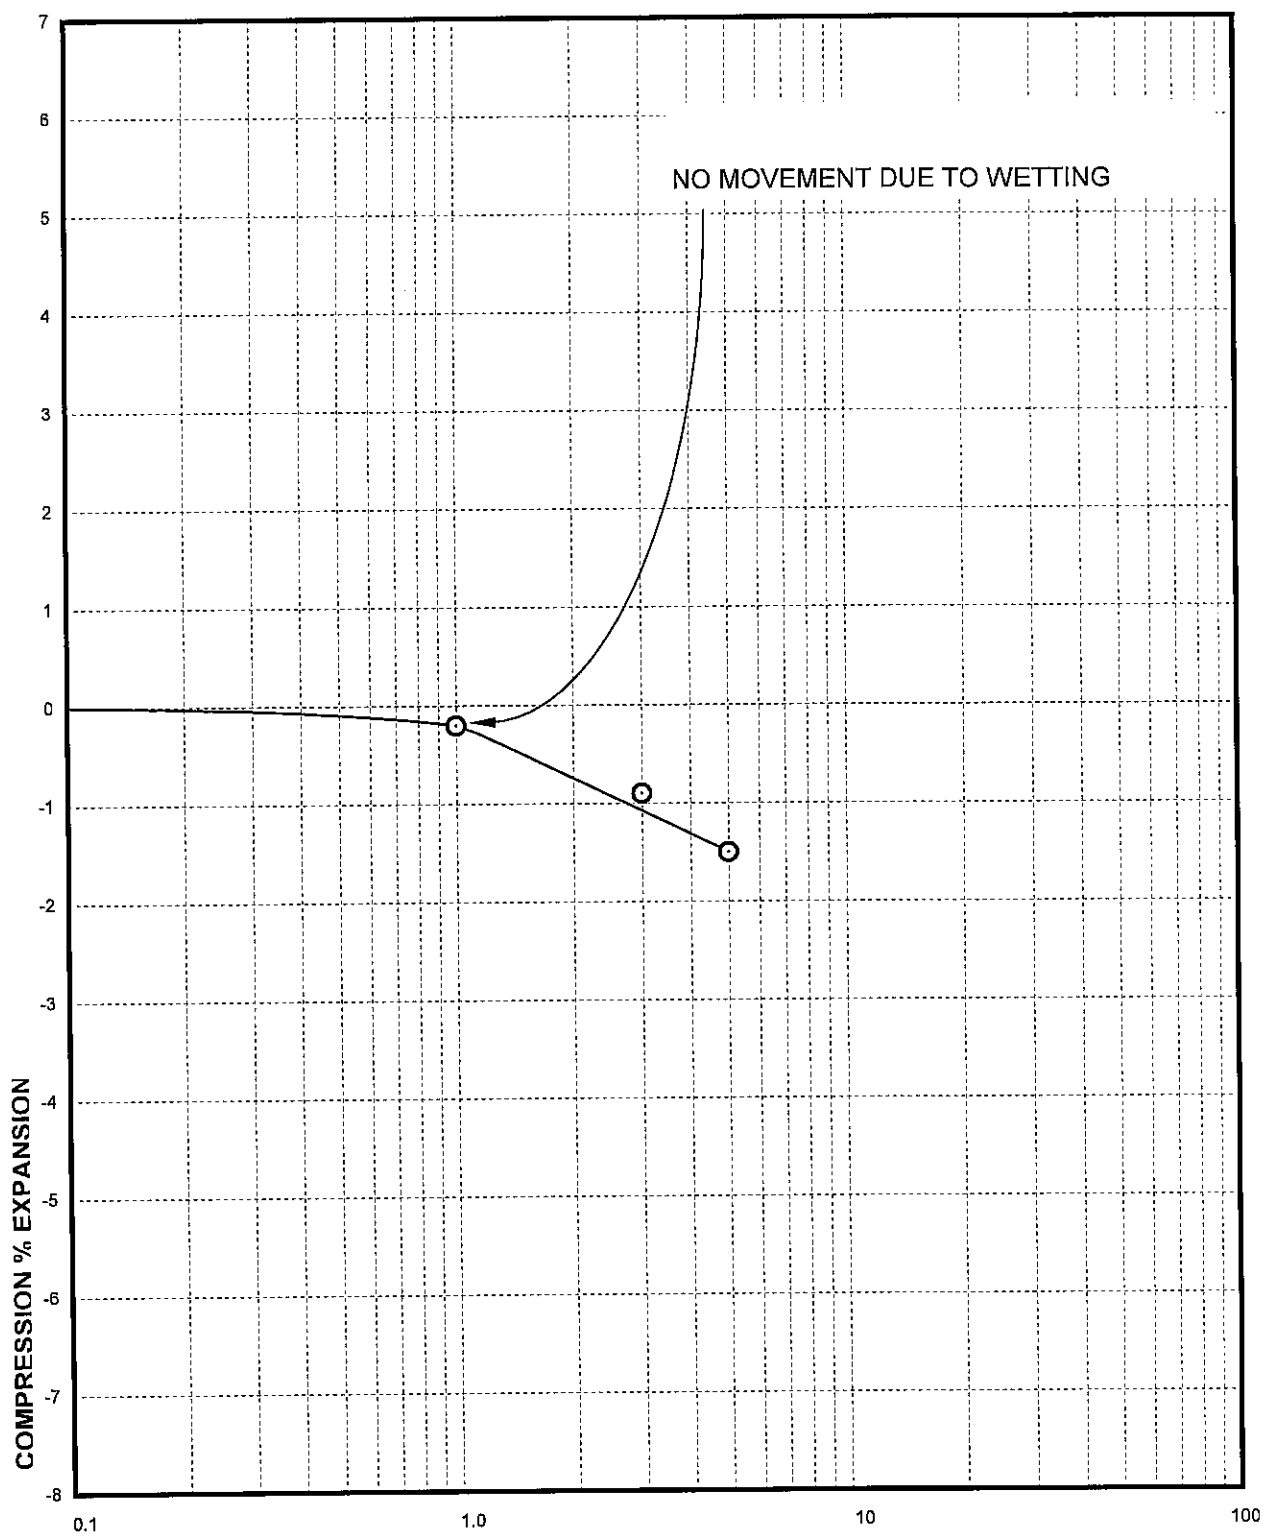
**Swell Consolidation
Test Results**

Sample of SAND, CLAYEY (SC)
From TH-3 AT 4 FEET

DRY UNIT WEIGHT= 120 PCF
MOISTURE CONTENT= 8.8 %

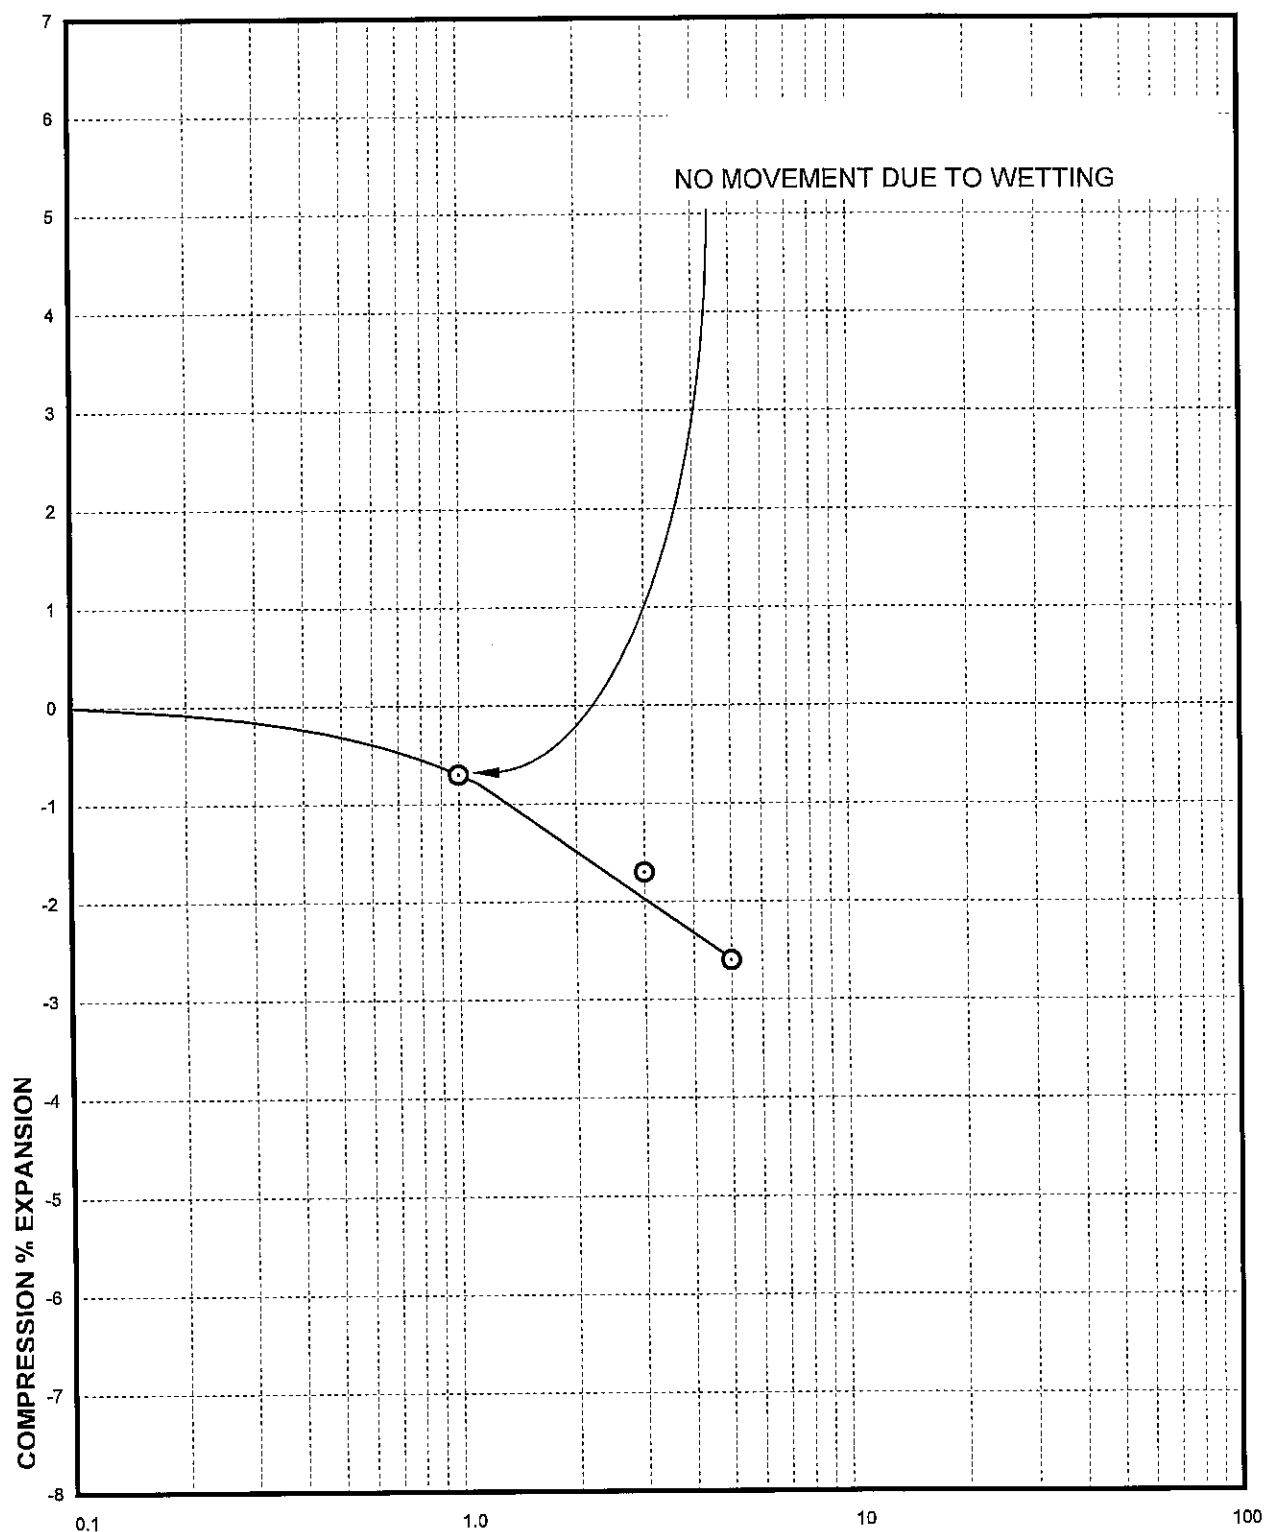
Swell Consolidation Test Results

Sample of CLAY, SLIGHTLY GRAVELLY (CL)
From TH-5 AT 14 FEET

DRY UNIT WEIGHT= 114 PCF
MOISTURE CONTENT= 11.2 %
