Inspection Photos Location Name: Government #2 Location ID:322339

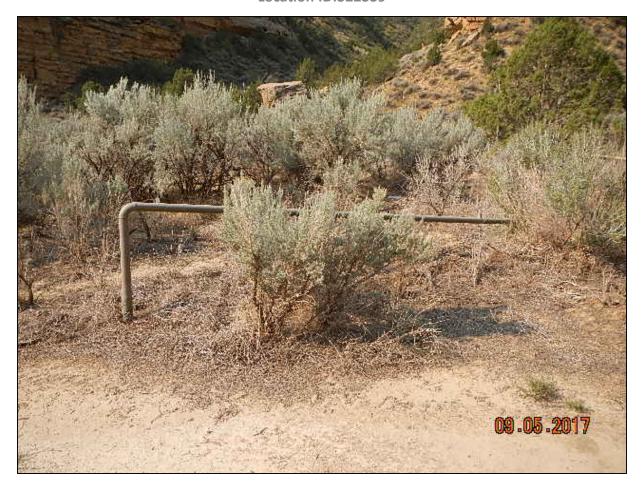
Photo 1. 2" line/riser located at 39.23712/-107.94482. Flowline risers not LO/TO or marked are considered unused equipment. For unused, unmarked flowline risers 24 hrs to lock out tag out. 30 days to remove riser.
