# Stormwater Inspection

November 3, 2017

Operator: PETROSHARE CORPORATION- 10454

Location Name: RUNNING CREEK #11-21

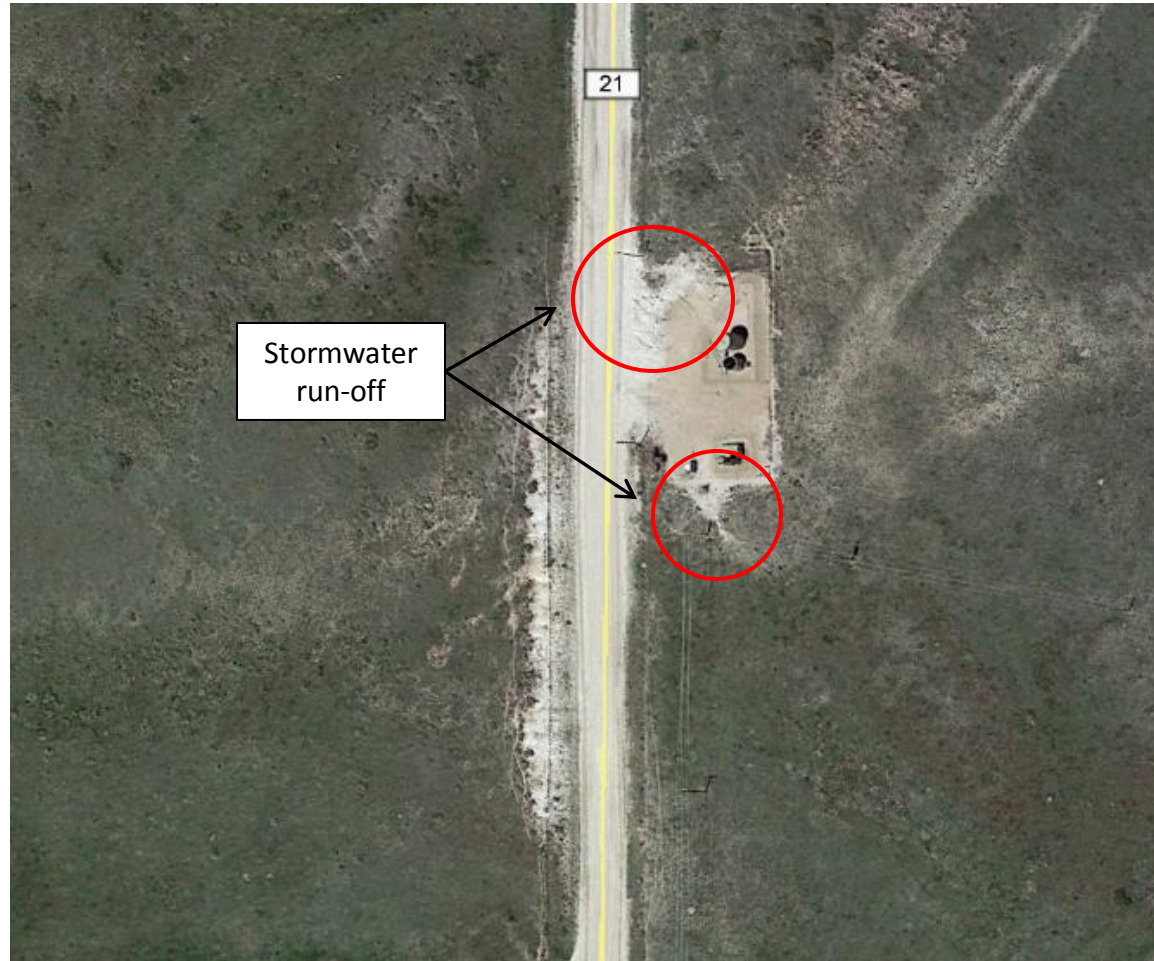
Google Earth aerial imagery taken 6/14/2016 illustrating tank battery location during operations. Two points of discharge were observed during the November 3, 2017 inspection along the northwest and southern location (highlighted in the red circle). Also, the Running Creek well pad to the northeast appeared to have stormwater erosion issues as well but COGCC staff did not inspect the location due to time constraints.

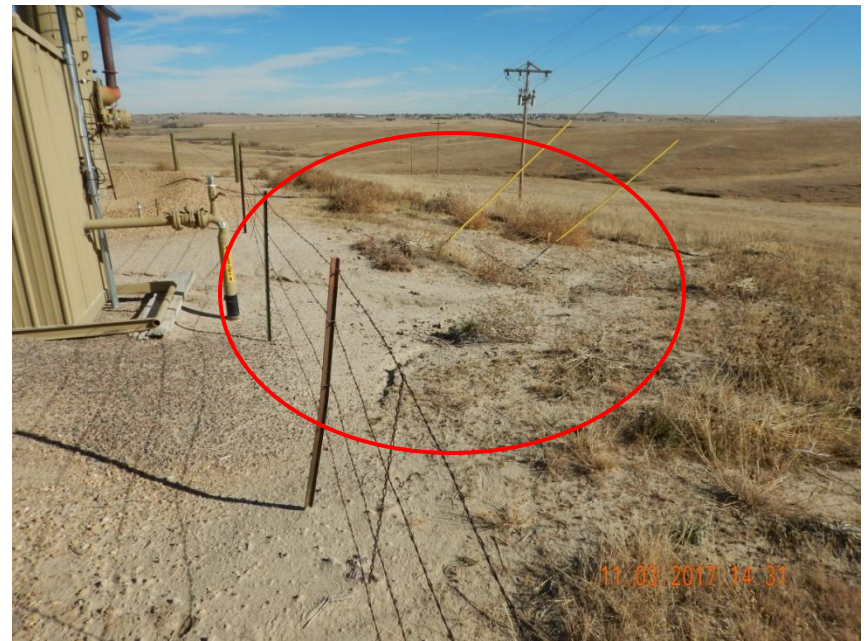
**Photo 2.** Photo taken from the southern location, facing East. Sediment discharge from location is occurring along the southern location and no observed BMPs have been implemented to control and manage stormwater erosion along any portion of the location.

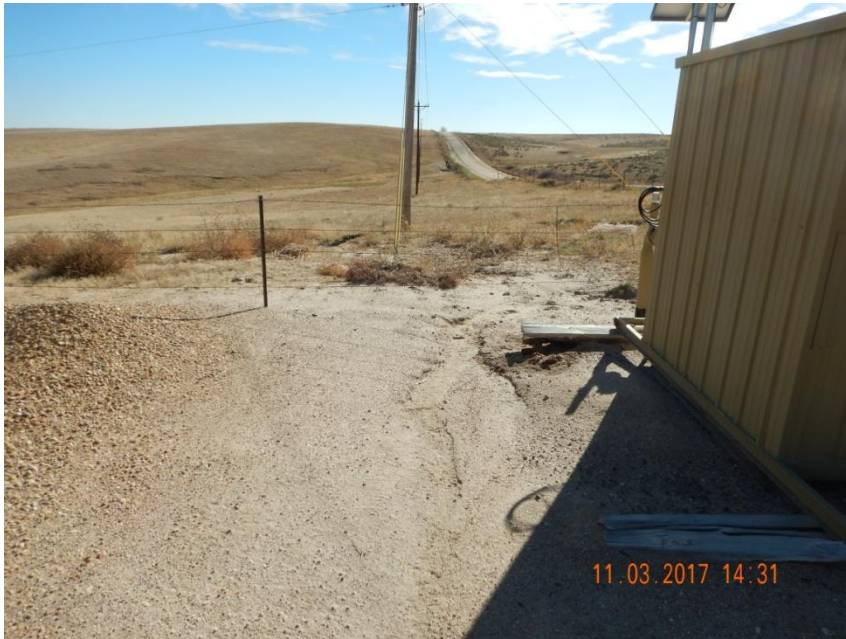
**Photo 3.** Photo taken from the southern location, facing South. Photo illustrates the area at which stormwater runoff is leaving the southern location.

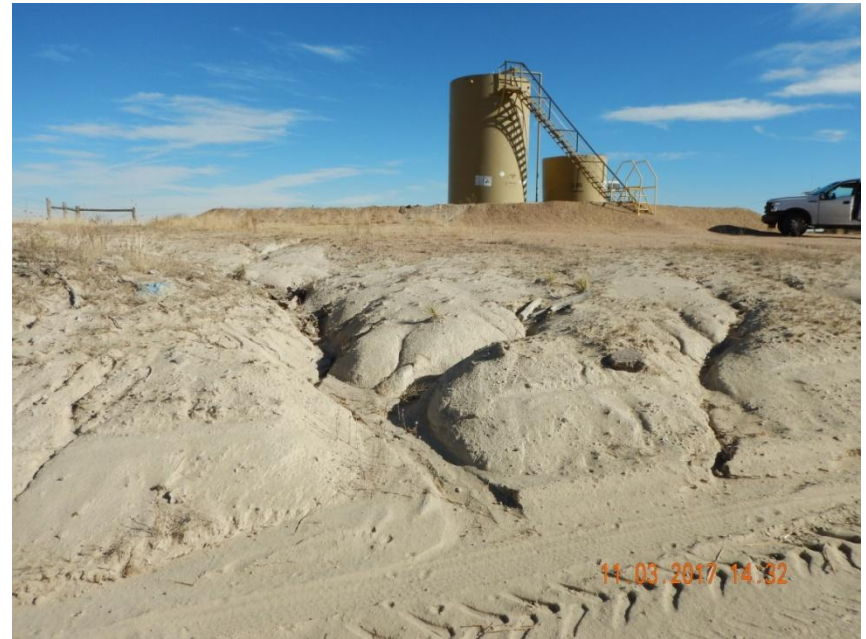
**Photo 4.** Photo taken from the northwest location, facing East. Gully erosion evident and no observed BMPs have been implemented to control and manage stormwater erosion along any portion of the location.
