Inspection Photos

Operator: PDC ENERGY INC - 69175

Location ID: 322636

Inspection Doc. Number: 682502935

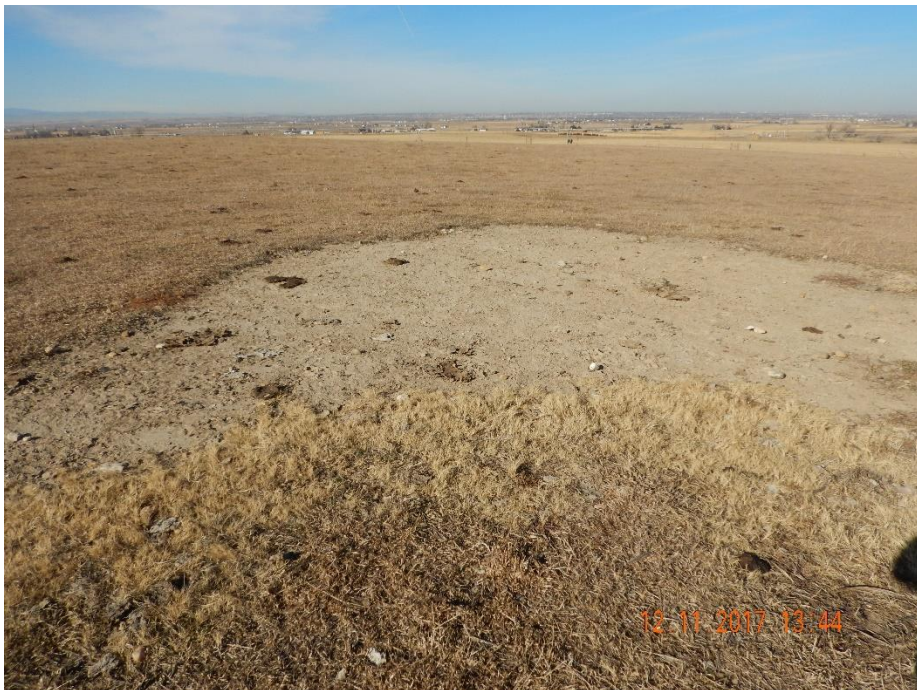
Photo 1: Photo taken from the well location, facing north. Previous inspections required operator to perform compaction alleviation by 7/8/2017 and to perform reclamation (revegetation activities) by 11/15/2017). Photo shows location remains bare and exposed soil, compaction concerns remains. Unable to find evidence that reclamation activities have been conducted.

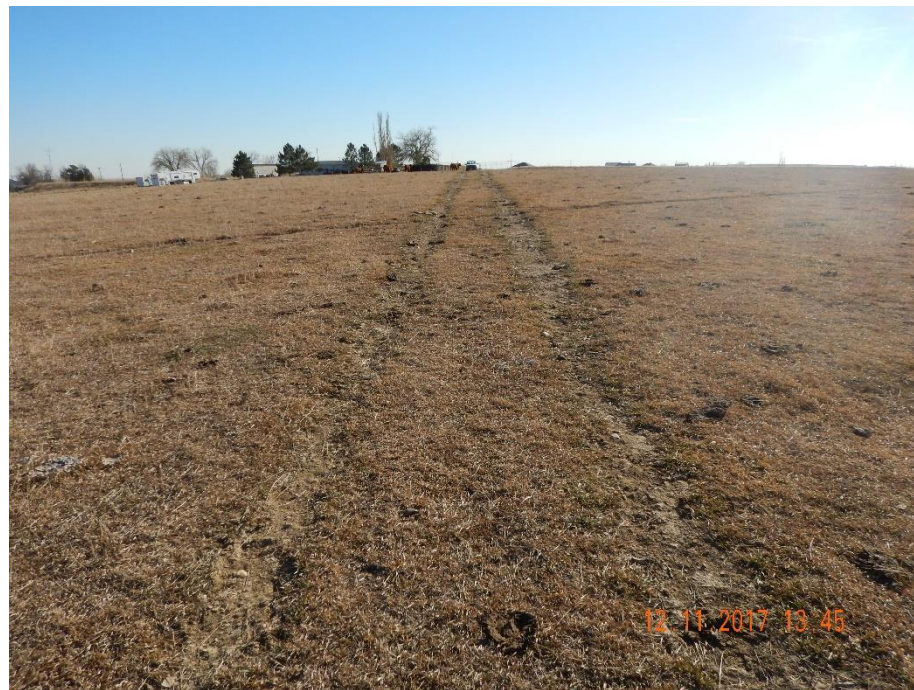
Photo 2: Photo taken from the well location, facing south. Previous inspections required operator to perform compaction alleviation by 7/8/2017 and to perform reclamation (revegetation activities) by 11/15/2017). Photo shows location access road remains unreclaimed

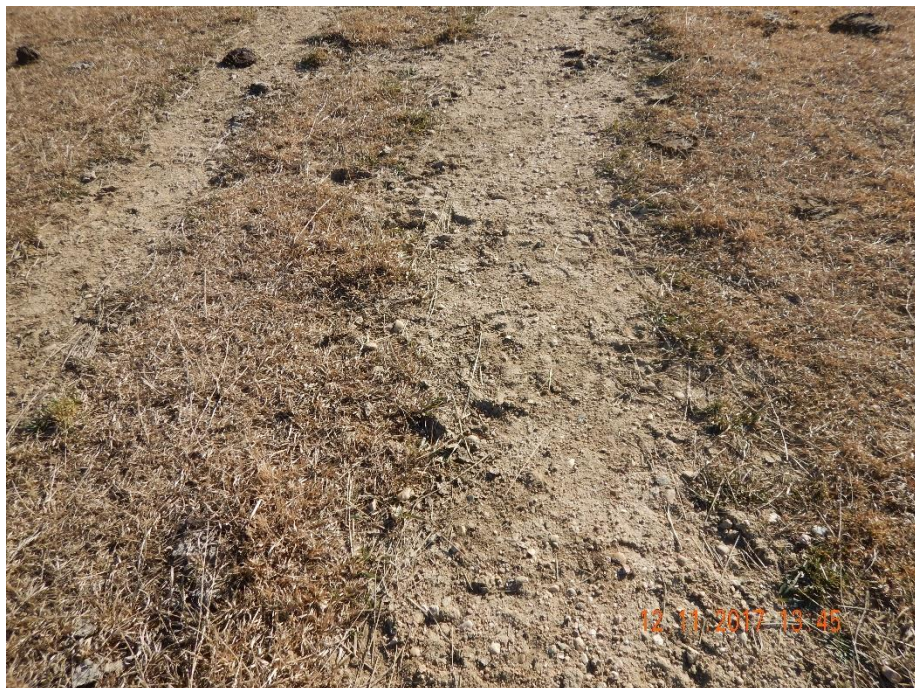
Photo 3: Photo taken from the access road. Photo shows access road has not been reclaimed.

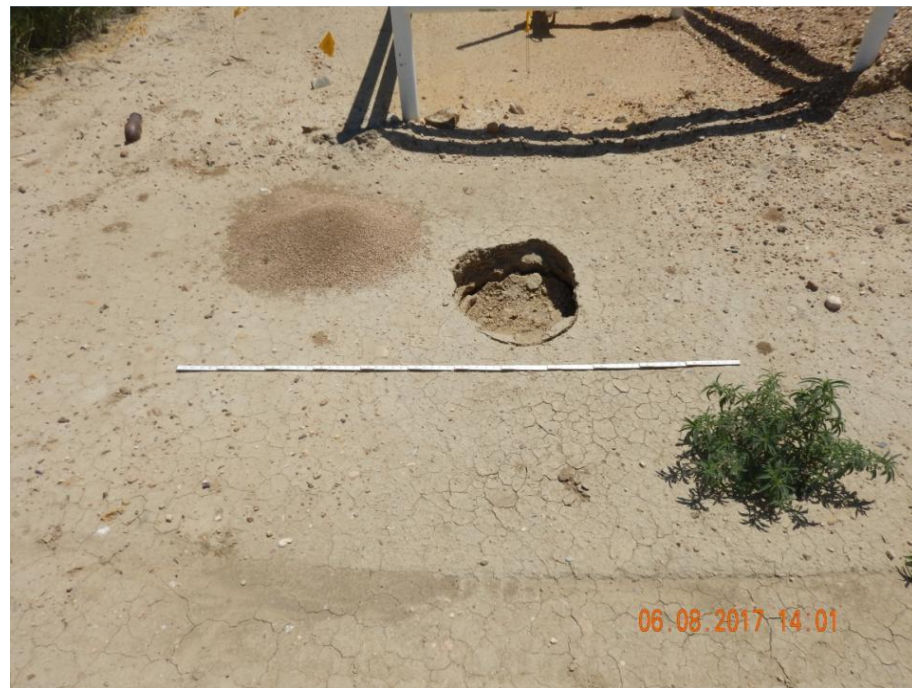
Photo 4: Photo from previous inspection dated 6/8/2017. Previous inspections required operator to repair subsidence concerns occurring on the former battery location. Photos 4-6 date from 6/8/2017 to 12/11/2017 show subsidence has not been repaired and degradation has continued, and hole has expanded. 6 foot measuring stick for reference.

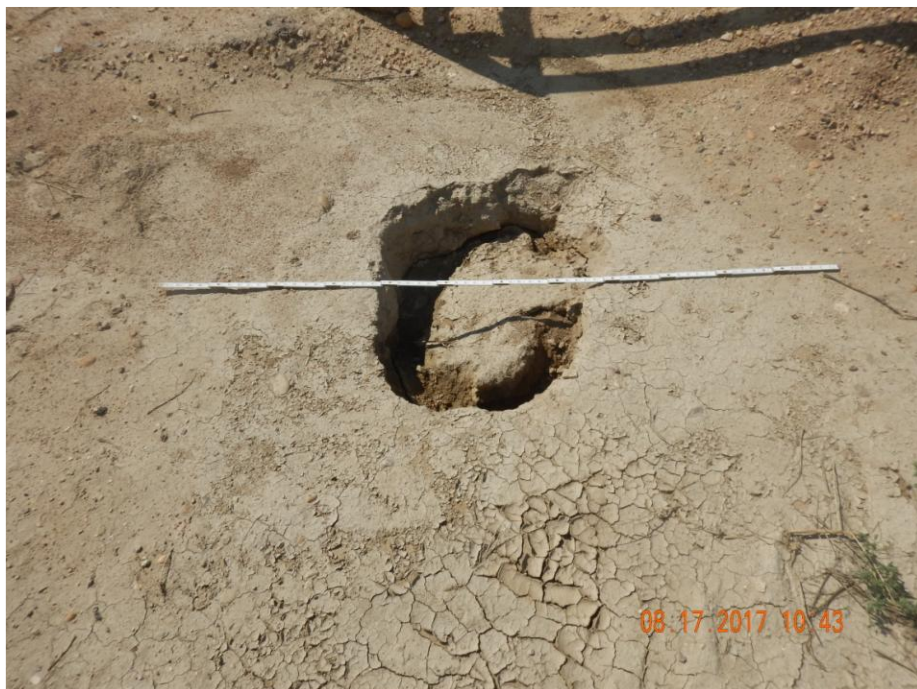
Photo 5: Photo taken from inspection dated 8/17/2017. See comments under photo 4.

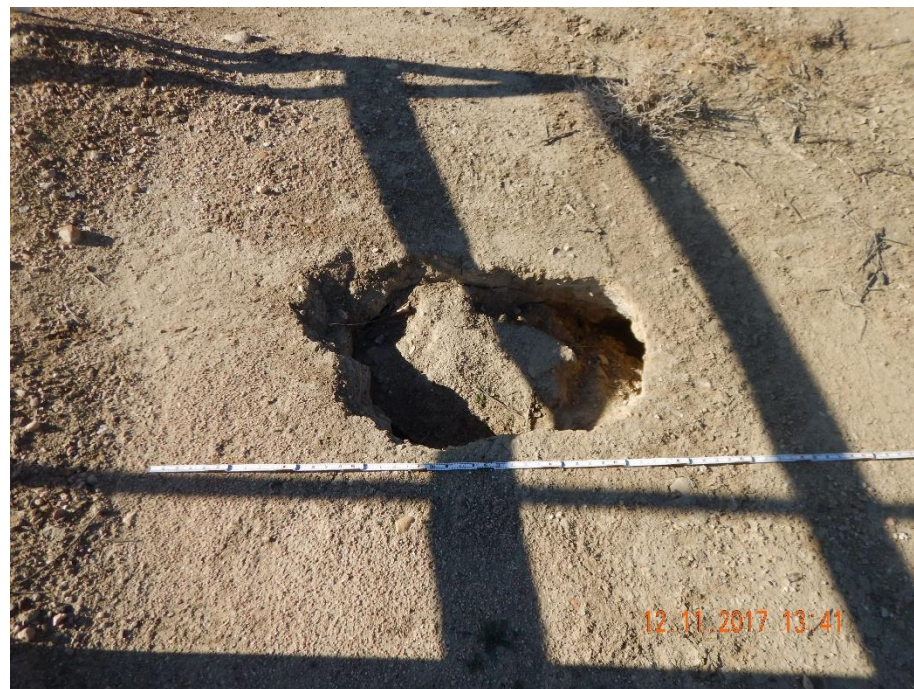
Photo 6: Photo dated 12/11/2017. Photo shows subsidence has not been repaired, and has been allowed to continue to expand. 6 foot measuring stick for reference.
