Final Reclamation and Stormwater Inspection

June 7, 2018

Operator: EXTRACTION OIL & GAS INC - 10459

Location ID: 336511

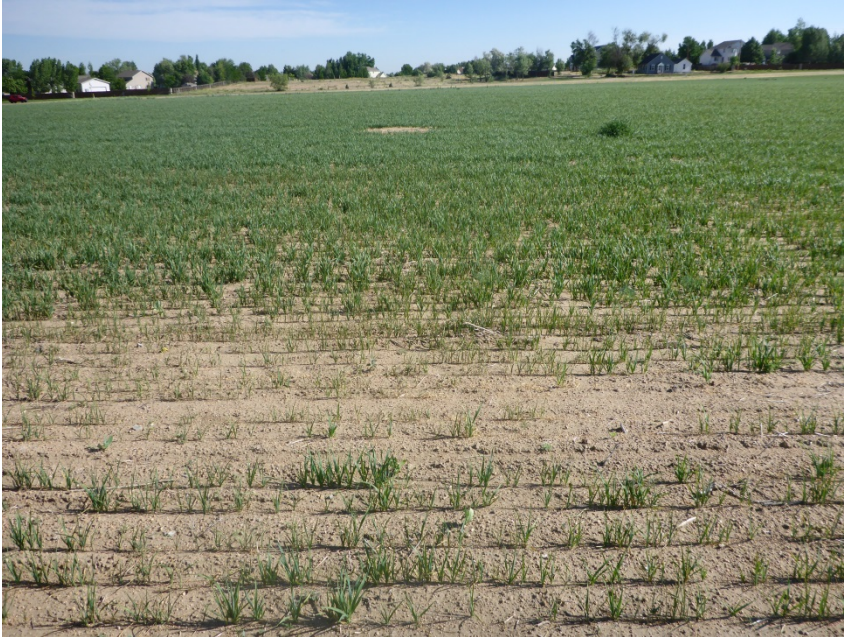
Photo 1. Photo taken from the well location, facing North. Appears the Operator has performed reclamation activities with all equipment removed. Gravel remains on the location which has not been decompacted.

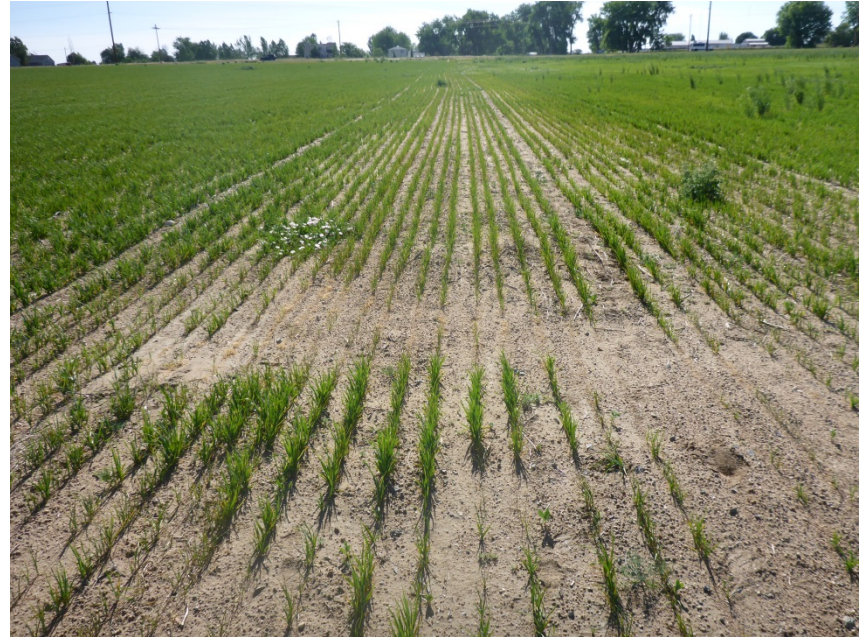
Photo 2. Photo taken from the well location, facing East. See comments from Photo 1.

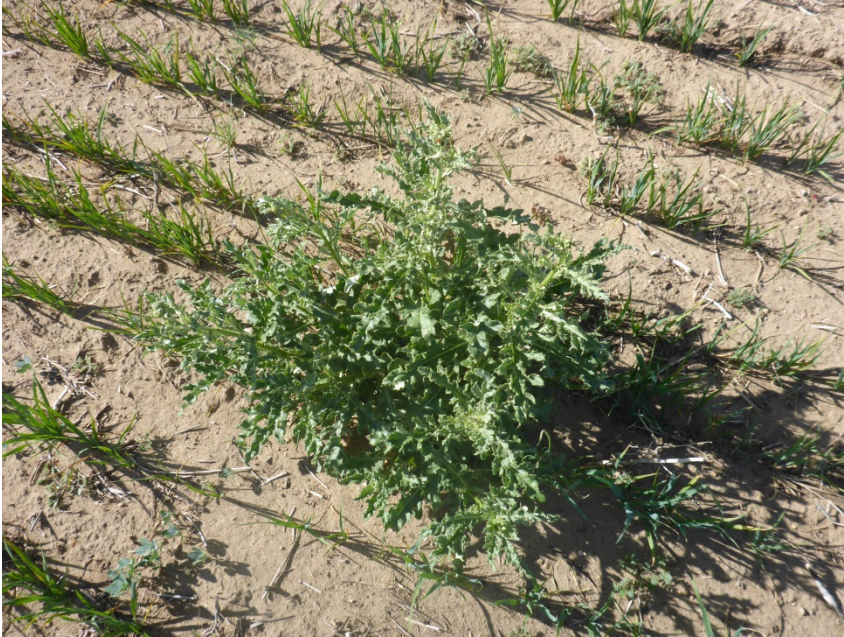
Photo 3. Photo taken from the facility, facing South. A List B Colorado Noxious weed species, Canada thistle (*Cirsium arvense*), is found at low densities at the well site .

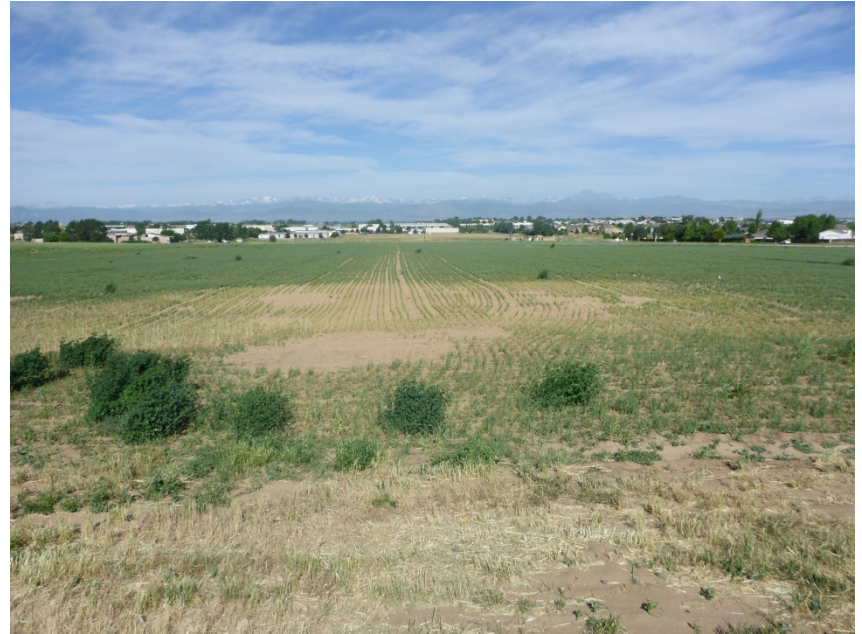
Photo 4. Photo taken showing the tank battery location, facing West. See comments from Photo 1.
