# Final Reclamation Inspection

Operator: NOBLE ENERGY INC- #100322

API: 05-123-21031

Inspection Photos  
Location Name: CERVI #42-27  
API: 05-123-21031

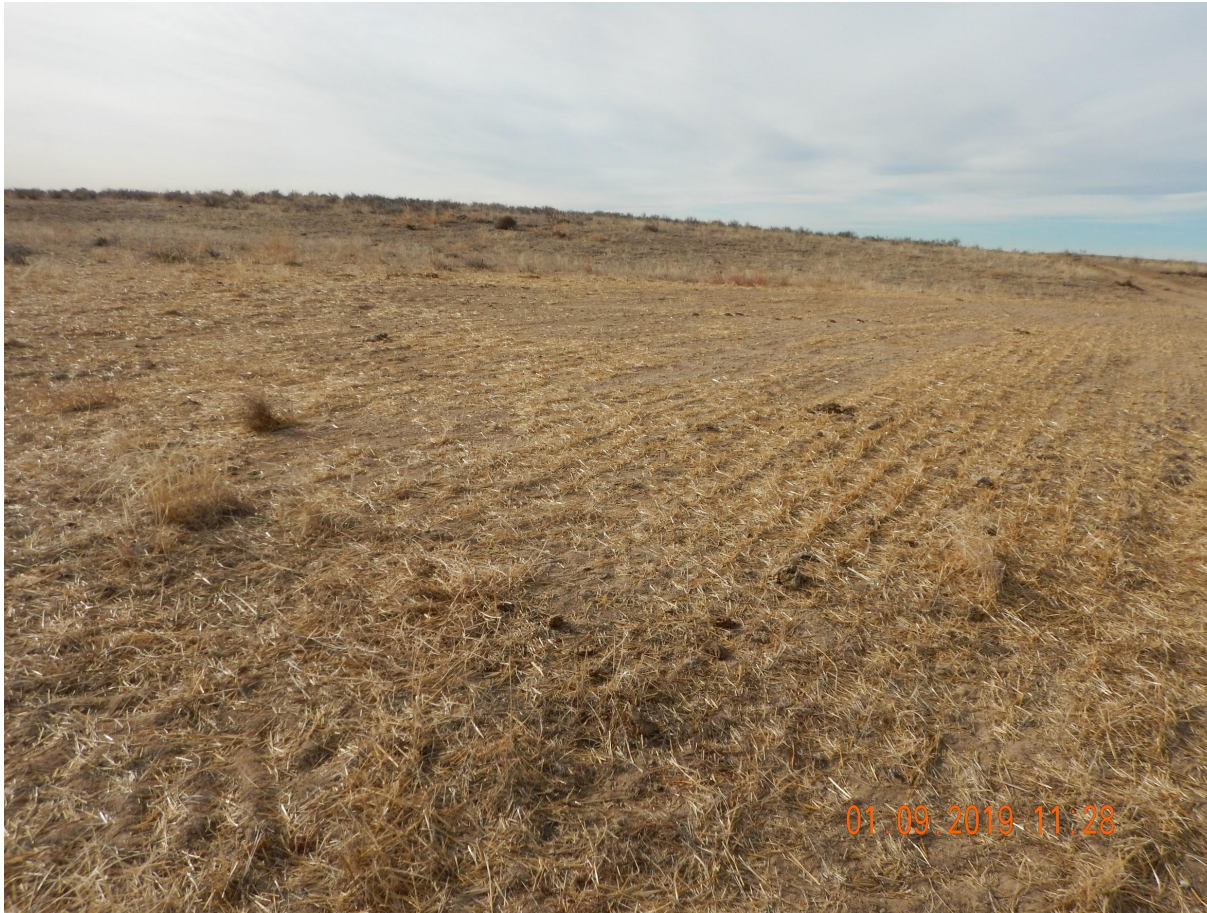
**Photo 3.** Photo taken from the northeastern well location, facing West. See comments under Photo 1.

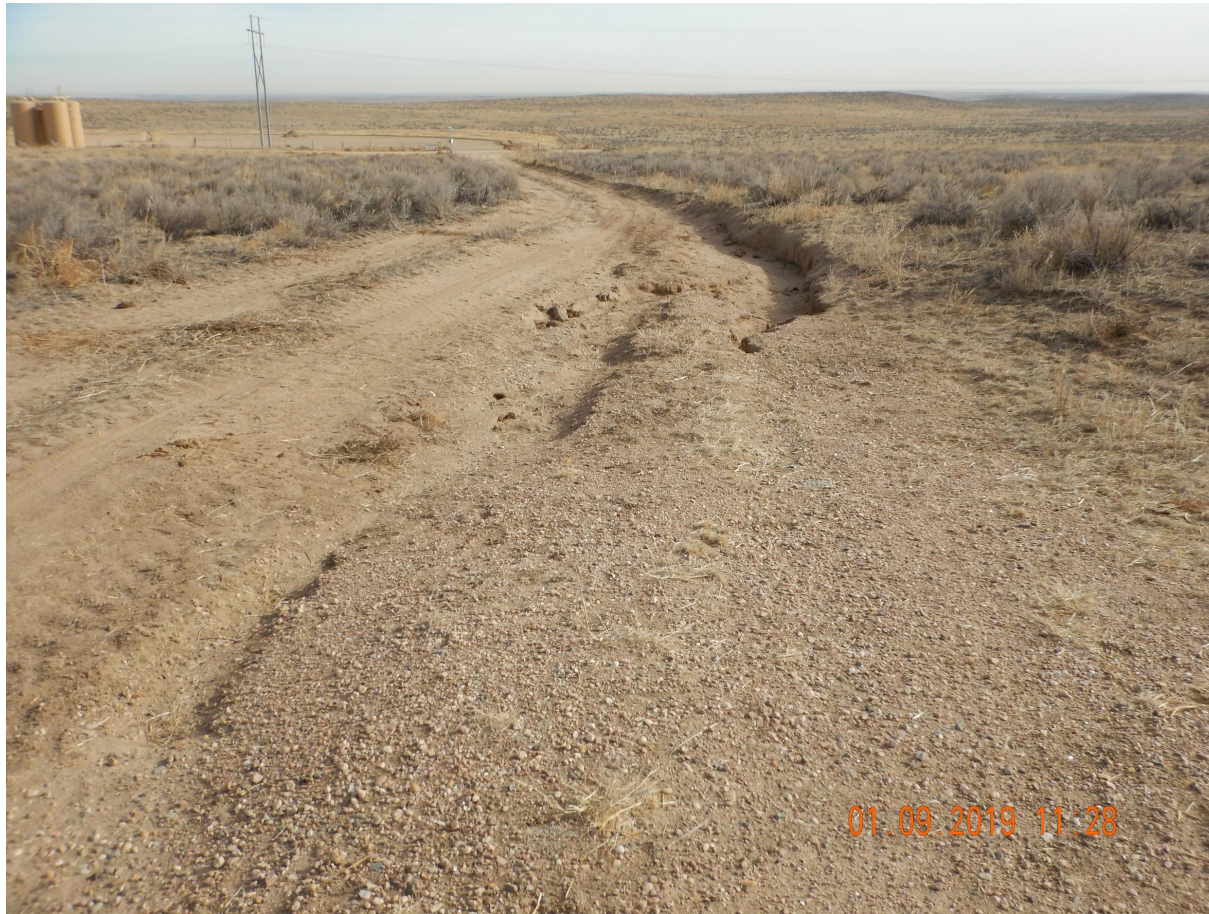
**Photo 4.** Photo taken from the former well location access road, facing East. Operator shall repair erosion along the access road. Note: the gravel that has been washed eastward was likely from the well location.

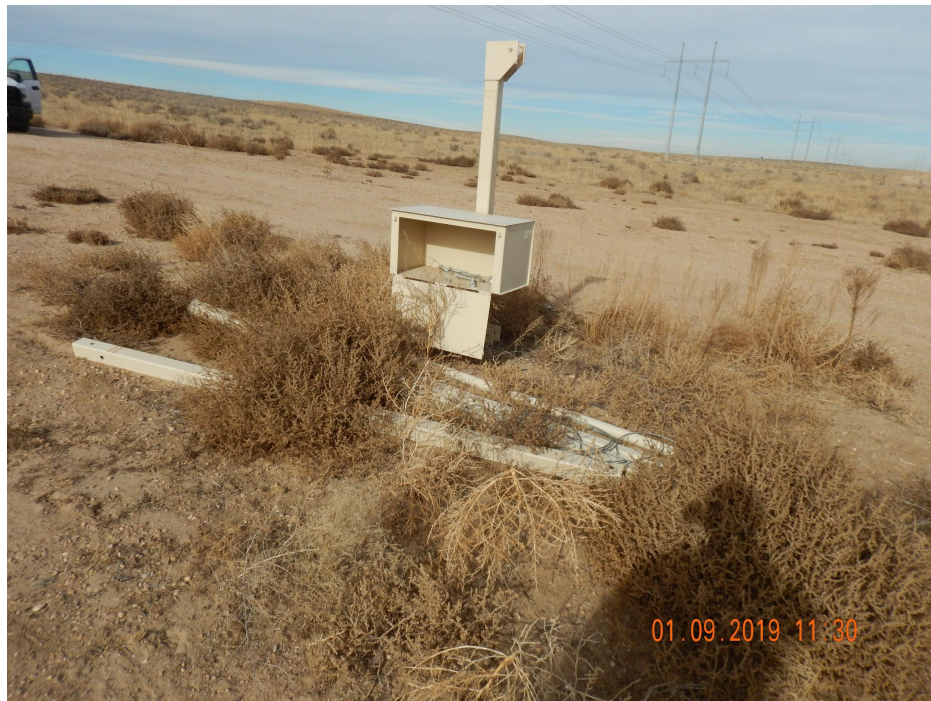
**Photo 5.** Photo taken from the southern tank battery location, facing North. Operator has failed to remove all equipment per Rule 1004. Note the unmanaged Russian thistle.

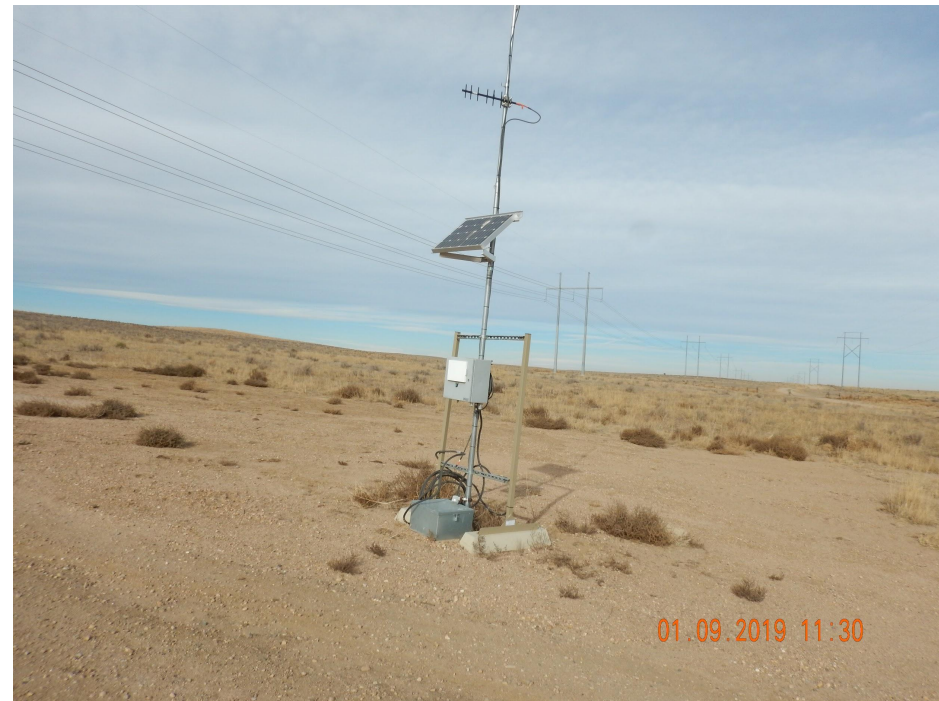
**Photo 6.** Photo taken from the northern tank battery location, facing North. See comments under Photo 5.

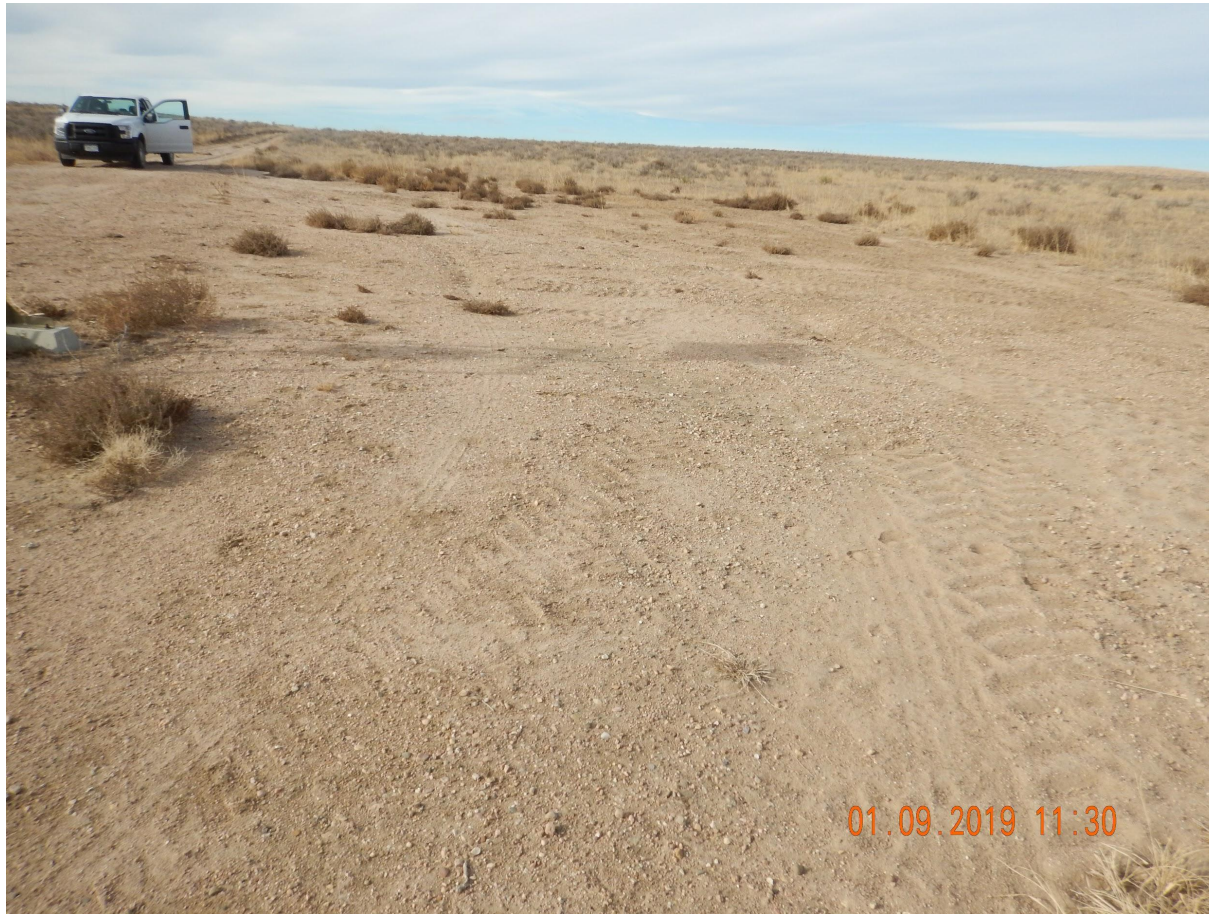
**Photo 7.** Photo taken from the northern tank battery location, facing West. Operator has failed to perform final reclamation activities at the tank battery per Rule 1004.
