Inspection Photos

Operator: WHITING OIL & GAS CORPORATION -
96155

Location ID: 427181

Inspection Doc. Number: 682504548
Weld County, CO

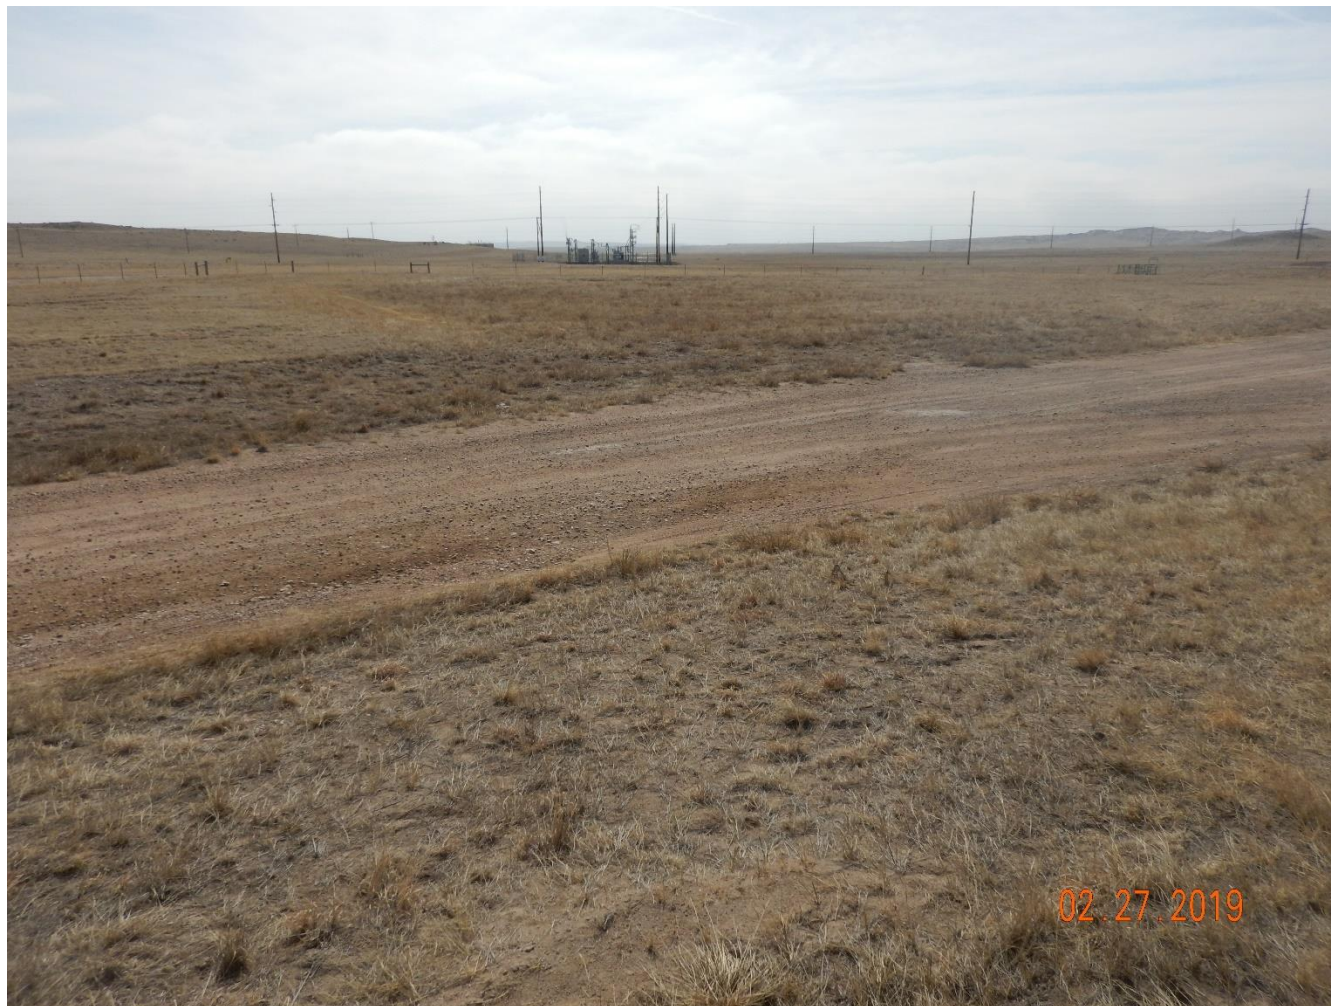
Photo 1: Photo taken from the north end of the location, facing south. Photos 1-3 provide an overview of the interim and production areas of the location from south, southwest to west.

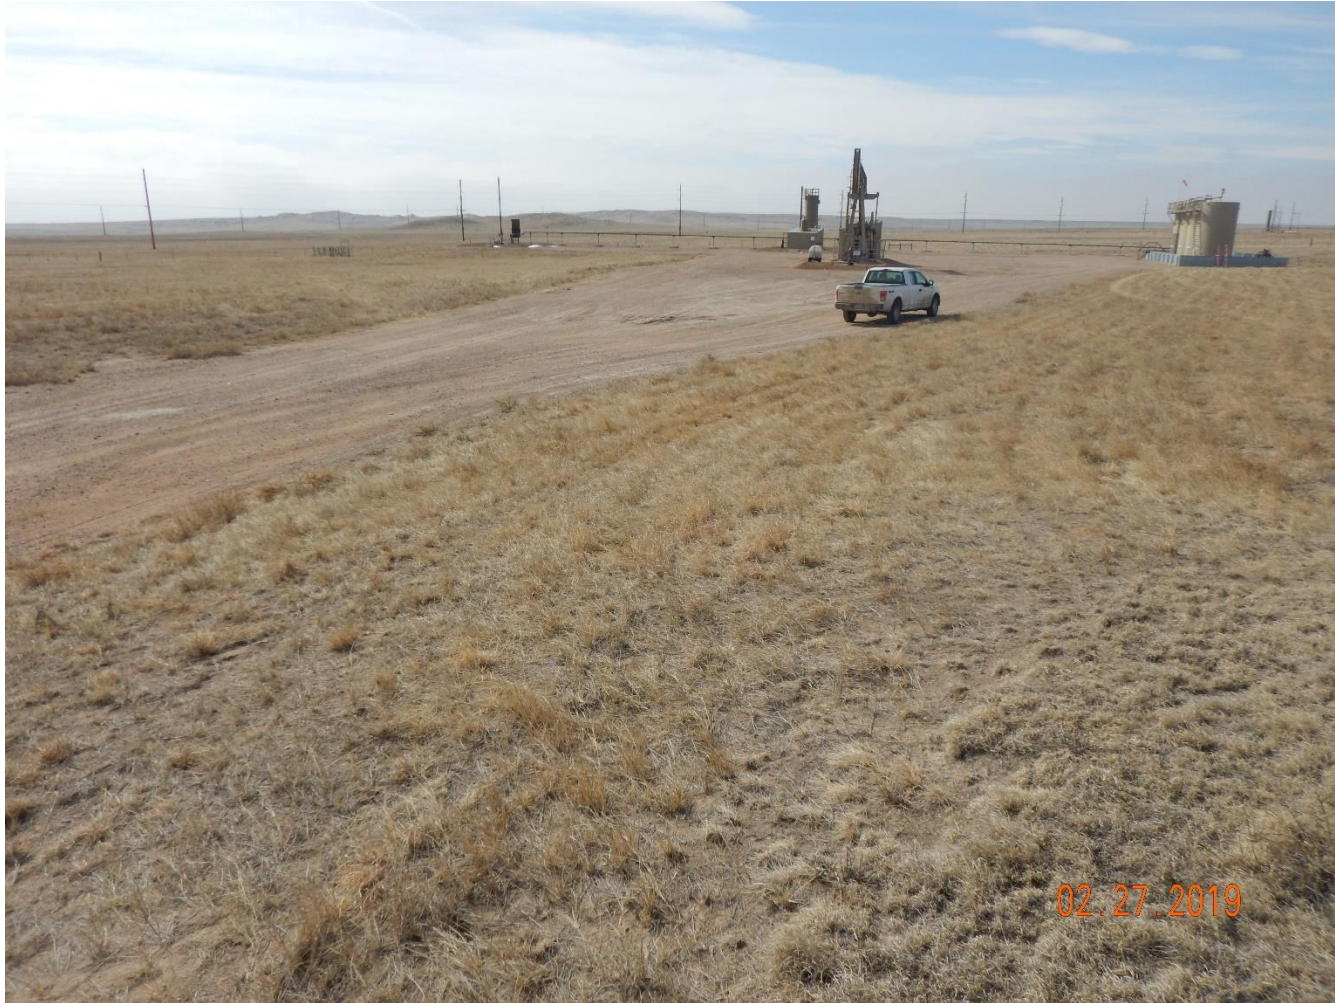
Photo 2: See comments under photo 1.

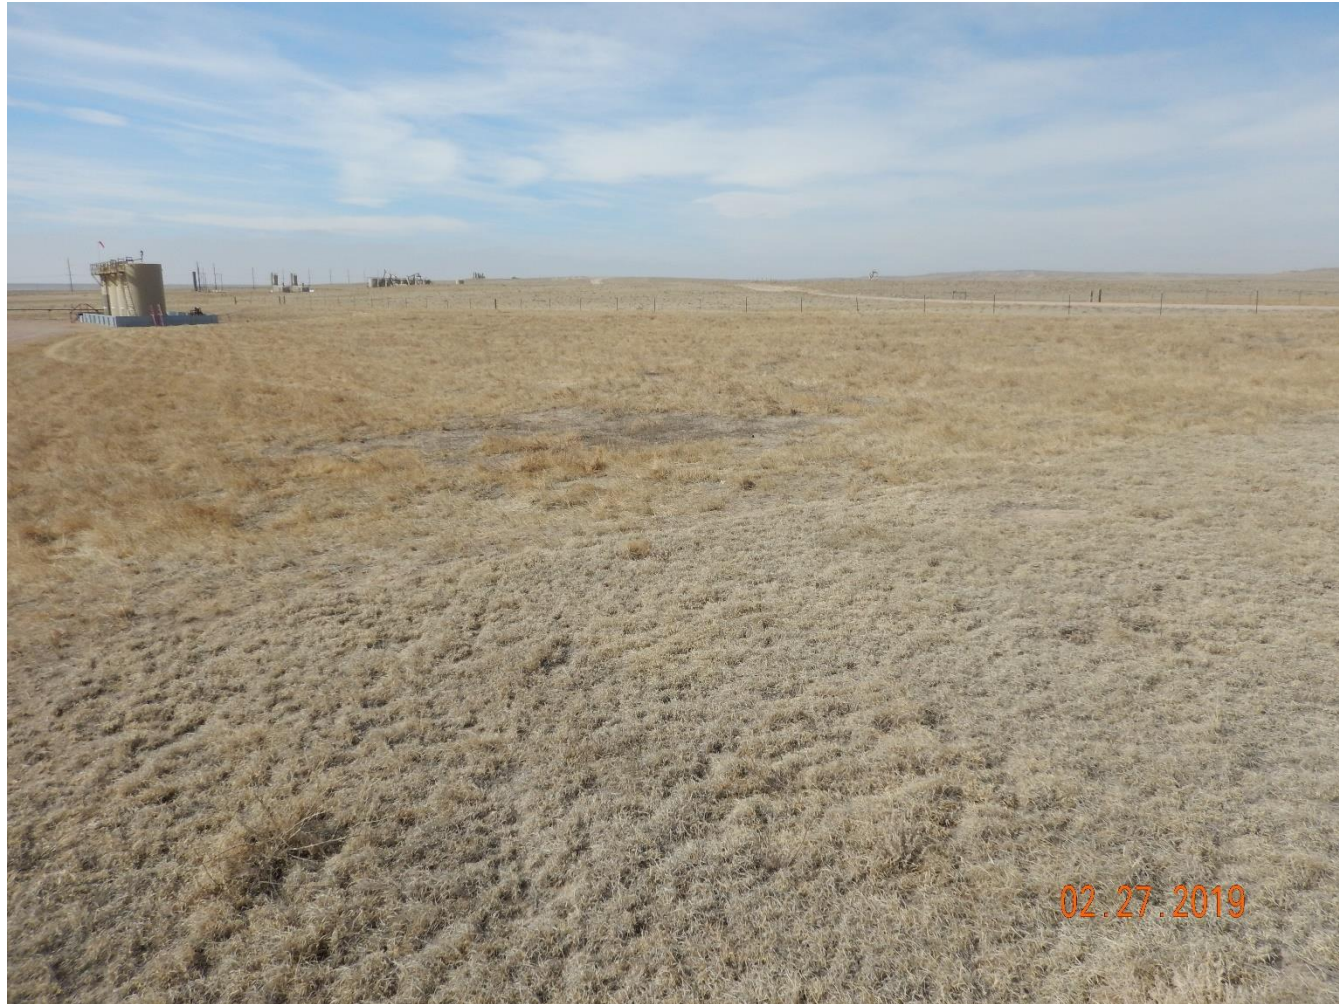
Photo 3: See comments under photo 1.

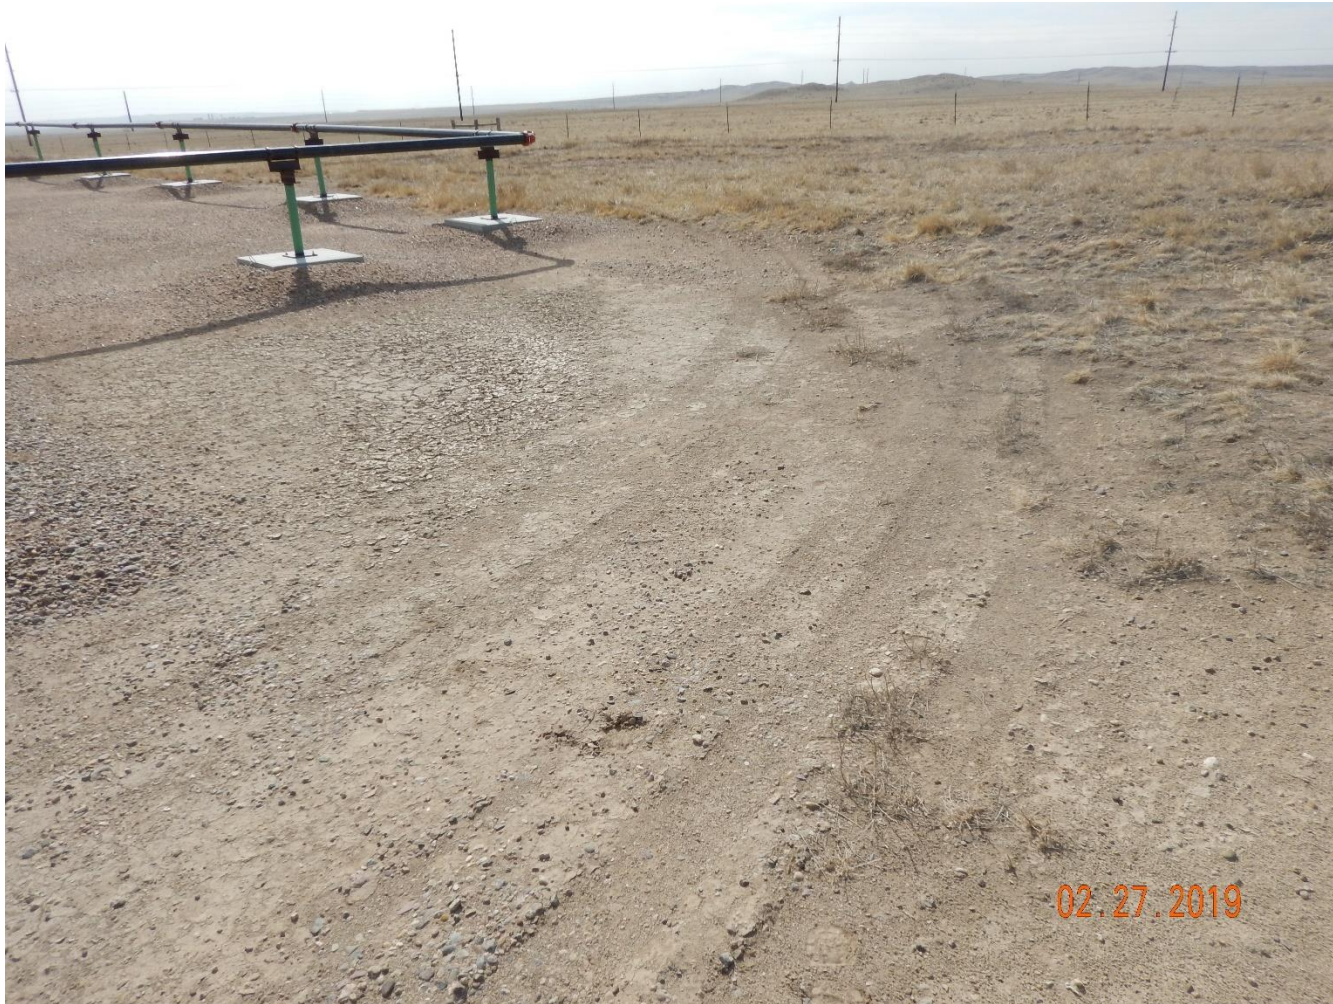
Photo 4: Photo taken from the northwest end of the pad, facing southwest. Photo shows operator appears to have traveled off of the designated pad onto the interim areas. This is not compliant with rules 1002.e. Restrict all equipment and vehicle traffic to the constructed pad and designated access road.

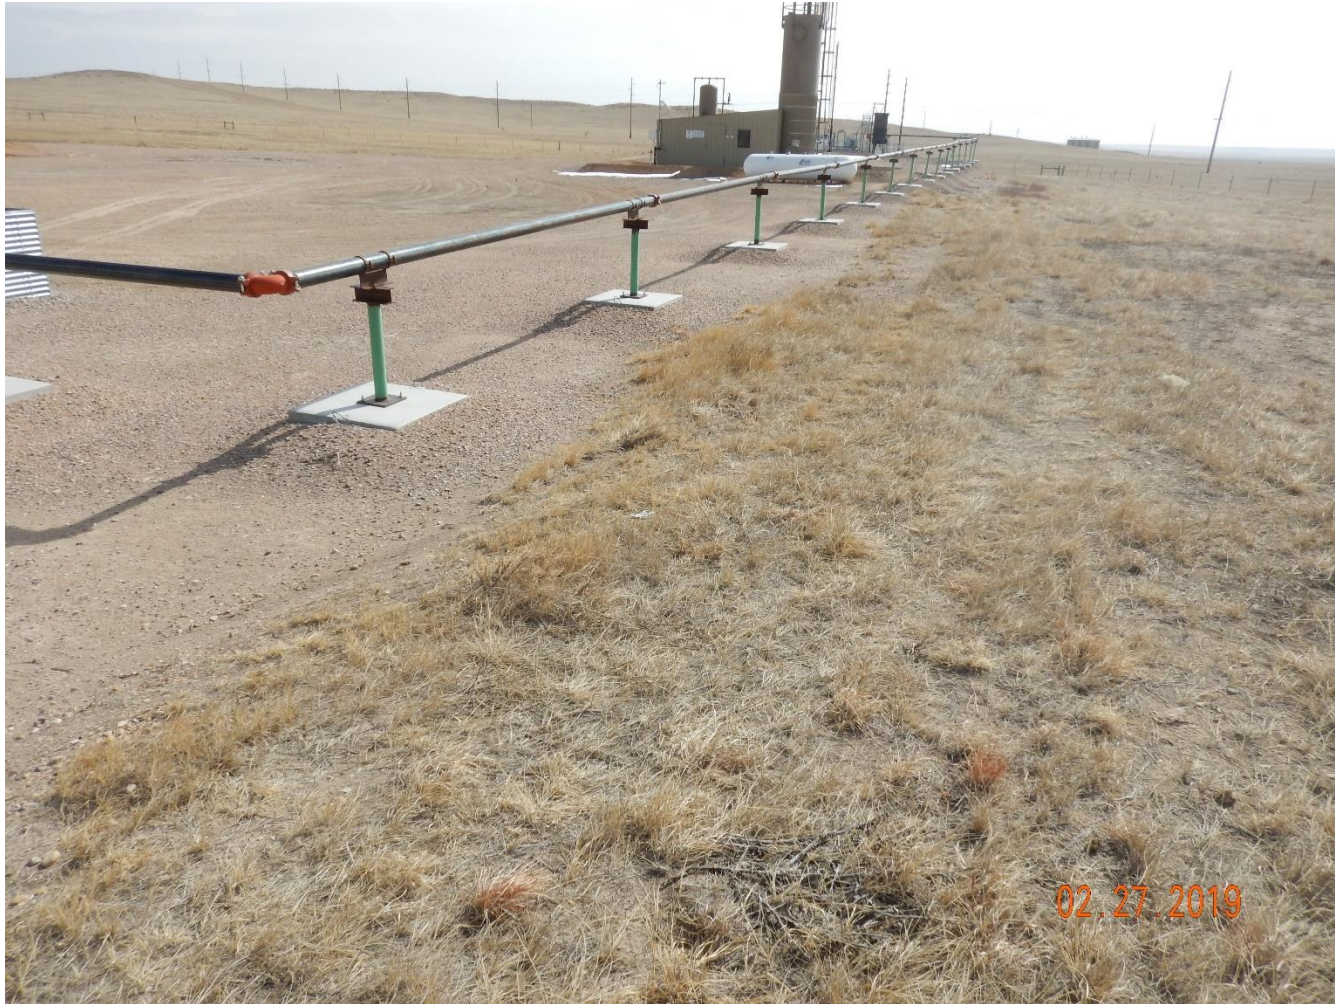
Photo 5: Photo taken from the northwest end of the pad, facing south. See comments under photo 4.

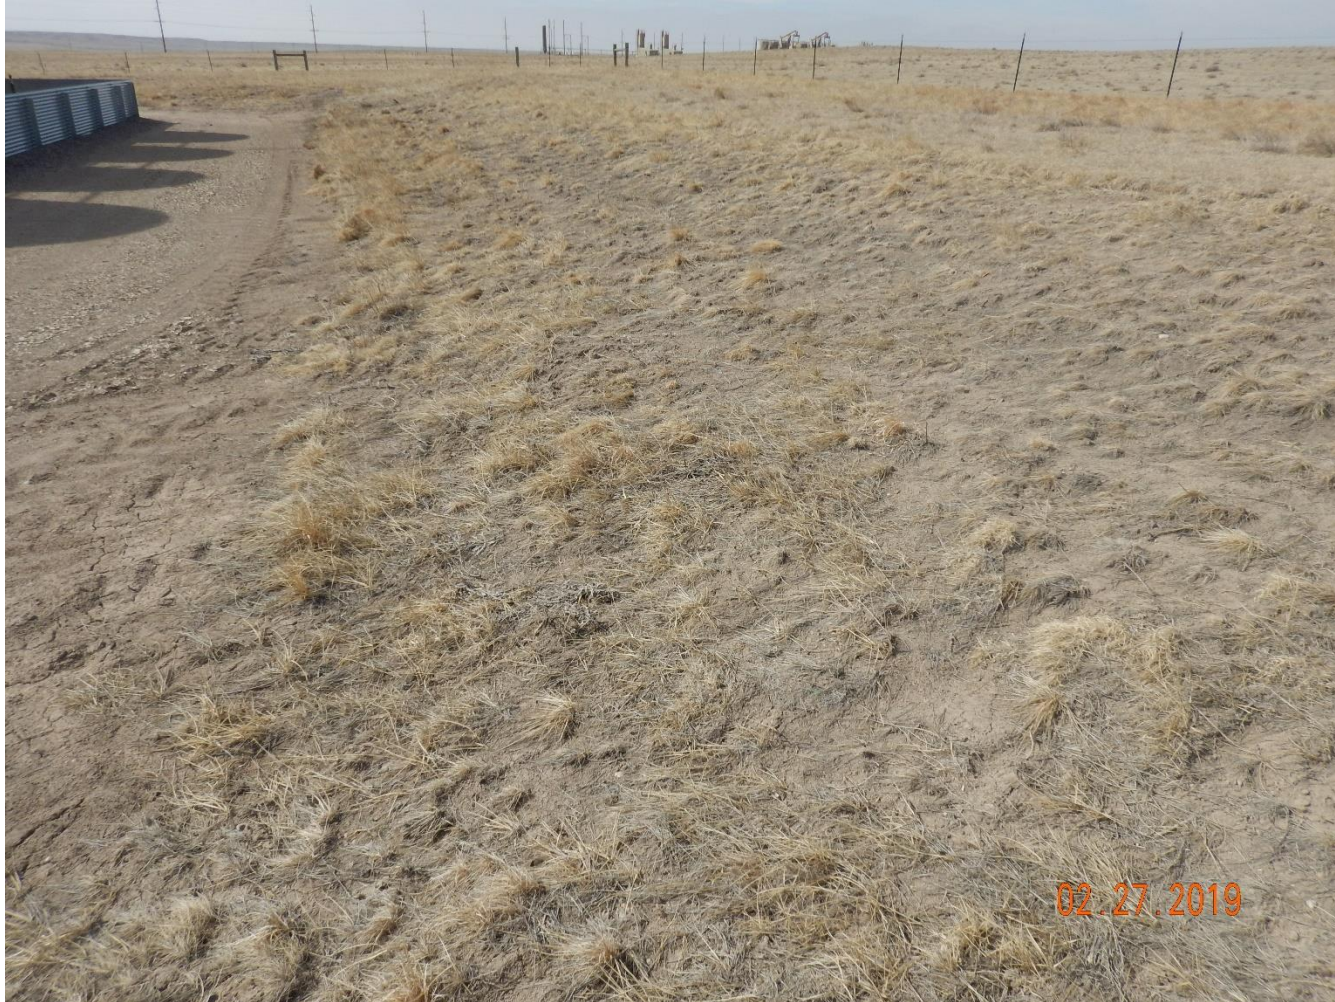
Photo 6: Photo taken from the north end of the pad. Photo shows vegetation on the slopes of the interim area. These areas may require additional seeding to meet reclamation requirements.

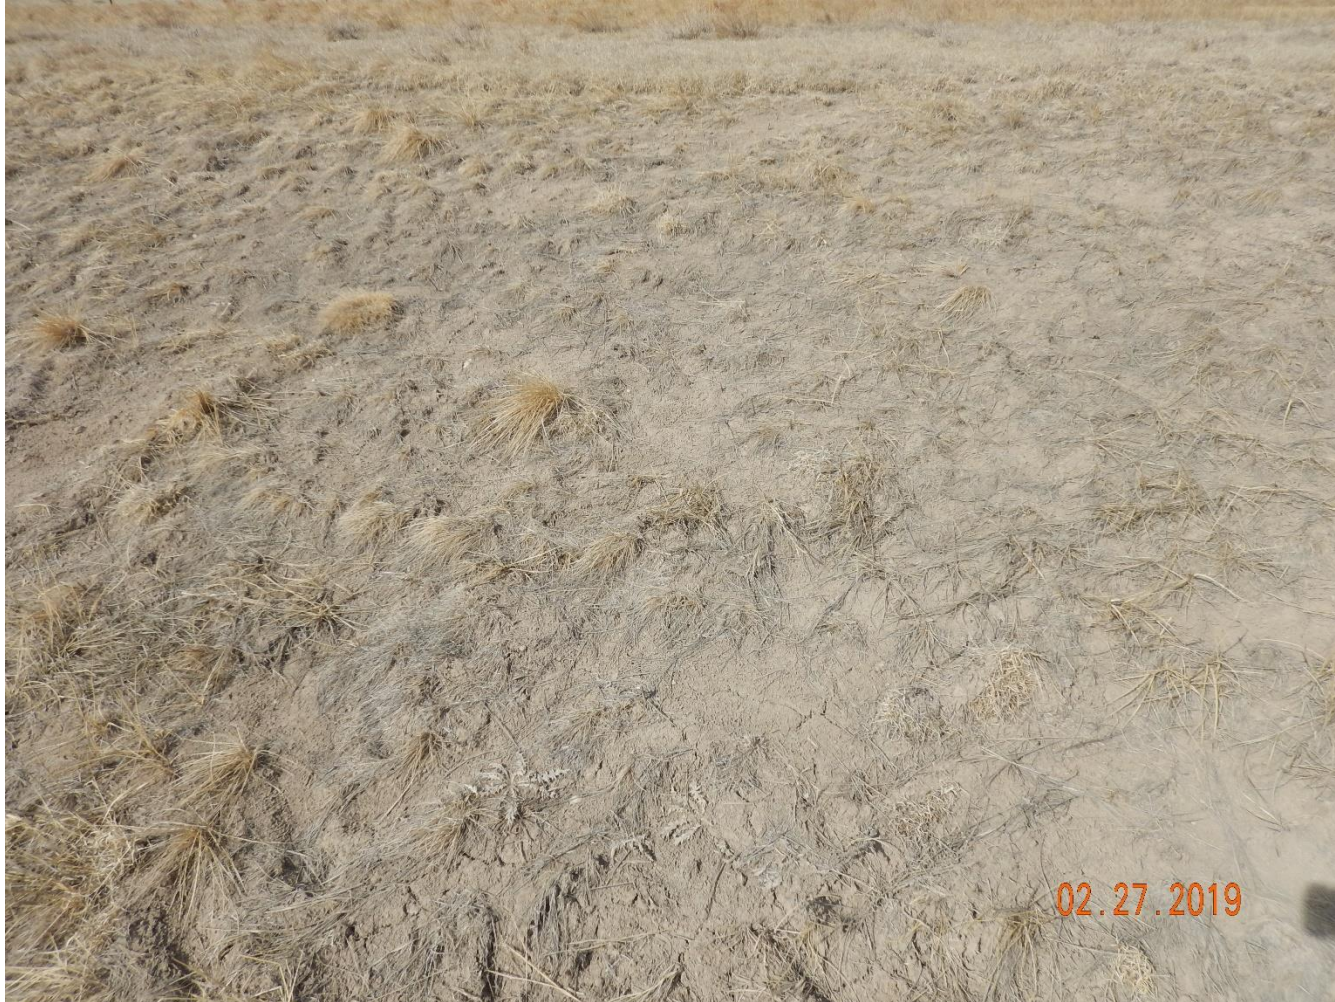
Photo 7: See comments under photo 6.

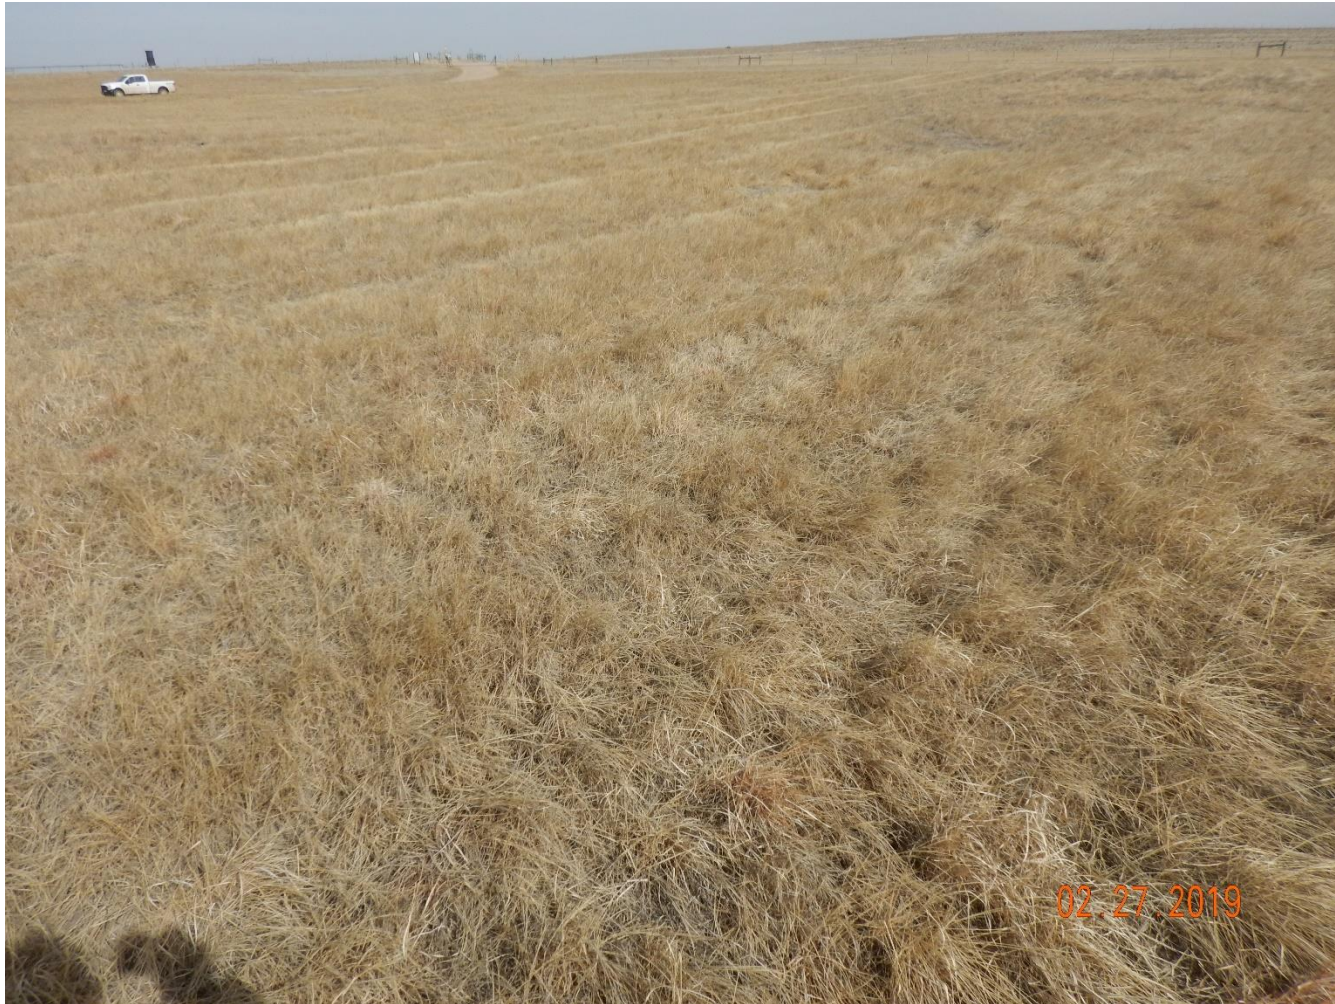
Photo 8: Photo taken from the south end of the location, facing northeast. Photo shows vegetation over the reclamation area.
