Construction and Storm Water Inspection

Operator: GREAT WESTERN OPERATING COMPANY LLC – 10110

Location ID: 452180

Location Name: GREAT WESTERN OPERATING – 100322/3N68W1

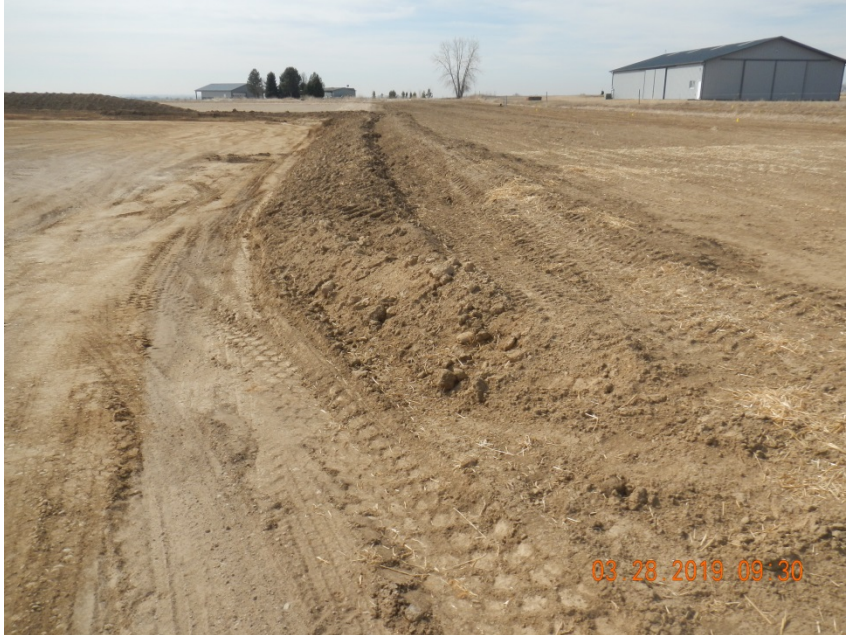
Photo 1. Photo taken from the northwestern perimeter of the location, facing South. Photo illustrates a compacted BMP that has been installed around parts of the location.

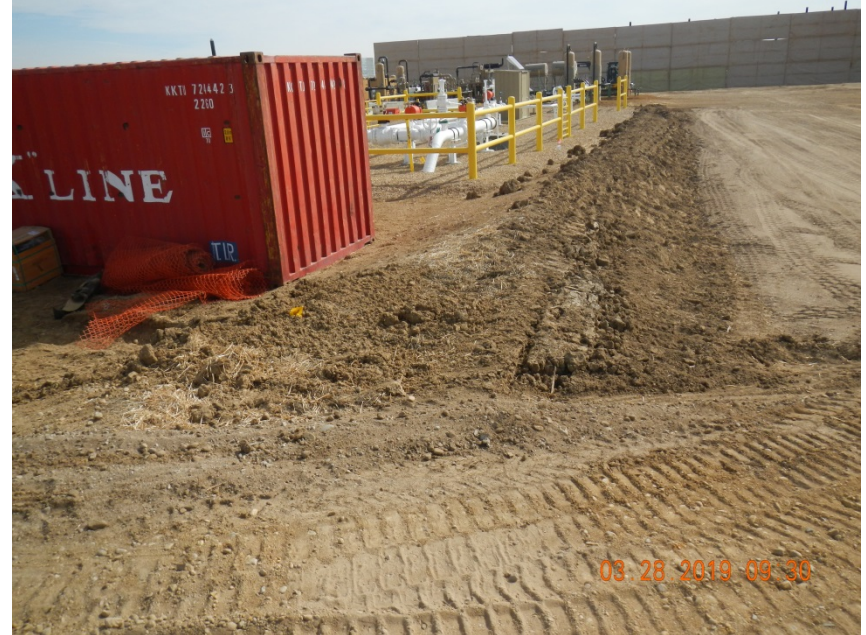
Photo 2. Photo taken from the northwestern perimeter of the location, facing East. See comments from Photo 1.

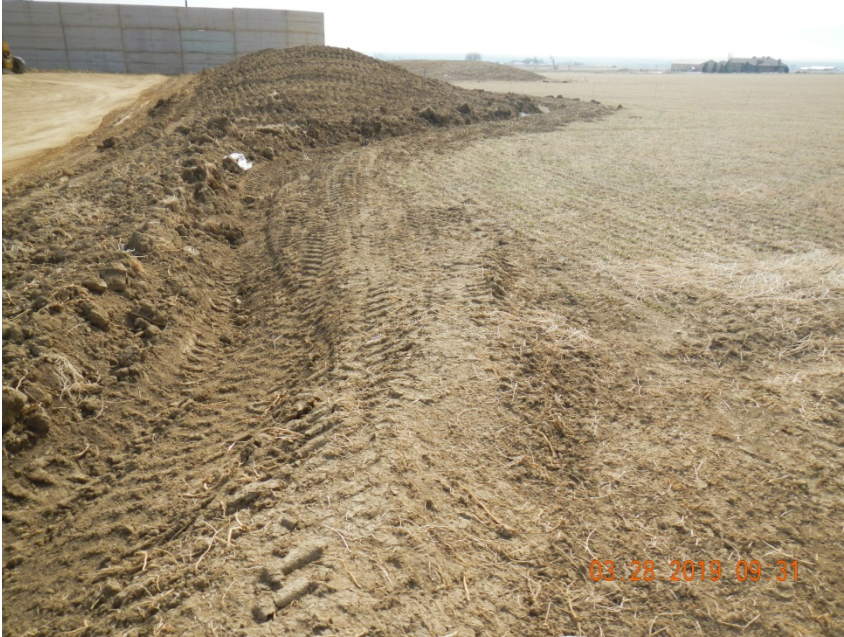
Photo 3. Photo taken from the southwestern perimeter of the location, facing East. Photo illustrates the topsoil stockpile being stored along the southern area.

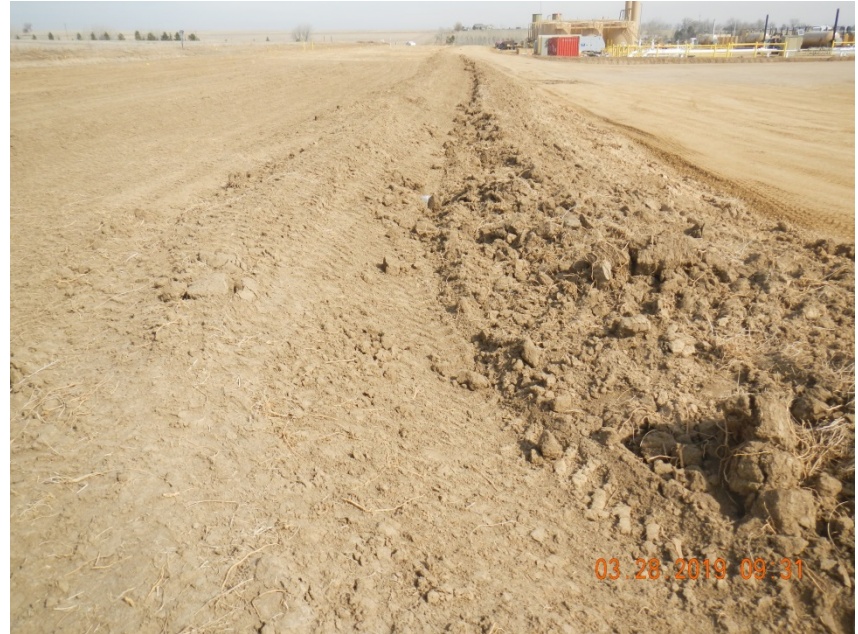
Photo 4. Photo taken from the southwestern perimeter of the location, facing North. See comments from Photo 1.

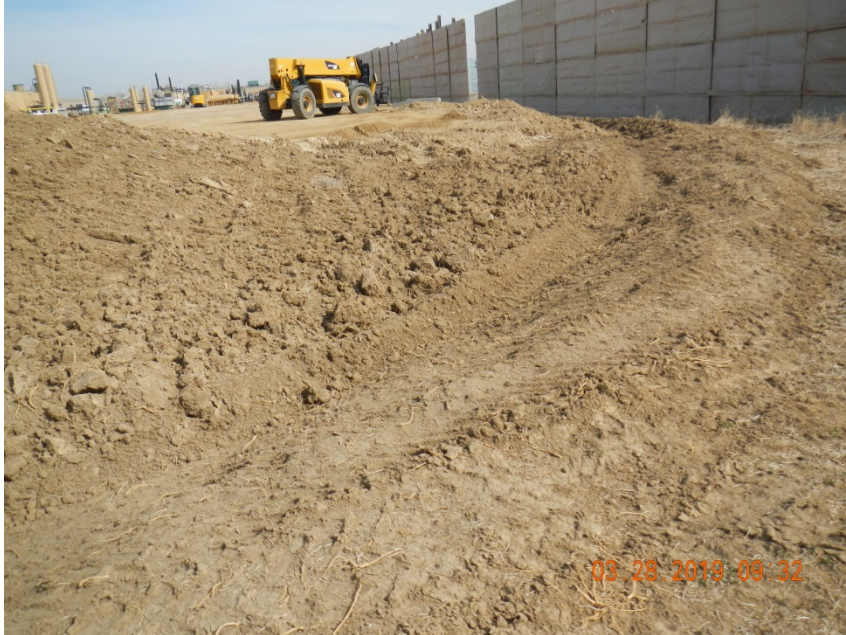
Photo 5. Photo taken from the southeastern perimeter of the location, facing North. See comments from Photo 1.

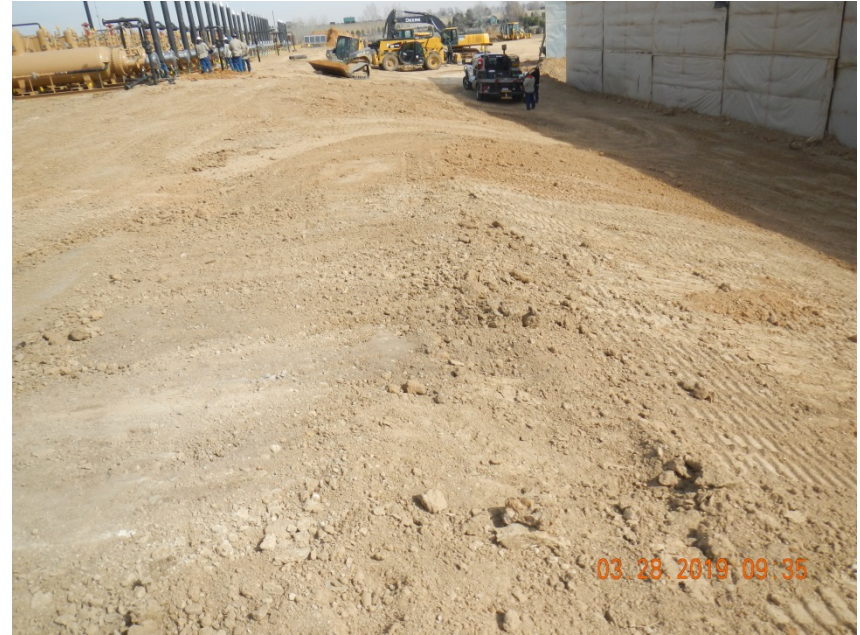
Photo 6. Photo taken from the eastern perimeter of the location, facing North. The ditch and berm BMP does not go around the entire perimeter of the location.

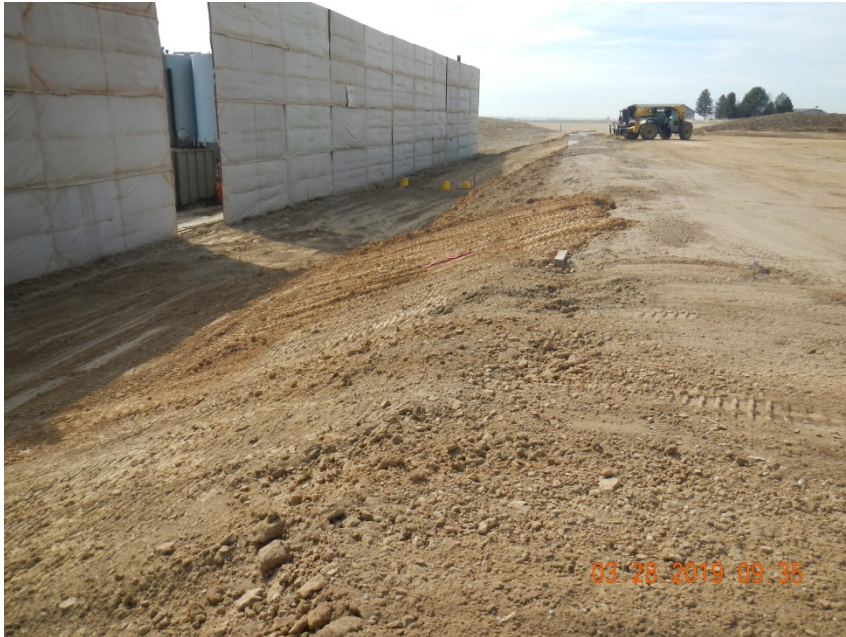
Photo 7. Photo taken from the northeastern perimeter of the location, facing South. See comments from Photo 6.

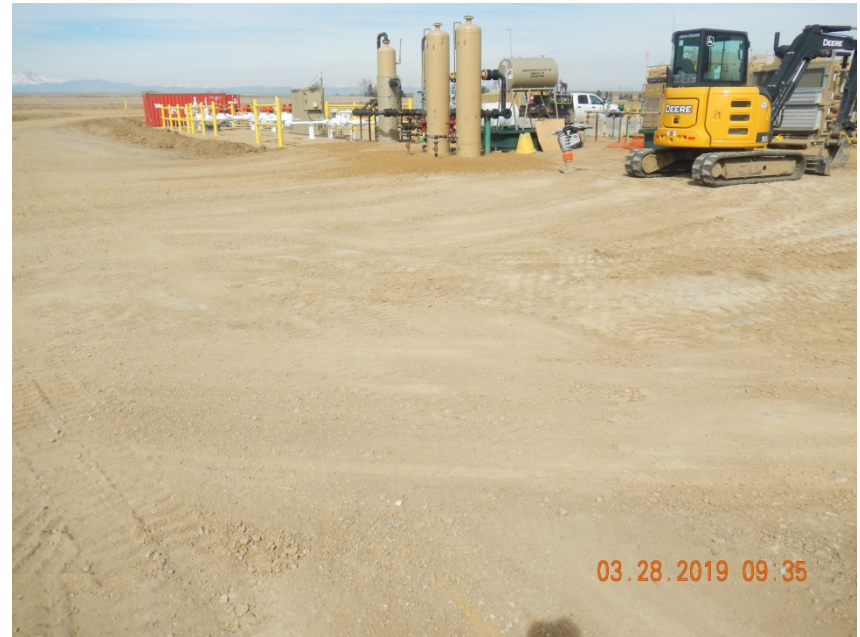
Photo 8. Photo taken from the northeastern perimeter of the location, facing West. No silt traps with stabilized outlets were observed on location.
