Final Reclamation Inspection

Operator: ANADARKO WATTENBERG OIL COMPLEX LLC -
#10600

Location ID#: 319793

SESE Section 7 T1S R67W

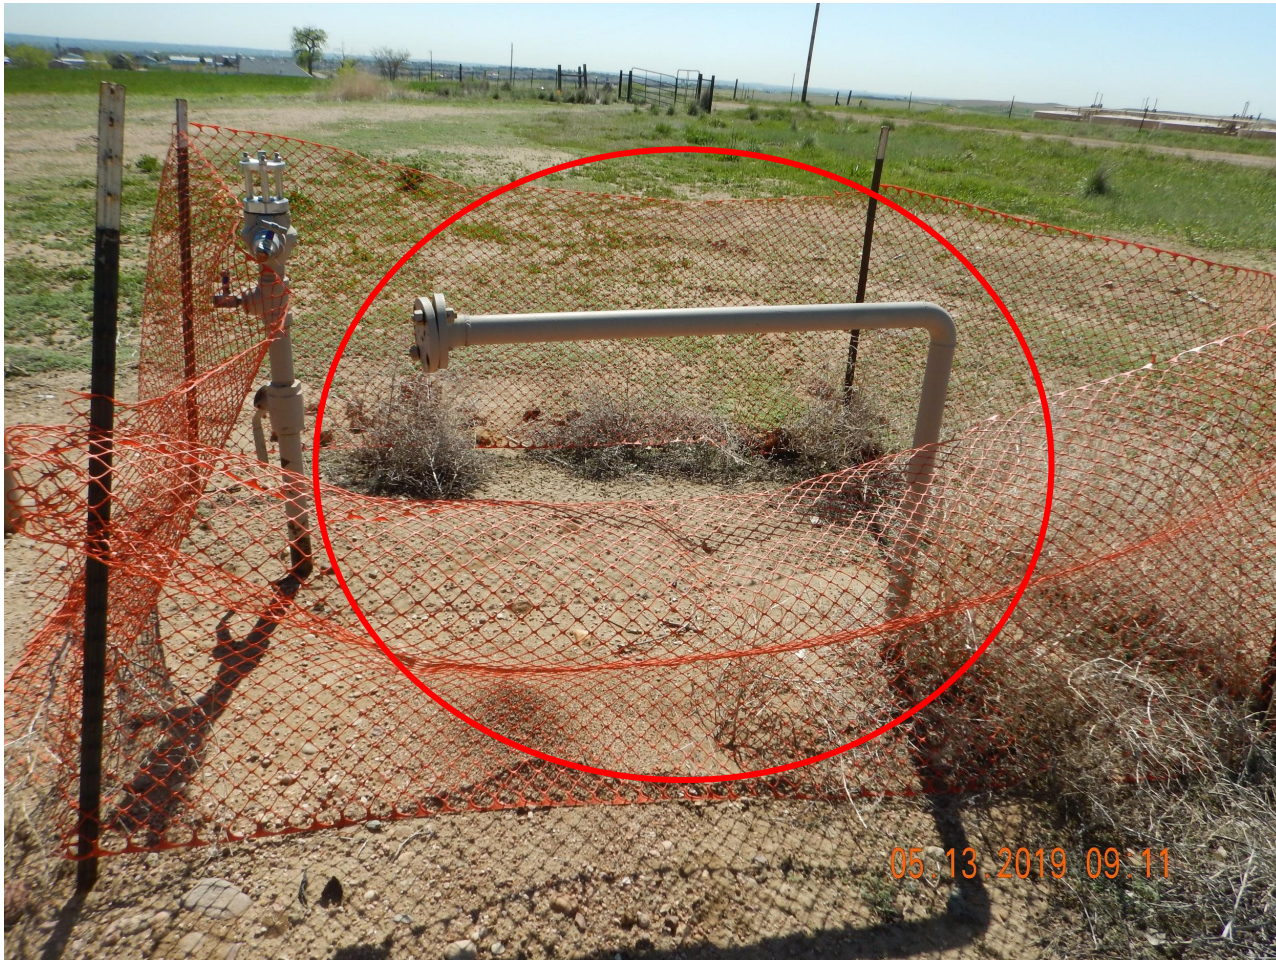
Photo 1. Photo taken from the tank battery location (39.972112, -104.924897), facing East. Riser (red circle) has been left on location. Operator shall remove riser per Rule 1004.a.

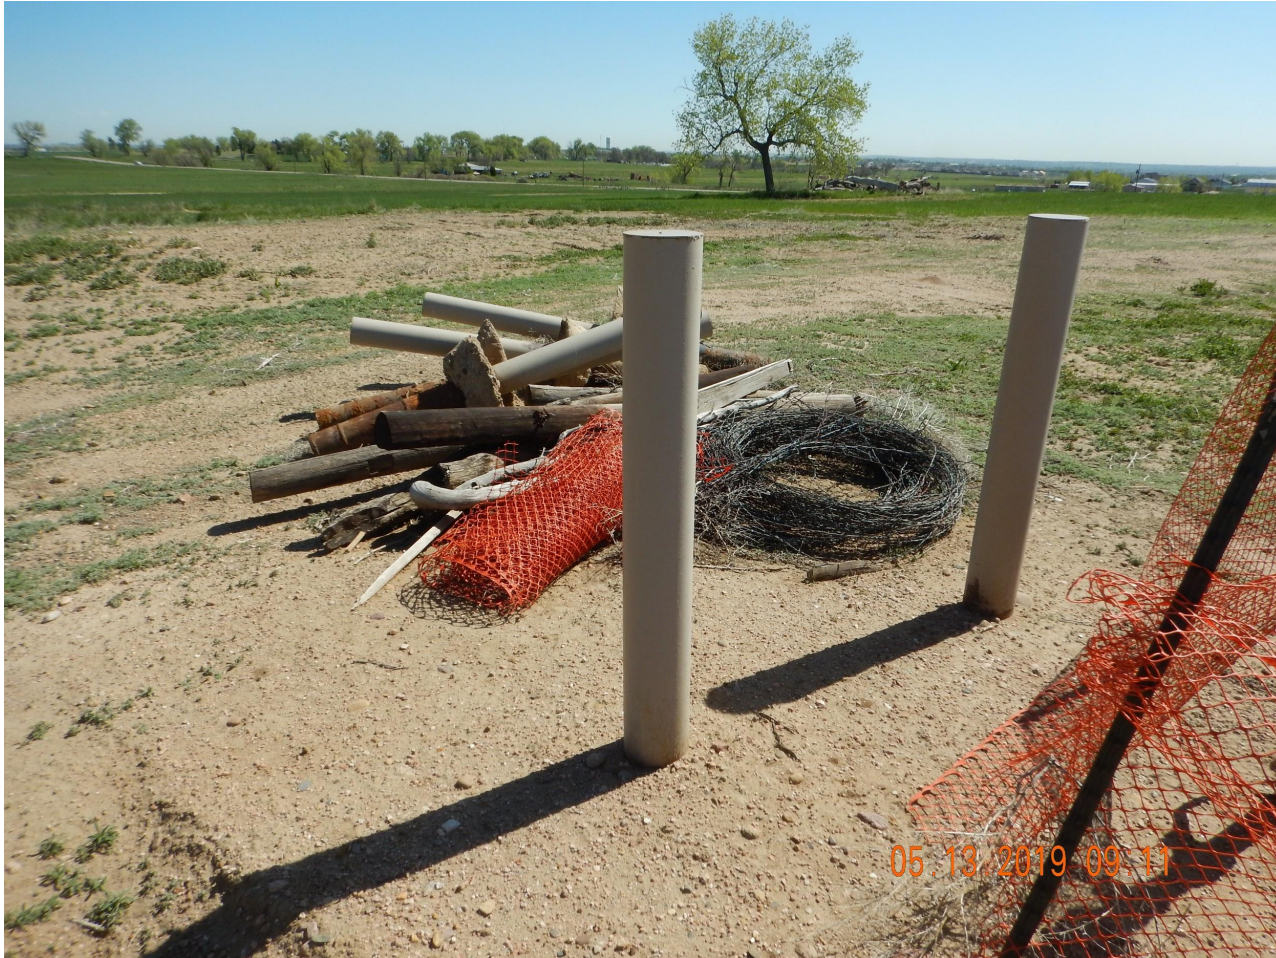
Photo 2. Photo taken from the tank battery location, facing Northeast. Debris left on location. This debris appears to be from the removal of the meter run on location. There was other debris observed on location as well. A corrective action has already been issued to remove this debris by 5/28/2019 (Field Inspection Report Doc. #697500130).
