Inspection Photos
Operator: BP America
Location/API #: 067-07464
Date: 10-24-2019

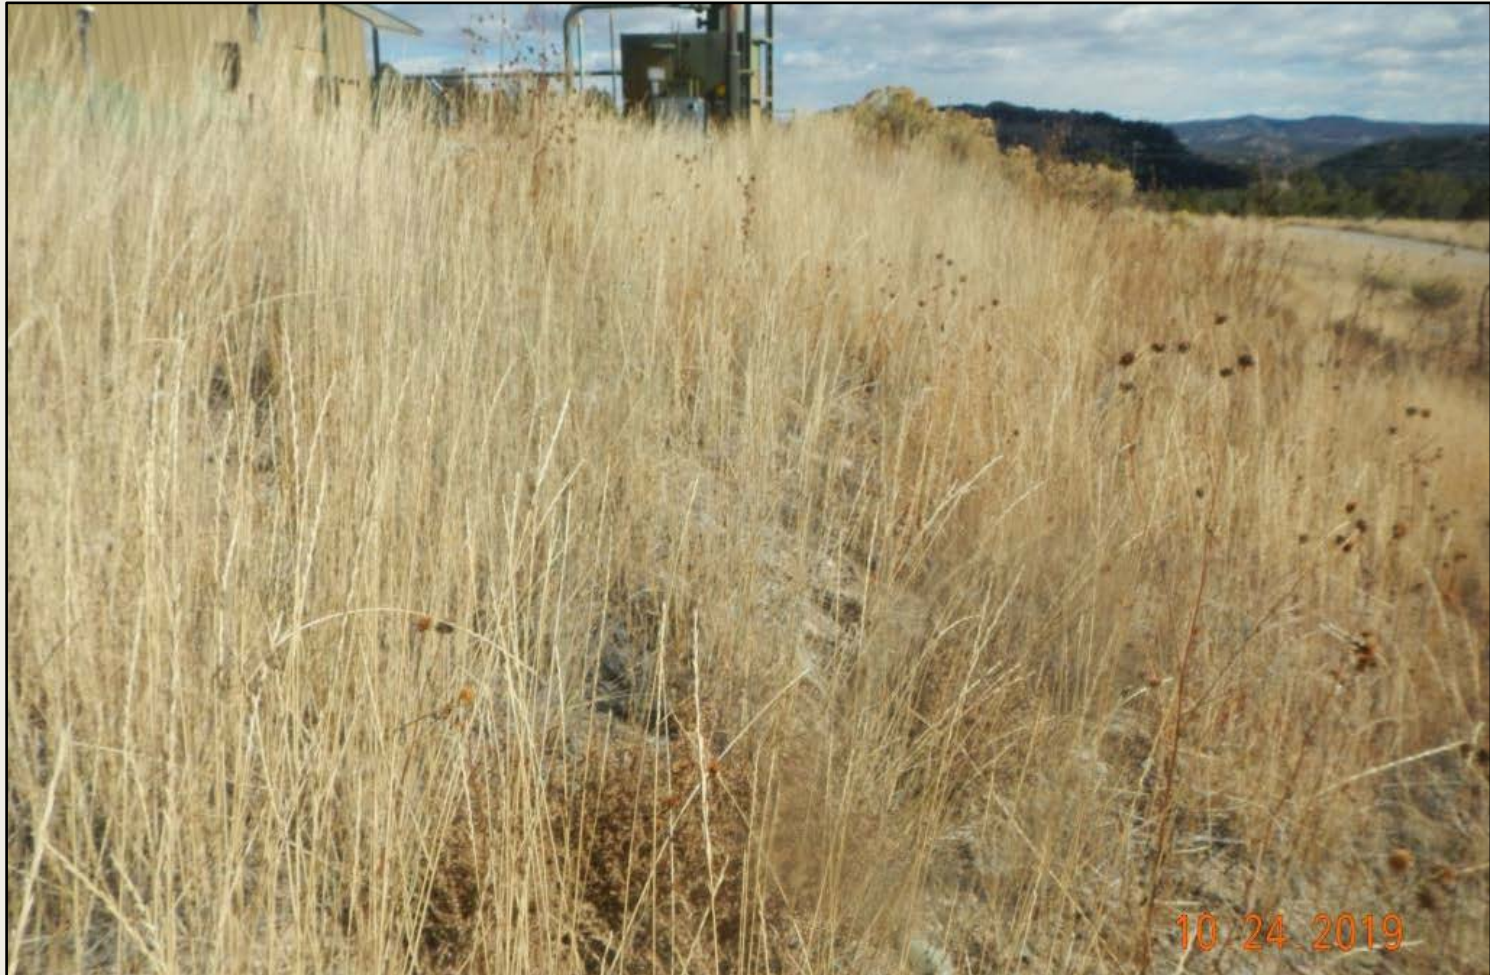
Photo 1. View of the southern project area from the southwestern edge facing eastward.

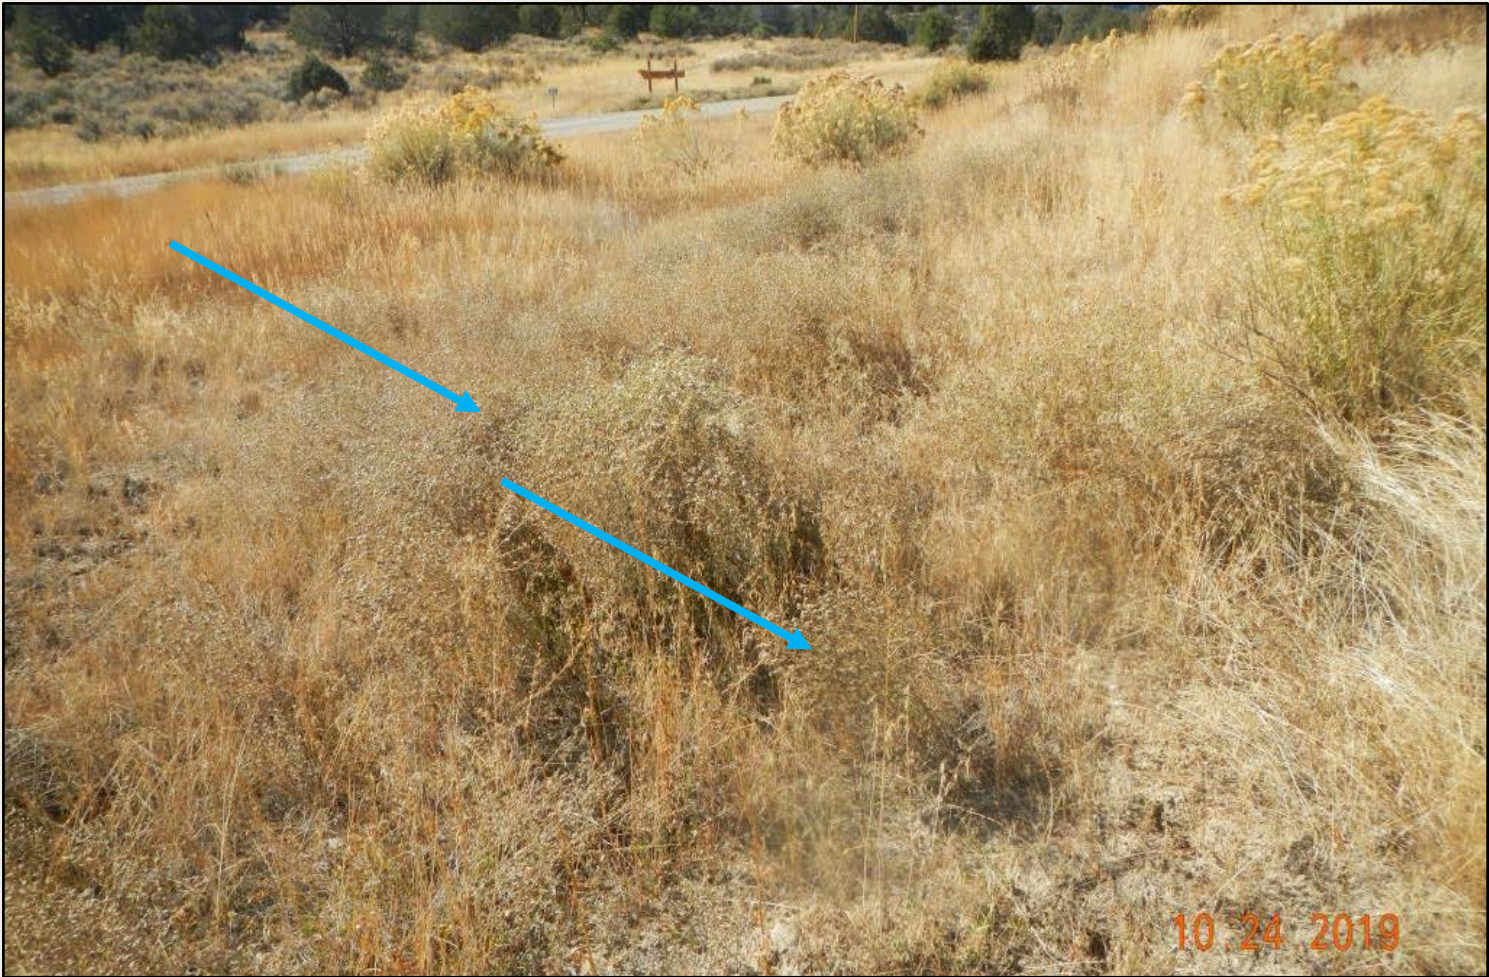
Photo 2. View of Russian knapweed infestation (blue arrows) within the southern fill slope. Approximately 1000 individuals observed.

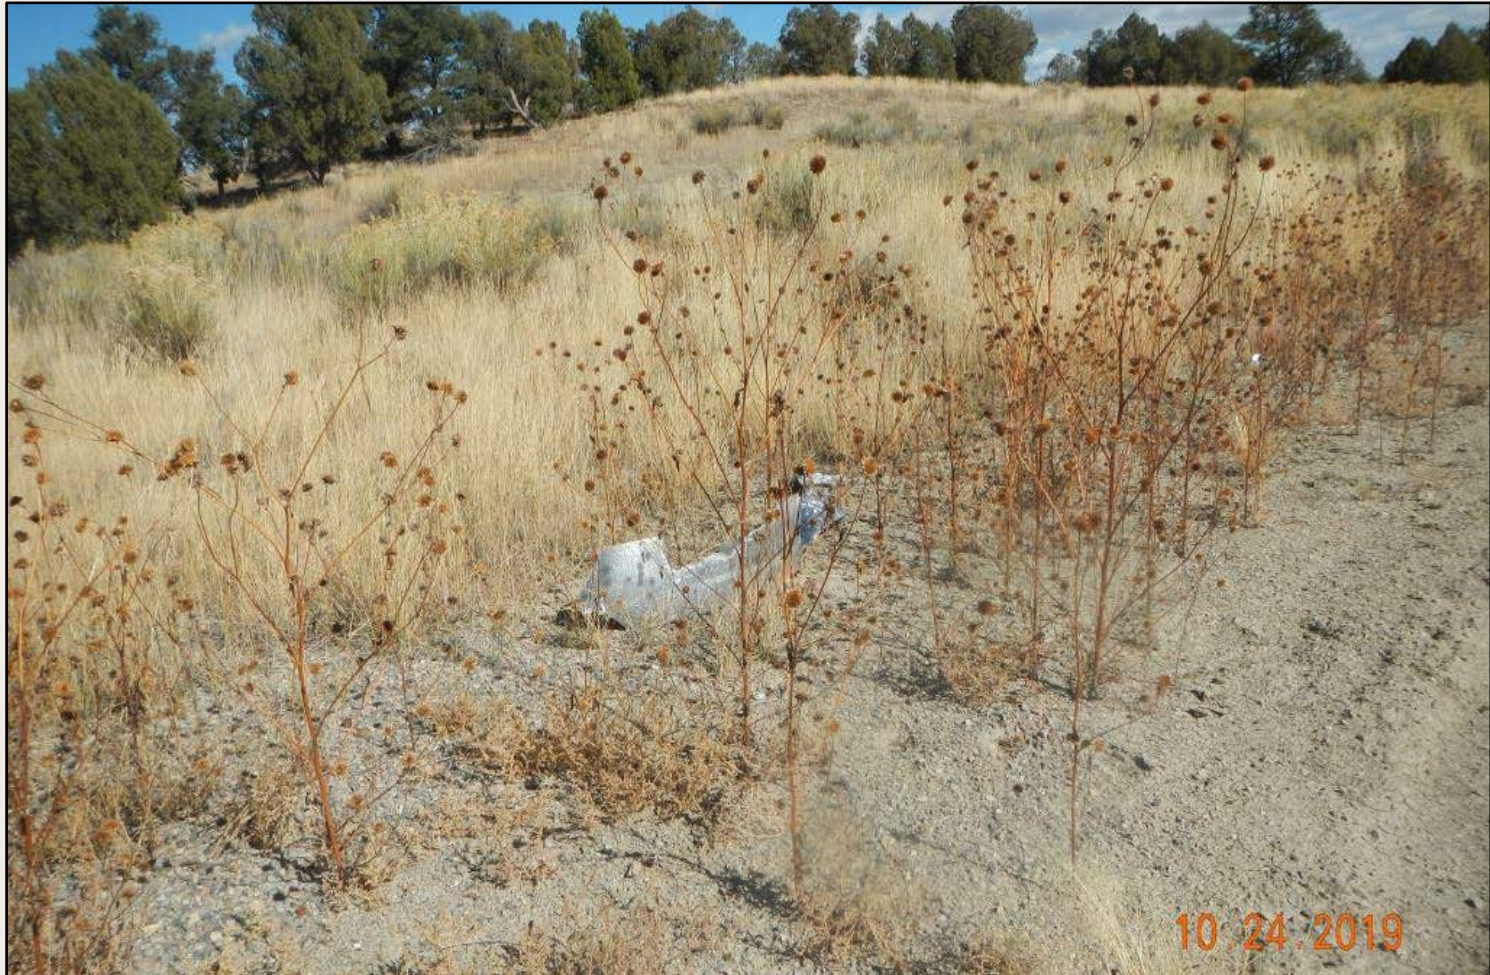
Photo 3. View of trash/debris blown to the edge of the northern working area.

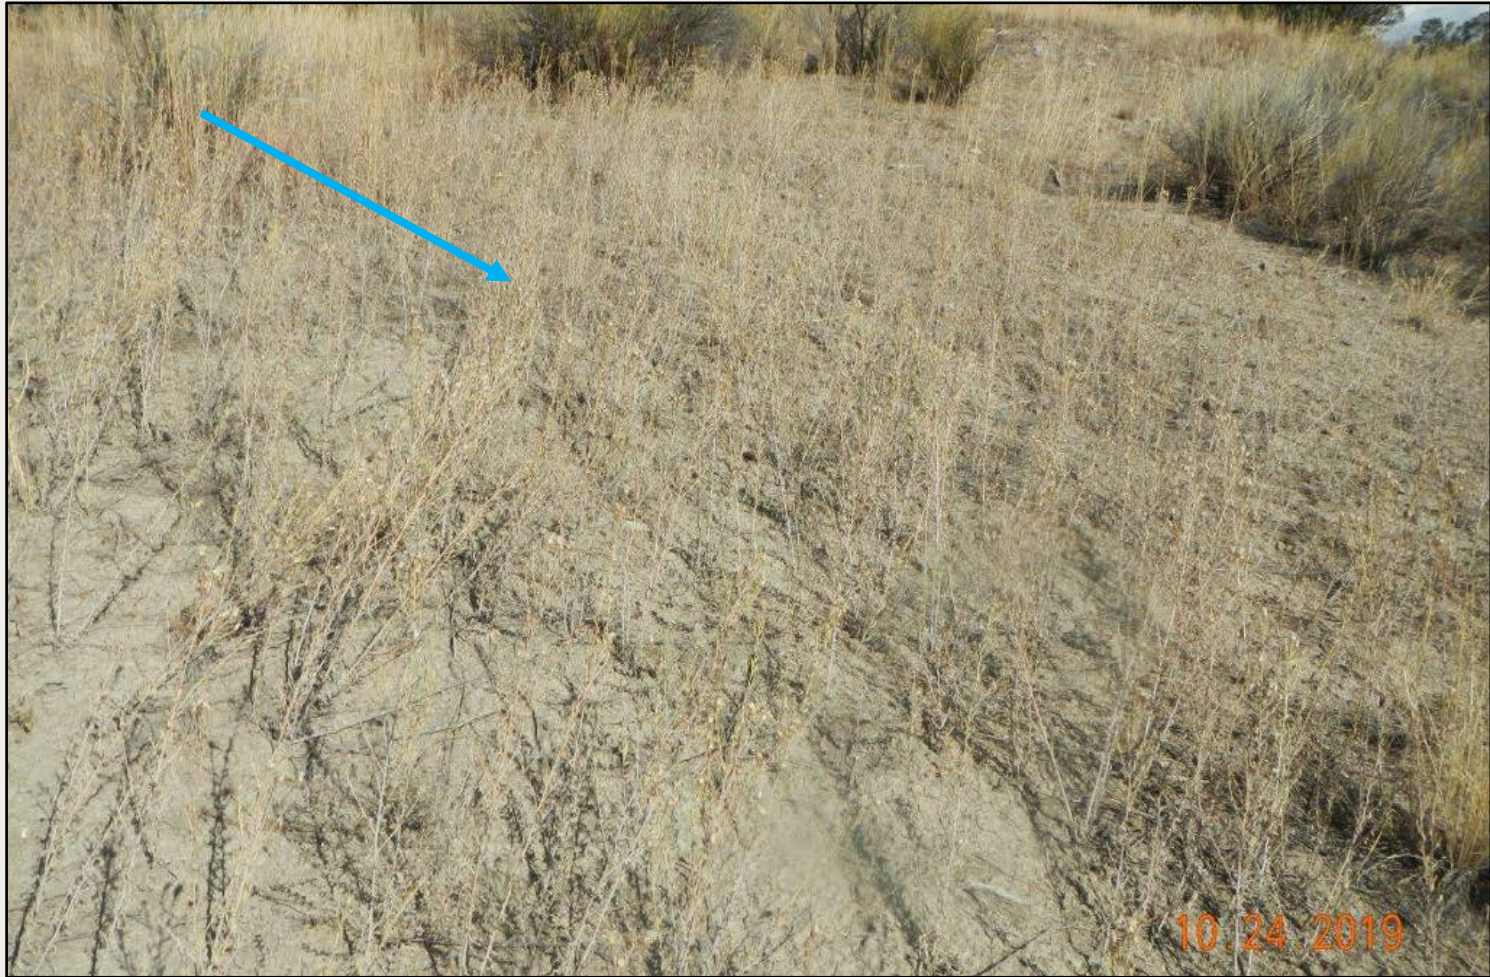
Photo 4. View of Russian knapweed infestation within the northern cut-slope. Areas with knapweed will require revegetation and stabilization after treatment.

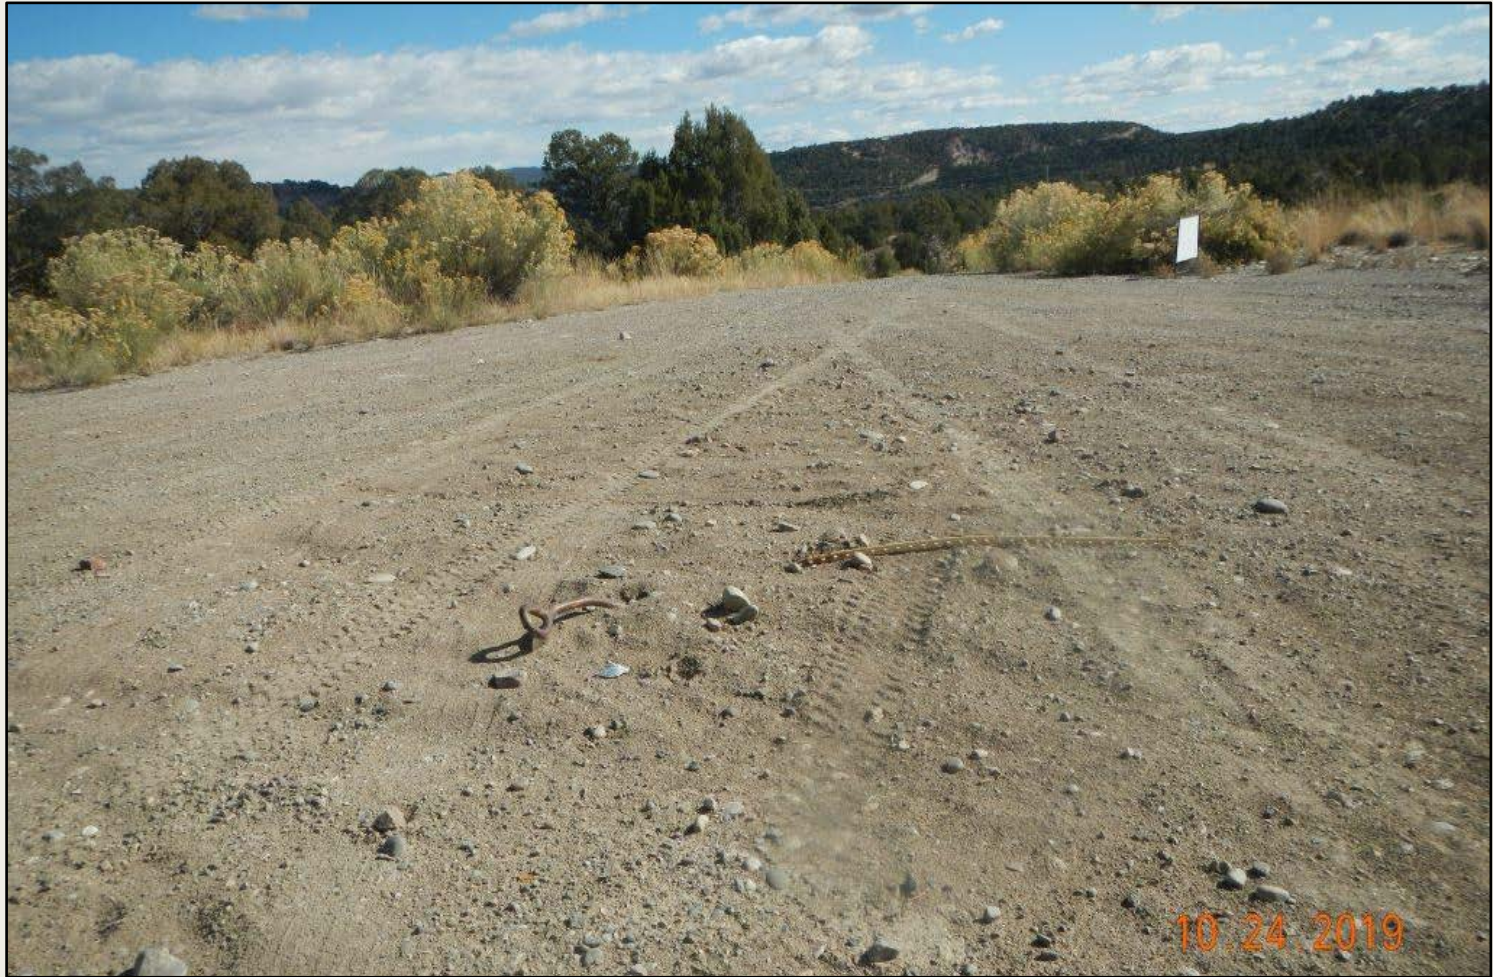
Photo 5. View of unmarked rig anchor at the well pad entrance.

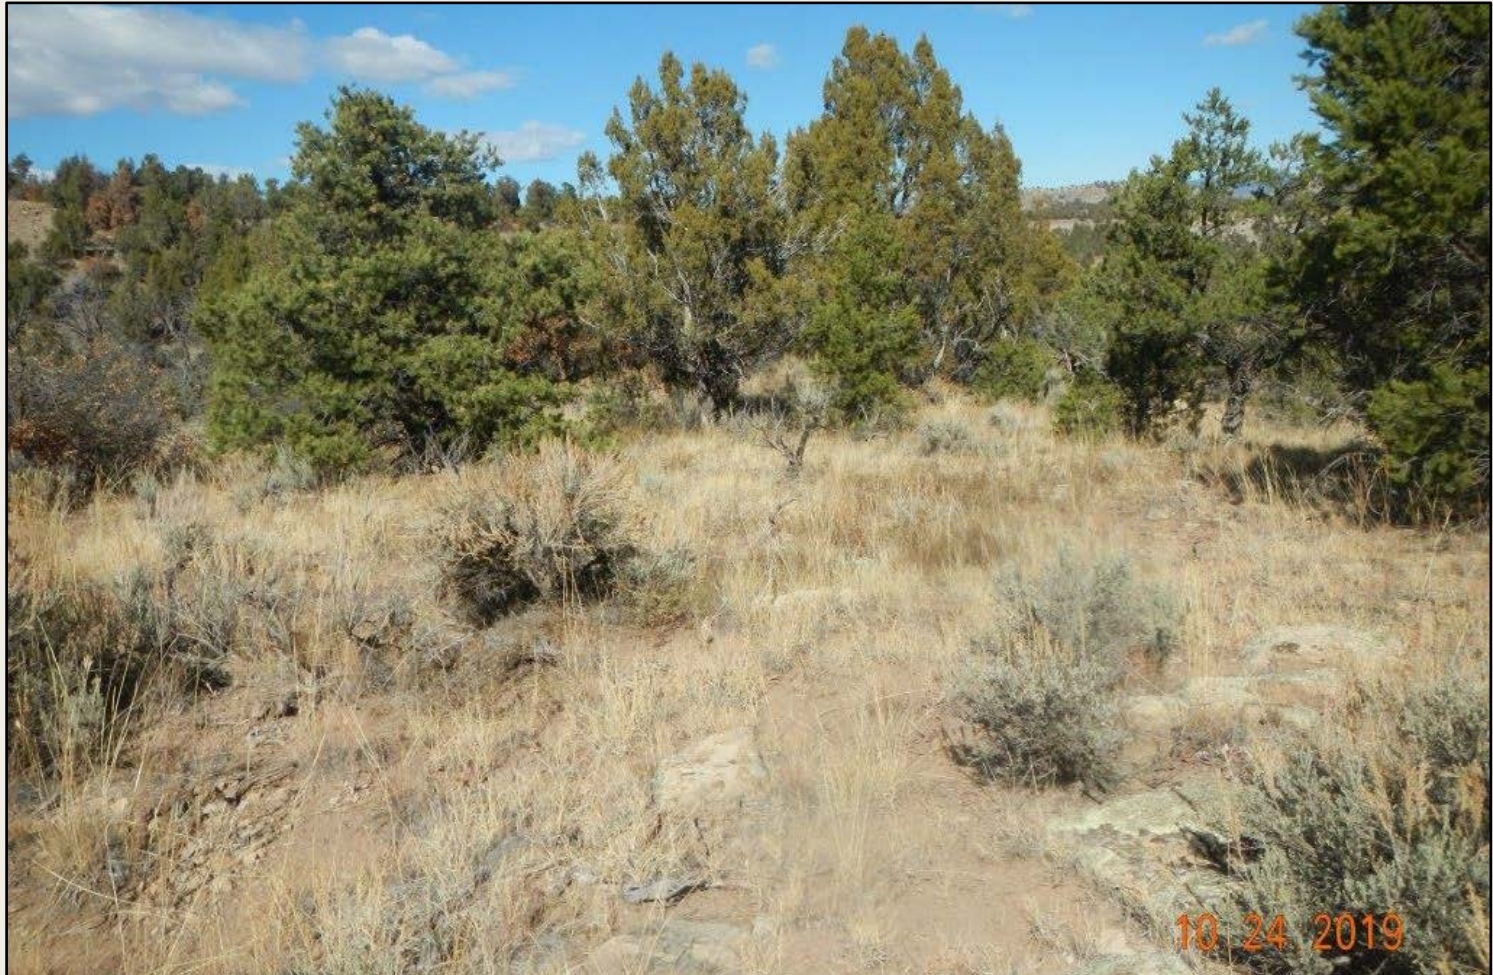
Photo 6. View of reference are vegetation comprised of mixed pinyon juniper woodland, and sagebrush shrubland with native grasses such as James galleta and forbs such as *Tetrandeum* sp.
