# Construction and Stormwater Inspection

January 28, 2020

Operator: HIGHPOINT OPERATING CORPORATION- #10071

Inspection Photos  
Location Name: Fox Creek /25 SE  
Location ID: 466299

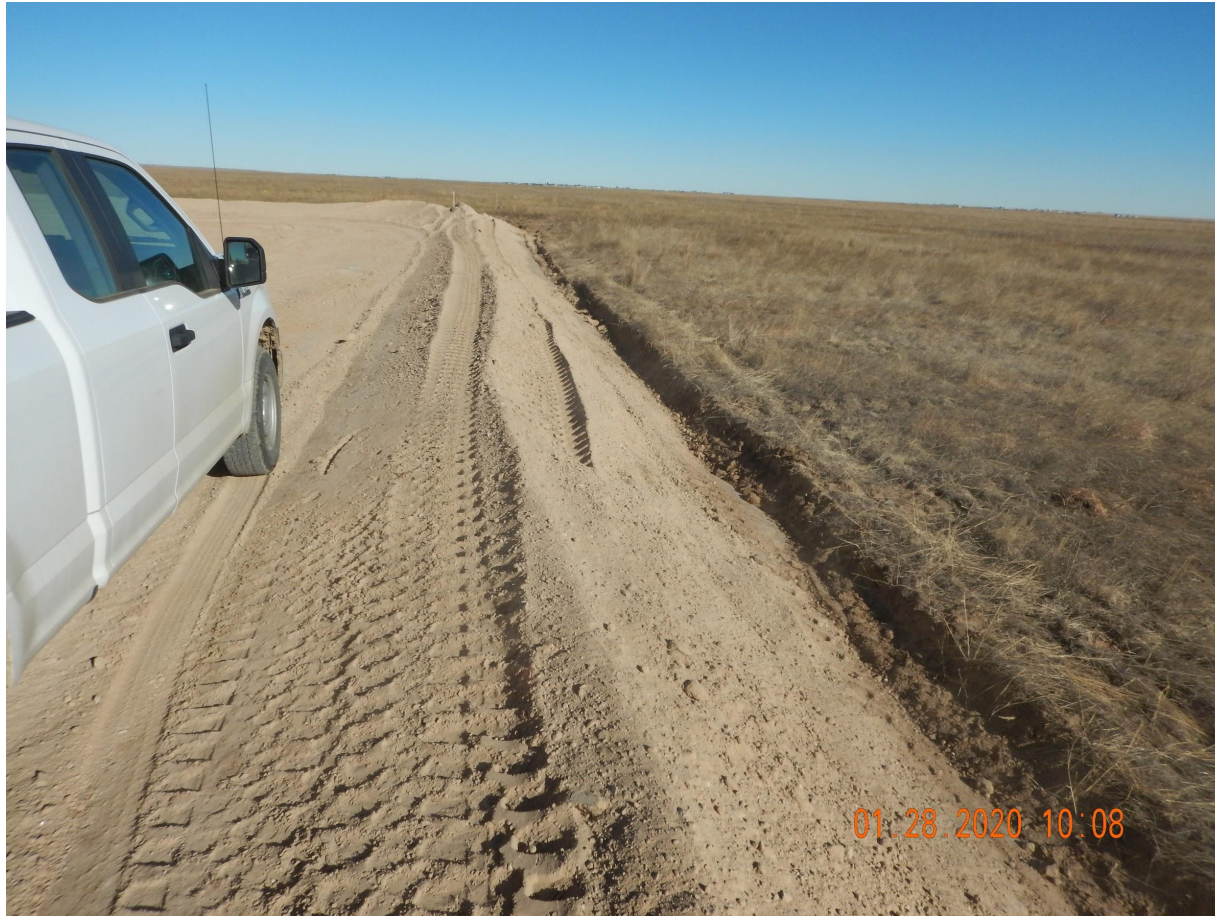
**Photo 1.** Photo taken from the northeastern perimeter of location, facing North. Photo illustrates a berm and ditch BMP. The ditch BMP could be installed to a greater depth and more “V” shaped.

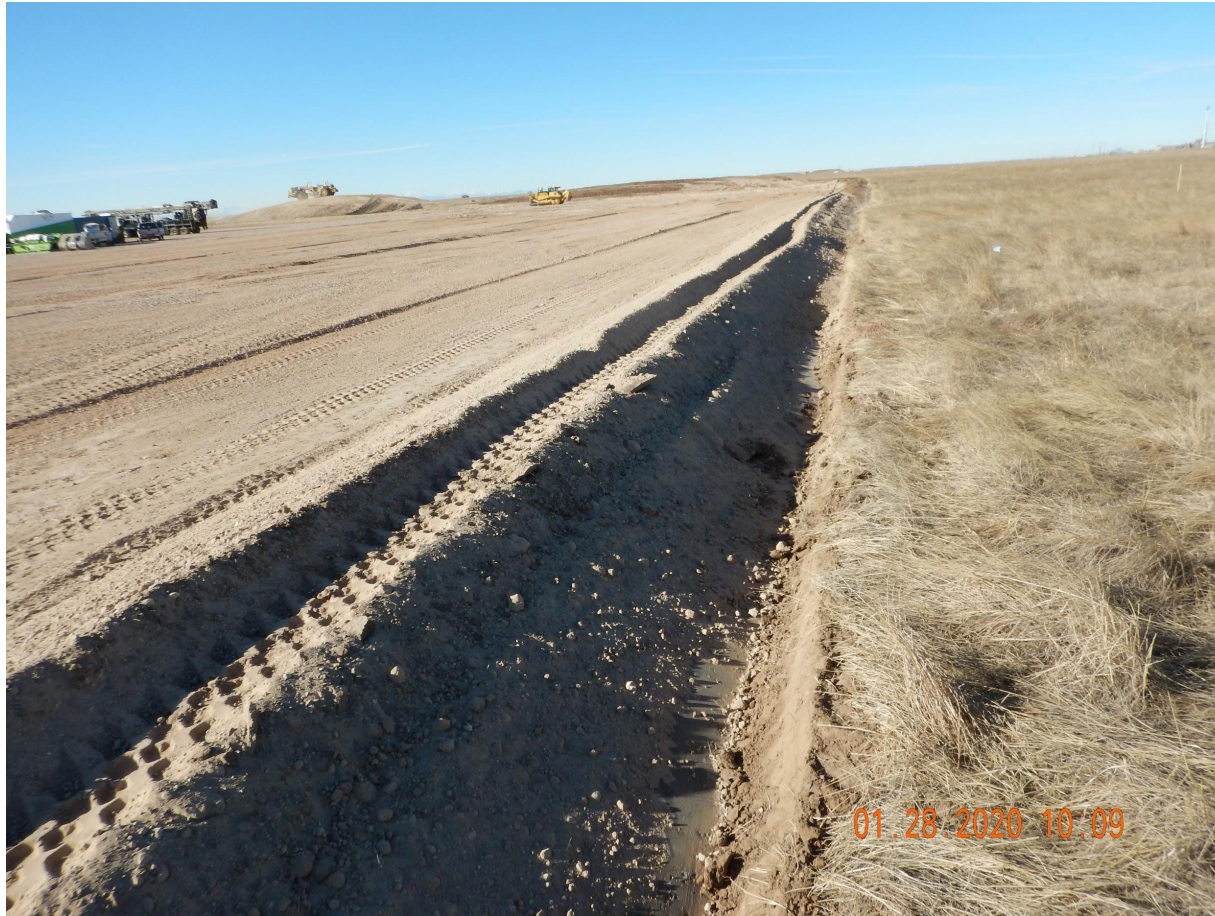
**Photo 2.** Photo taken from the northeastern perimeter of location, facing West. See comments under Photo 1 regarding the ditch BMP.

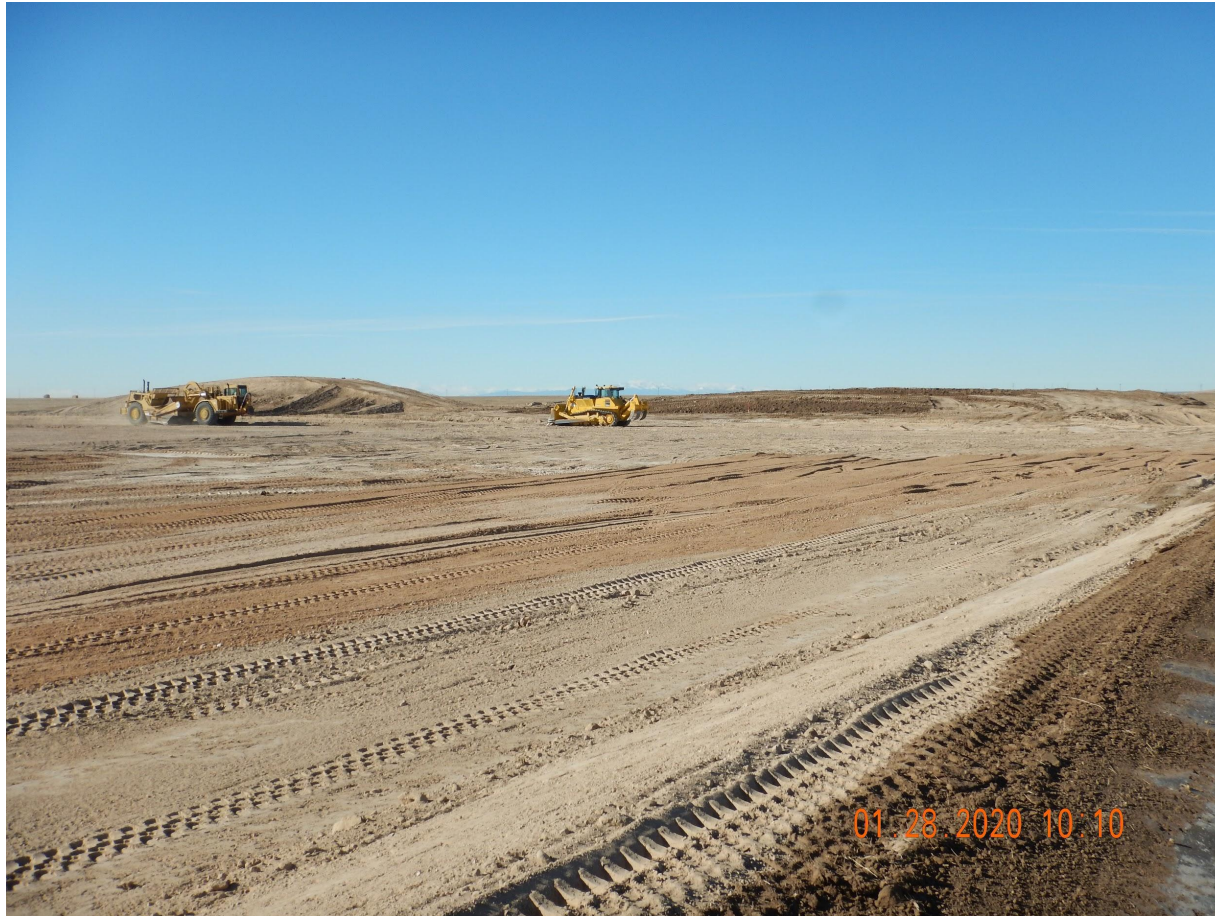
**Photo 3.** Photo taken from the northern perimeter of location, facing Southwest. Photo illustrates the stockpile to the right is topsoil and the stockpile to the left is of subsoil.

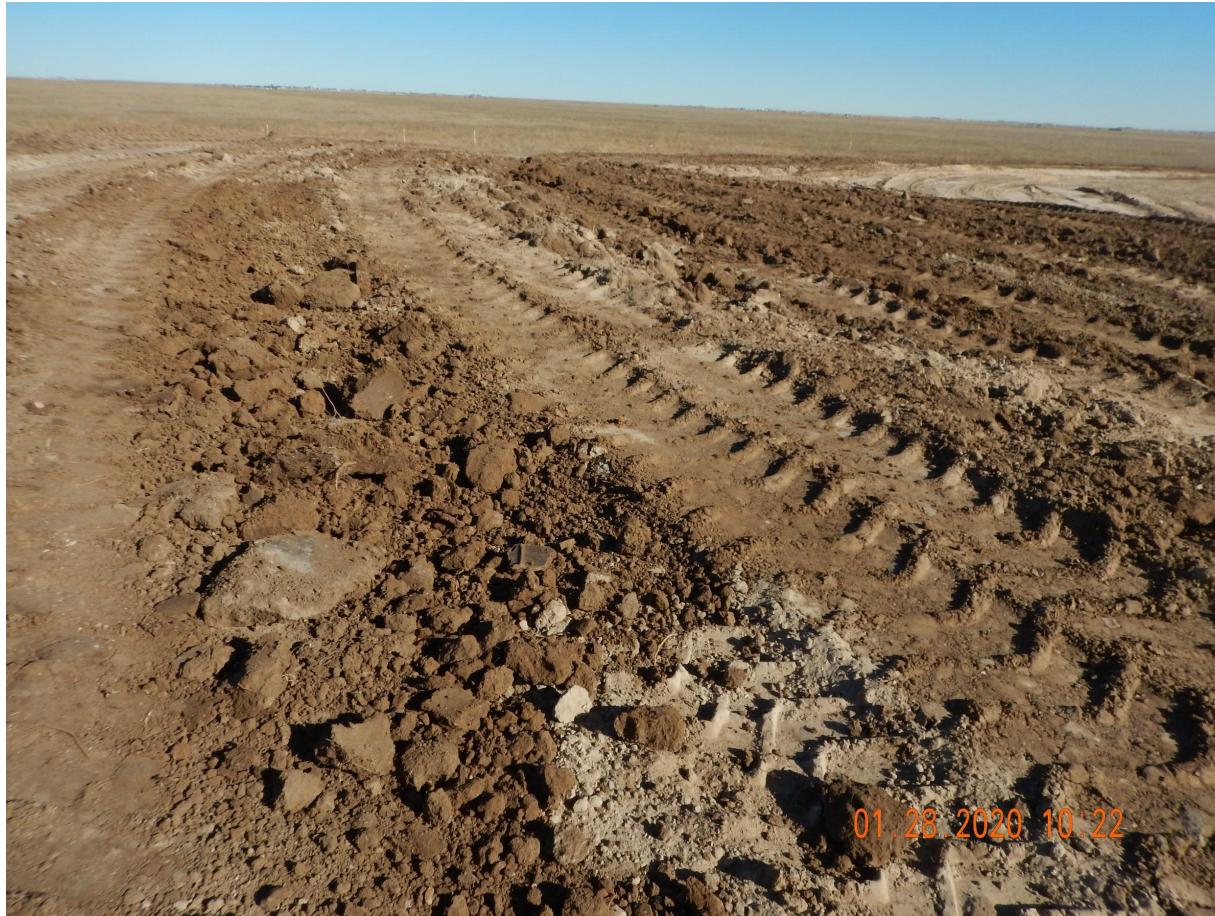
**Photo 4.** Photo taken from the topsoil stockpile, facing North. Photo illustrates there is some mixing of topsoil and subsoil. COGCC staff communicated to an Operator representative on location and on the phone, this observation and why topsoil should not be mixed.

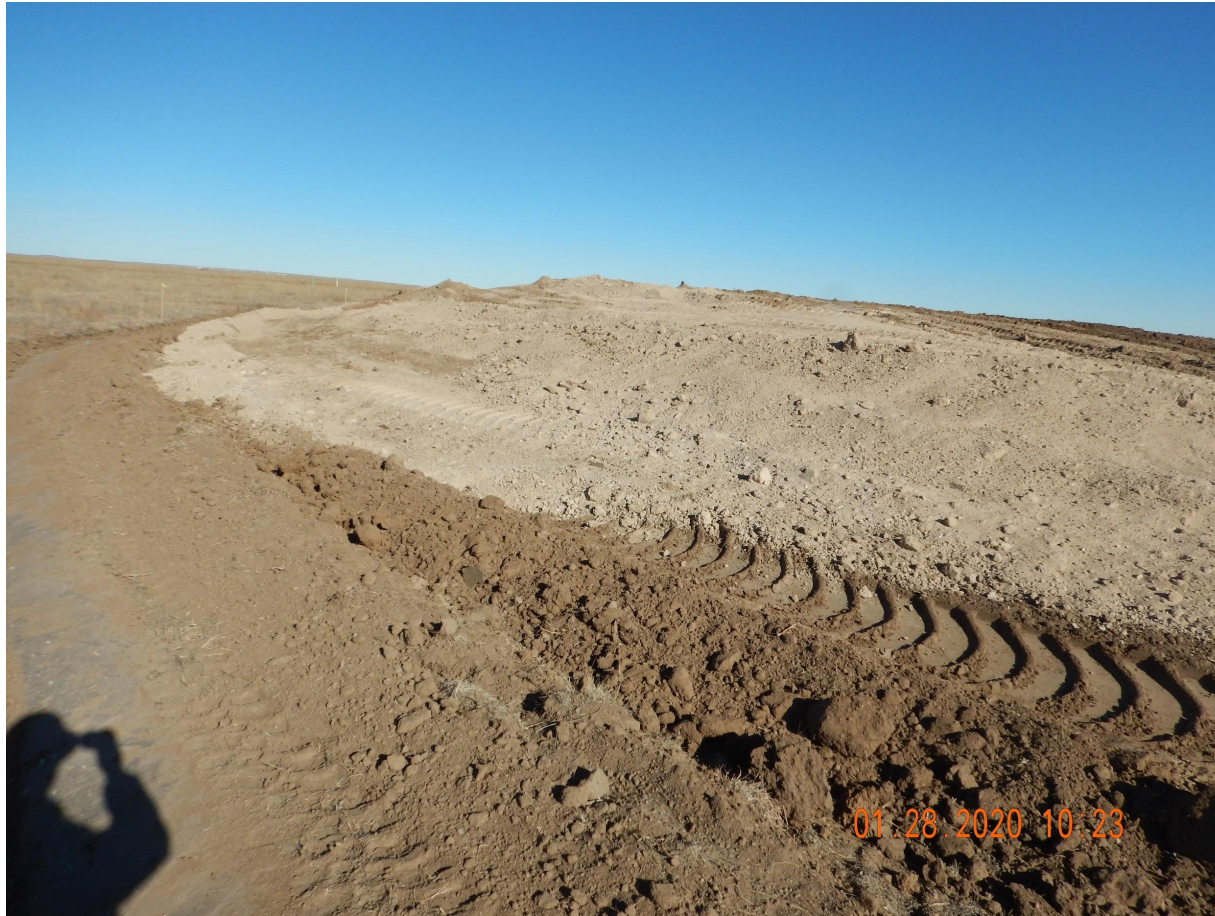
**Photo 5.** Photo taken from the west-facing topsoil stockpile, facing North. Photo illustrates subsoil being mixed with topsoil. COGCC staff communicated to an Operator representative on location and on the phone, this observation and why topsoil should not be mixed. Operator should remove any subsoil from the topsoil.

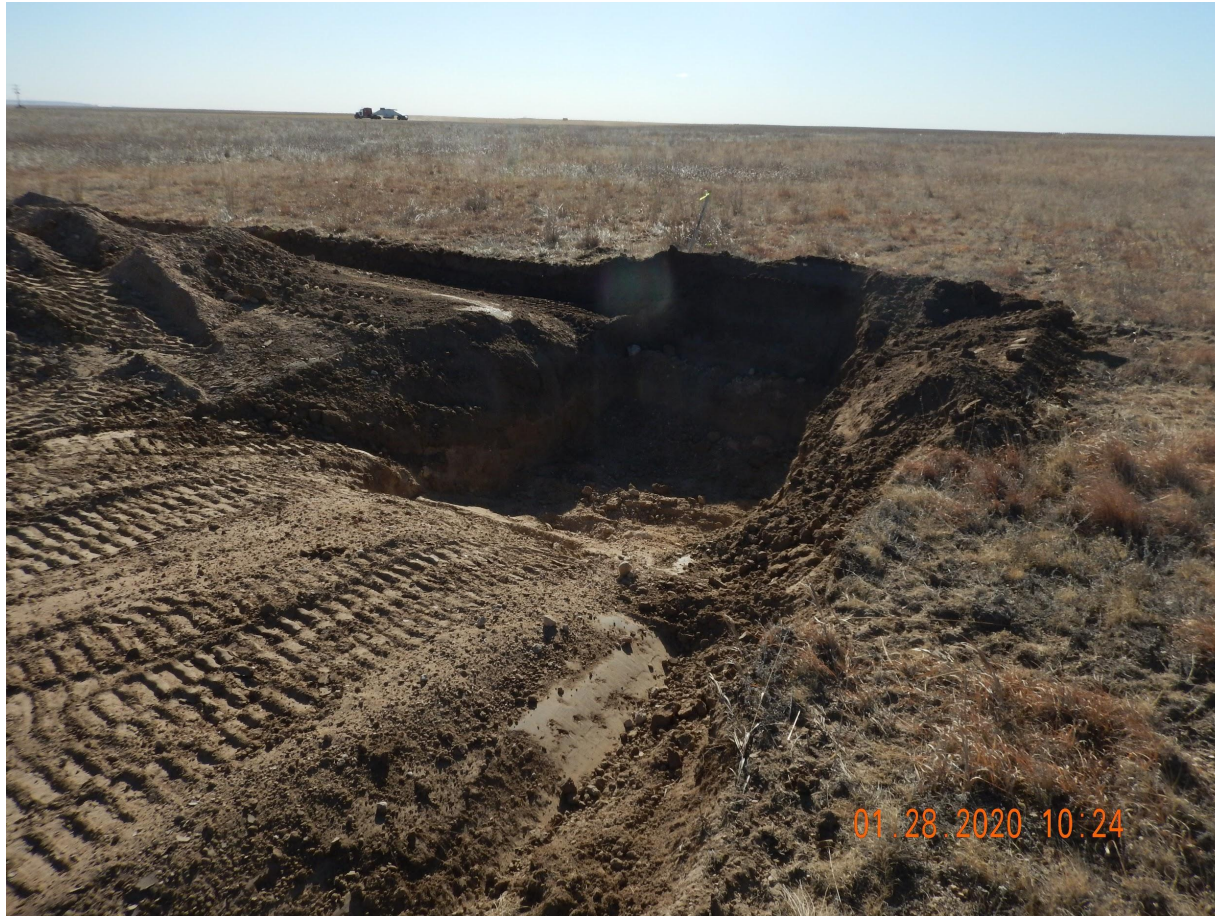
**Photo 6.** Photo taken from the southwestern perimeter of location, facing South. Photo illustrates a sediment trap in-process of being installed.

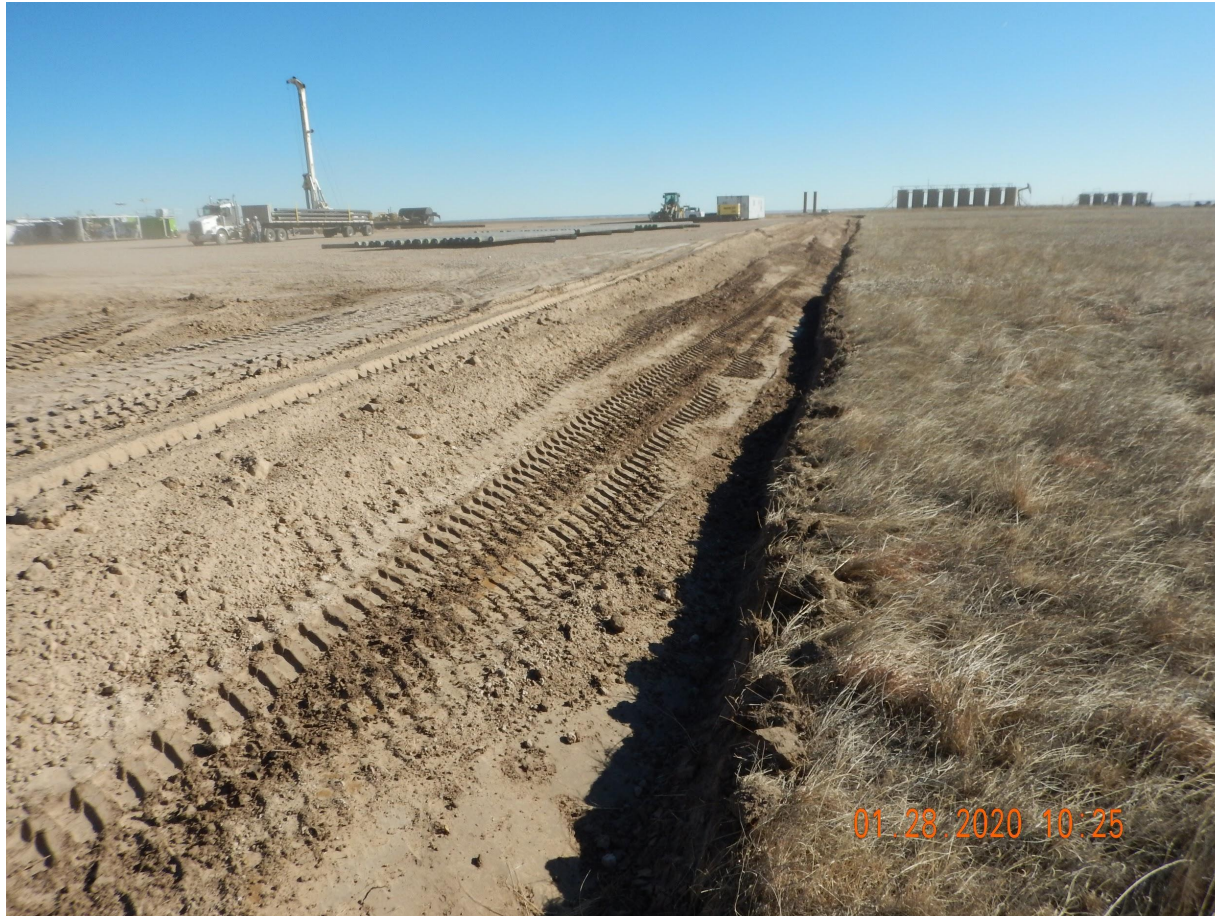
**Photo 7.** Photo taken from the southern perimeter of location, facing East. See comments under Photo 1.

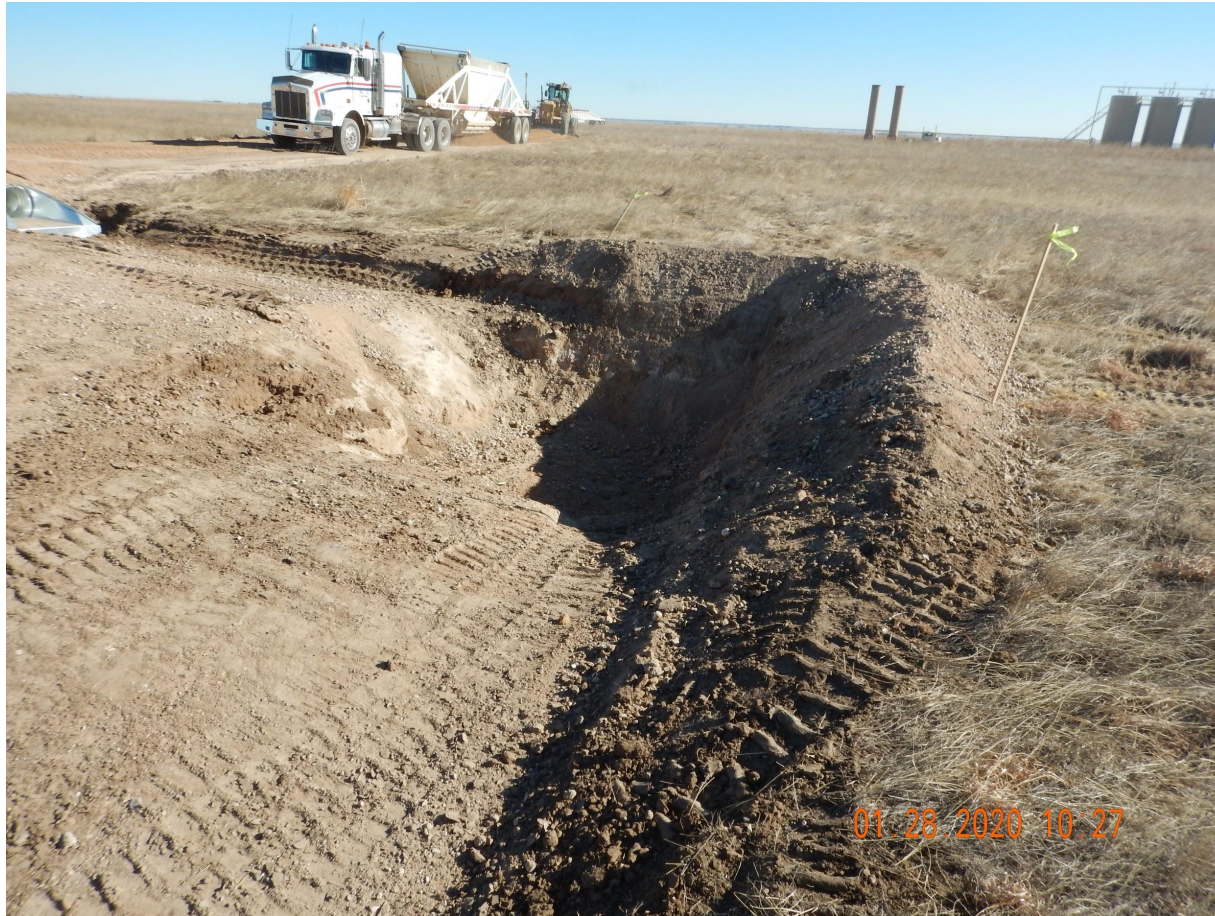
**Photo 8.** Photo taken from the southeastern perimeter of location, facing East. See comments under Photo 6.

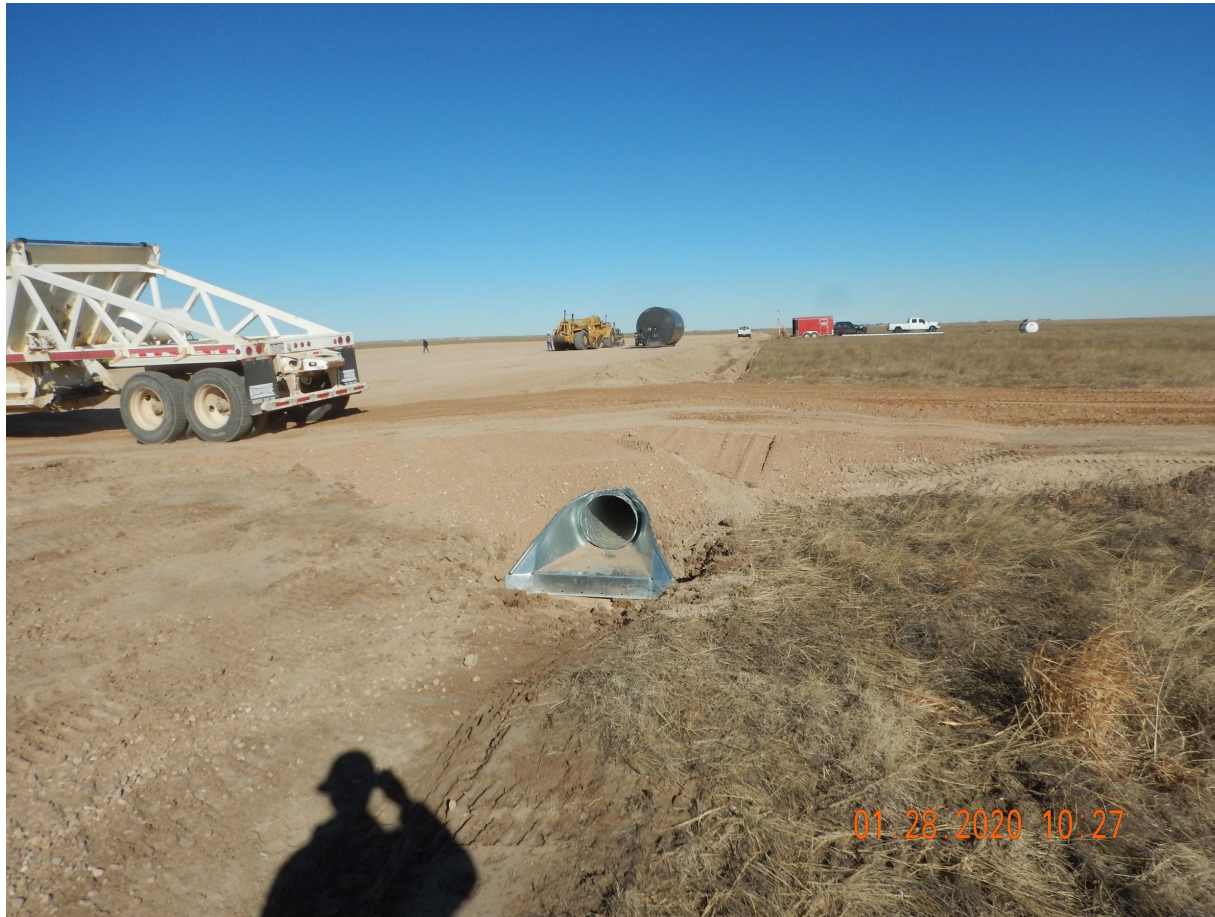
**Photo 9.** Photo taken from the southeastern perimeter of location, facing North. Photo illustrates a culvert installed in conjunction with the ditch BMP which is directed to a sediment trap.
