Inspection Photos

Operator: RIO MESA RESOURCES INC - 74740

Location ID: 398059

Rio Blanco County, CO

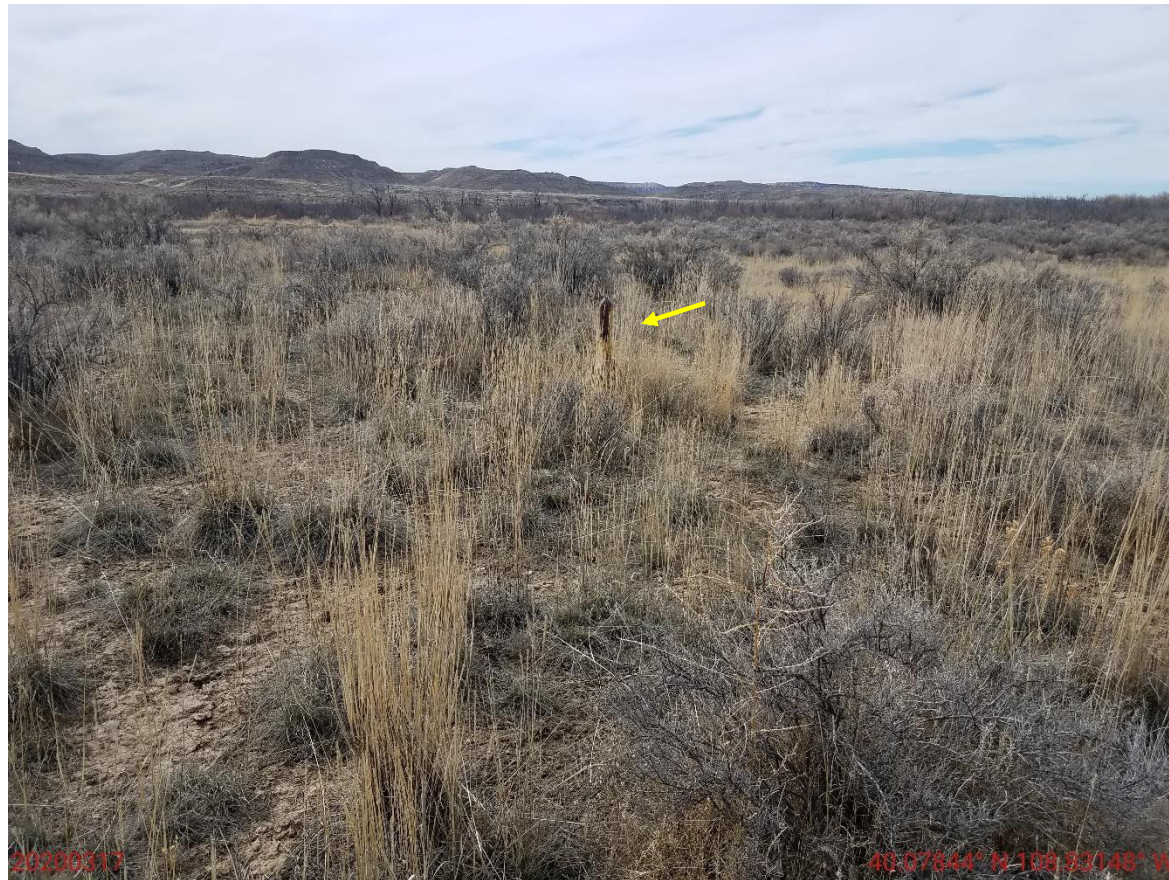
Photo 1: Photo taken from the well Location, facing west. Photo shows above grade well marker. Well marker is less than 4 feet AGL. An audible gas leak was detected coming from the well casing.
