Inspection Photos
Operator: BP America
API: 067-08701
Date: 11/17/2020

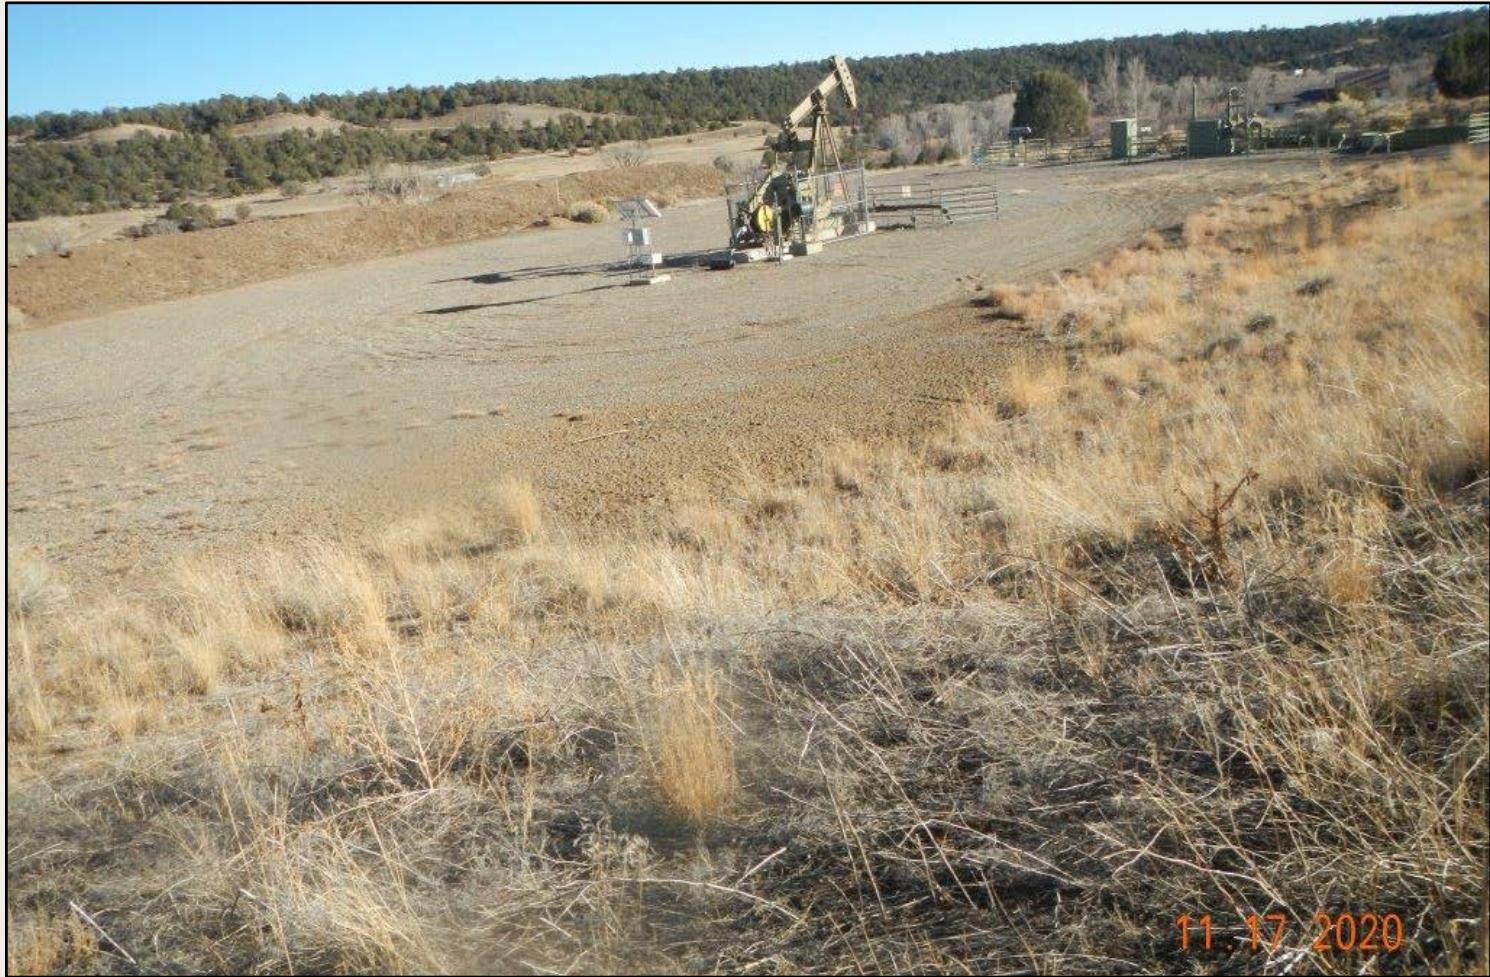
Photo 1. View of the project area from the northwestern corner facing center.

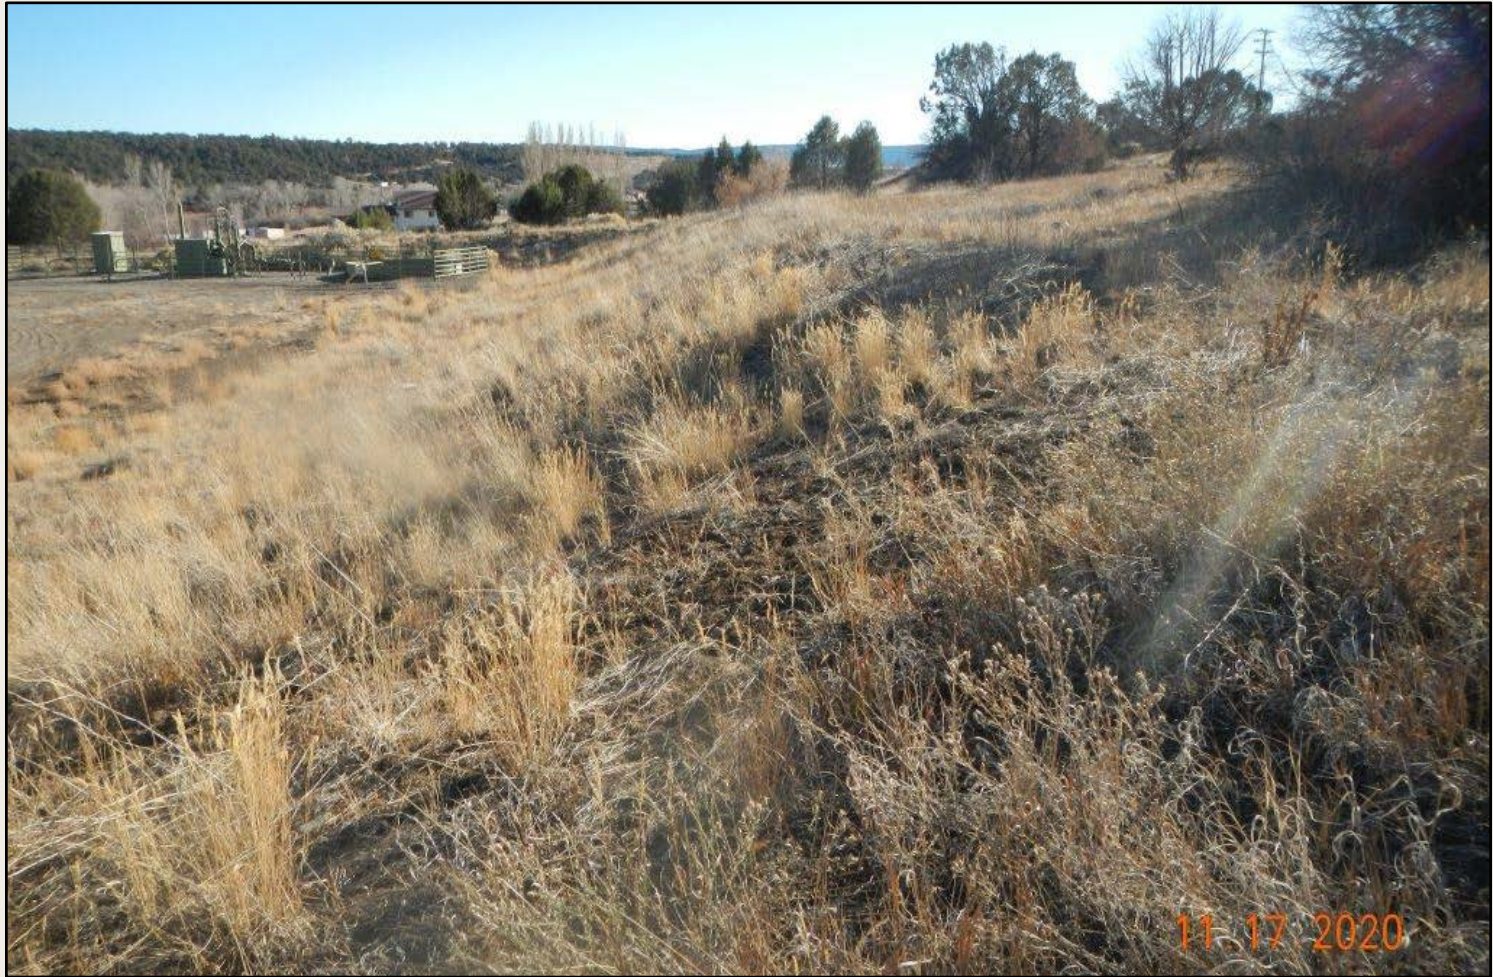
Photo 2. View of the western project area from the northwestern corner facing southward. Revegetation is progressing with grasses such as smooth brome, crested wheatgrass, and sand dropseed.

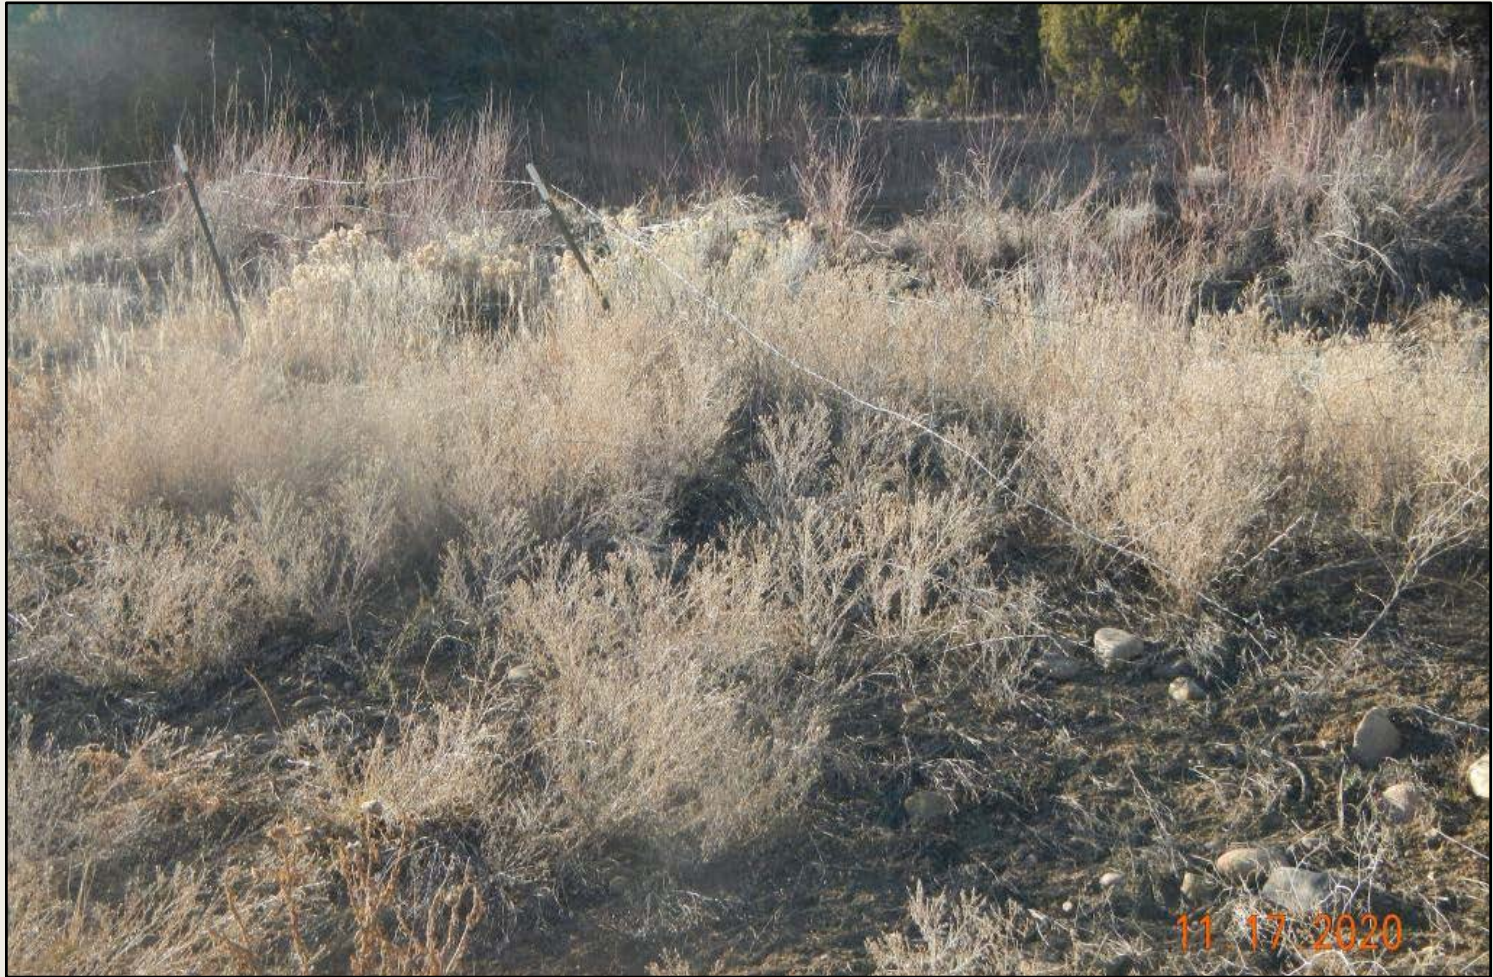
Photo 3. View of Russian knapweeds within the northwestern project area. Approximately 1000 individuals observed.

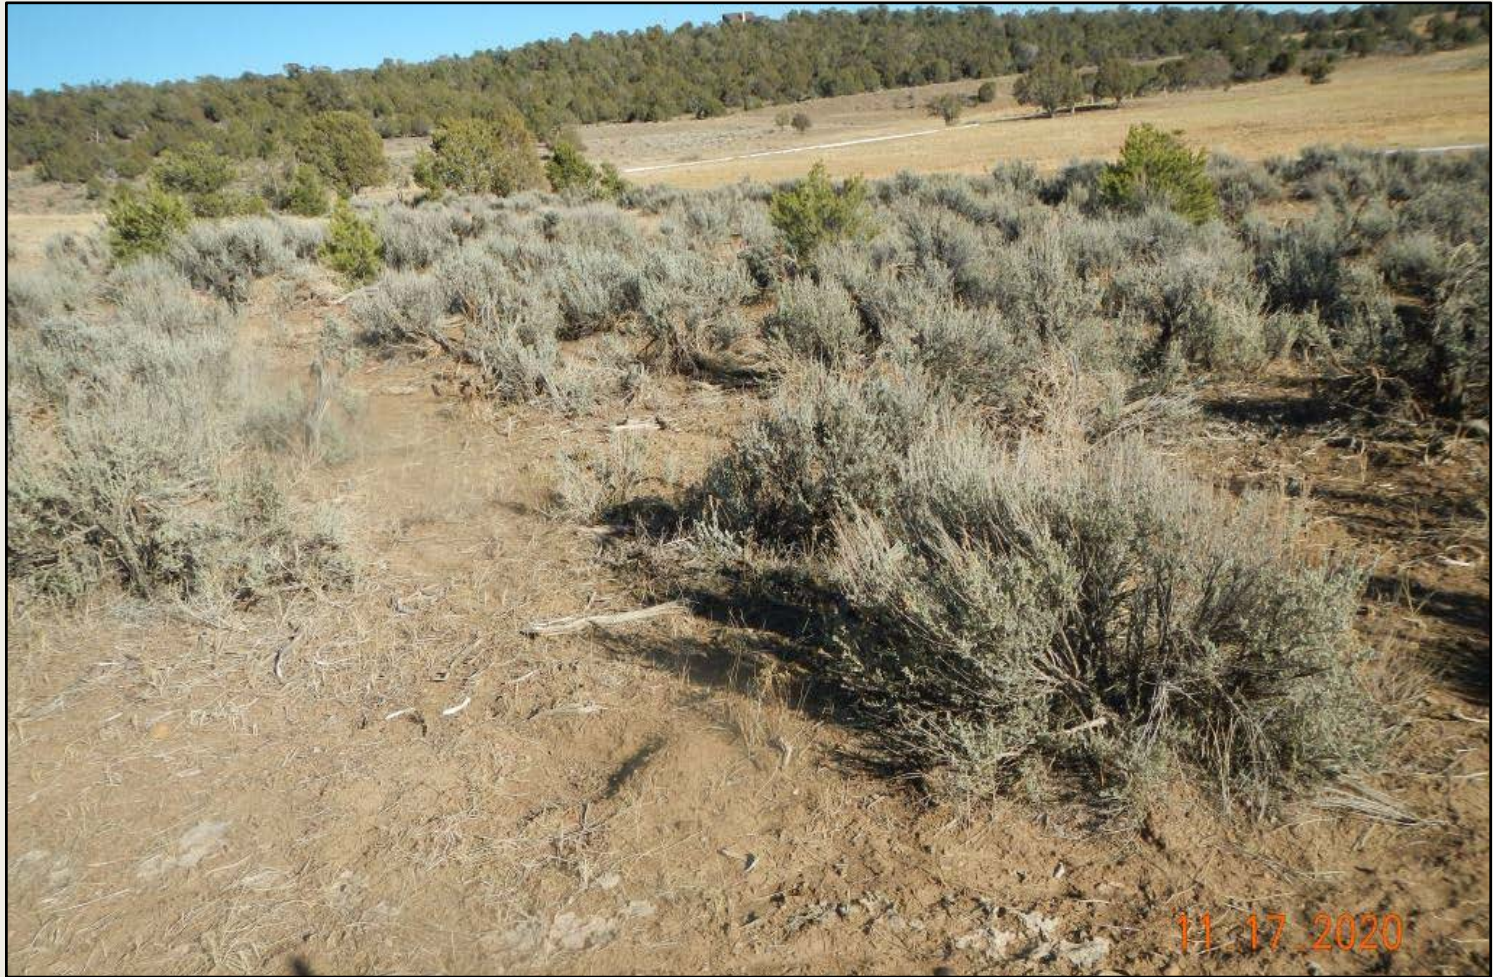
Photo 4. View of the reference area comprised of sagebrush shrubland with scattered pinyon and juniper trees and understory of grasses and forbs such as western wheatgrass and snakeweed.
