# Interim Reclamation and Stormwater Inspection

May 20, 2021

Operator: GREAT WESTERN OPERATING COMPANY LLC- #10110

Location ID: 453934

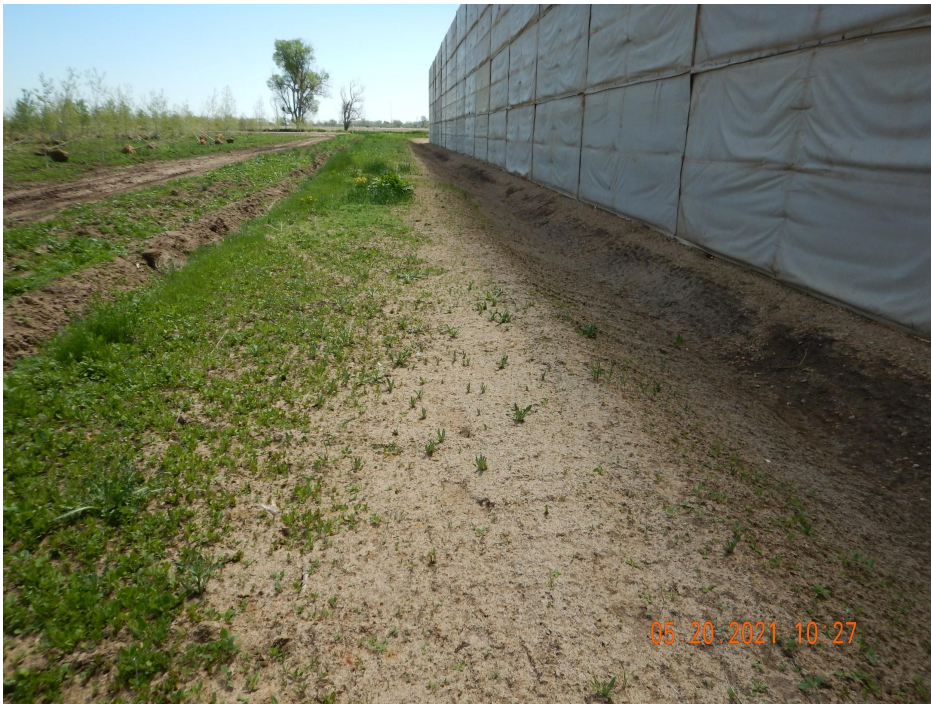
**Photo 1.** Photo taken from the northern location, facing East. Photo illustrates a cut slope that has been seeded and hydromulched.

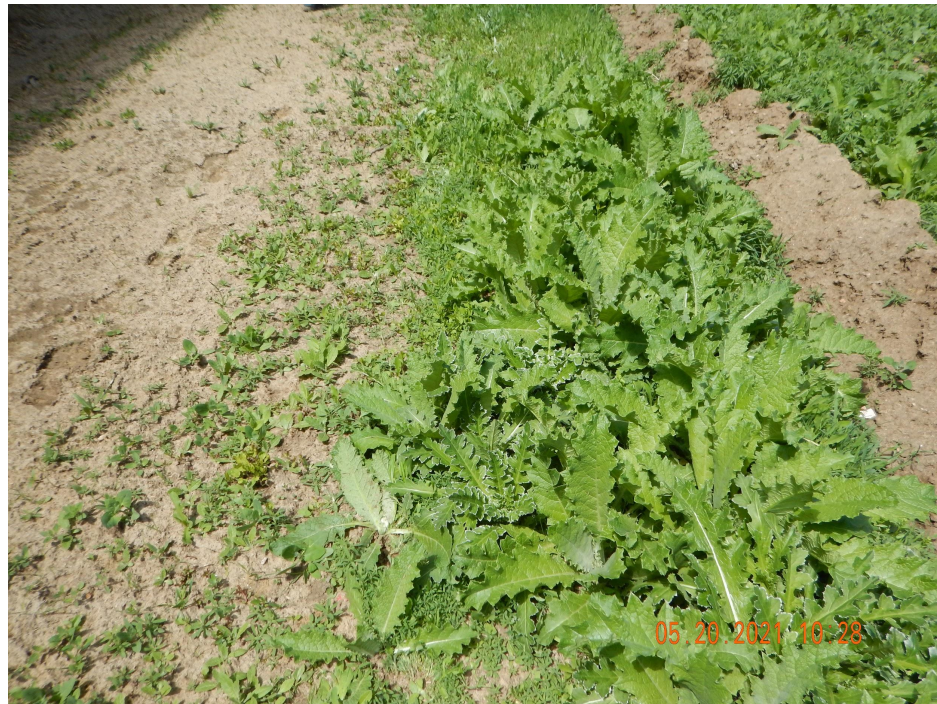
**Photo 2.** Photo taken from a section of the northern location. Photo illustrates a List B Colorado noxious weed, Scotch thistle.

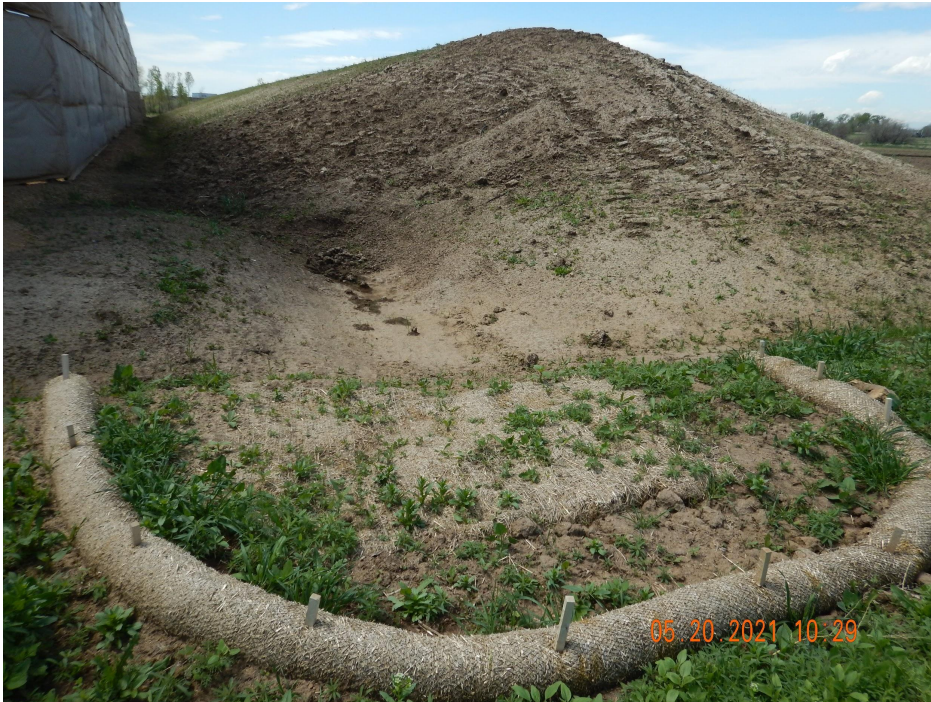
**Photo 3.** Photo taken from the northwestern location, facing South. Photo illustrates a stormwater BMP and the topsoil stockpile.

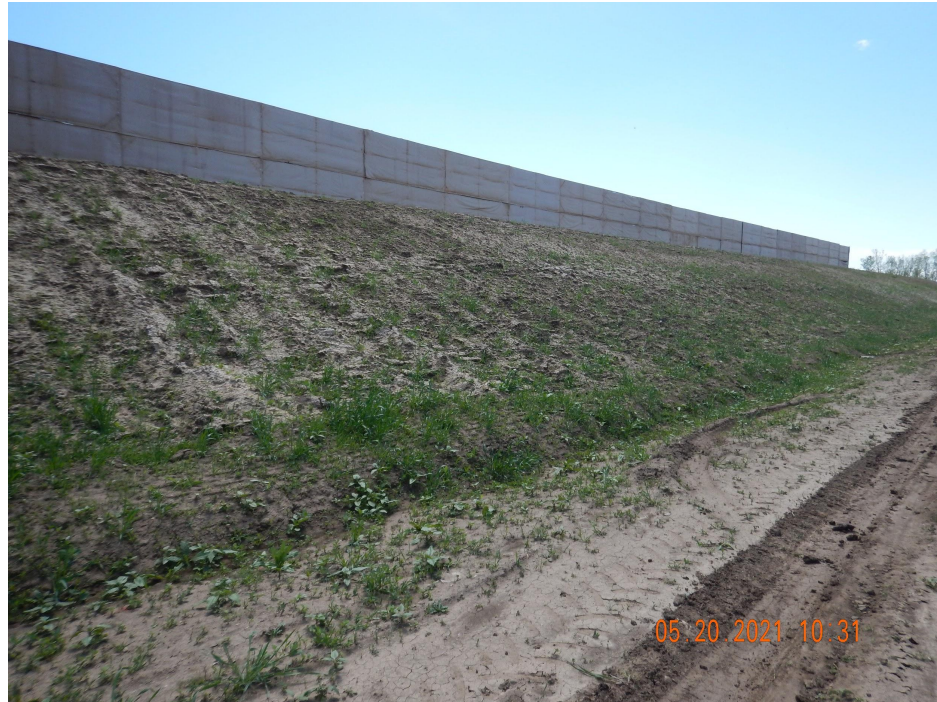
**Photo 4.** Photo taken from the western location, facing Southeast. Photo illustrates the topsoil stockpile has been tracked, seeded and hydromulched. Germination of desirable plant species were observed throughout most of the stockpile. There was a bare area along the southern stockpile.

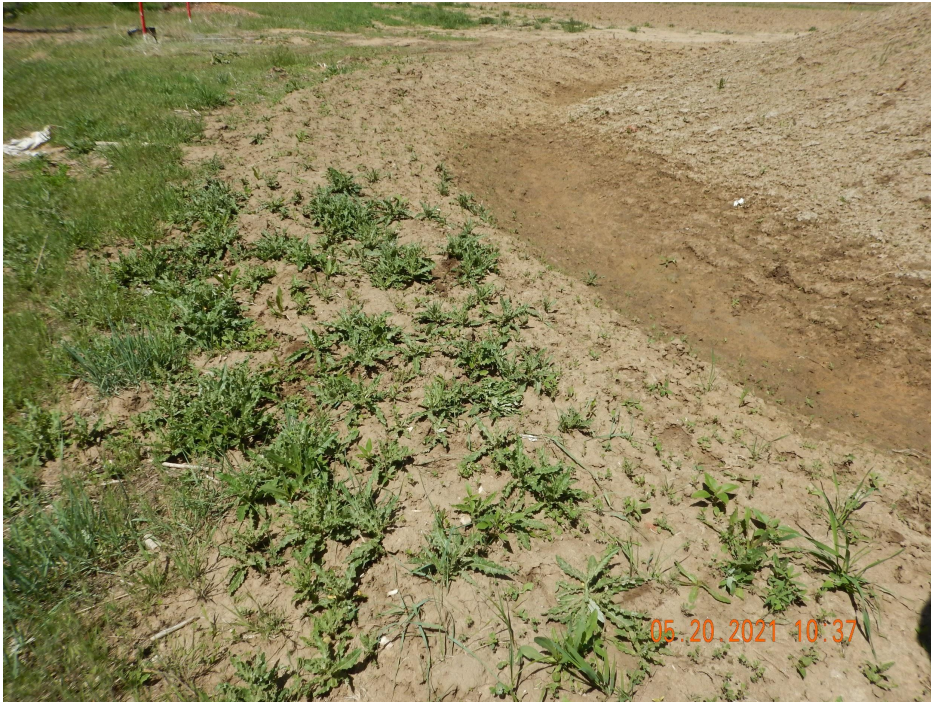
**Photo 5.** Photo taken from the southwestern location. Photo illustrates a List B Colorado noxious weed, Canada thistle.

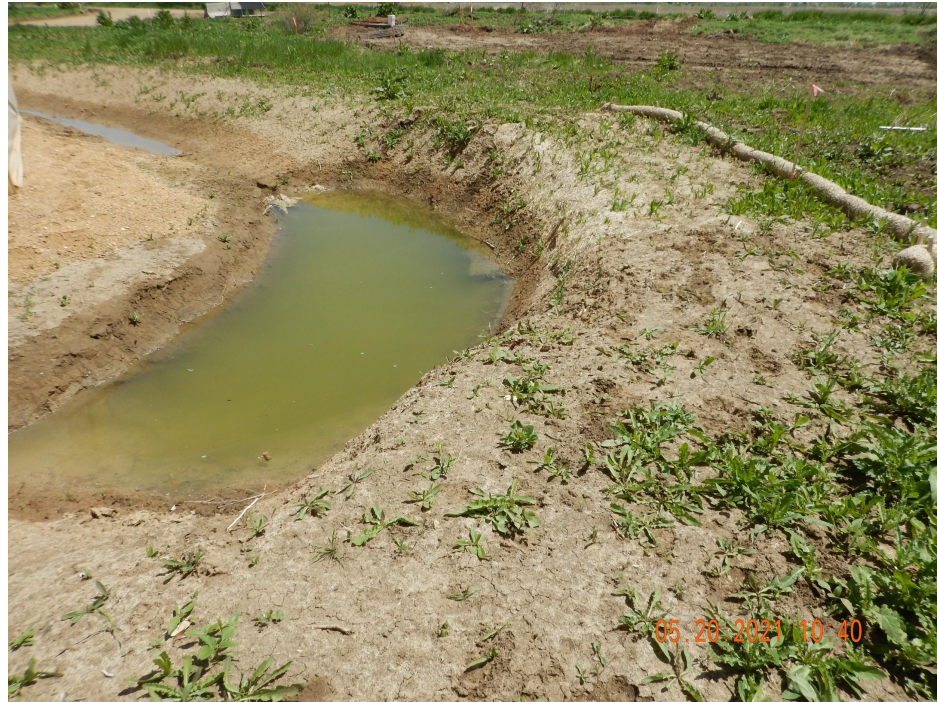
**Photo 6.** Photo taken from the southeastern location, facing Northeast. Photo illustrates a sediment trap with a temporarily stabilized outlet.
