Inspection Photos

Operator: GUNNISON ENERGY LLC # 10515

Location ID: 324459

Gunnison County, CO

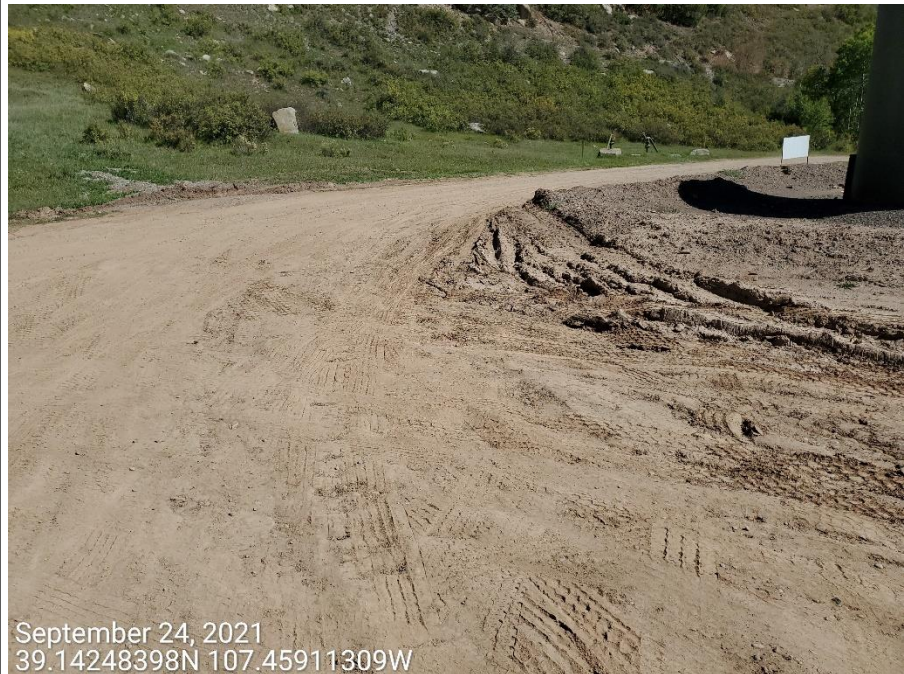
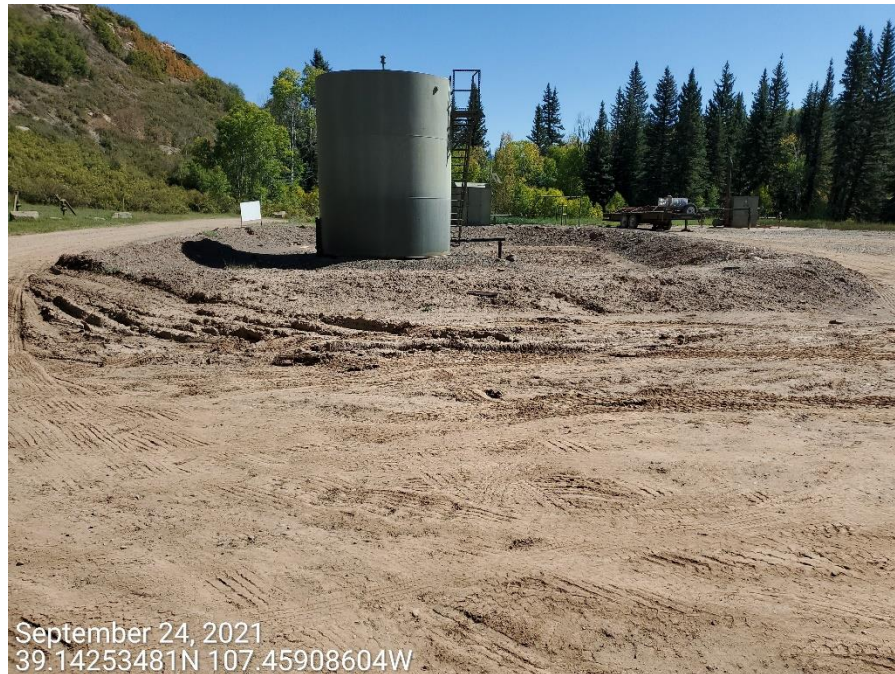
Photo 1: Photo taken from the production areas on the Location. Photos show control measures to stabilize/protect the production area are missing or insufficient; vehicle rutting, tracking and degradation observed on pad and location entrance.

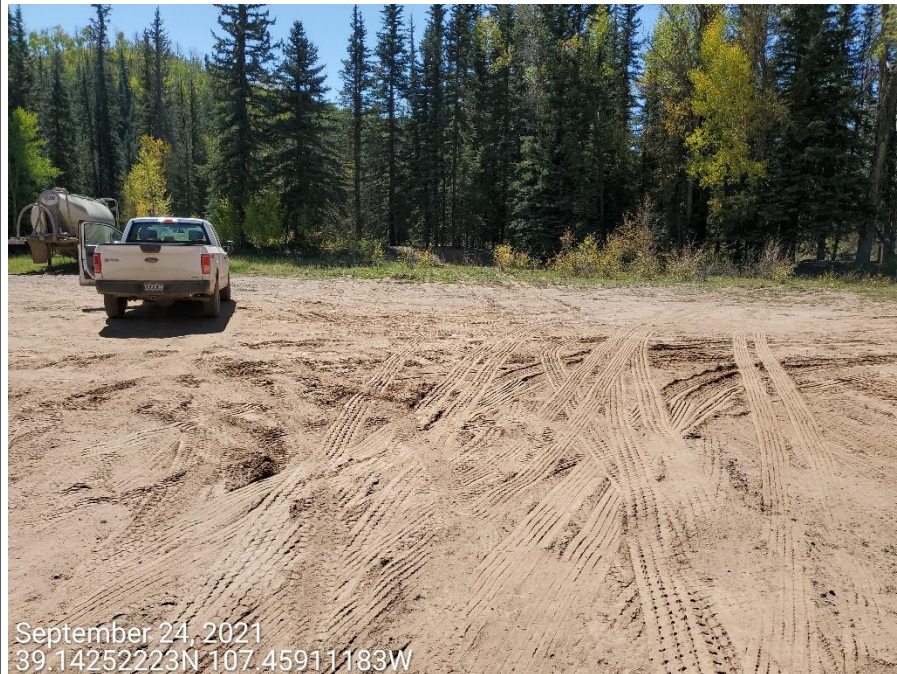
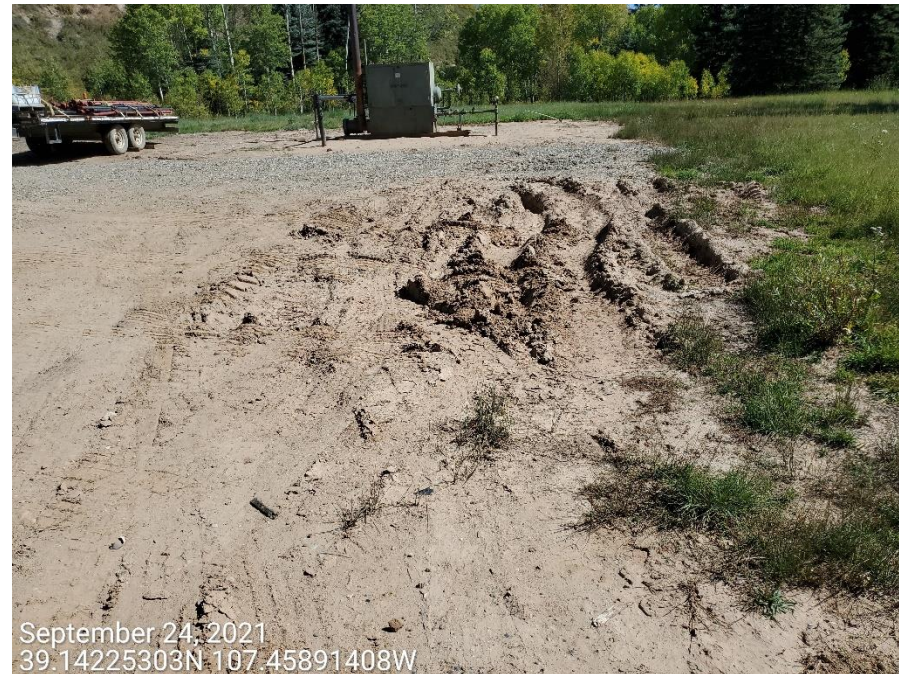
Photo 2: Photo taken from the production areas on of the Location. Photos shows control measures to stabilize/protect the production area are missing or insufficient; vehicle rutting, tracking and degradation observed on pad and location entrance.

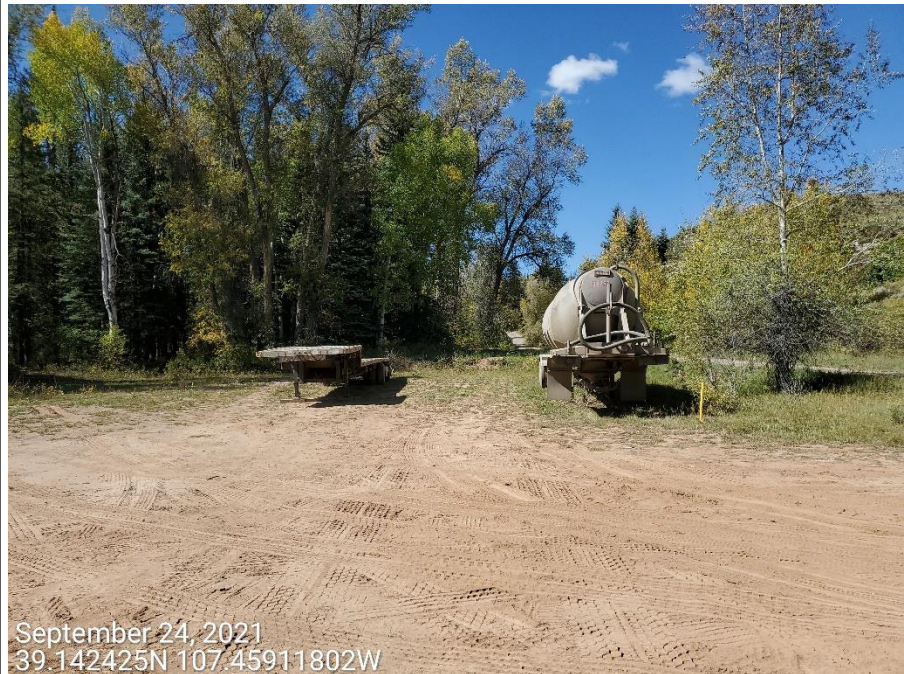
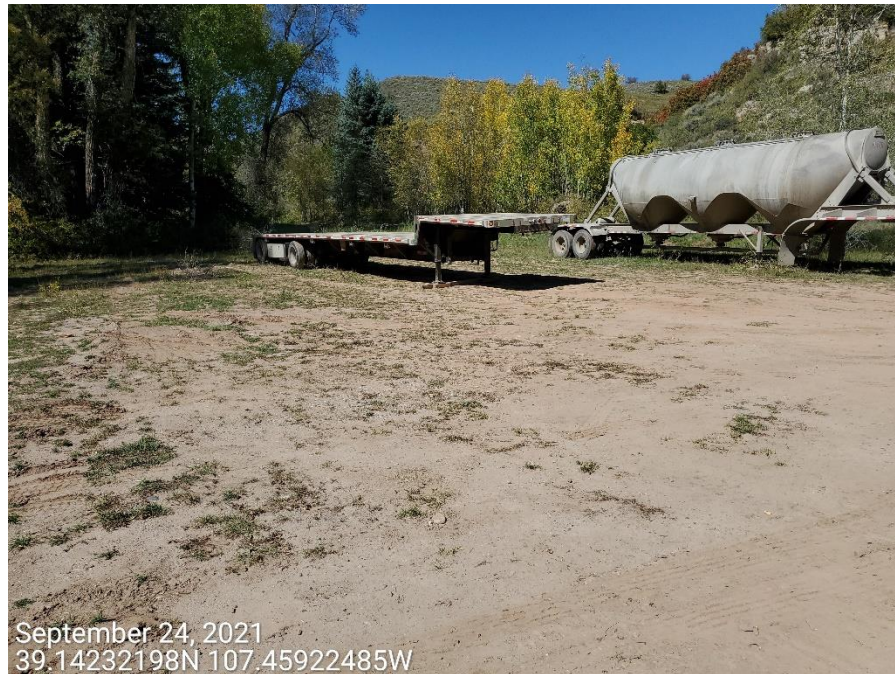
Photo 3: Photos taken from the west end of the Location. Photo shows vehicle travel and storage of trailers on the interim and off-site areas of the Location has resulted in additional degradation and disturbance. Areas require reclamation.

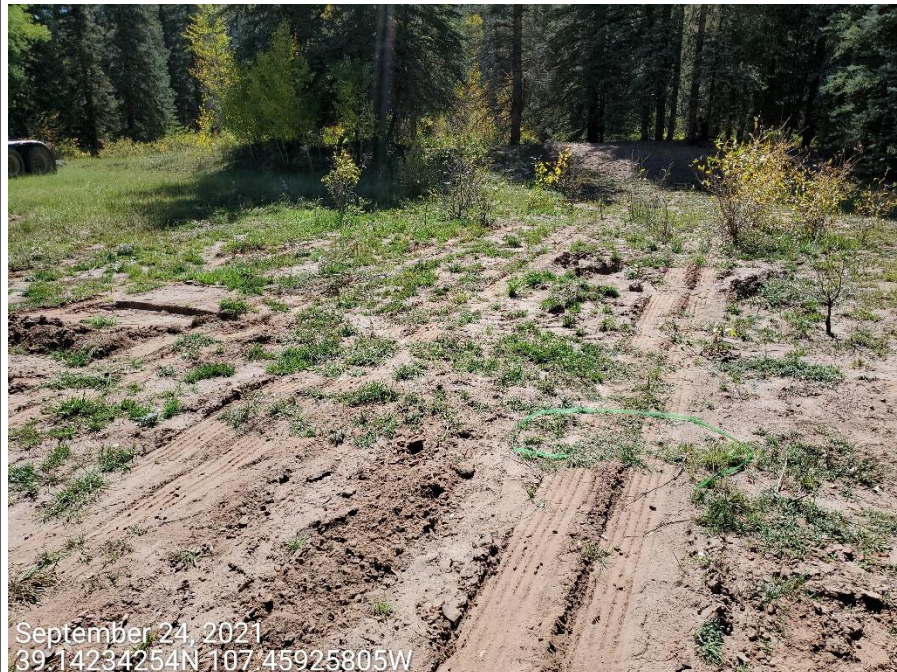
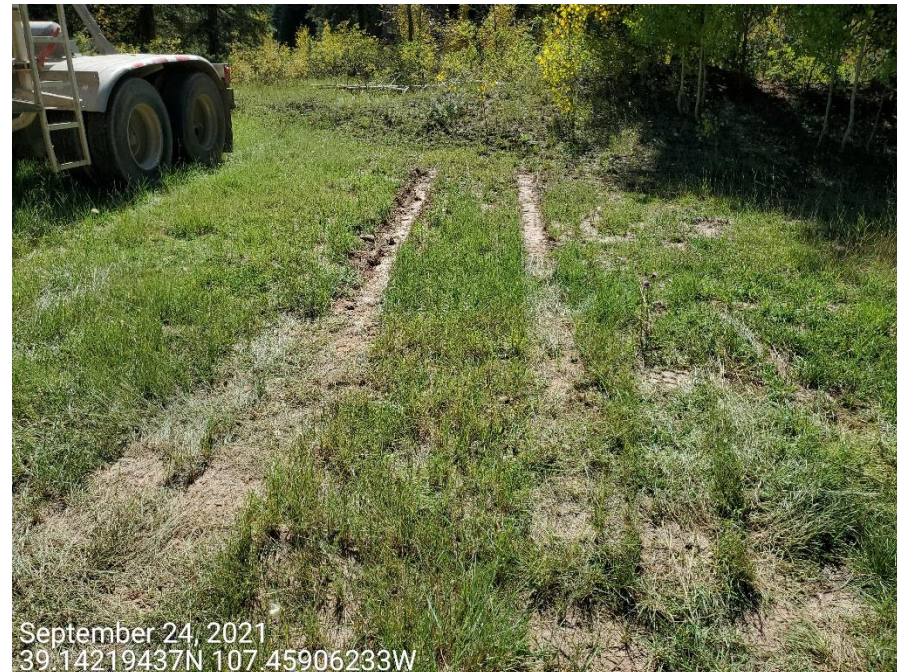
Photo 4: Photos taken from the southern end of the Location. Photo shows vehicle travel and storage of trailers on the interim and off-site areas of the Location has resulted in additional degradation and disturbance. Areas require reclamation.

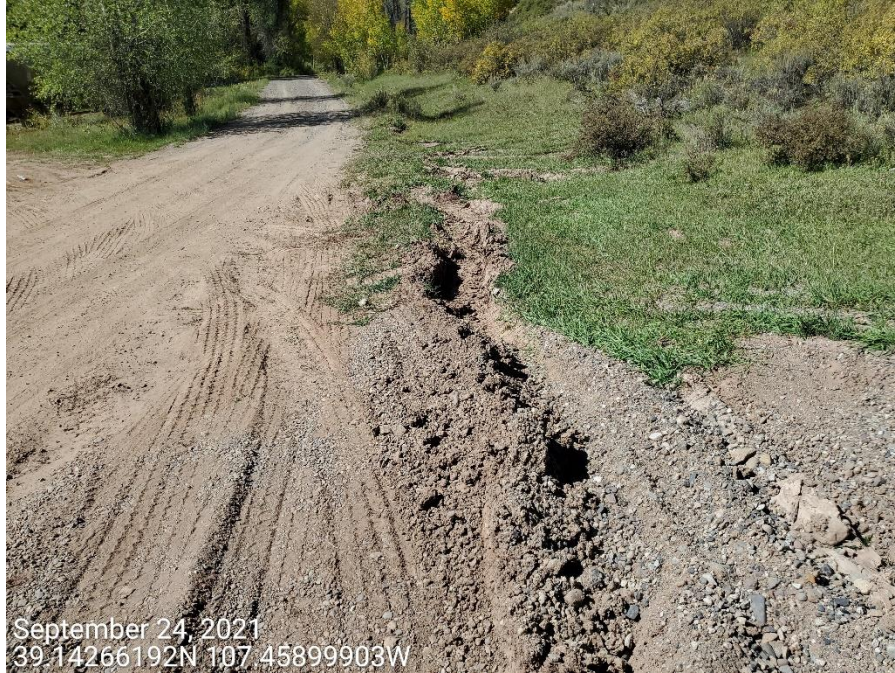
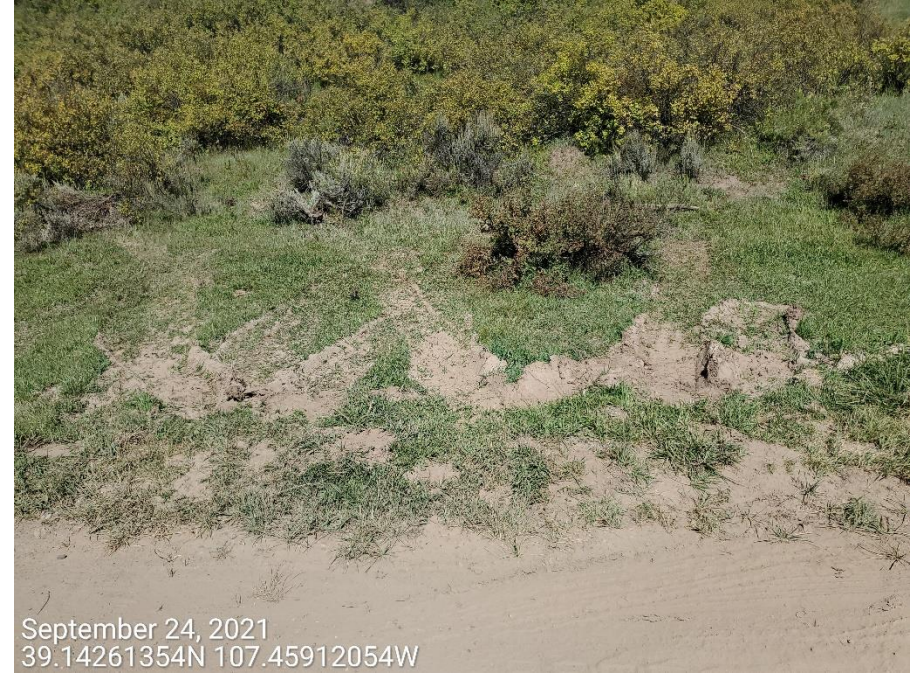
Photo 5: Photos taken from the access road on the north end of the Location. Photo shows vehicle travel on off-site areas of the Location has resulted in additional degradation and disturbance. Areas require reclamation.

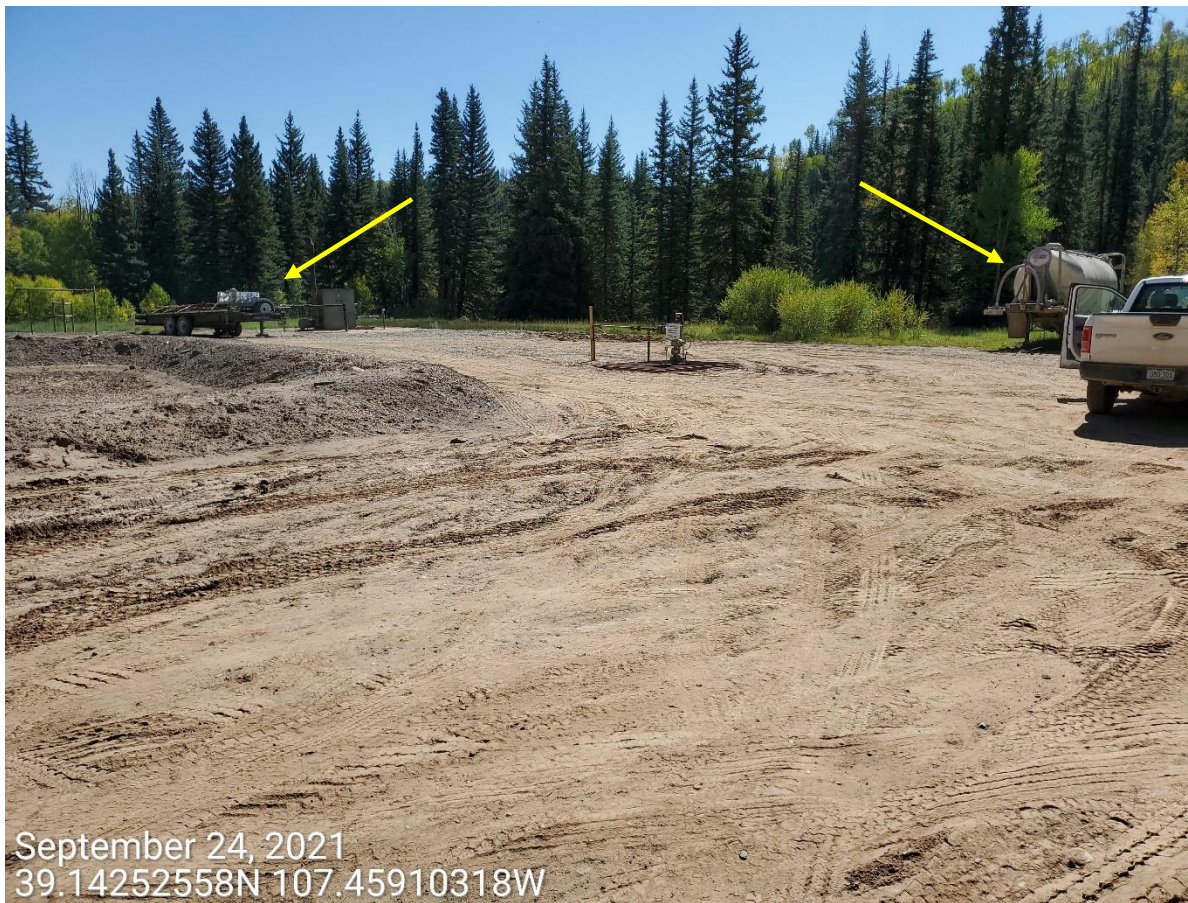
Photo 6: Photo shows trailers stored on interim/off-site areas of the Location, and the eastern areas of the pad.

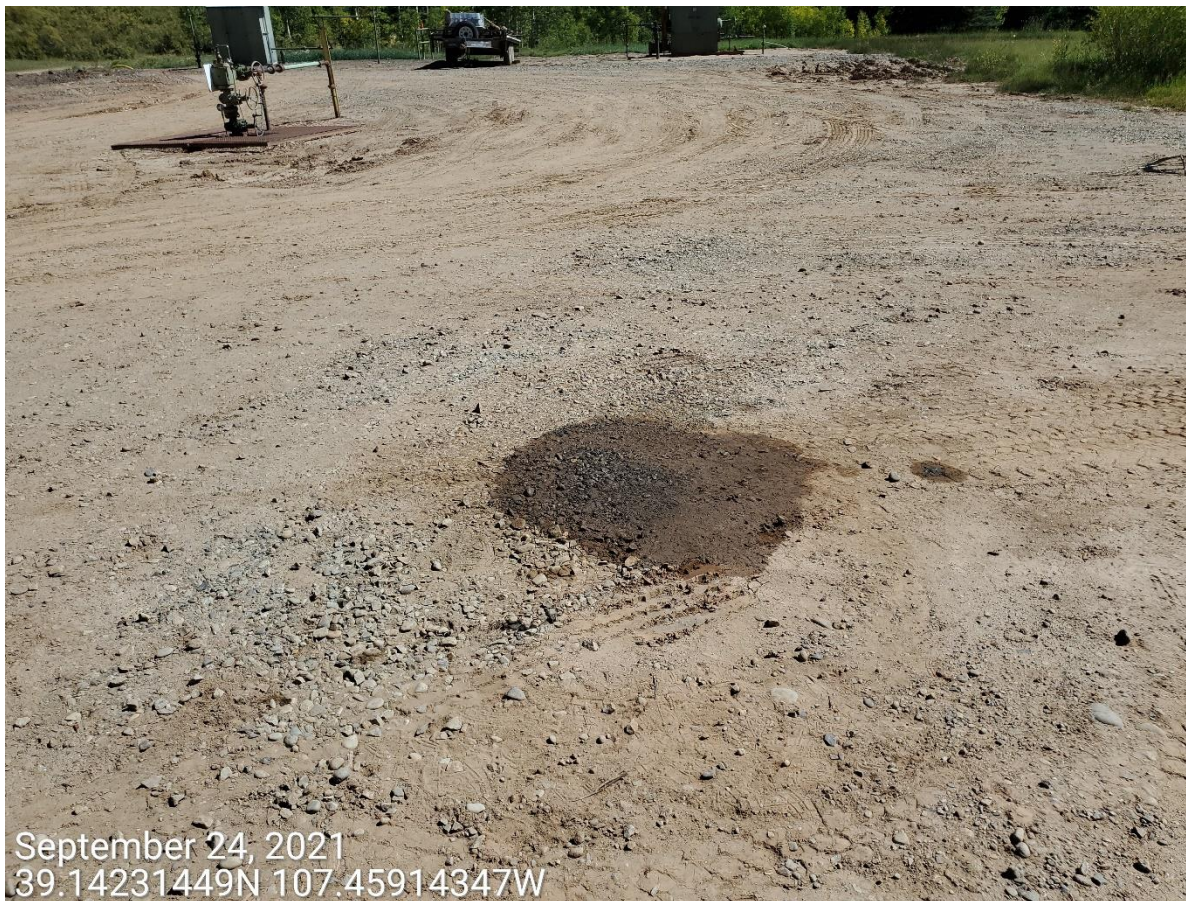
September 24, 2021
39.14231449N 107.45914347W

Photo 7: Photo shows stained soils observed to the southwest of the well.
