Produced Water Vessel
Attachment B

TANK BATTERY DECOMMISSIONING FORM

SITE NAME: Linkus 32-24							DATE: 6/4/2021	REM. PROJECT #: 16854	WEATHER: 70s and Sunny	
SITE DIRECTIONS: Rd 8 & Rd 13, W 1/8, S 1/8 into, W 500'							CLIENT: PDC/ Erin Crawford			
LEGALS AND LAT/LONG: 40.038885, -104.948633. SWNE 24 1N 68W 6							TASMAN PERSONNEL: Cody Miller			
SOIL TYPES: Silty Sand - SM							SURFACE GRADIENT: South			
SOIL SAMPLING							FACILITY INFRASTRUCTURE			
Date/Time	Soil Sample ID	PID (ppm)	Visual	Olfactory	Photo?	Grab or Lab Sample?	EQUIPMENT		Quantity	
							Above Ground Storage Tank (AST)		1	
6/4/2021 09:42	BKG01@2.5'	0.0	No Staining	No Odor	Yes	Lab	Buried or Partially Buried Vessel		1	
6/4/2021 09:53	SS01@3'	2293	HC Staining	HC Odor	Yes	Lab	Separator		1	
6/4/2021 10:12	PWV01-B@4'	1494	HC Staining	HC Odor	Yes	On-Hold	Emission Control Device (ECD)			
6/4/2021 10:22	SS02@3'	291.3	HC Staining	Slight HC Odor	Yes	Lab	Dump Line		1	
6/4/2021 10:28	AST01@0-6"	12.8	No Staining	No Odor	Yes	Lab	Wellhead

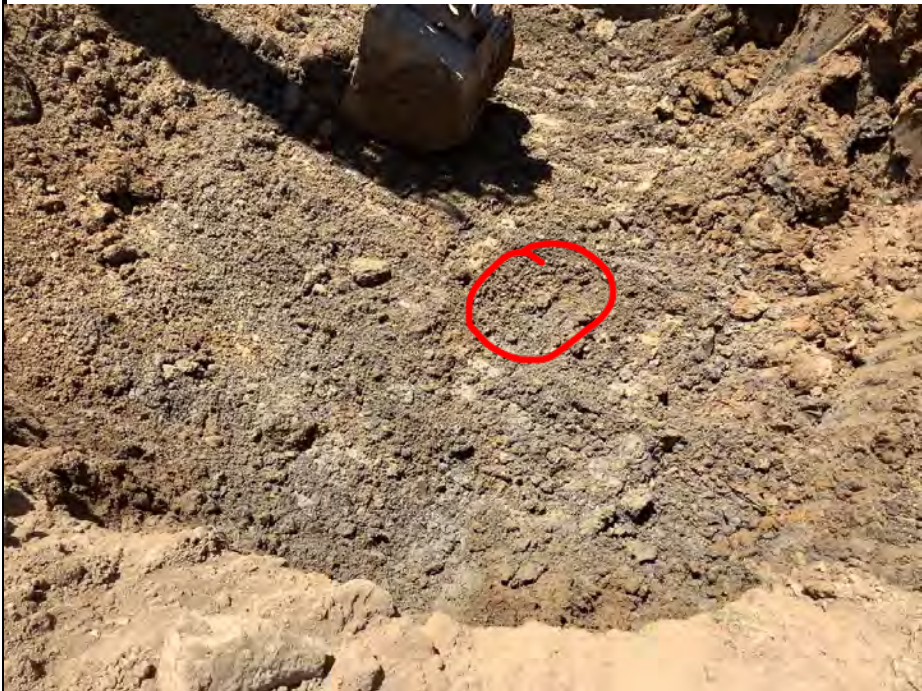
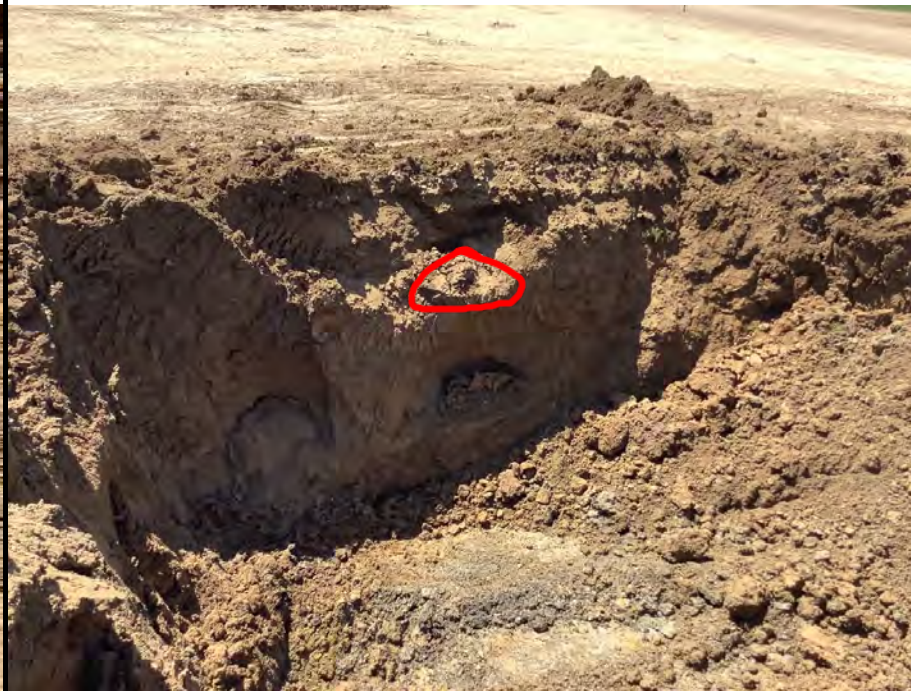
Equipment ID: S01		Equipment Type:		Equipment ID: S02		Equipment Type:					
Material:		Volume:		Contents:		Material:		Volume:		Contents:	
Notes/Conditions:						Notes/Conditions:

6/8/2021 15:34	G01@6'	643.4	HC Staining	HC Odor	Yes	Grab	Flowline			
6/8/2021 15:48	G02@6'	673.3	HC Staining	Slight HC Odor	Yes	Grab	Other:			
							Soil Loads Removed			
							IMPACTED SOIL IDENTIFIED?			
							ESTIMATED VOLUME OF IMPACTS:			
							Date	Number	CY	
							6/8/2021	8	80	
							Total Removed		8	80
							Disposal Facility: Front Range Landfill			
							Groundwater Recovery			
							DATE GW ENCOUNTERED:		DEPTH:	
							GROUNDWATER IN CONTACT WITH IMPACTED SOIL?			
							LNAPL OR SHEEN OBSERVED ON GW?			
GROUNDWATER SAMPLING							Date		BBLS	
Date/Time	Groundwater Sample ID	Depth Collected	Turbid?	Sheen?	Odor?	Photo?				
							Total Removed		0	
							Disposal Facility:

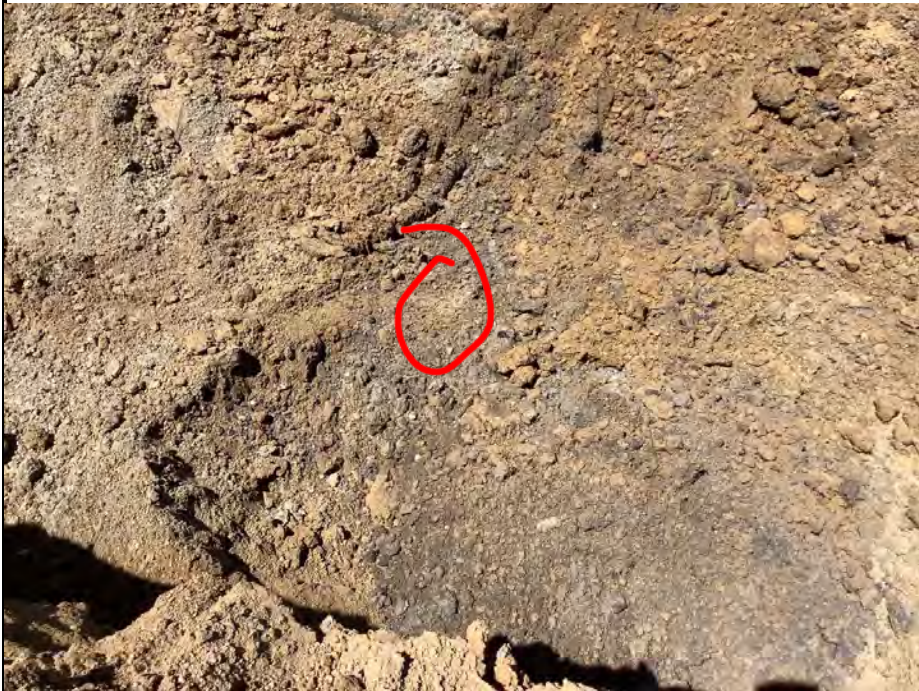
Equipment ID: S10		Equipment Type:		Equipment ID: G03		Equipment Type:	
Material:	Volume:	Contents:		Material:	Volume:	Contents:	
Notes/Conditions:				Notes/Conditions:

6/9/2021 13:50	G03@6'	1029	HC Staining	Strong HC Odor	Yes	Grab	Flowline					
6/9/2021 15:12	G04@6'	416.9	HC Staining	HC Odor	Yes	Grab	Other:					
							Soil Loads Removed					
							IMPACTED SOIL IDENTIFIED?					
							ESTIMATED VOLUME OF IMPACTS:					
							Date		Number		CY	
							6/9/2021		11		110	
							Total Removed		11		110	
							Disposal Facility: Front Range Landfill					
							Groundwater Recovery					
							DATE GW ENCOUNTERED:			DEPTH:		
							GROUNDWATER IN CONTACT WITH IMPACTED SOIL?					
							LNAPL OR SHEEN OBSERVED ON GW?					
GROUNDWATER SAMPLING							Date		BBLS			
Date/Time	Groundwater Sample ID	Depth Collected	Turbid?	Sheen?	Odor?	Photo?						
							Total Removed		0			
							Disposal Facility:
