# Inspection Photos

API: 087-07201

Operator: PETRON DEVELOPMENT COMPANY

Inspection Date: 10/25/2021

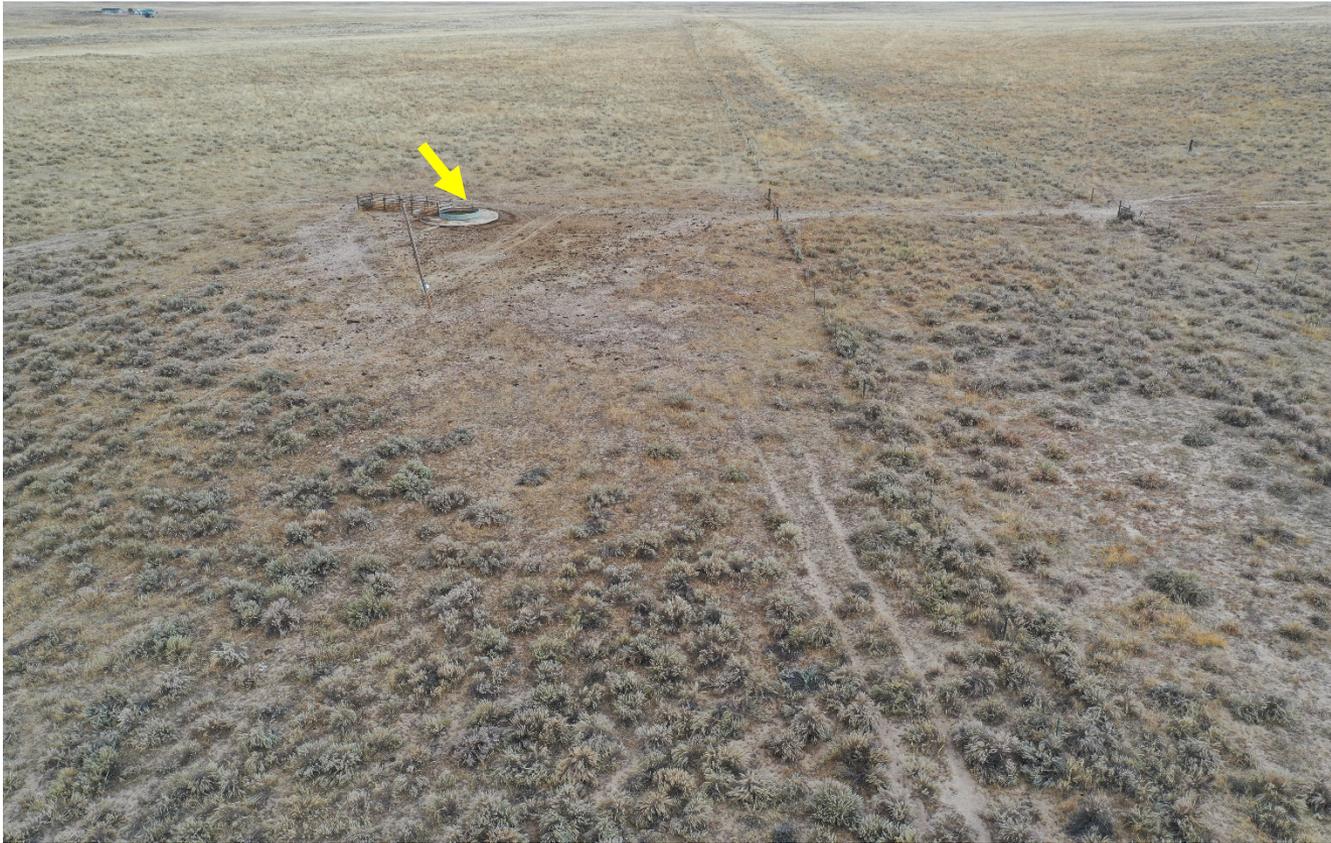
**Photo 1.** Drone aerial photo facing northwest toward the well site location. There is a livestock water tank located at the yellow arrow.

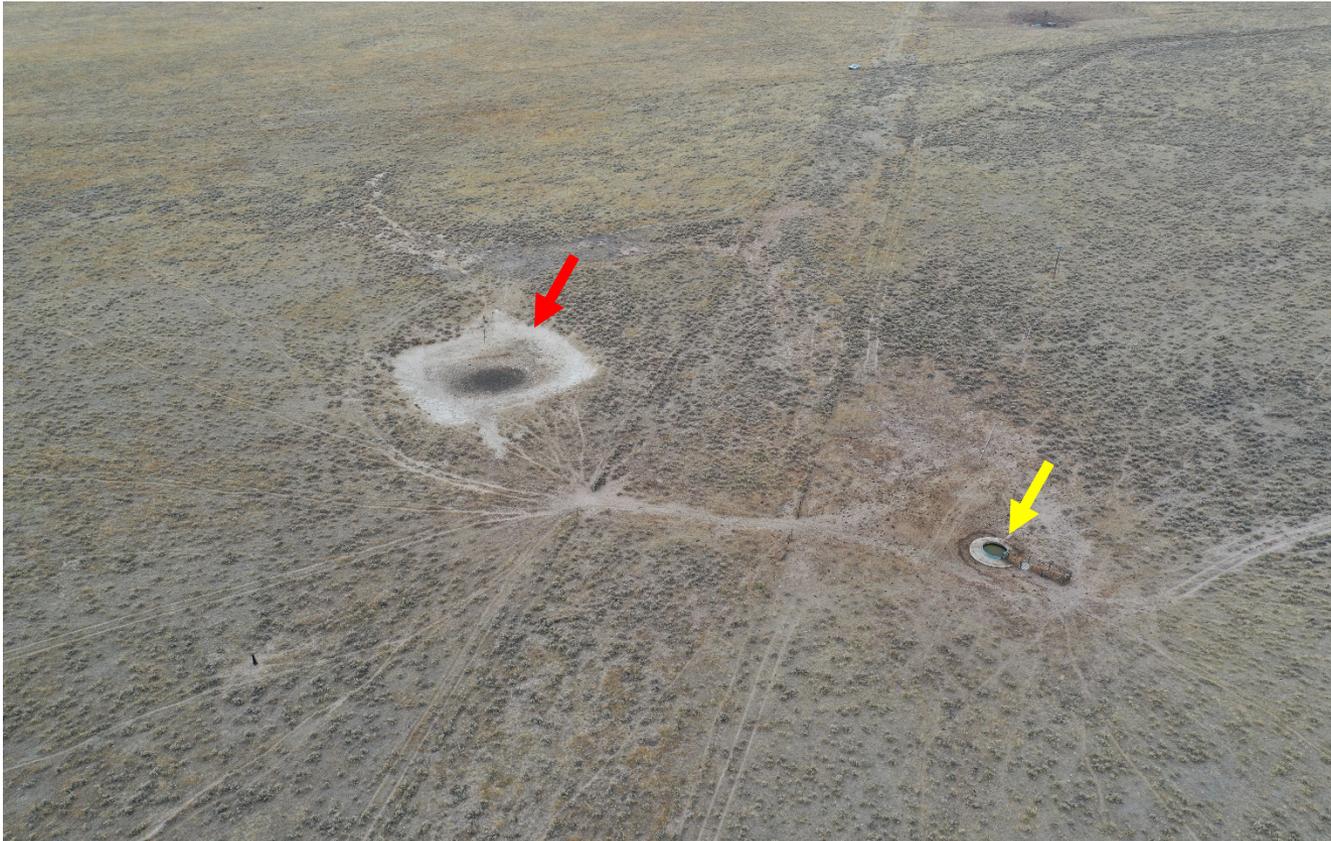
**Photo 2.** Drone aerial photo facing east toward the well site location. The associated pit is located at red arrow. There is a livestock water tank located at yellow arrow.

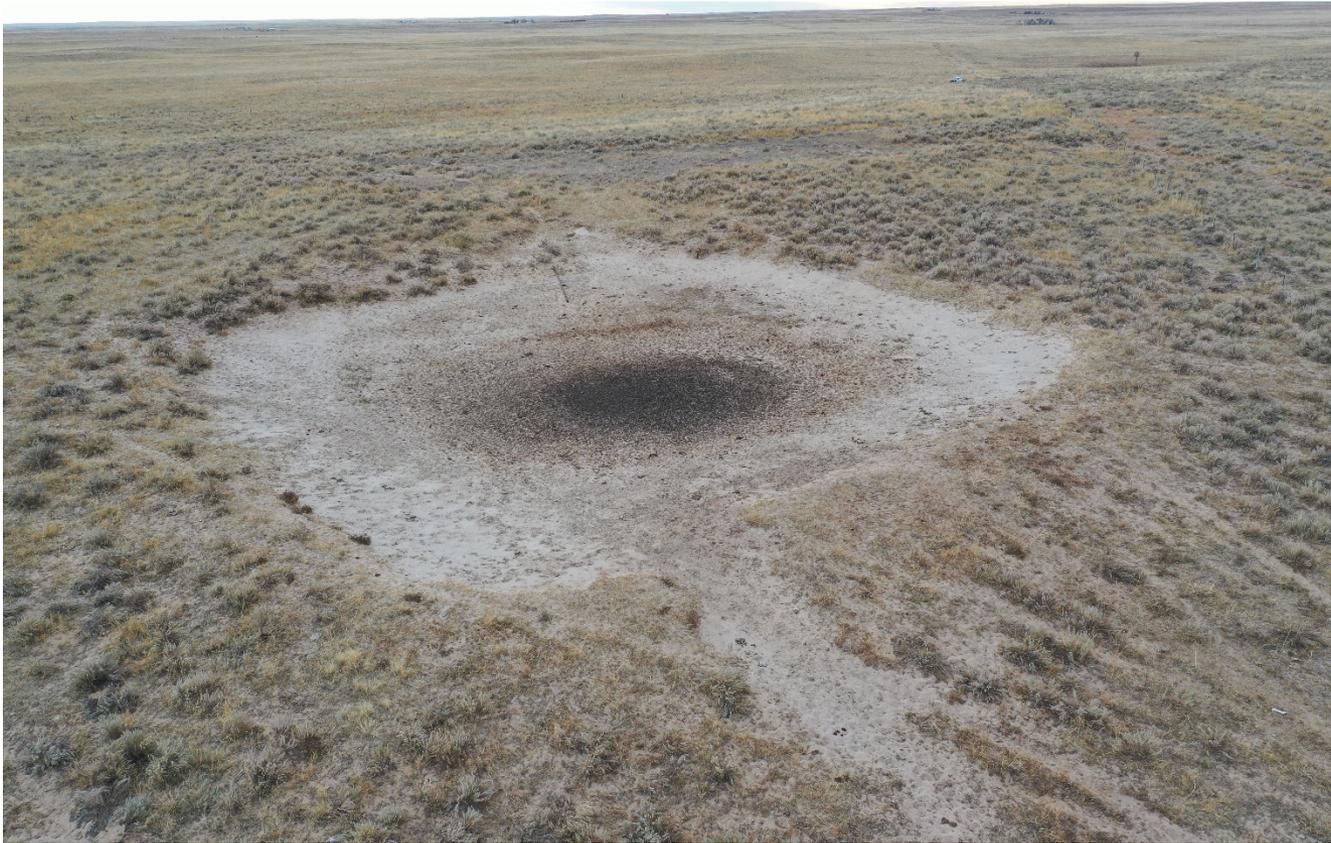
**Photo 3.** Facing east. The JAMES HUNT 1 Pit is not closed and reclaimed per 1004 Rules.

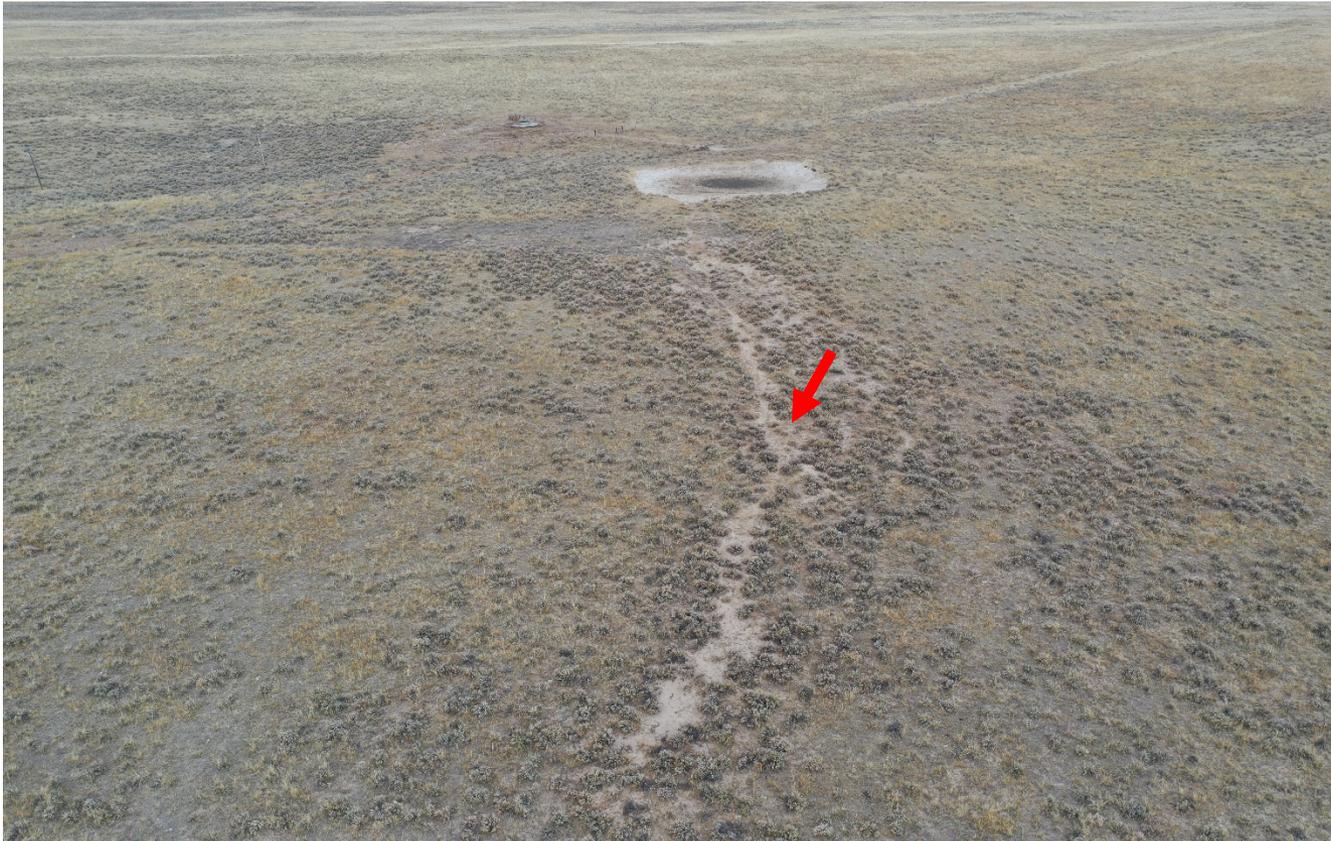
**Photo 4.** Facing southeast. It appears there was a former spill that occurred downhill from the pit shown in the direction of the red arrow. This area has insufficient vegetation re-establishment and extends out approximately 450' from the pit.

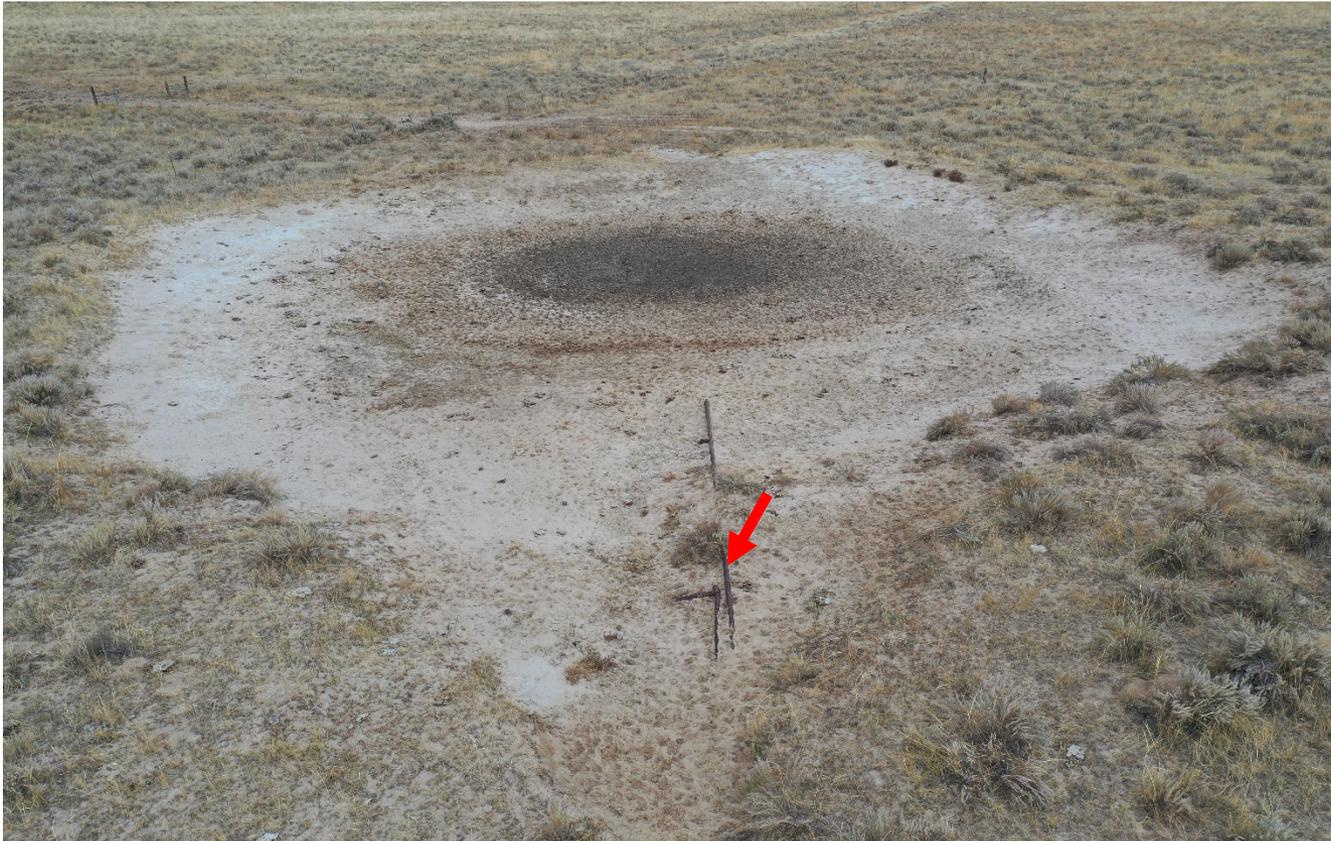
**Photo 5.** Facing southeast toward the pit. There is exposed piping shown at red arrow. The piping equipment was never removed.
