Attachment B

TANK BATTERY DECOMMISSIONING FORM

| SITE NAME: RICE 22-1,2 Tank Battery | | | | | | | DATE: 11/4/2021 | REM. PROJECT #: 19554 | WEATHER: PARTLY CLOUDY | | |

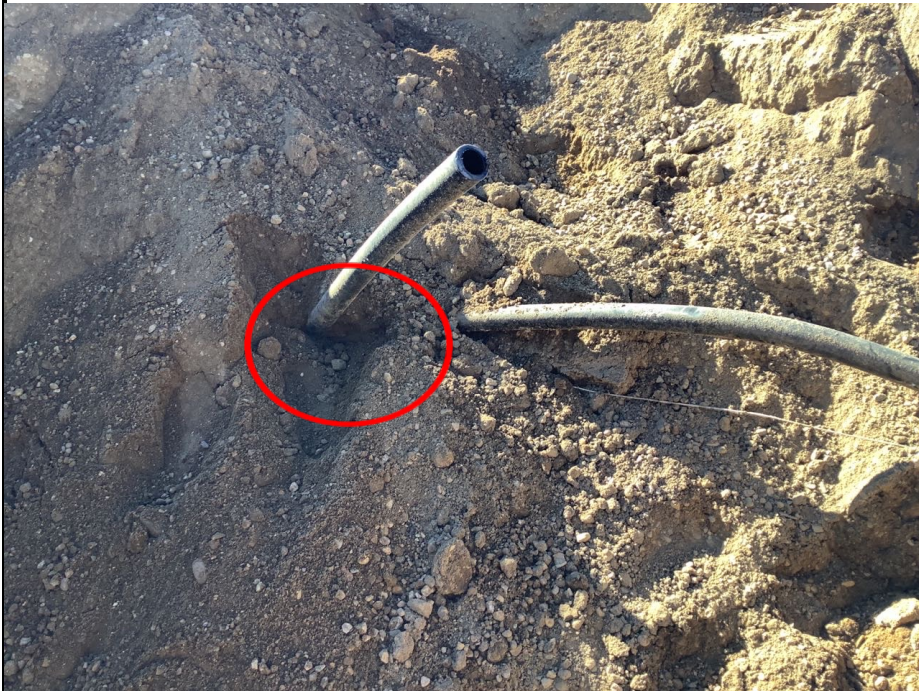
| Equipment ID: WDL01 @ 2.5' | | Equipment Type: | | Equipment ID: MH01 @ 0-6" | | Equipment Type: | |

| 11/4/2021 12:40 | WDL01 @ 2.5' | 0.6 | No Staining | No Odor | Yes | Grab | Flowline | | | | |

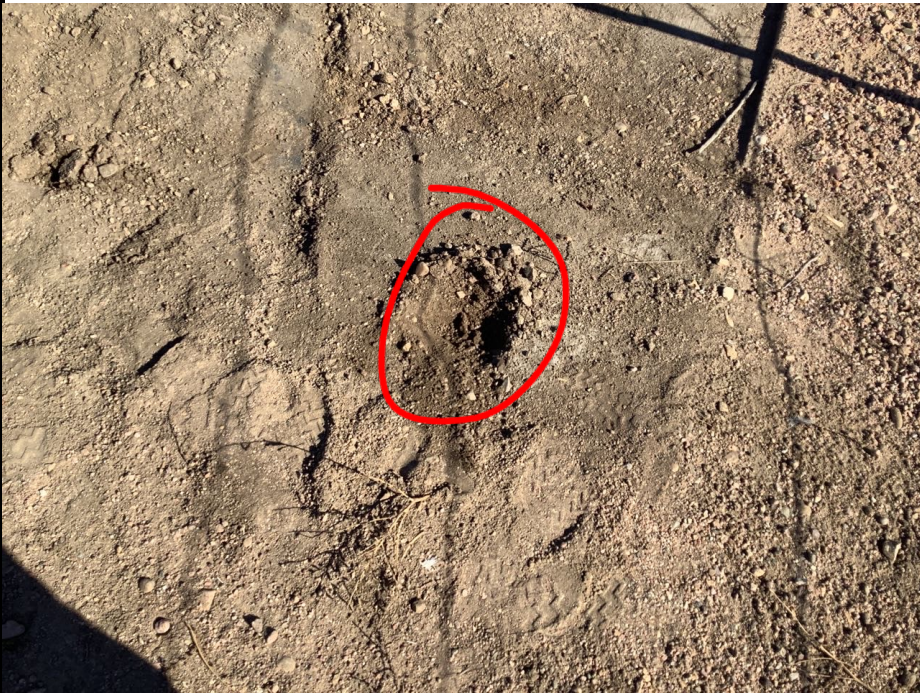
| Equipment ID: ECD01 @ 0-6" | | Equipment Type: | | Equipment ID: SEP01-FL @ 3' | | Equipment Type: | |

| 11/4/2021 13:37 | ECD01 @ 0-6" | 0.8 | No Staining | No Odor | Yes | Grab | ESTIMATED VOLUME OF IMPACTS: | | | | |

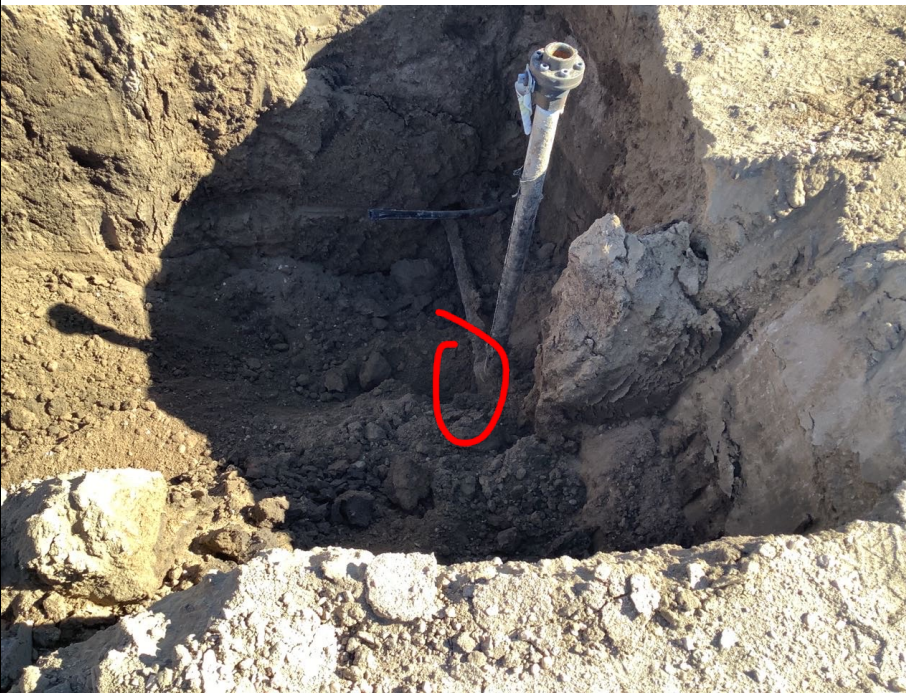
| 11/4/2021 12:45 | SEP01-FL @ 3' | 2.4 | No Staining | No Odor | Yes | Lab | Other: Meter House | | 1 | | |
