# Interim Reclamation Inspection

Operator: NGL WATER SOLUTIONS DJ LLC- 10373

Location ID: 450612

Inspection Document #: 697503832

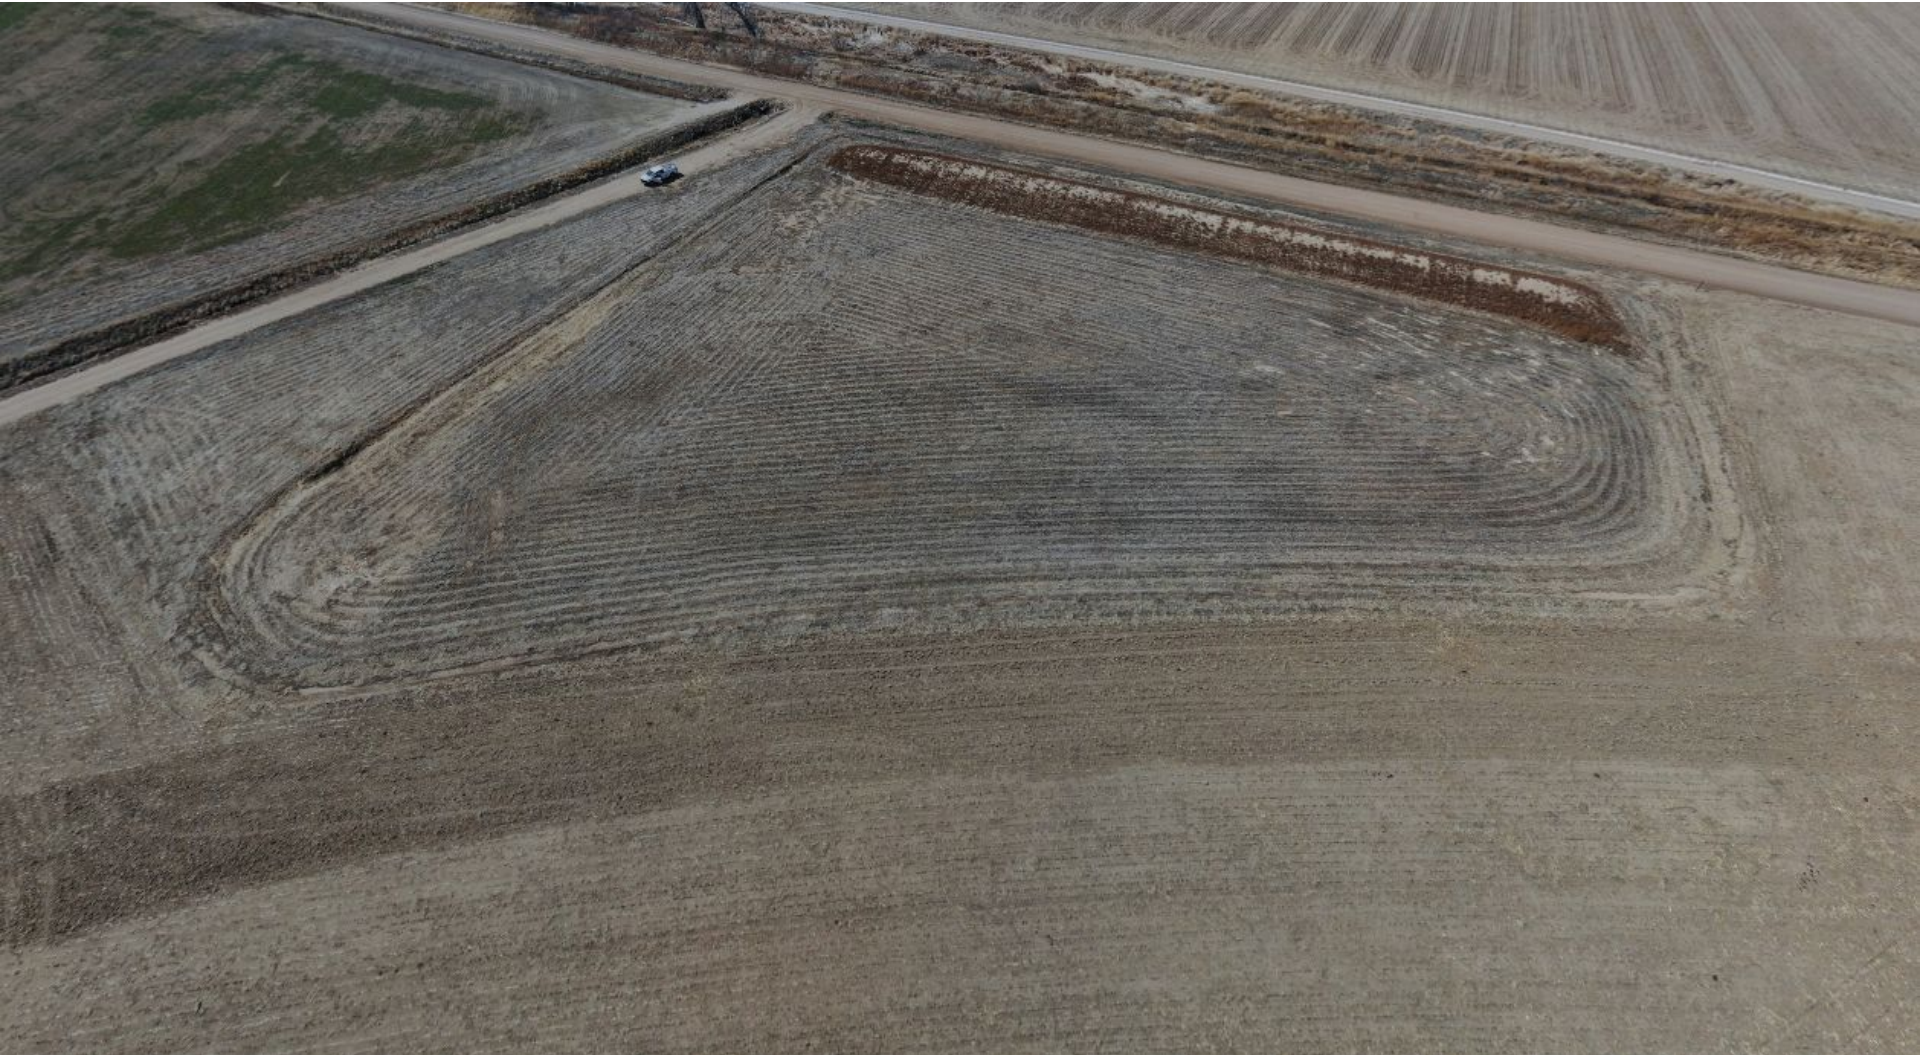
**Photo 1.** Drone aerial imagery taken 3/25/2022 illustrates the C10B location that was built back in April 2020.

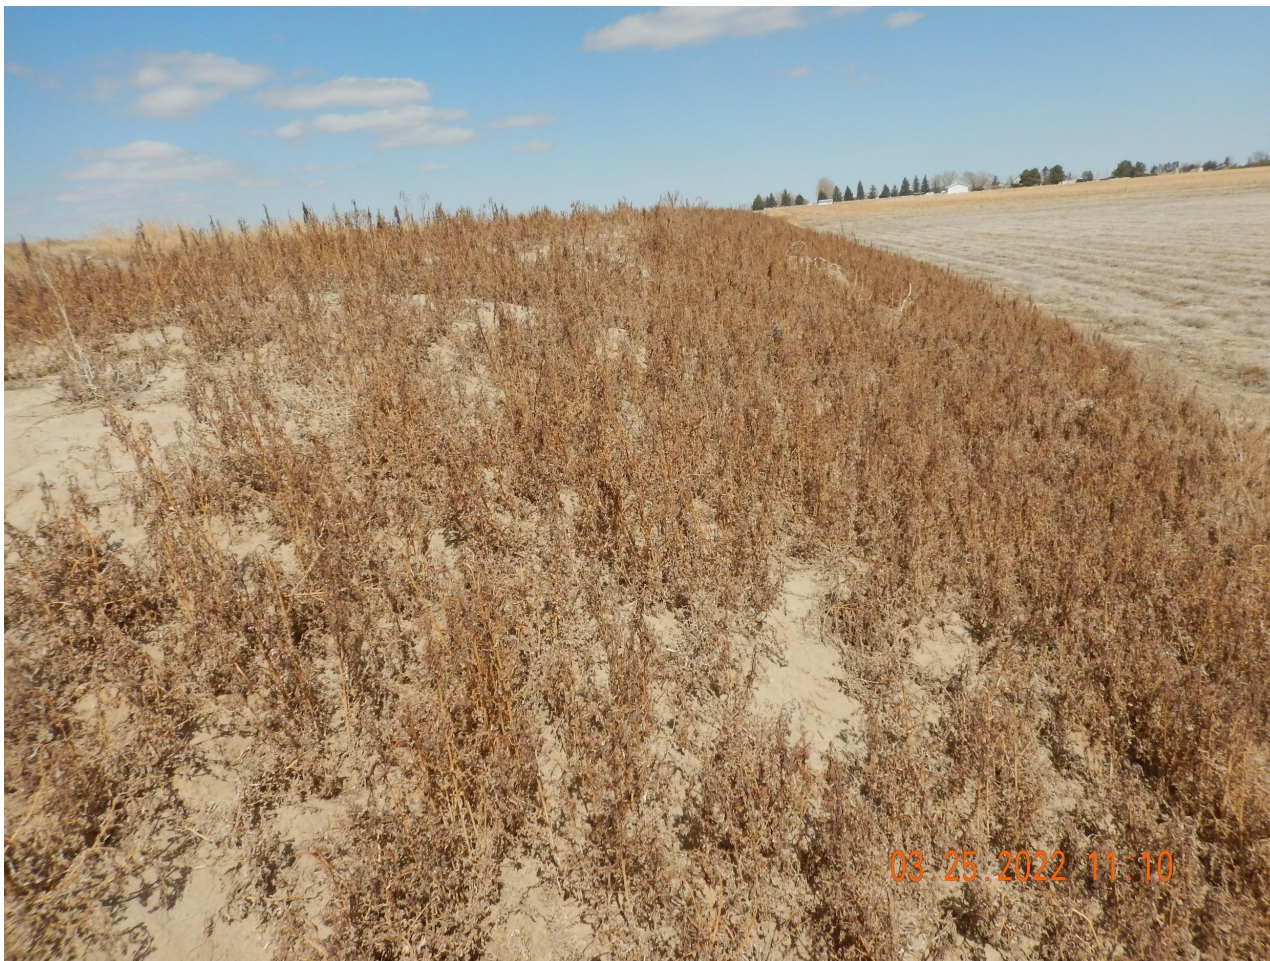
**Photo 2.** Photo taken from the southern topsoil stockpile, facing North. Photo illustrates the Operator has failed to prevent weed establishment on the stockpile. Kochia, an annual undesirable weed, was observed throughout the entire stockpile.

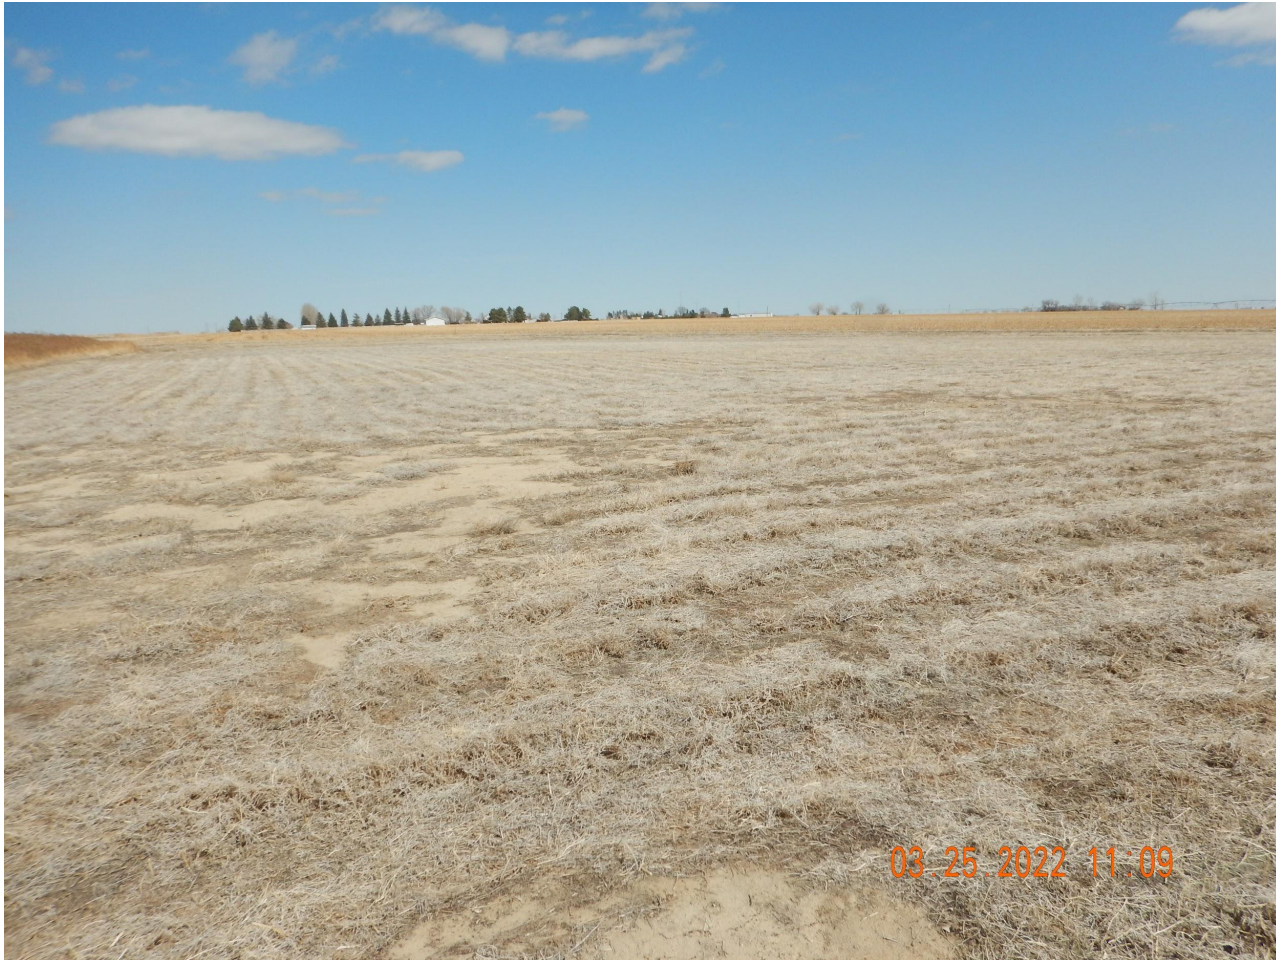
**Photo 3.** Photo taken from the southwestern location, facing North. Photo illustrates the location has established with Kochia but it appears the location is being mowed to control the undesirable weed.
