Interim Reclamation and Stormwater Inspection

Operator: KERR MCGEE OIL & GAS ONSHORE LP - #47120

Location ID: 327393

Inspection Photos
Location Name: CANNON #37N-3HZ
Location ID: 327393

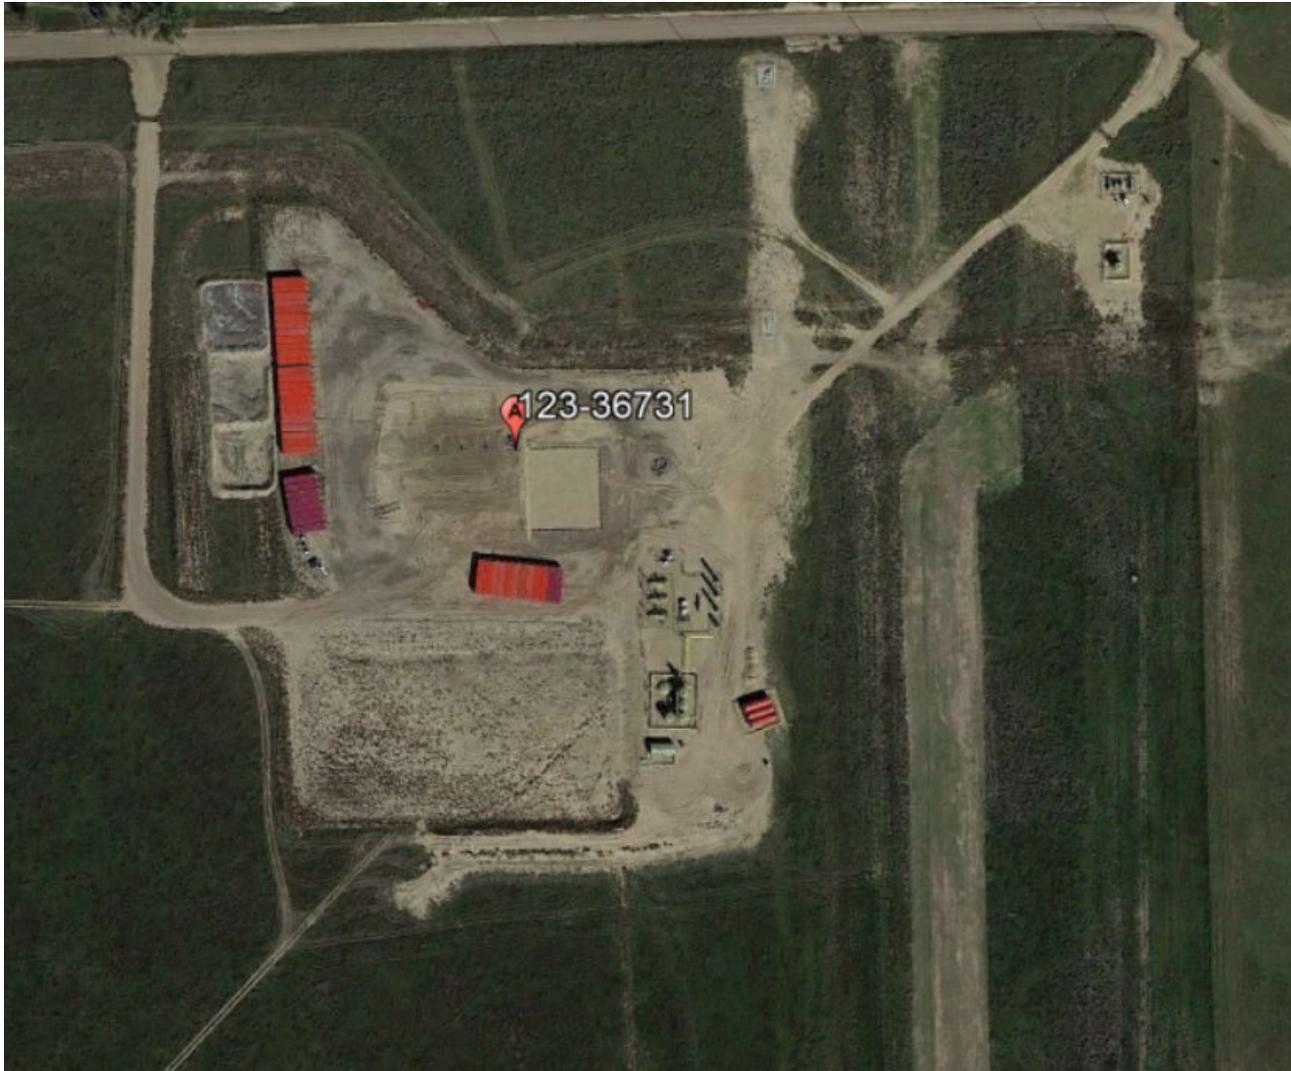
Photo 1. Google Earth aerial imagery from 10/6/2013. Photo illustrates the total disturbance area during drilling operations.

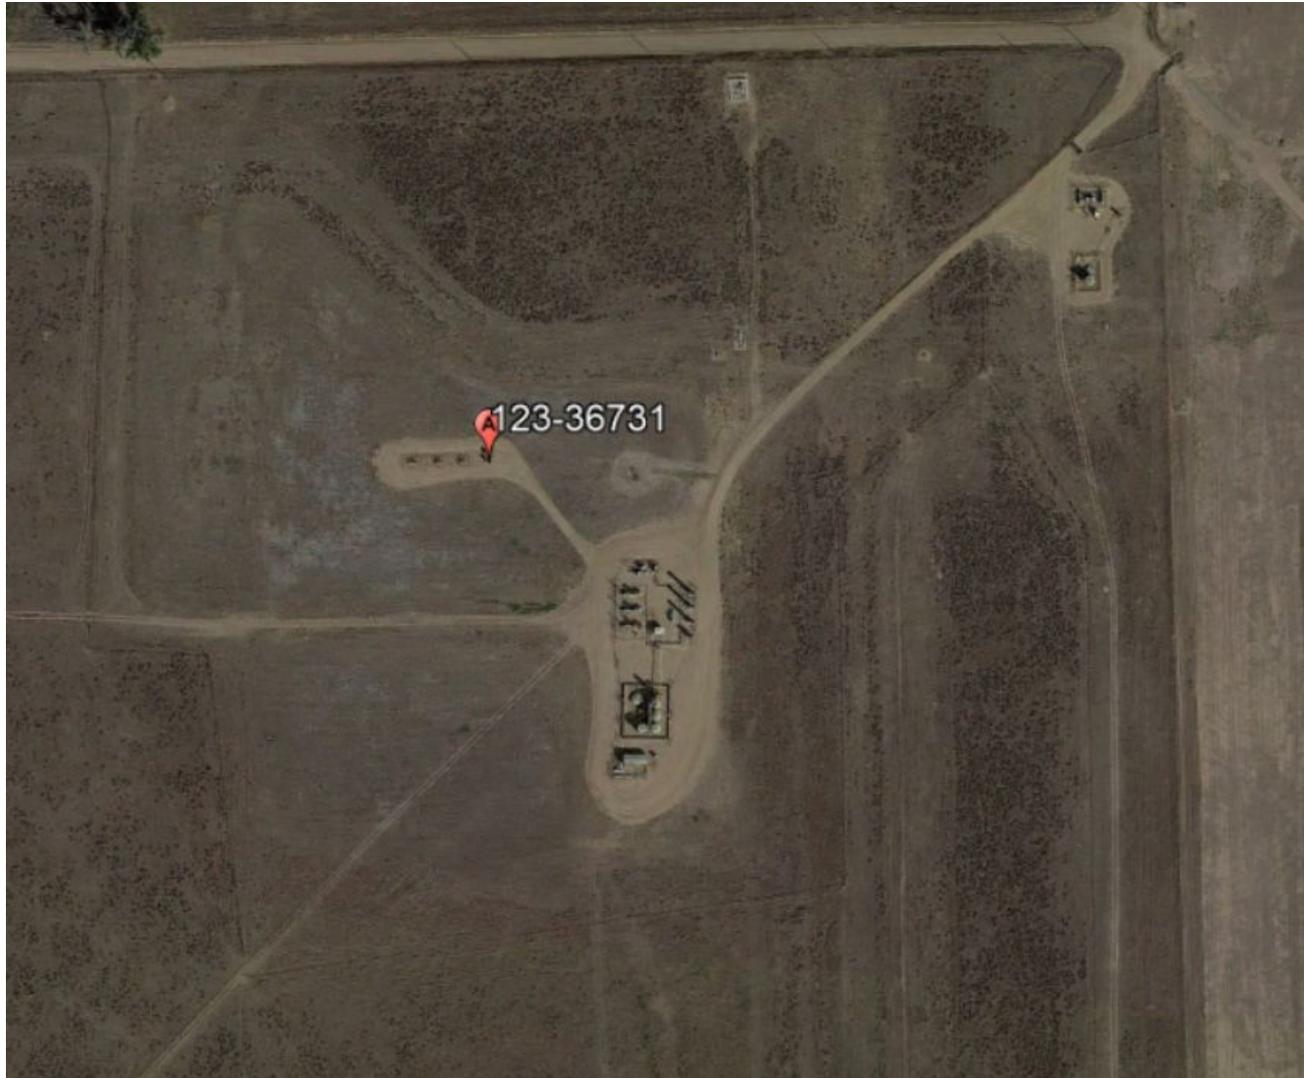
Photo 2. Google Earth aerial imagery from 9/29/202. Photo illustrates the location after interim reclamation has been completed.

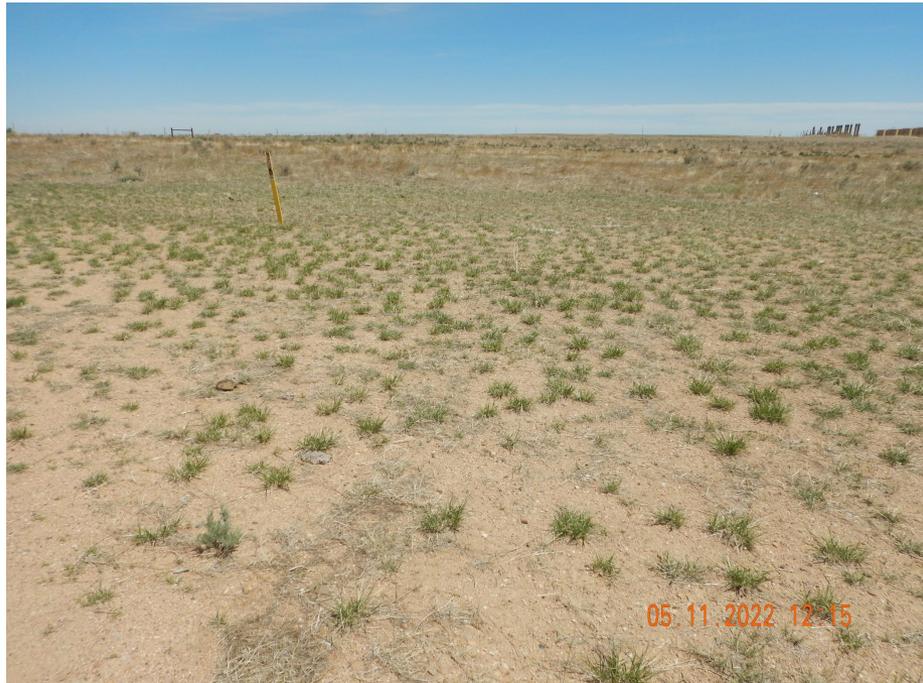
Photo 3. Photo taken from eastern interim reclamation area, facing East. Photo illustrates desirable perennial vegetation which is better than reference areas that consist of annual grasses and shrubs.

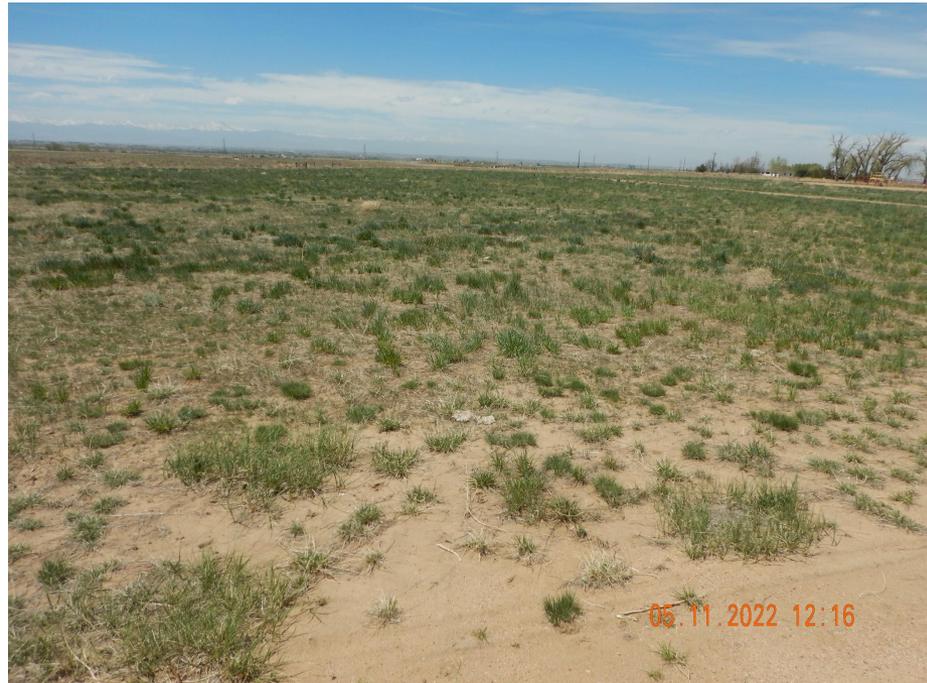
Photo 4. Photo taken from the southwest interim reclamation area, facing West. See comments under Photo 3.

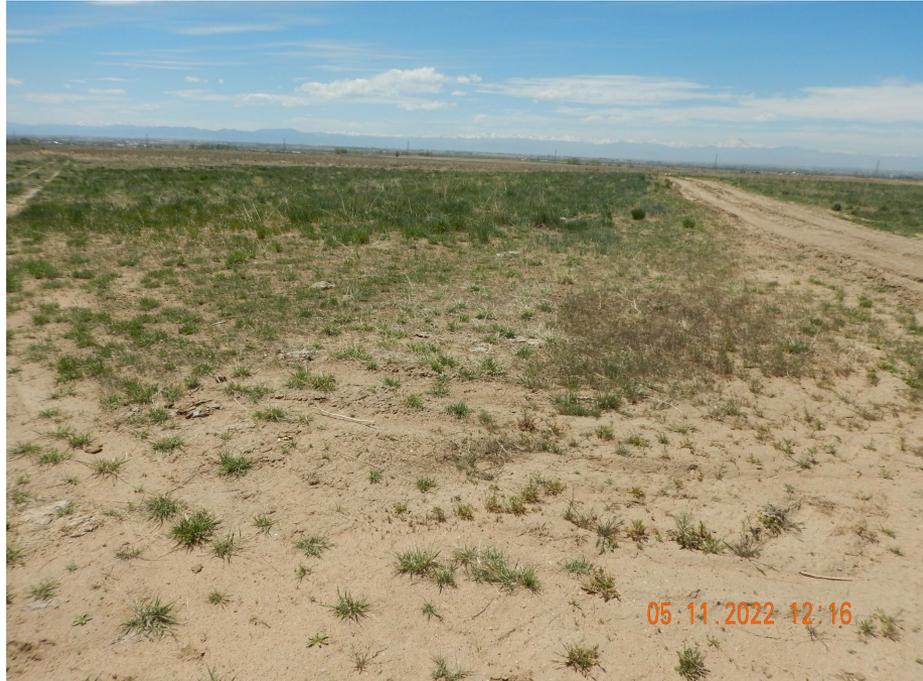
Photo 5. Photo taken from western interim reclamation area, facing West. See comments under Photo 3.

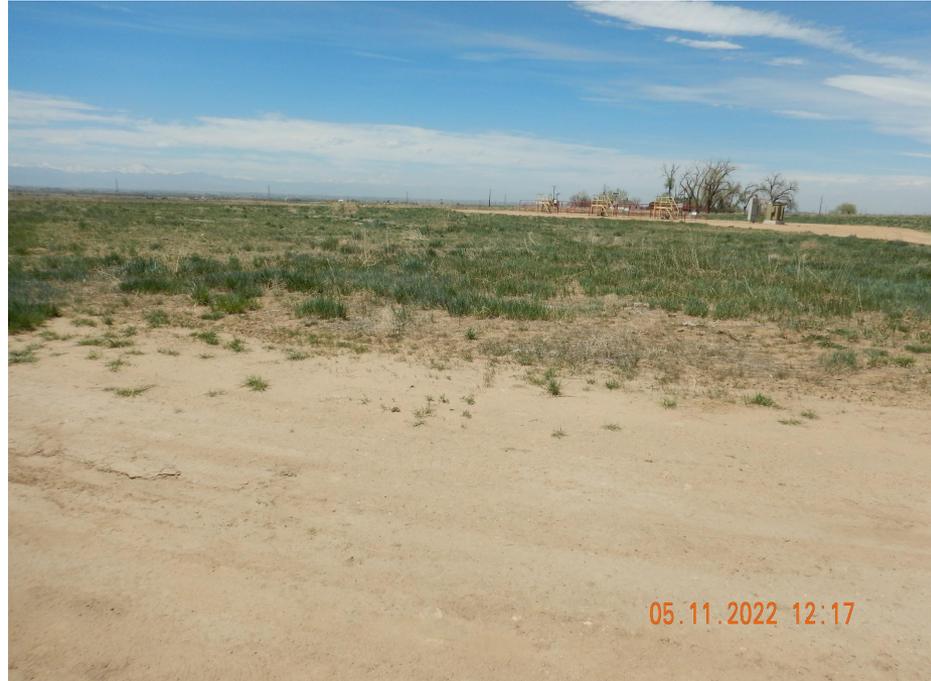
Photo 6. Photo taken from the northwest interim reclamation area, facing Northwest. See comments under Photo 3.

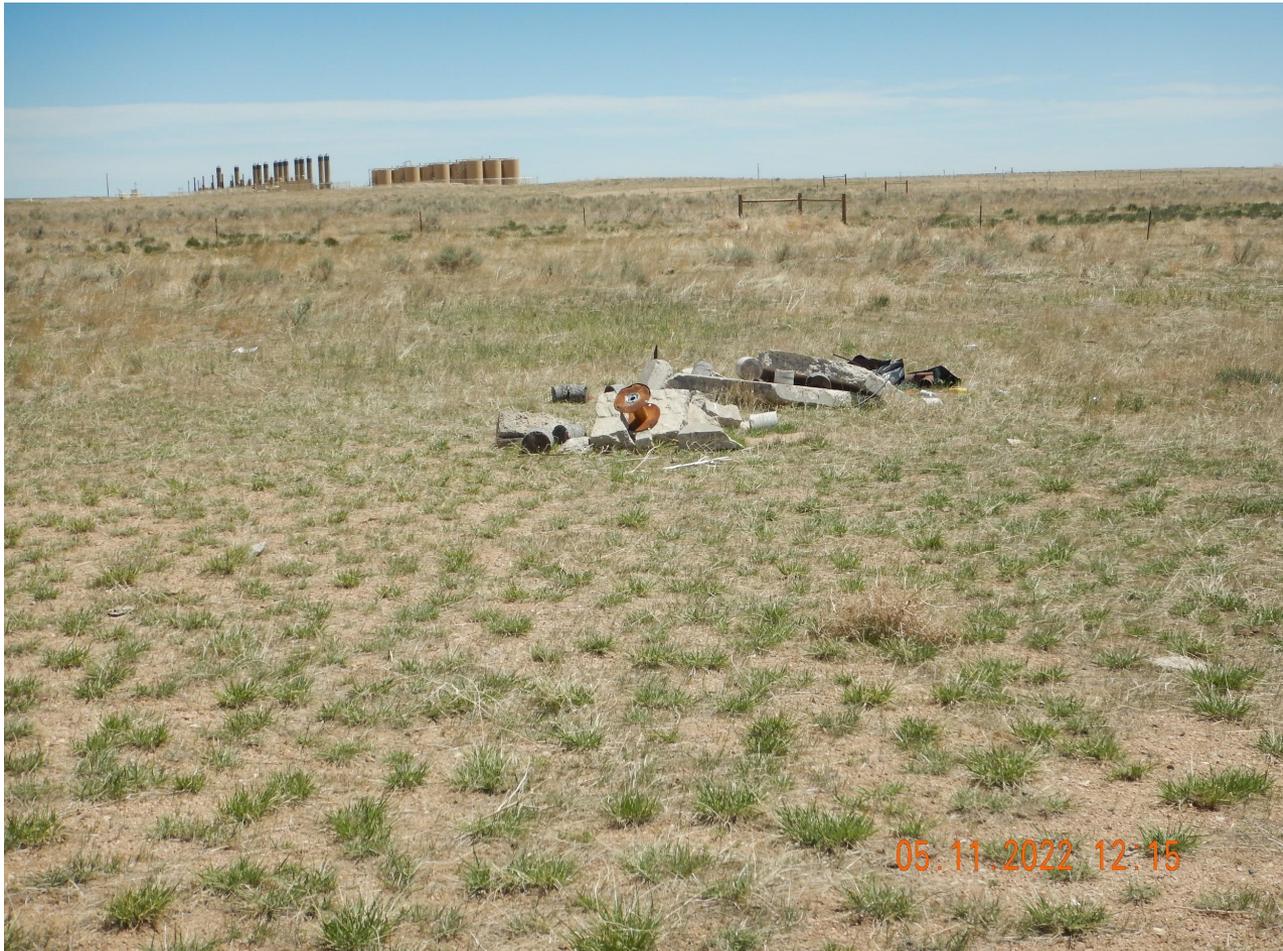
Photo 7. Photo taken from western interim reclamation area, facing West. See comments under Photo 3. Photo illustrates trash and debris that has been dumped on location.
