# Inspection Photos

API: 071-08113

Operator: EVERGREEN NATURAL RESOURCES

Inspection Date: 6/10/2022

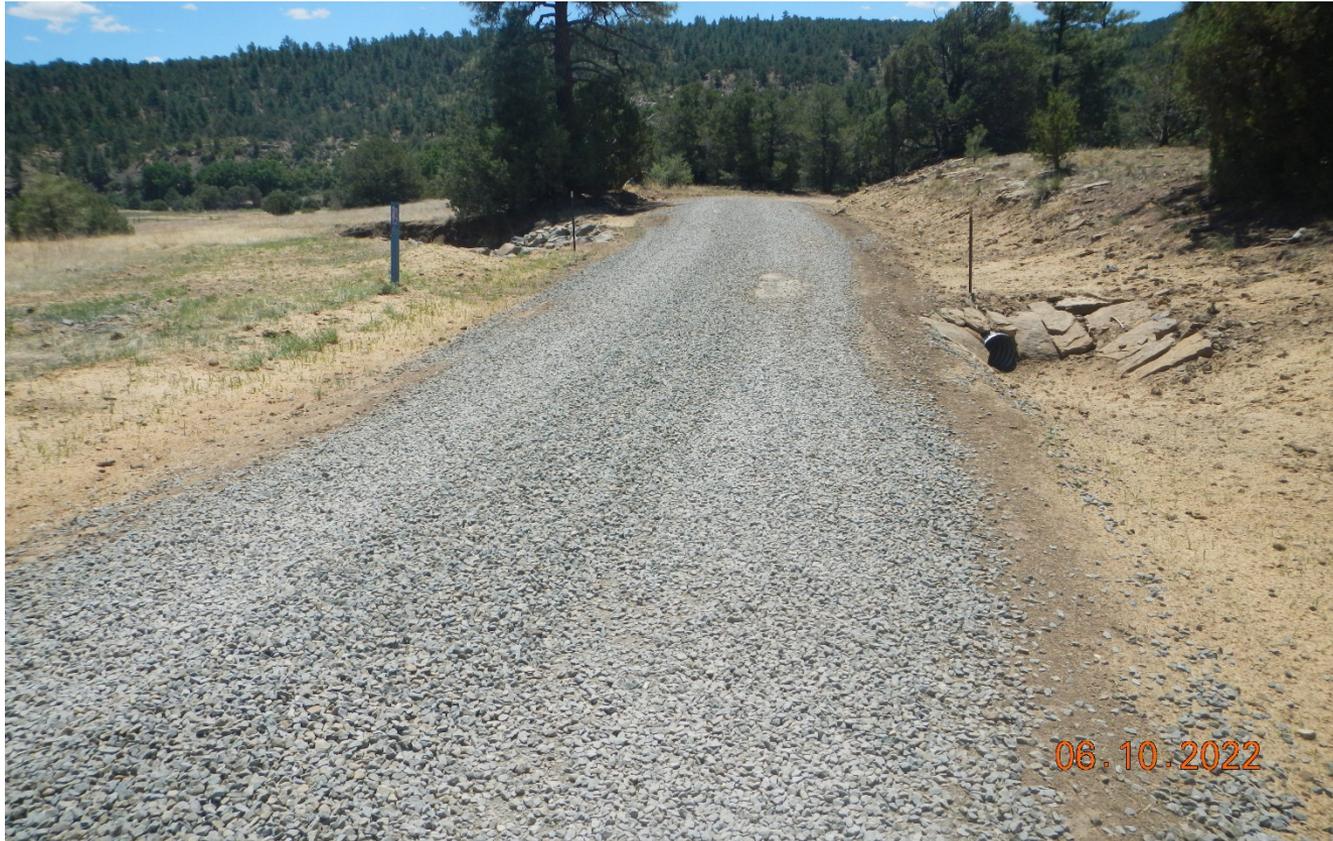
**Photo 1.** Facing southwest along the main road near the electric gate. The road and culvert has been repaired. Lat/Long:37.08136,-104.62910

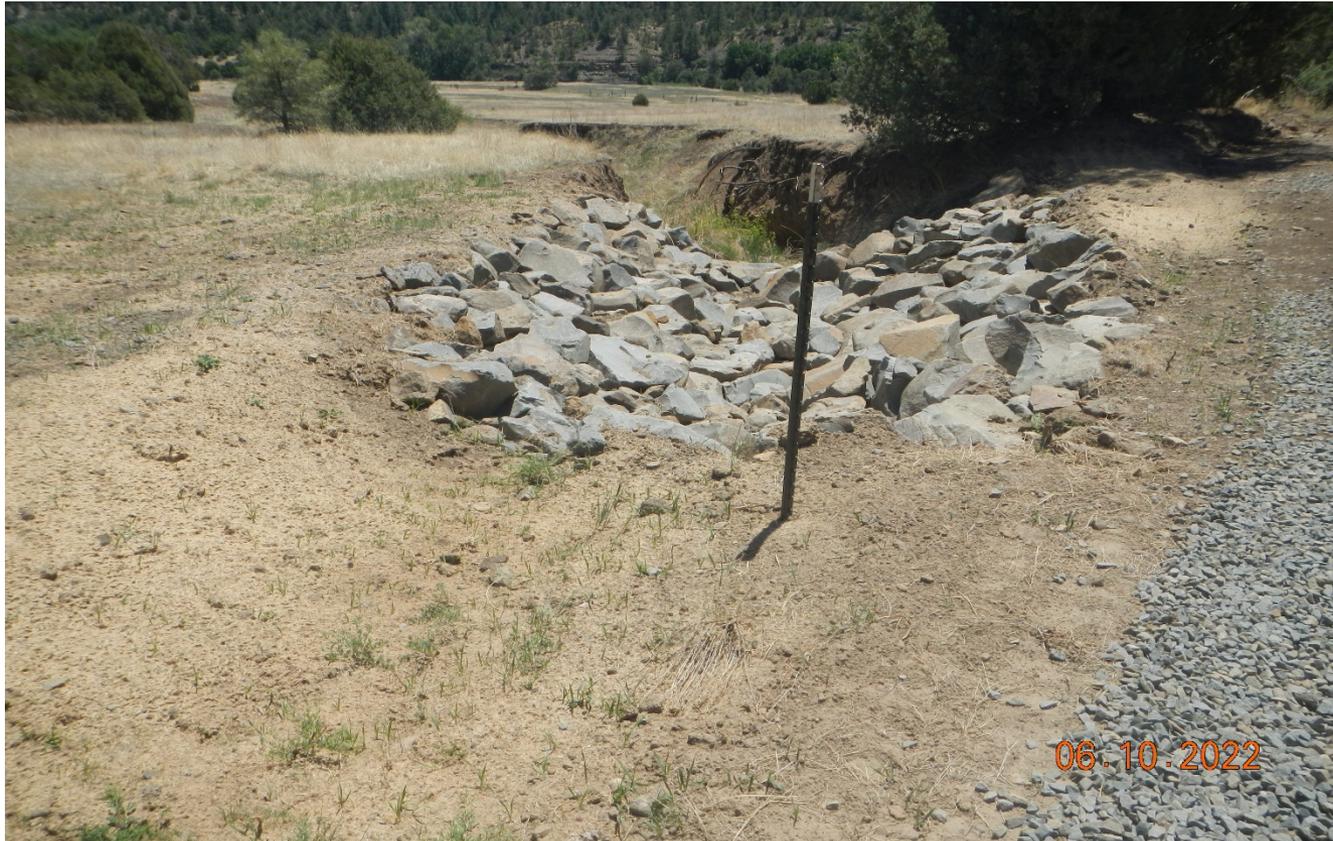
**Photo 2.** The erosion at the culvert outlet has been repaired with rock rip/rap outlet protection. Areas of disturbance were seeded and hydromulched.

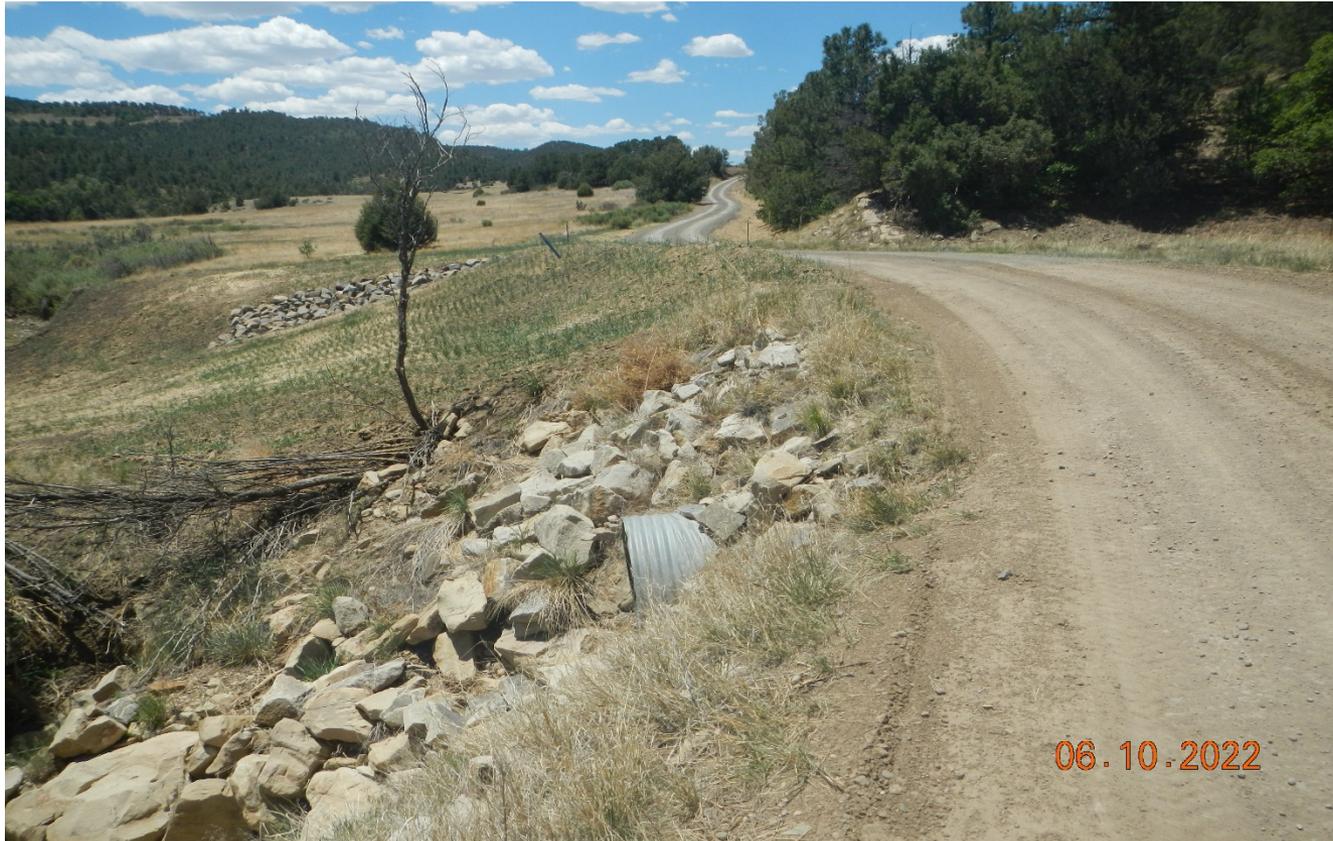
**Photo 3.** There is vegetation beginning to establish where areas of disturbance were previously seeded.

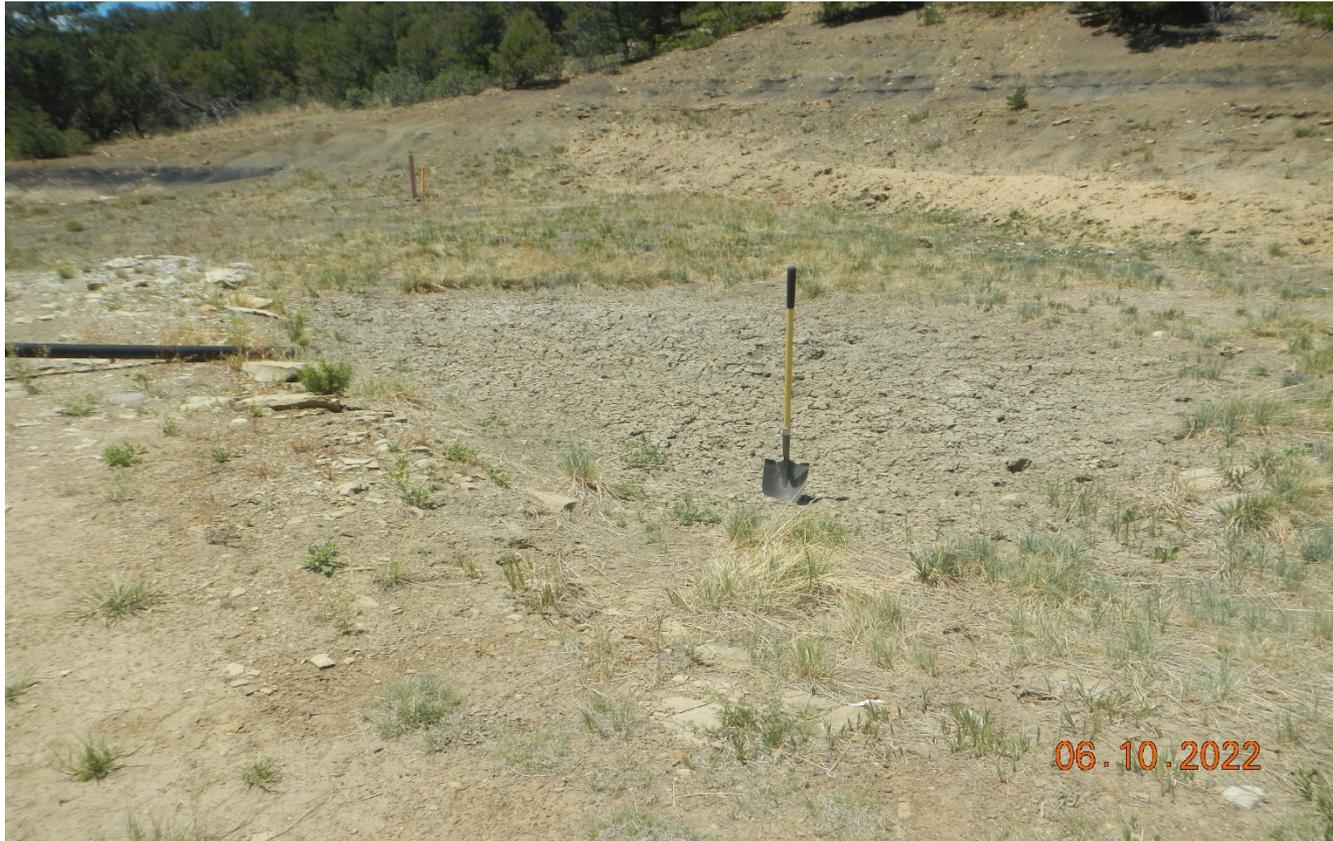
**Photo 5.** Facing toward the pit.. The pit is shallow; less than 2 ft. deep and needs to be constructed to allow 2 ft. freeboard. Previous corrective action was not completed.
