Inspection Photos and Issue Report

6/22/2022

Operator: CAERUS PICEANCE LLC #10456

Location ID: 479214

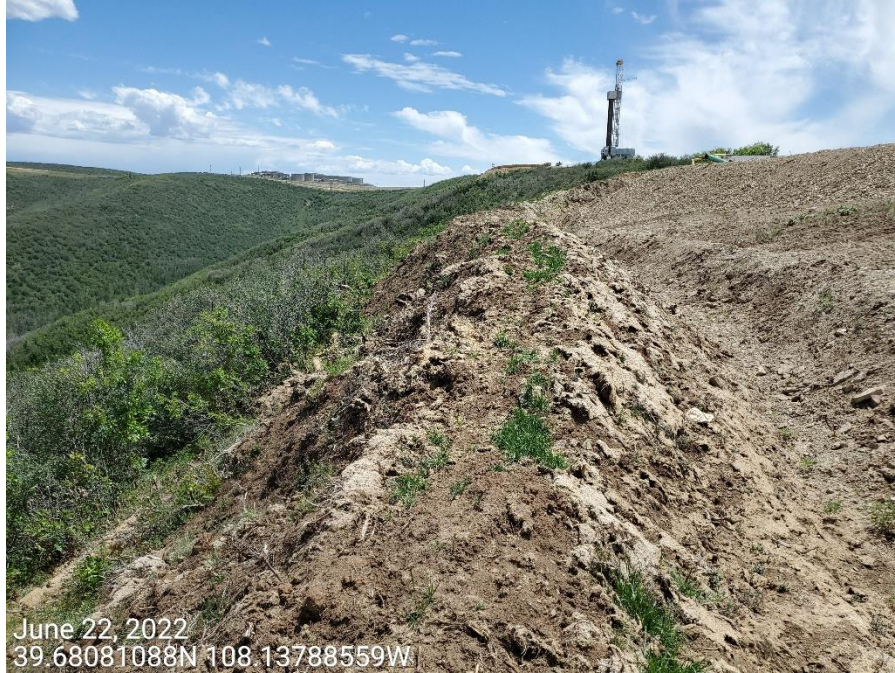
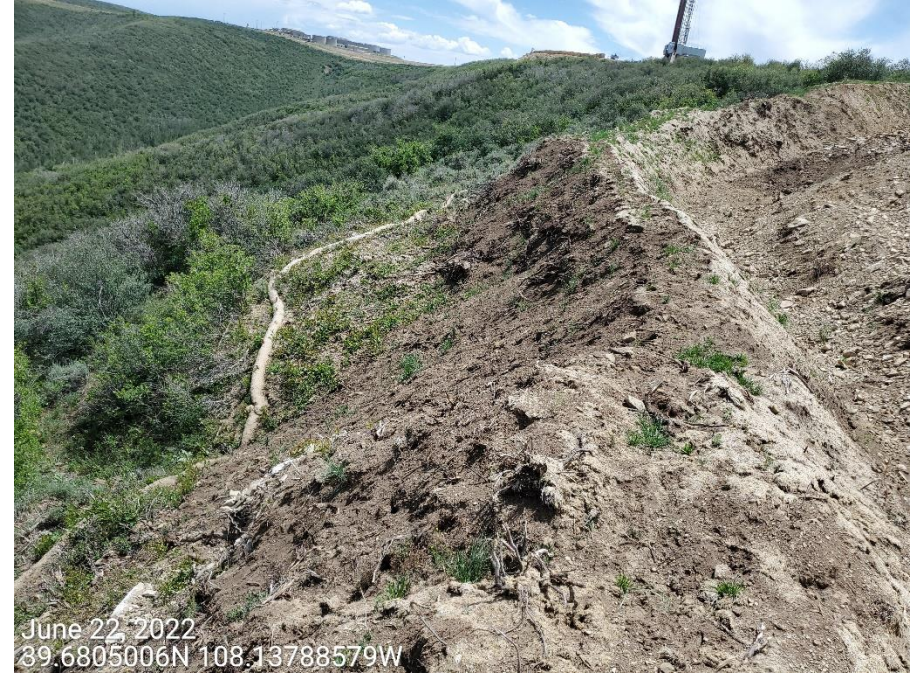
Photo 2: Photos taken from the perimeter of the Location. Photos examples showing that topsoil remains in use at the base of the fill slopes/subsoils of the Location as a berm and sediment trap/pond to manage stormwater. BMPs to minimize erosion and degradation at topsoil stockpiles have not been maintained.

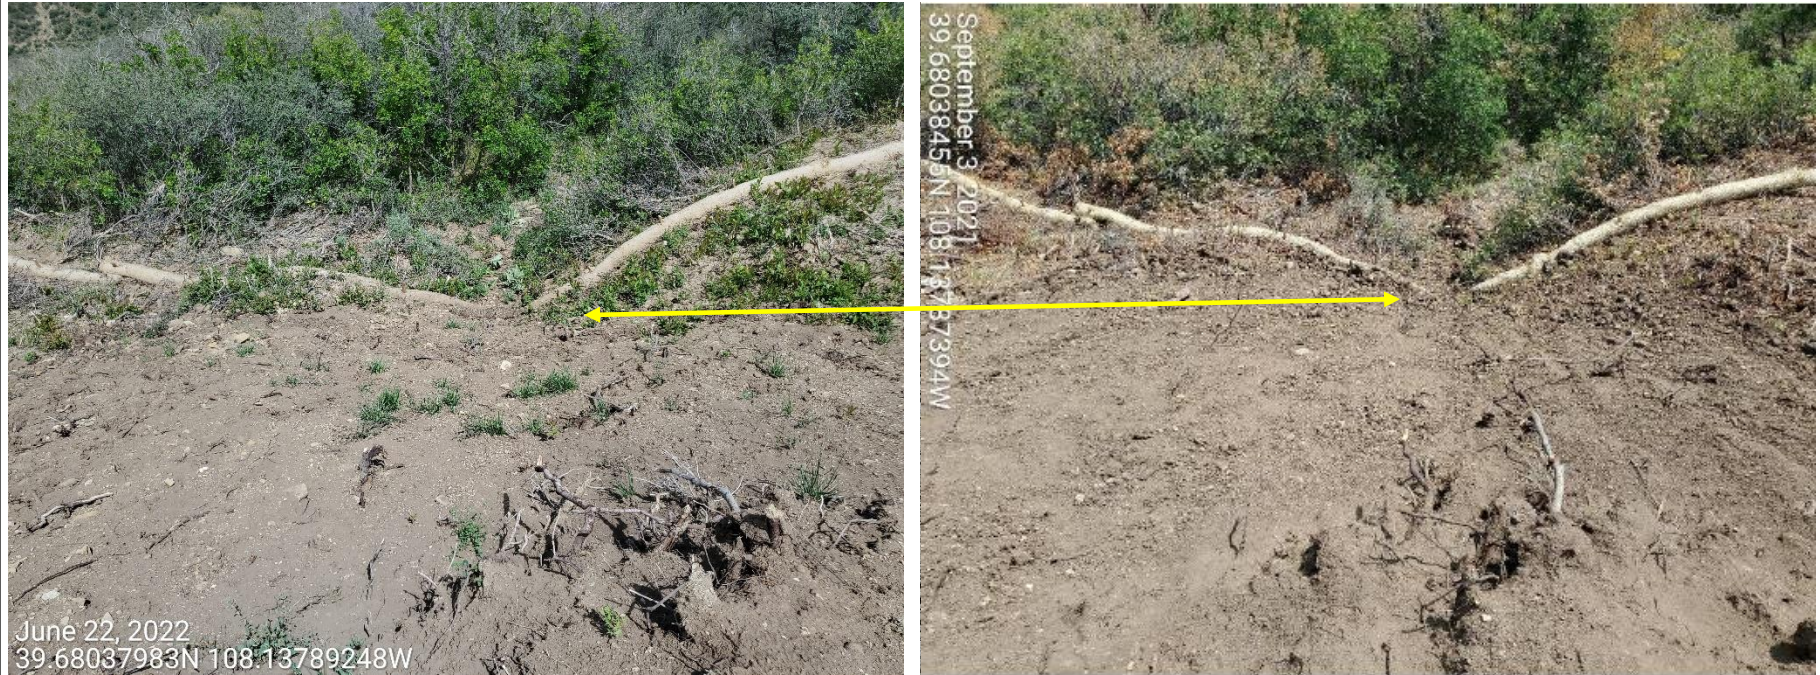
Photo 3: Photos taken from the perimeter of the Location. Photos examples showing that topsoil remains in use at the base of the fill slopes/subsoils of the Location as a berm and sediment trap/pond to manage stormwater. BMPs to minimize erosion and degradation at topsoil stockpiles have not been maintained.
