Inspection Photos

Operator: Beeman Oil & Gas Inc- #7125

Location Name: Bulldog /20-12H-892

Inspection Document #: 702800444

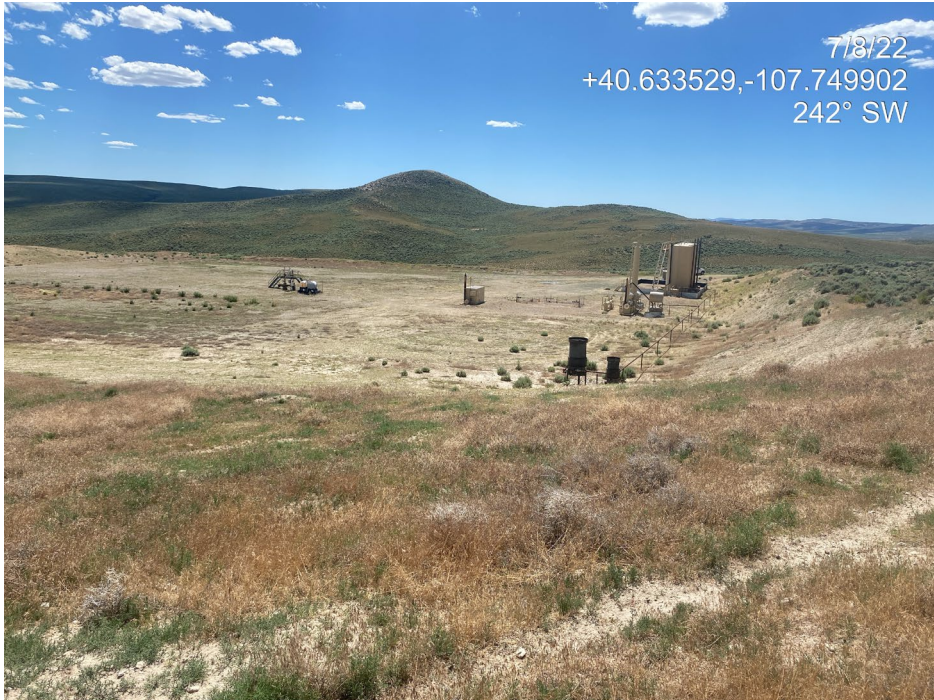
Photo 1. Photo taken from the northeast shows an overview of the northern portion of the Location. Photo also shows dense cover of cheatgrass (List C Noxious) and Russian thistle (undesirable plant species). Note, interim reclamation has not been performed.

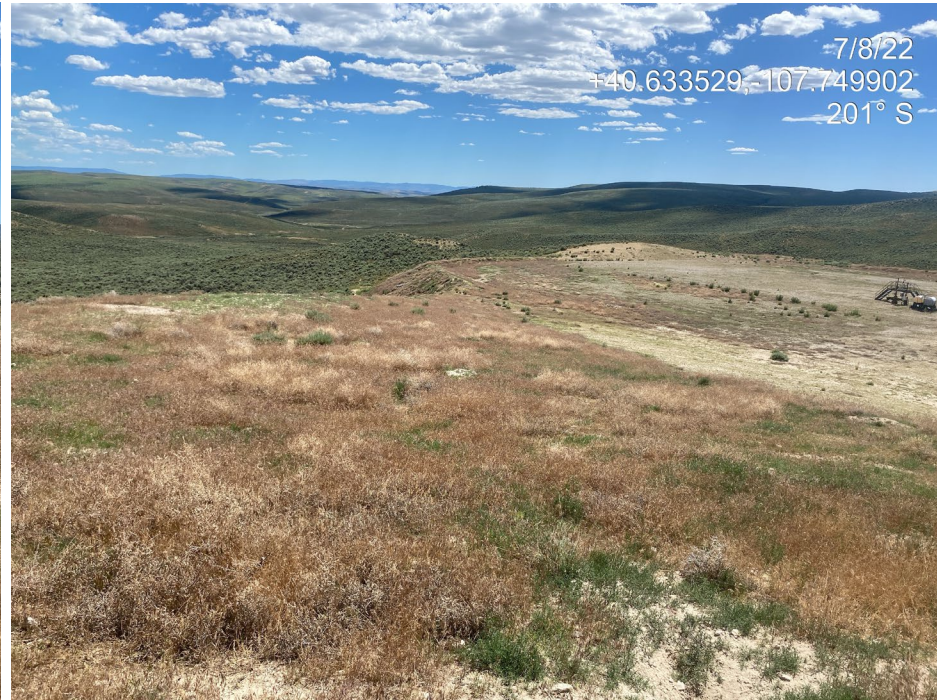
Photo 2. Photo taken from the northeast shows an overview of the southern portion of the Location. Refer to additional Photo 1 comments.

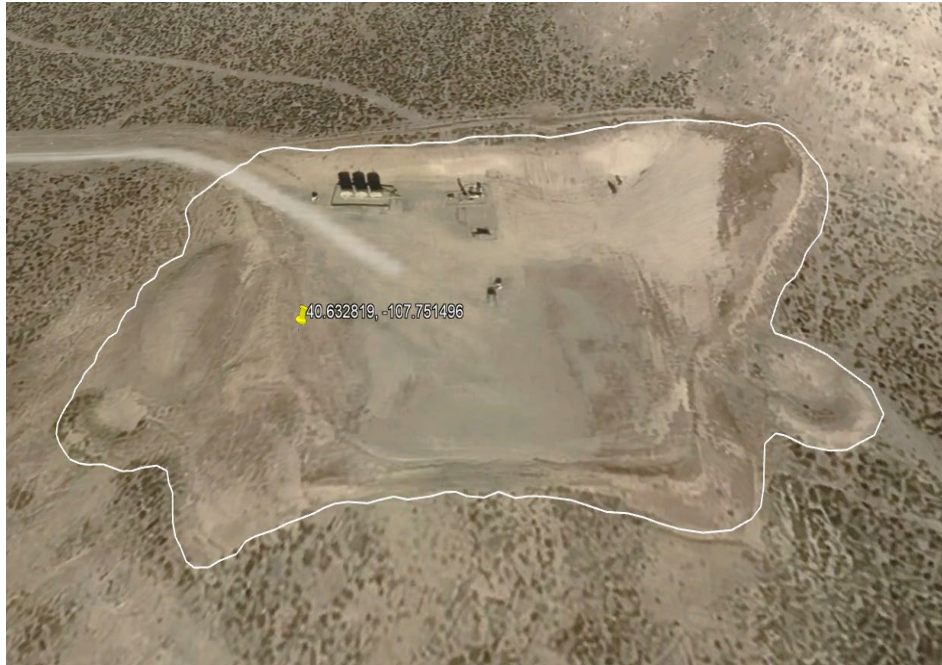
Photo 3. Photo shows aerial imagery of the Location from Google Earth. Imagery is dated 10/2019. The white line indicates a ground track walked during the 7/8/2022 inspection showing the approximate disturbance/unreclaimed area.

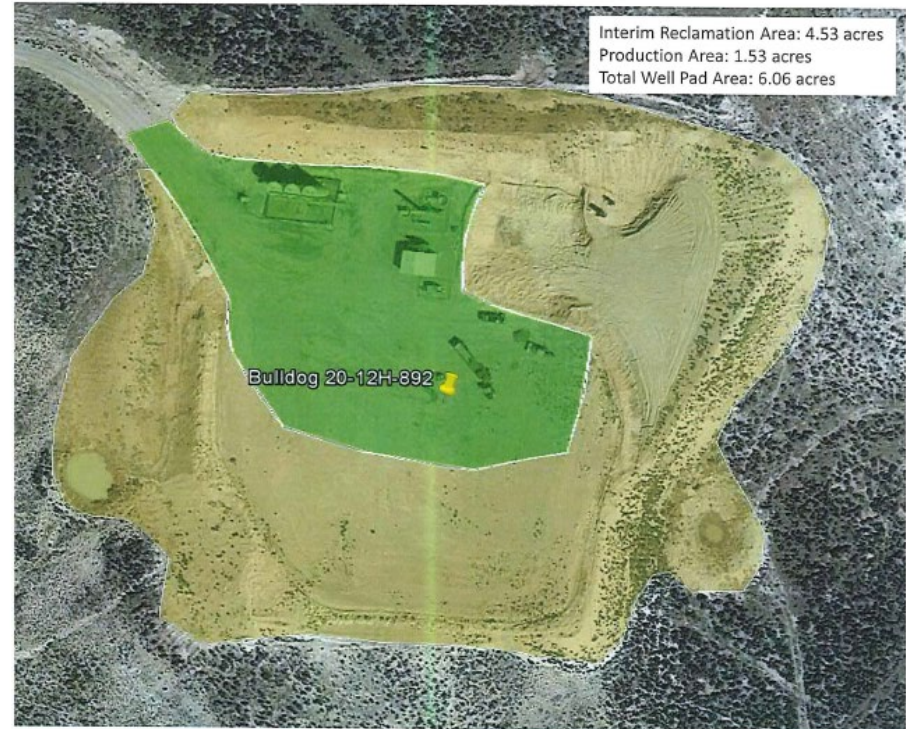
Photo 4. Photo shows the “Location Drawing” from document #401412004 which shows an estimate of production areas and interim reclamation areas included in variance request document #401291893. Variance expired 5/1/2022. Interim reclamation is required.

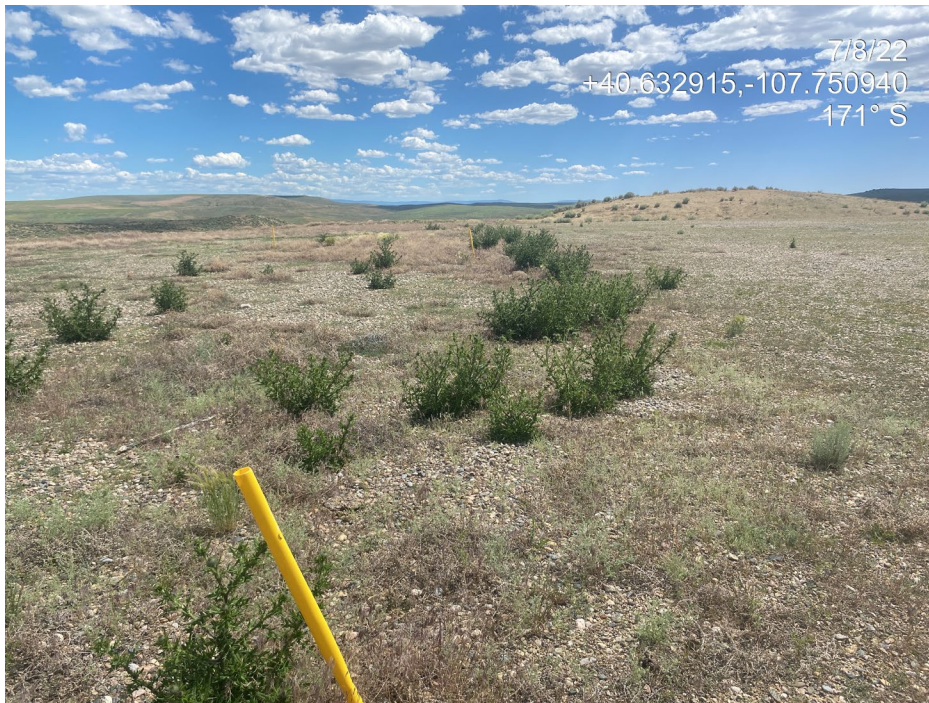
Photo 5. Photo taken from the center of the Location shows an example of bull thistle, a CO List B Noxious Weed on Location.

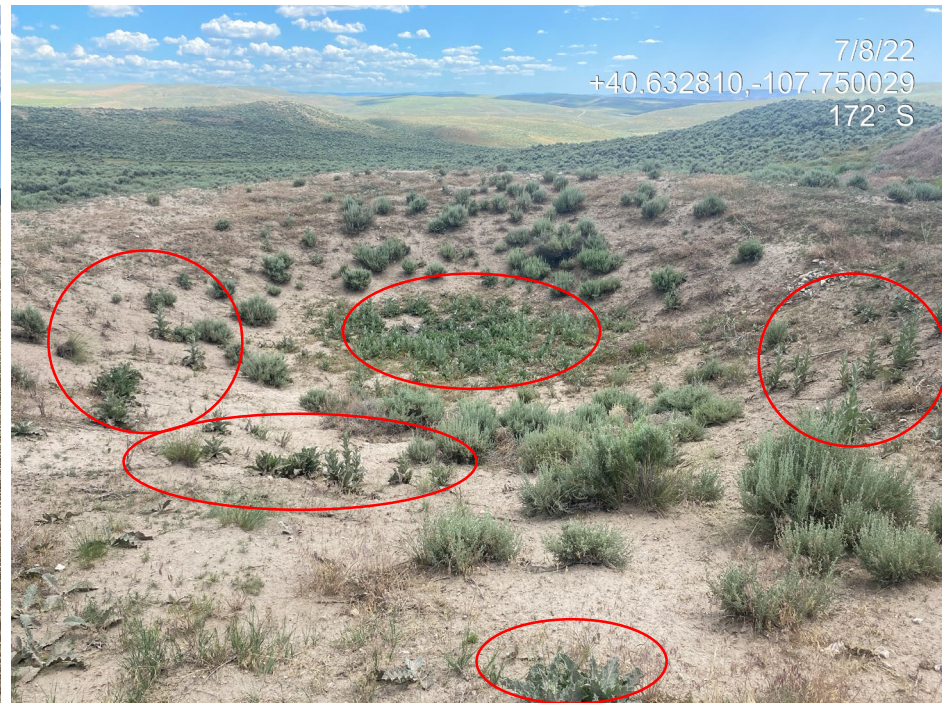
Photo 6. Photo taken at the sediment pond to the east of the Location shows an example of Scotch thistle, a CO List B Noxious Weed on Location.

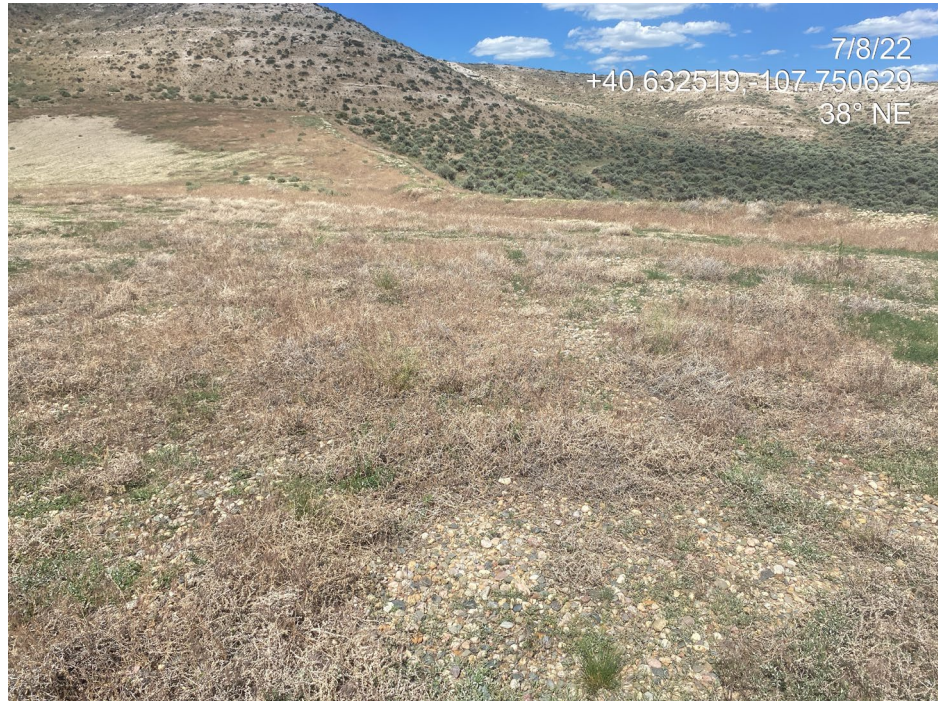
Photo 7. Photo taken at the south of the Location shows the pad surface covered with Russian thistle, an undesirable plant species.

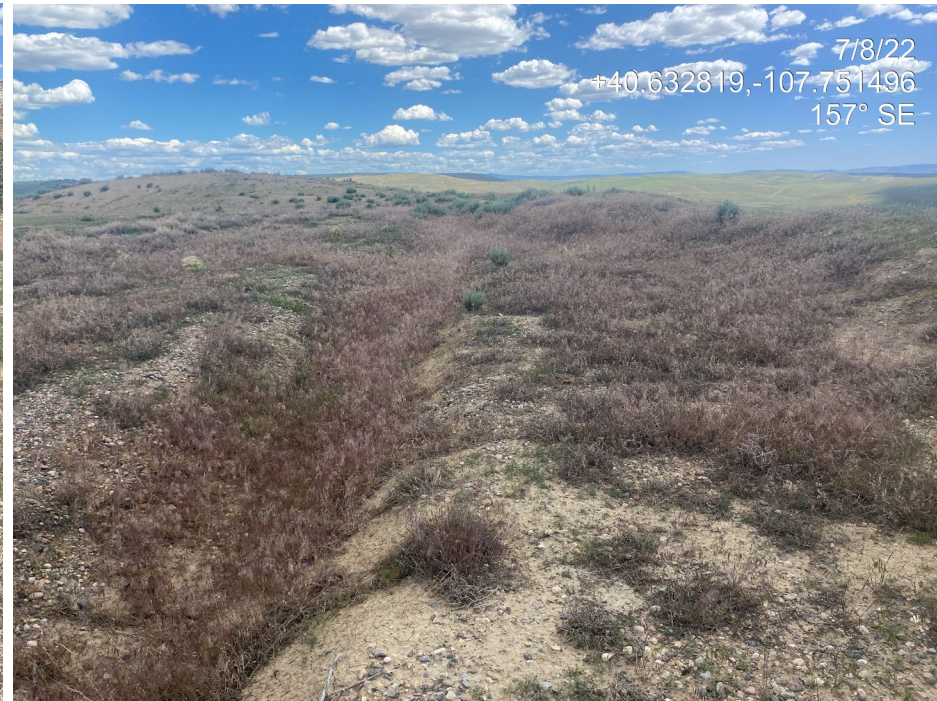
Photo 8. Photo taken from the west of the Location shows the pad surface covered with cheatgrass, a CO List C Noxious Weed.

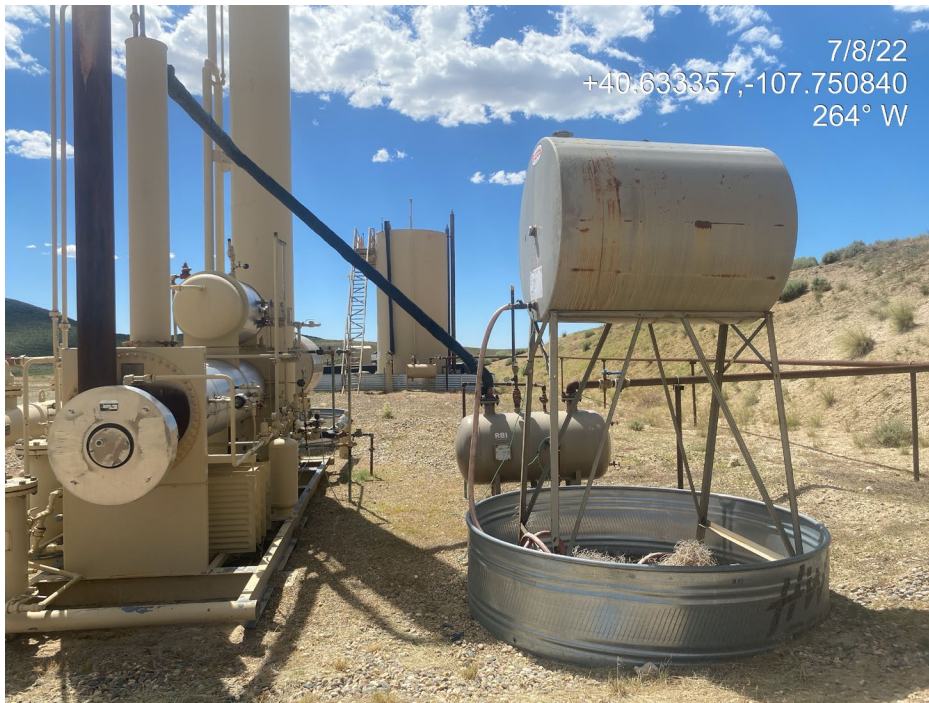
Photo 9. Photo taken from the north of the Location shows an example of missing or insufficient wildlife protection BMPs on a secondary containment stock tank.

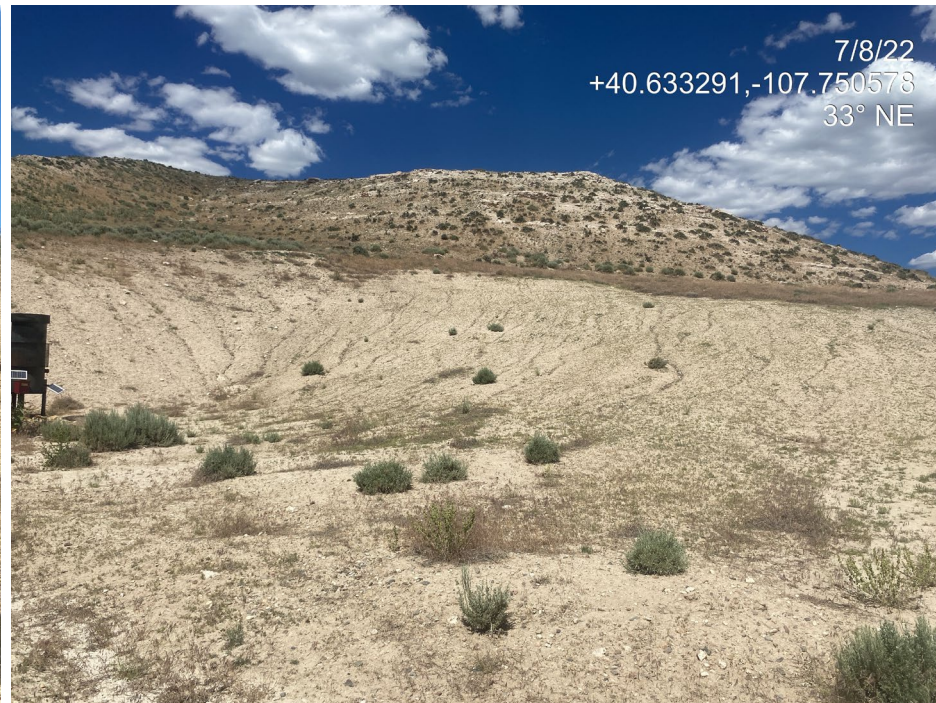
Photo 10. Photo taken at the northeast of the Location shows rill erosion occurring on the unstabilized and unprotected cut slope.
