Inspection Photos and Issue Report

7/14/2022

Operator: CHEVRON USA INC #16700

Location #324351

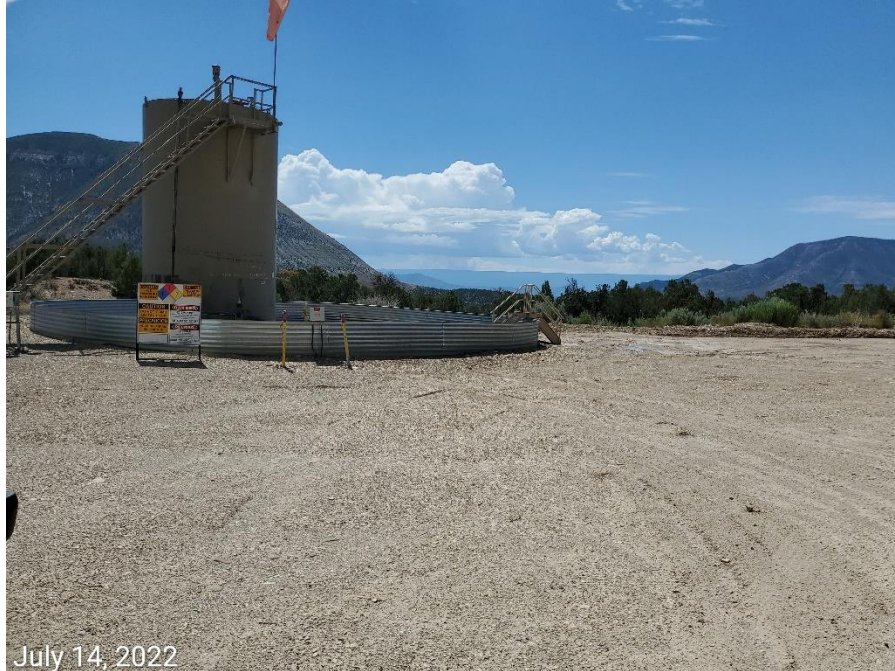
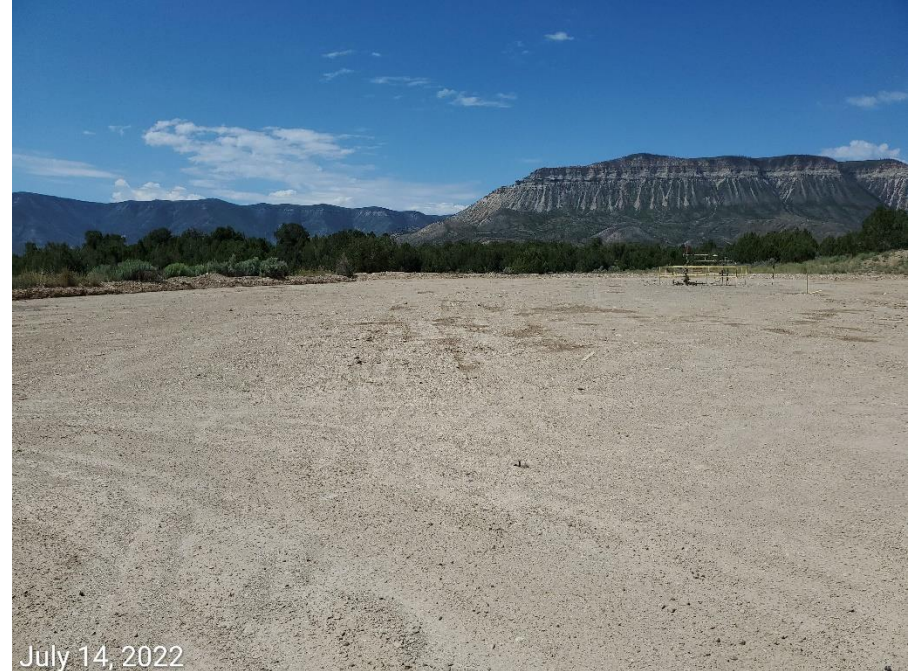
Photo 1: Photos 1-2 taken from the north end of the production pad. Photos provide an overview of the Location facing southeast, southwest, west to north.

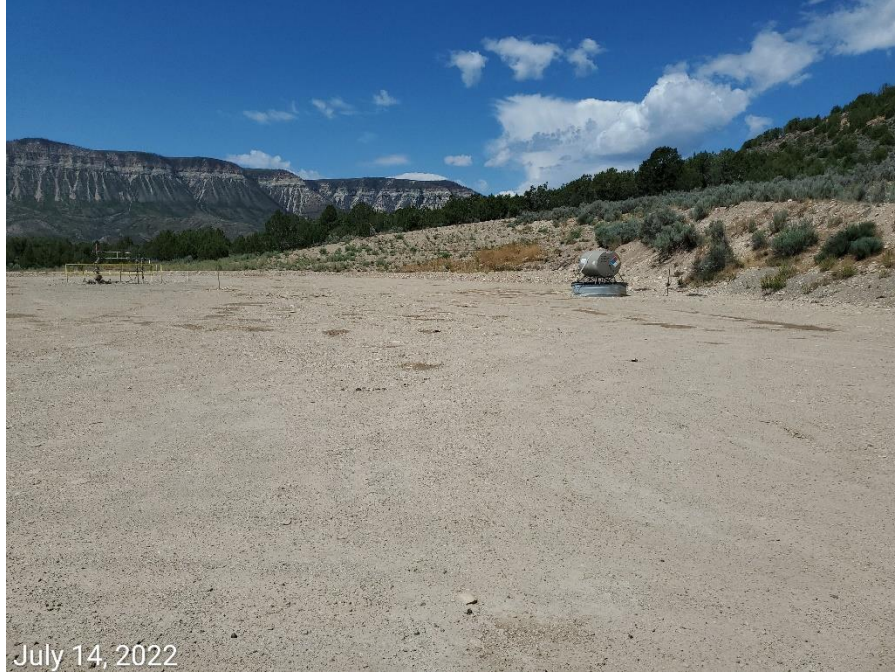
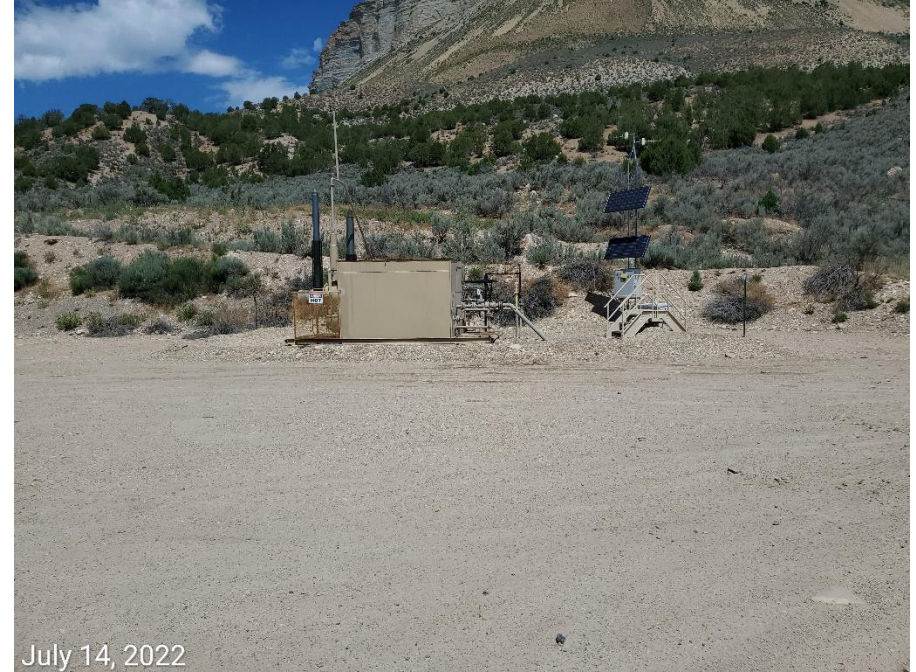
Photo 2: See comments under photo 1.

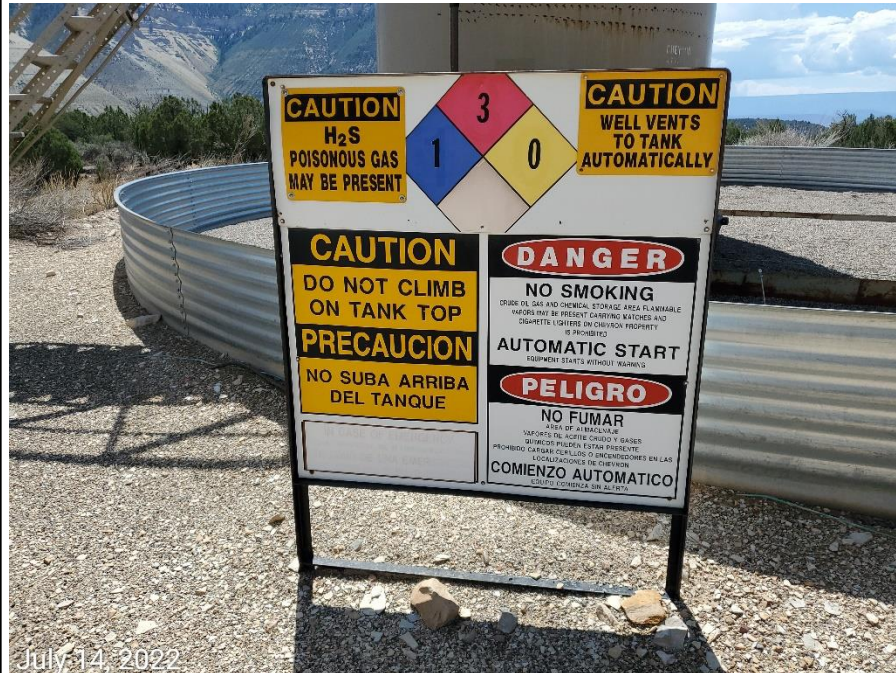
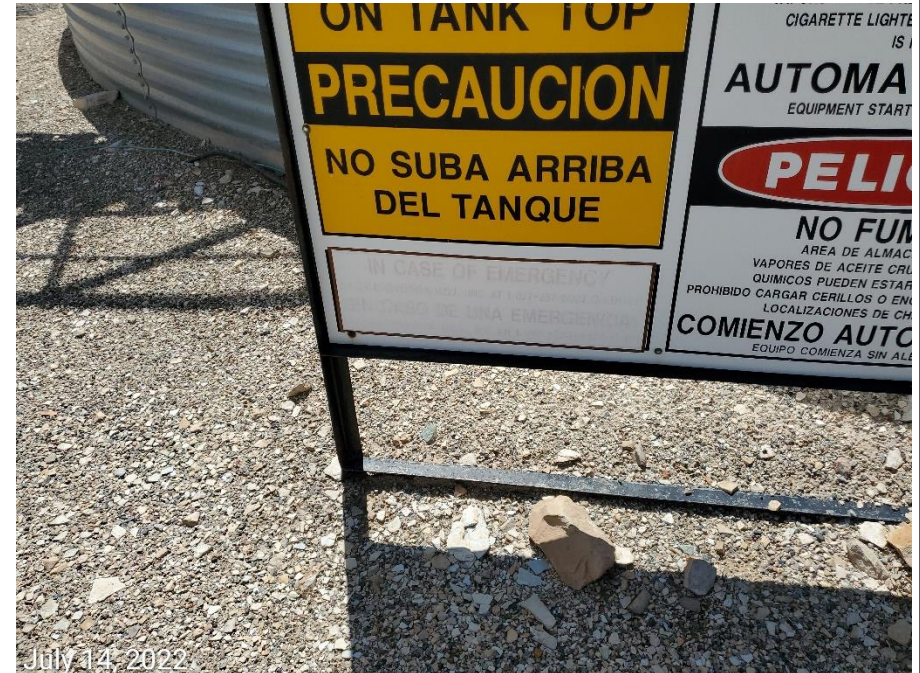
Photo 3: Photos show emergency contact information on sign is no longer legible.

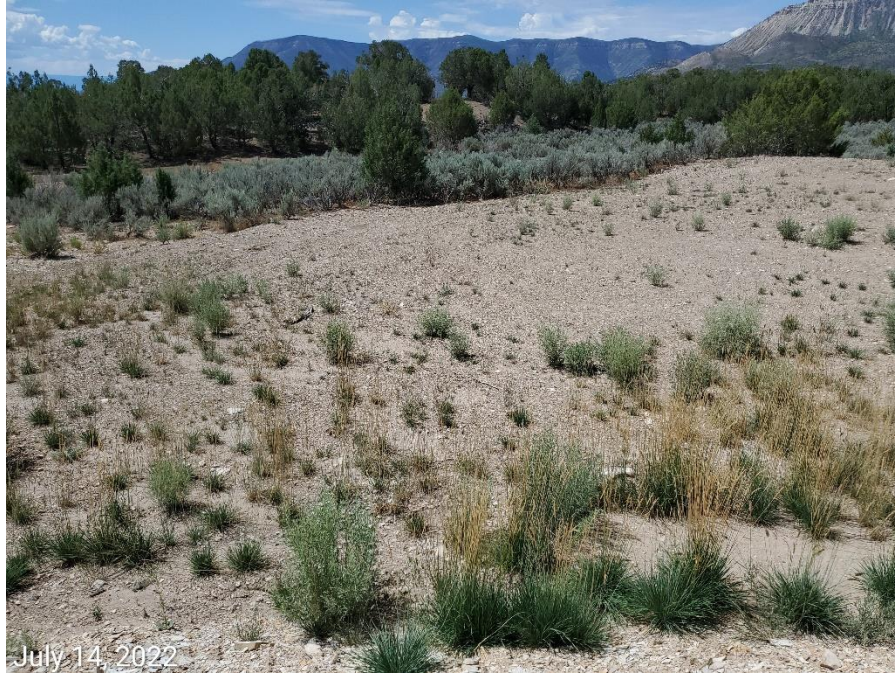
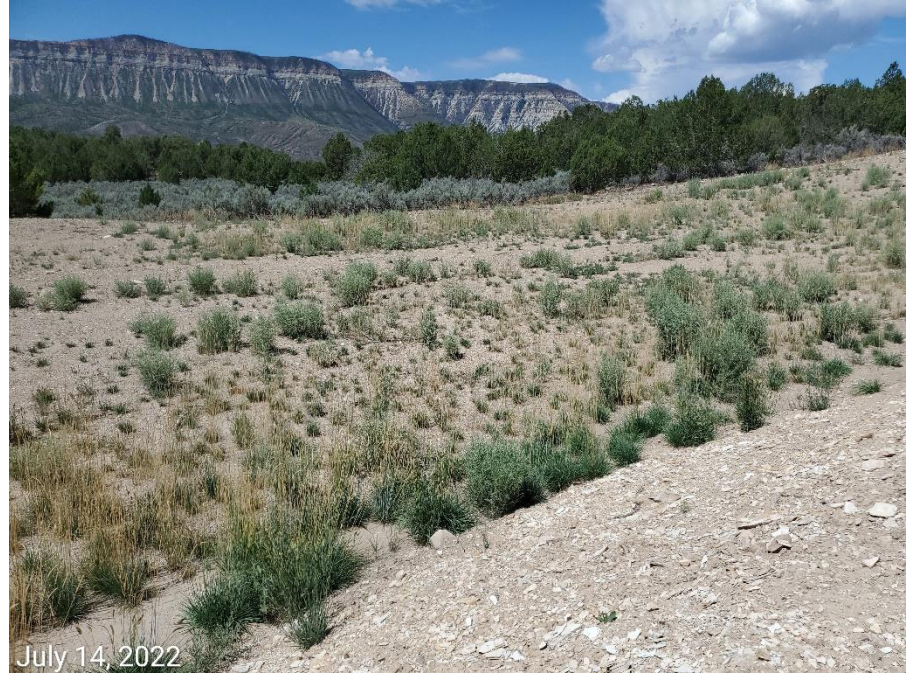
Photo 4: Photos taken from the interim areas on the west end of the Location. Photo shows areas not needed for production have been reclaimed. Overall reclamation is “in process”, however there are areas that do not appear to be progressing towards Rule 1003 uniform revegetation standards.

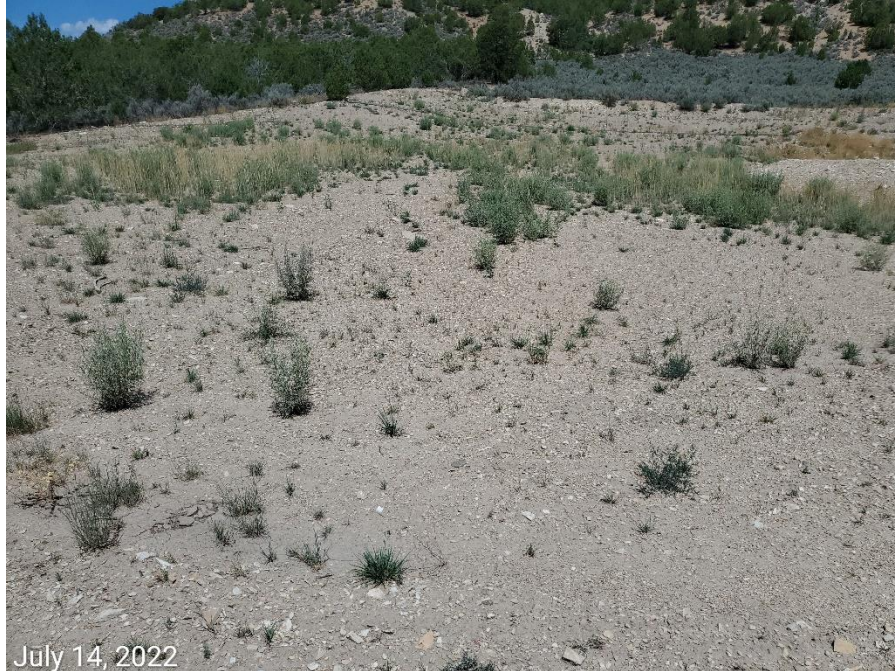
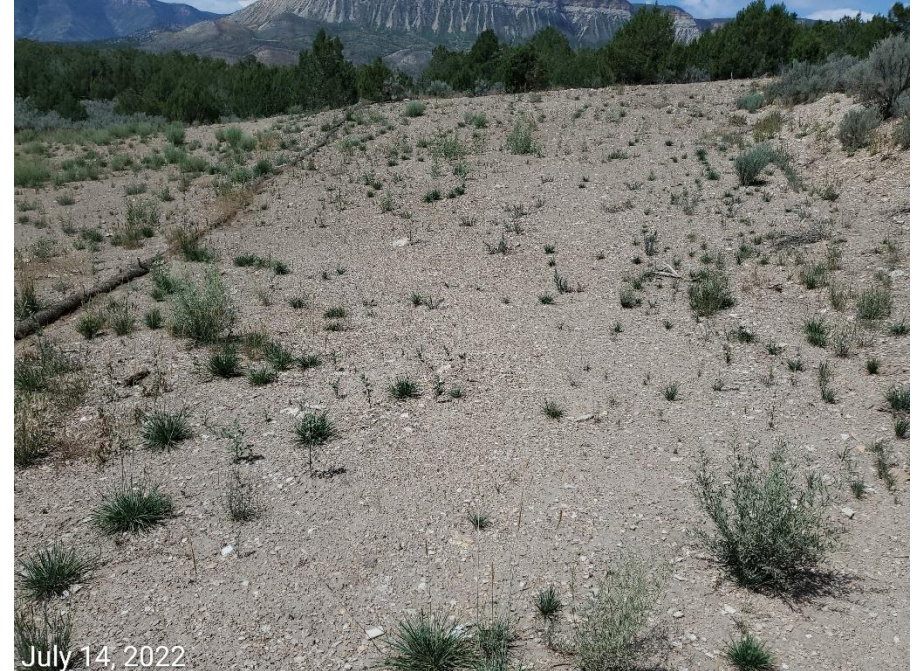
Photo 5: Photos taken from the interim areas on the west end of the Location. Photo shows areas not needed for production have been reclaimed. Overall reclamation is “in process”, however there are areas that do not appear to be progressing towards Rule 1003 uniform revegetation standards.

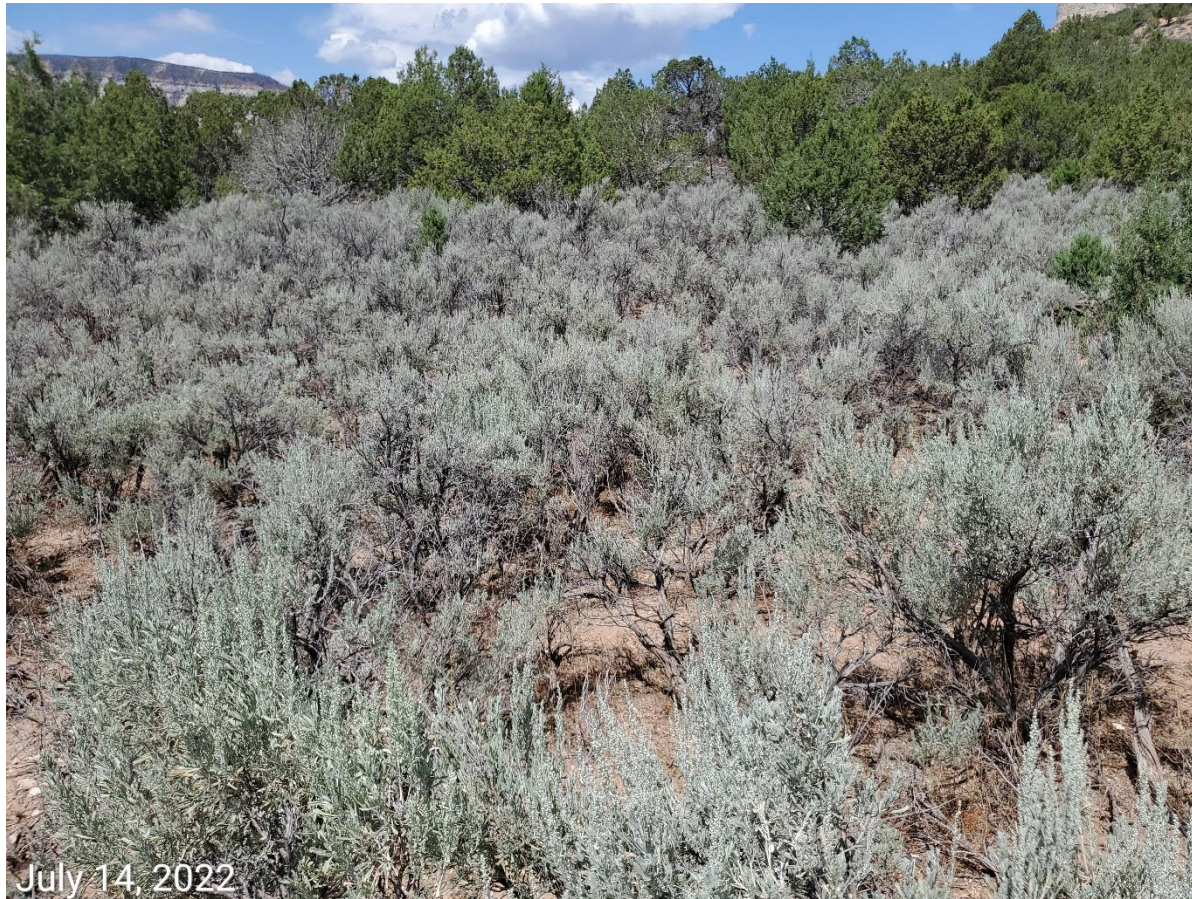
Photo 6: Photo shows adjacent reference areas.

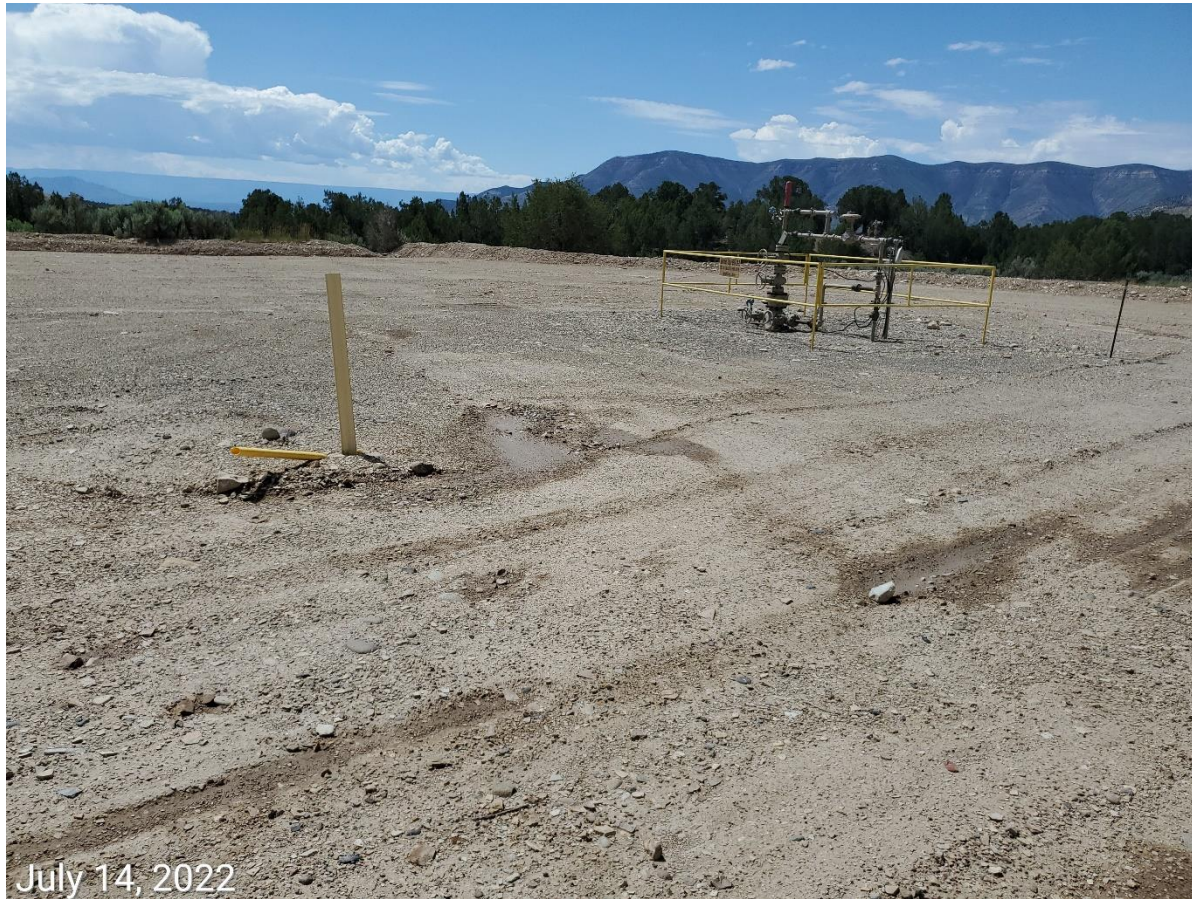
Photo 7: Photo shows single marked anchor observed on the Location. Unclear if this is the only anchor remaining on the Location, or if remaining anchors have been buried and can't be located. Ensure anchors on Location are marked per 1003 requirements, if remaining anchor is no longer necessary, it should be removed in accordance with Rule 606.
