Inspection Photos

API: 125-09027

Operator: PRIME OPERATING COMPANY

Inspection Date: 7/20/2022

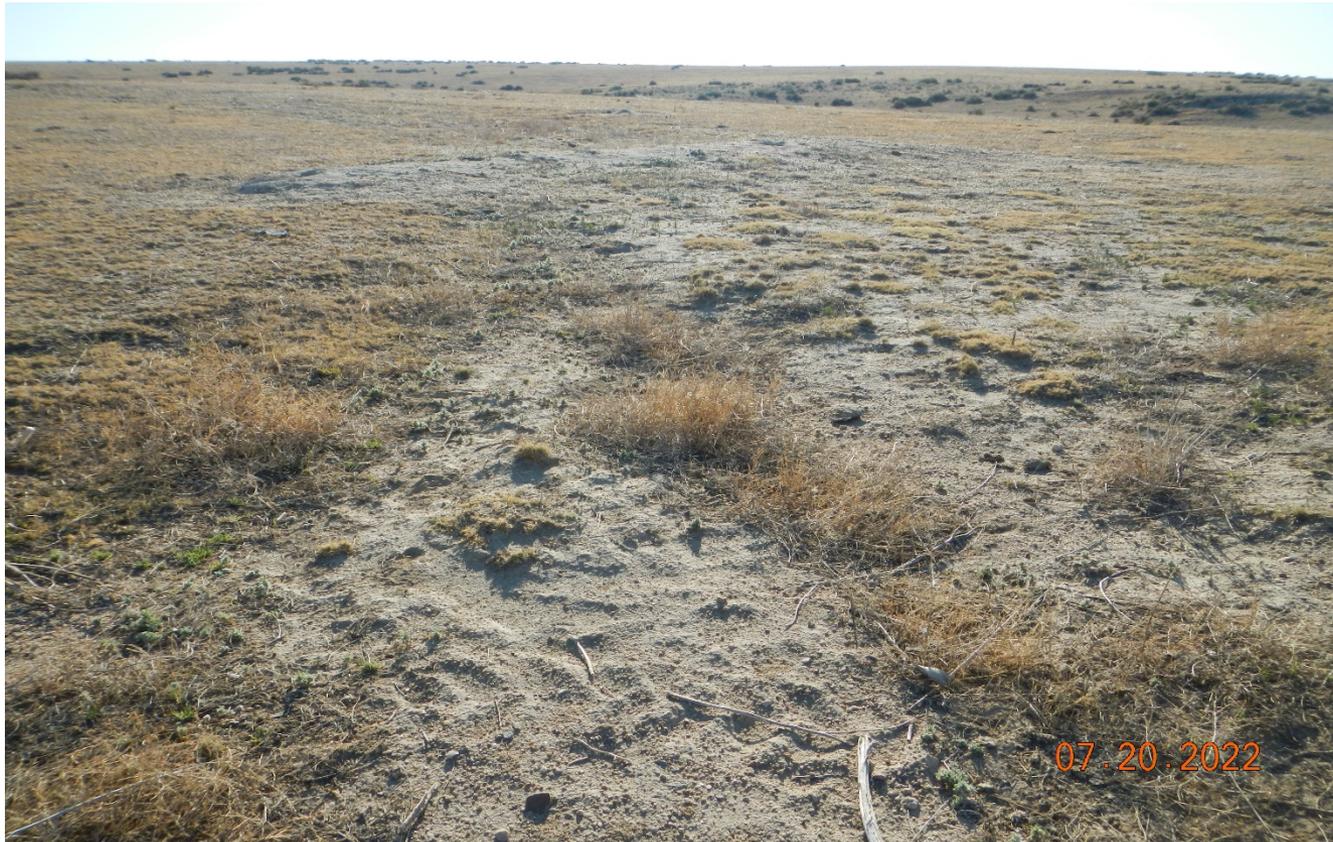
Photo 1. Facing northeast at the beginning of the access road. The vegetation along the former road has not established.

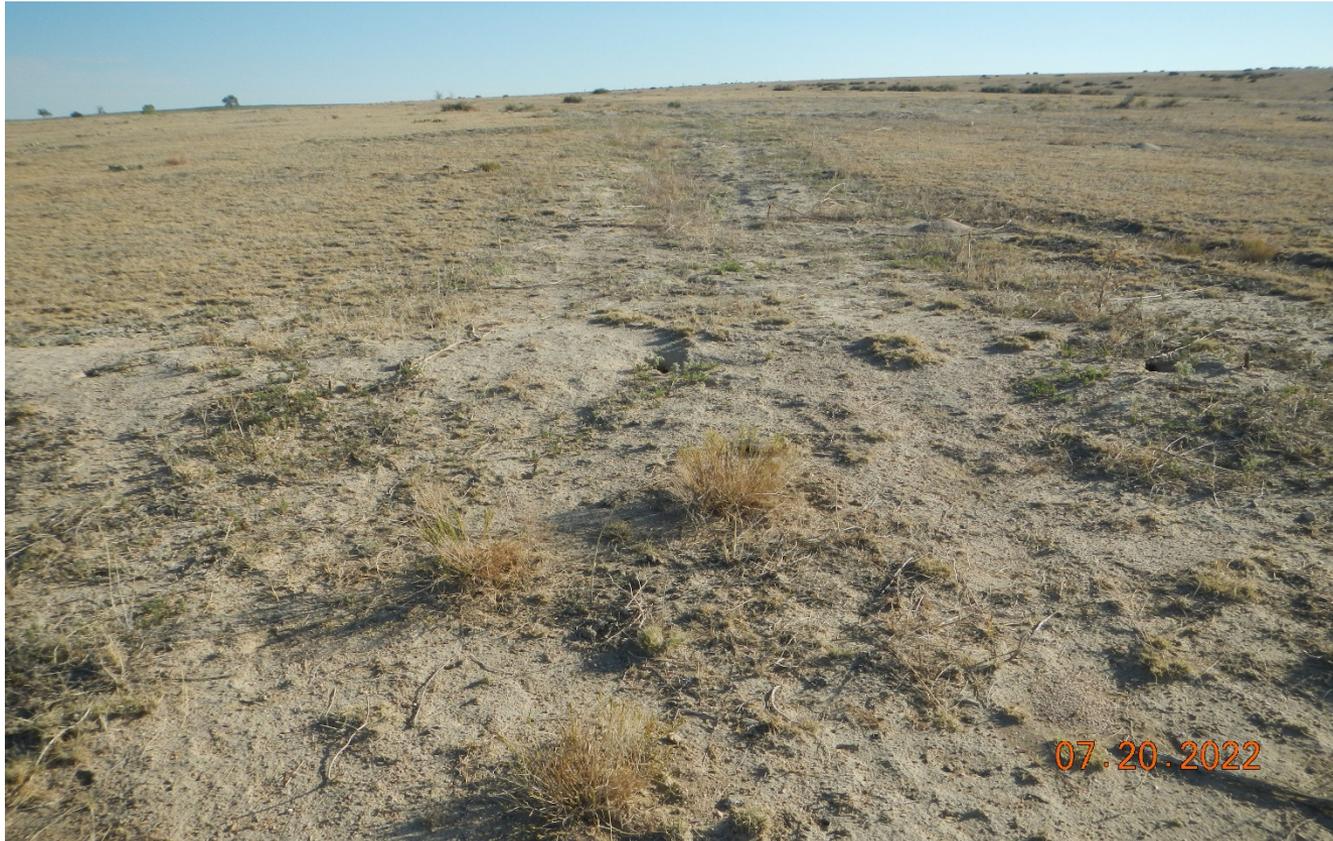
Photo 2. Facing northeast at the beginning of the access road. The vegetation along the former road has not established. There are areas of erosion that need to be repaired and stabilized.

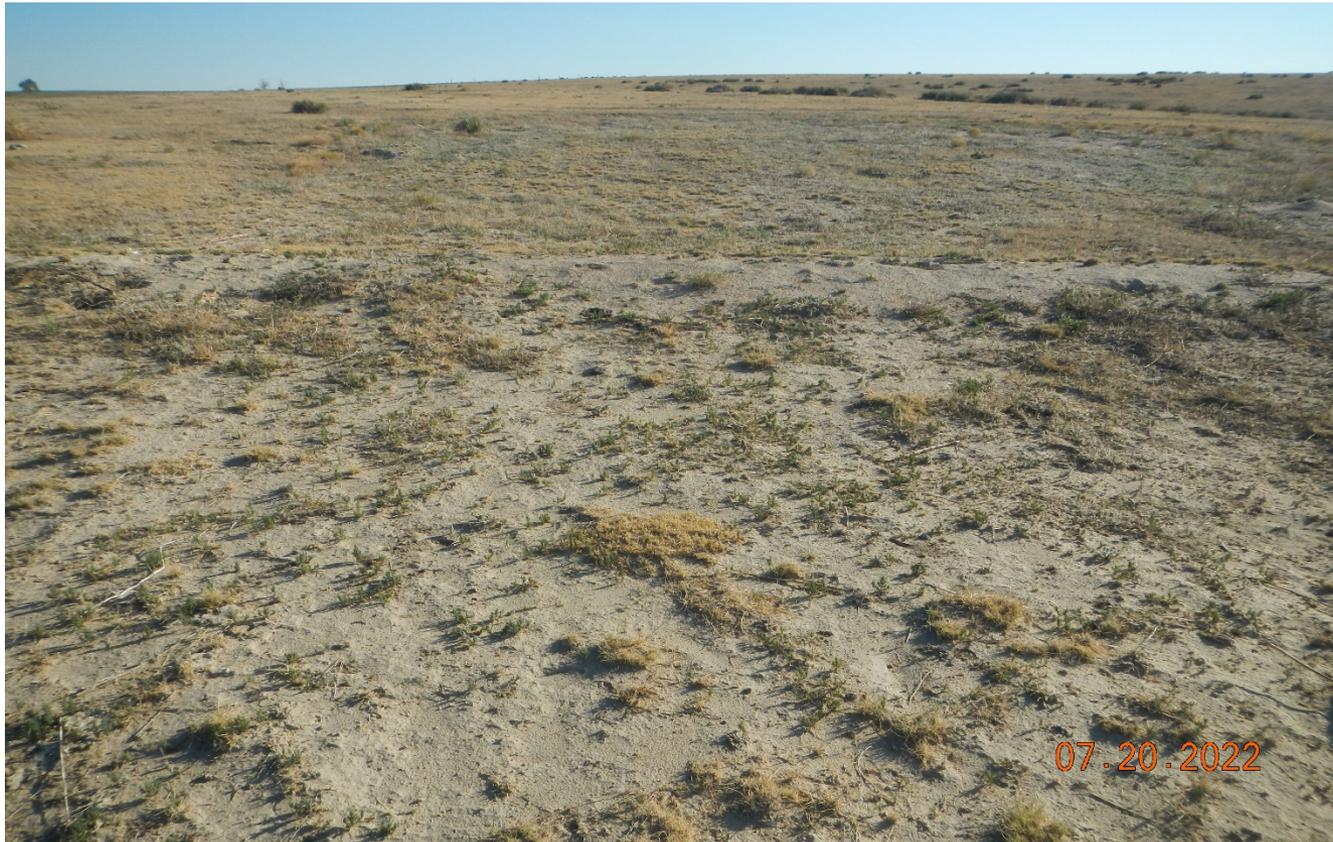
Photo 3. Facing northeast toward the location. The location has not established desirable vegetation cover of at least 80% of reference area levels.

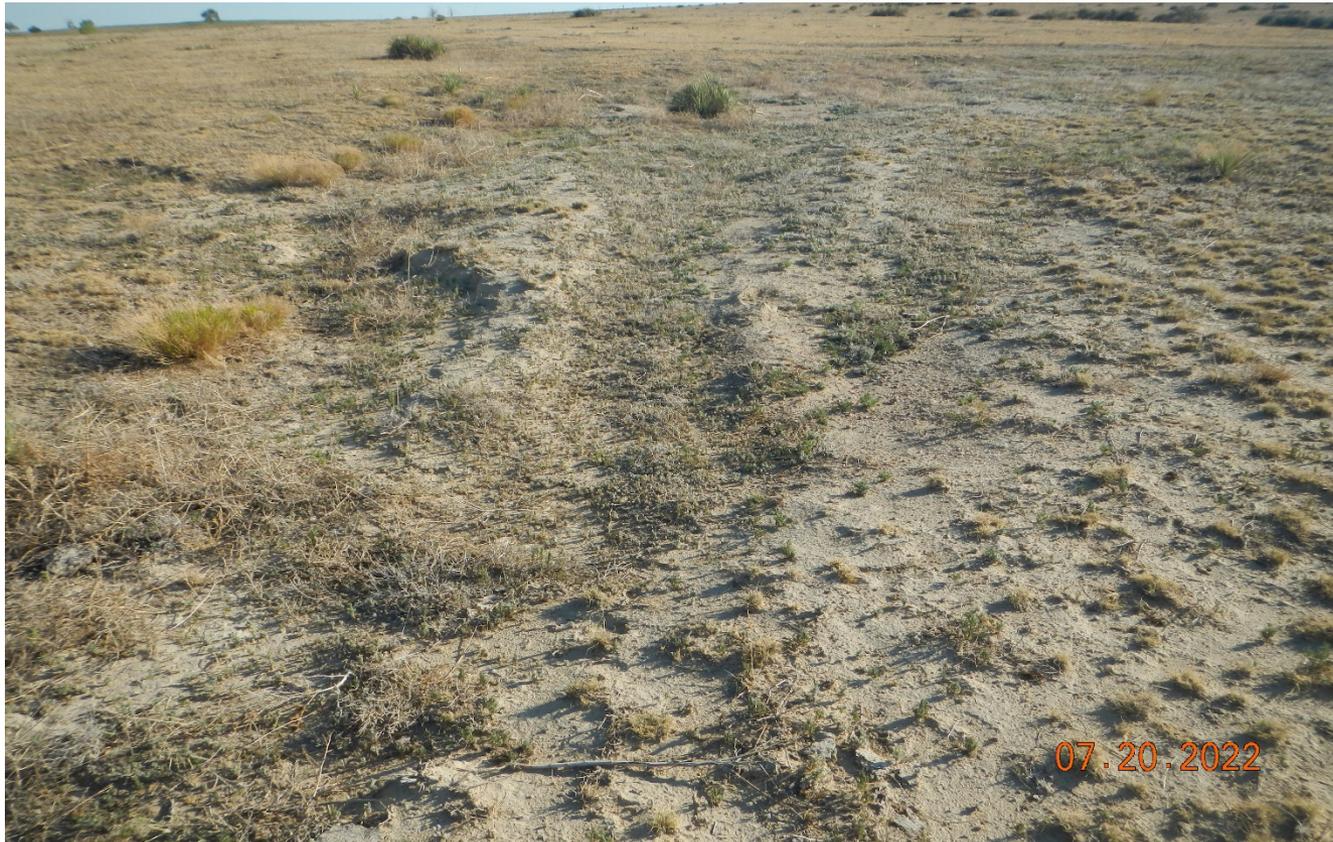
Photo 4. There are areas of sparse vegetation and undesirable weeds.

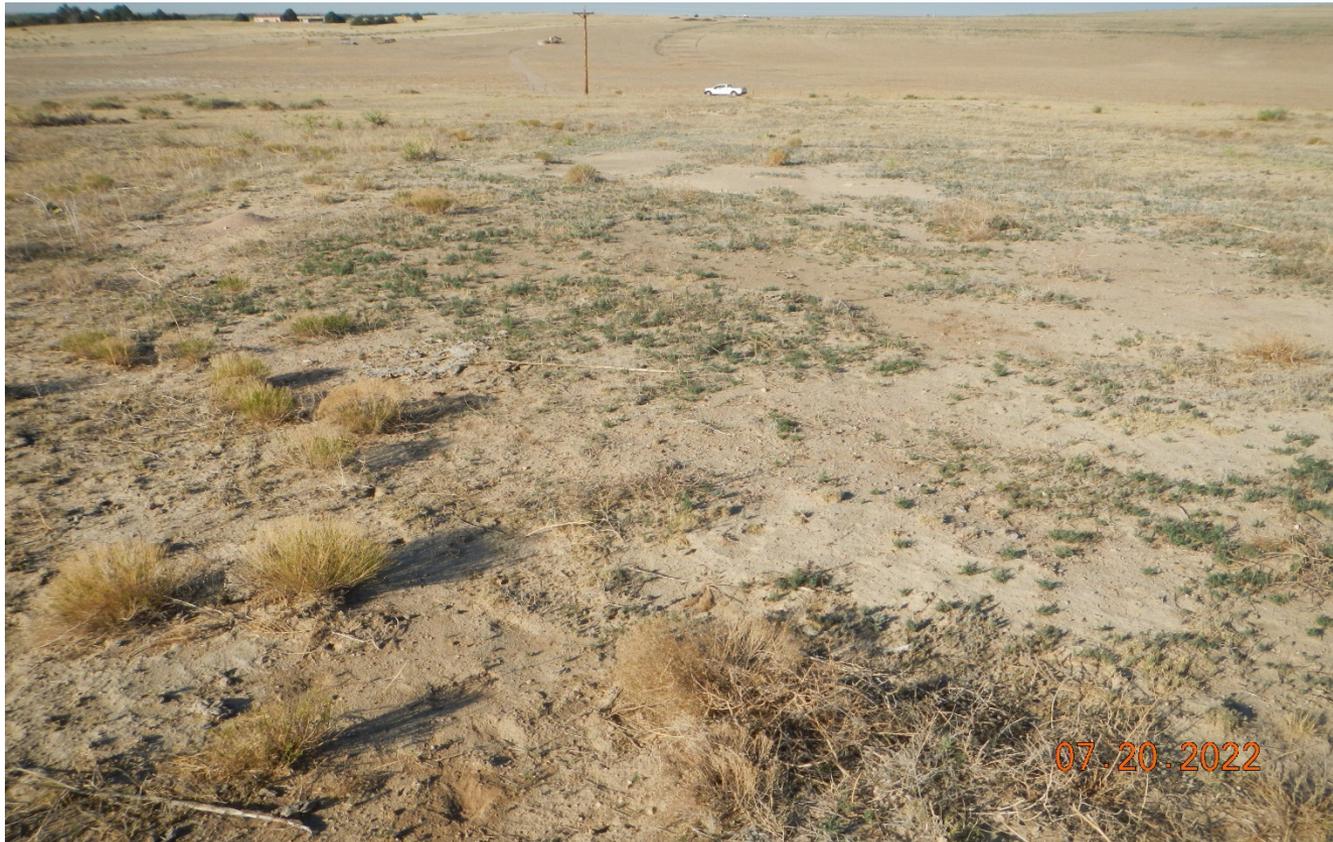
Photo 5. Facing southwest at the location. There are areas of sparse vegetation and undesirable weeds.

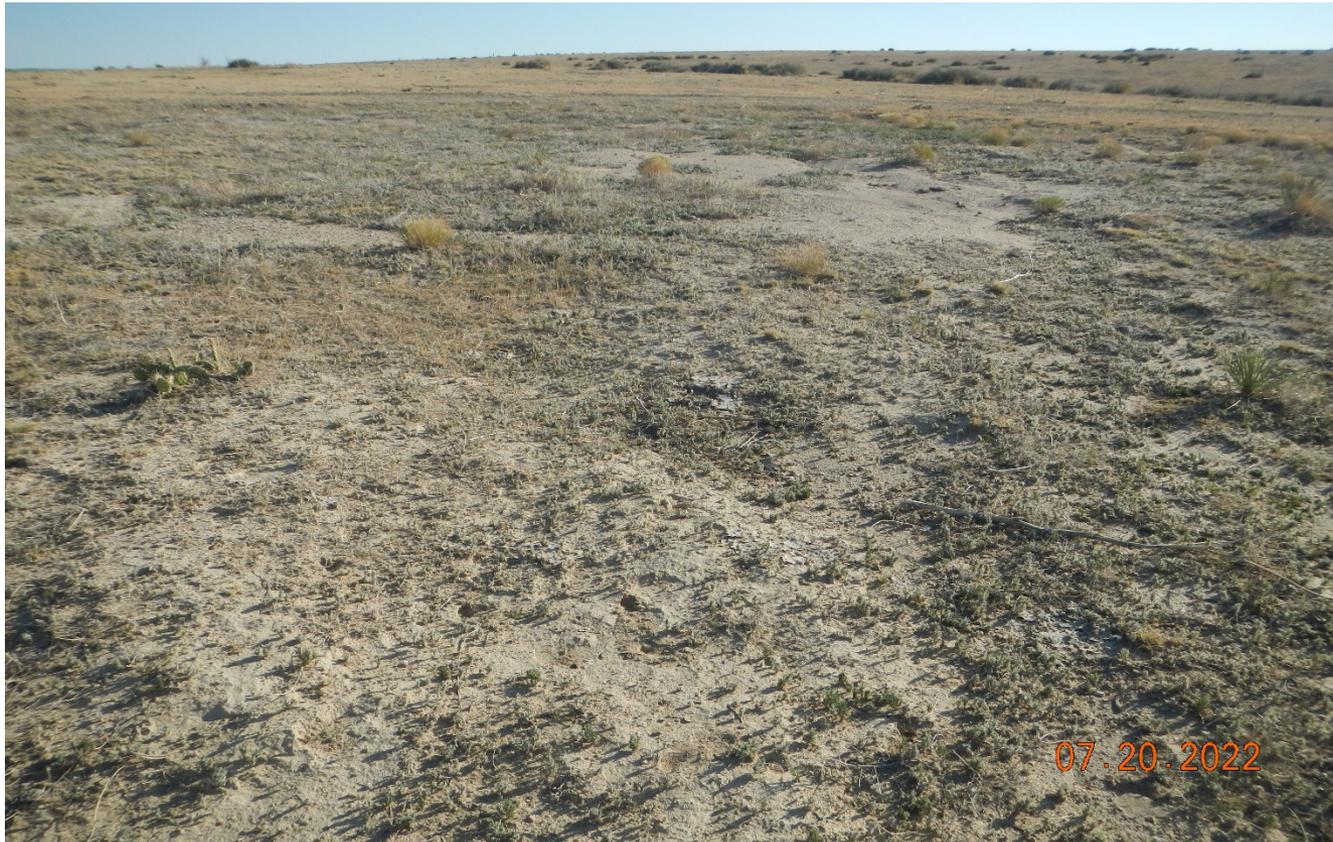
Photo 6. Center of the location facing northeast. There are areas of sparse vegetation and undesirable weeds.

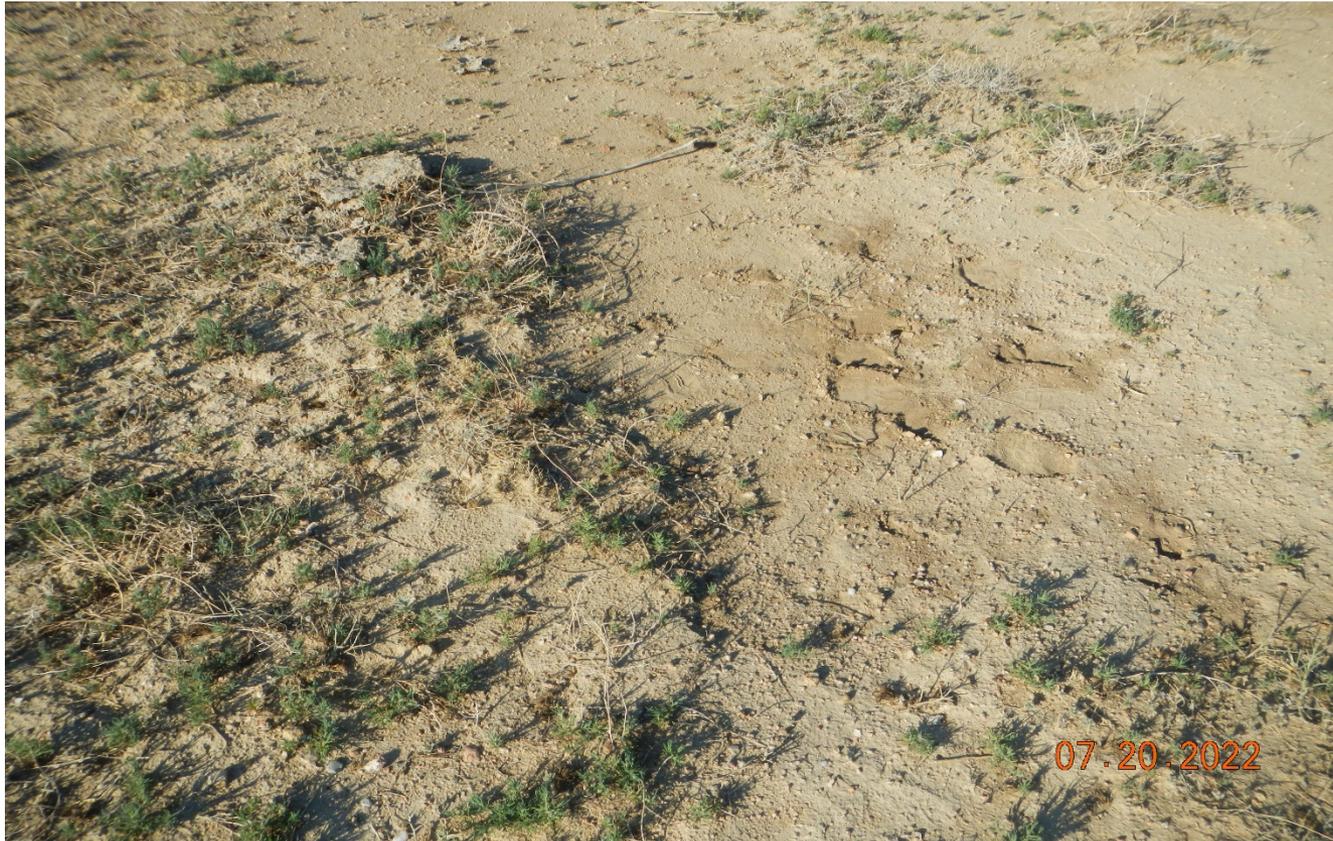
Photo 7. View of groundcover at the center of the location shows bare soils as well as undesirable weeds (Kochia, Russian thistle).

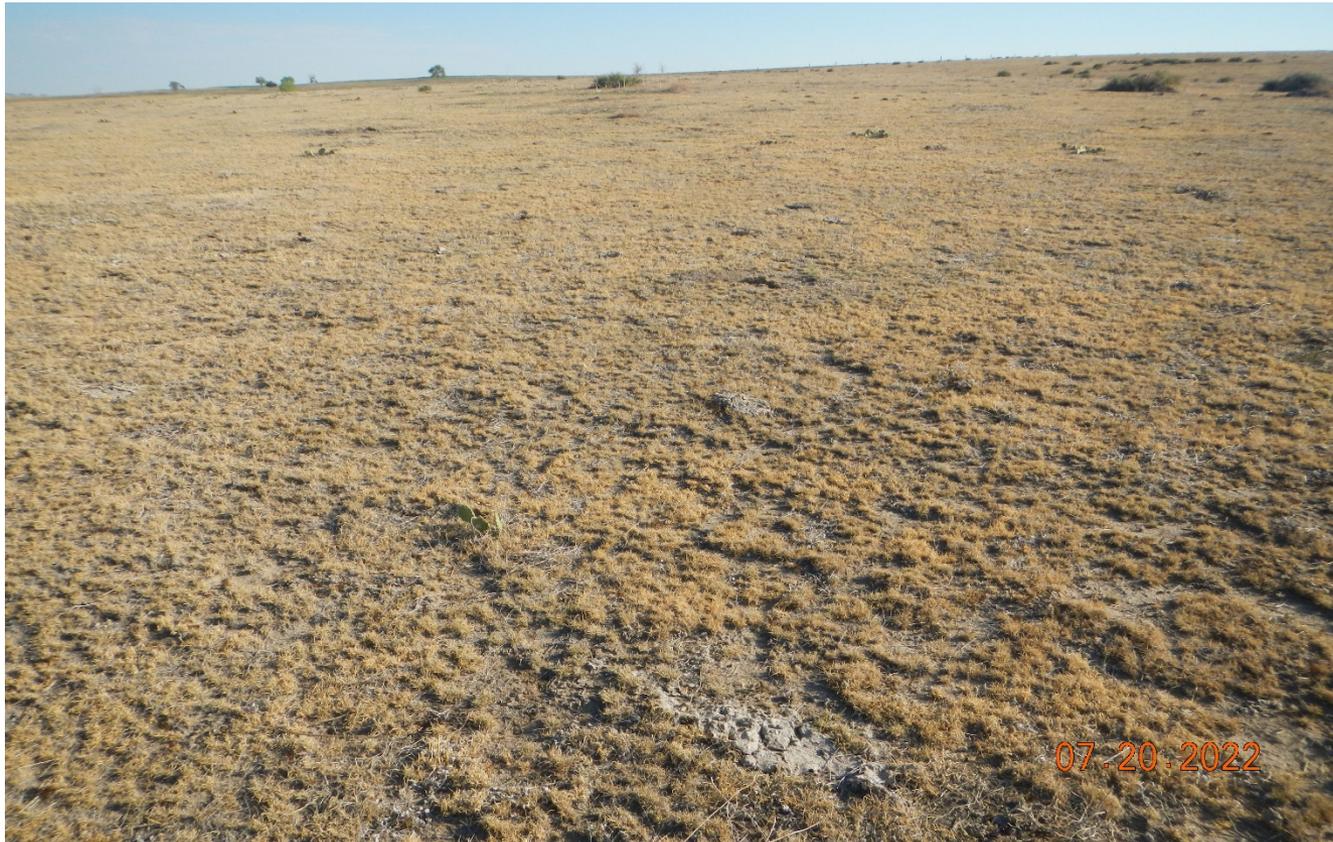
Photo 8. Facing north at the surrounding undisturbed Buffalo grass pasture.
