# Inspection Photos

API: 061-06287

Operator: CHEMCO INC

Inspection Date: 10/12/2022

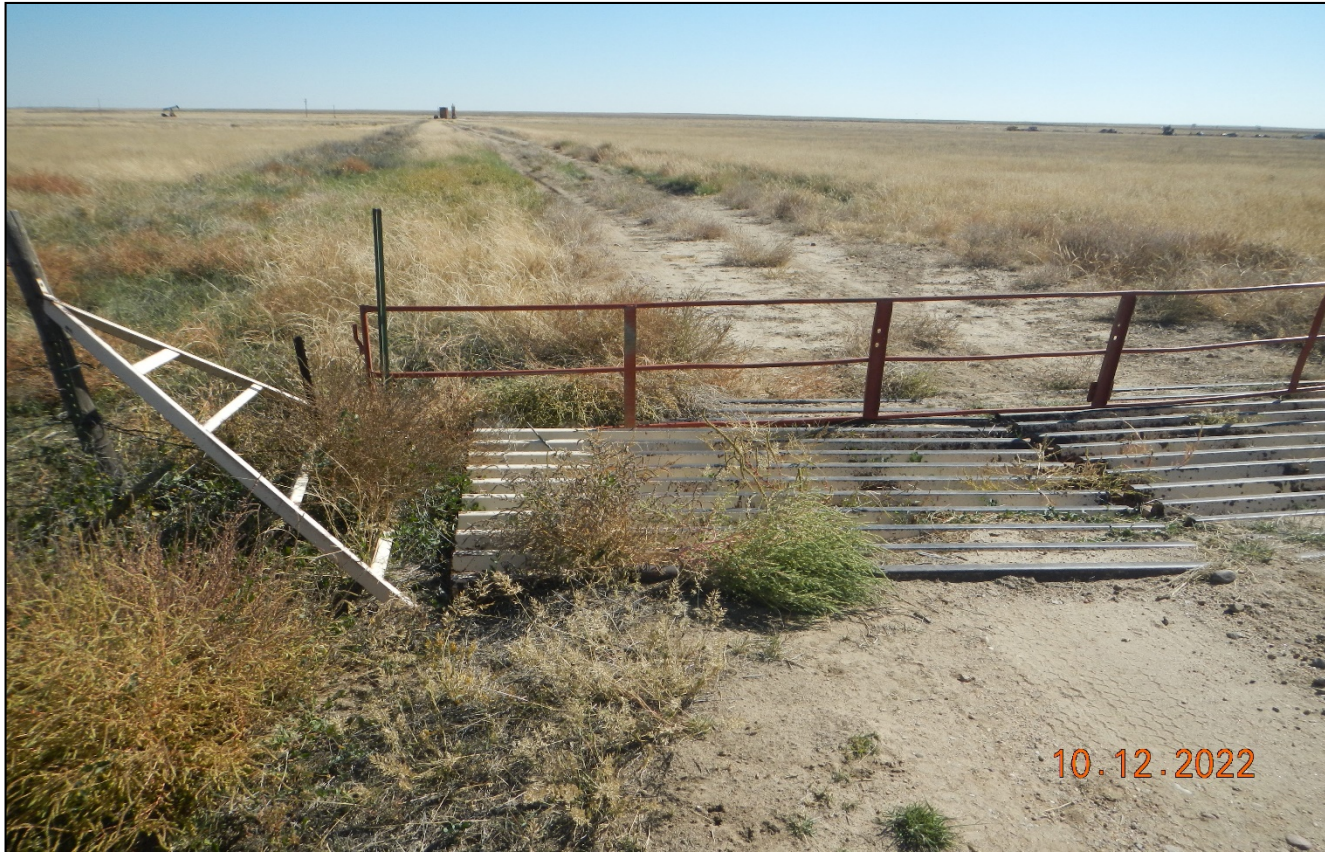
**Photo 1.** Facing east at the beginning of the access road. The cattleguard is filled in with sediment and needs to be cleaned out and maintained. There is a heavy red panel wired to prevent livestock from crossing cattleguard which makes it difficult to access.

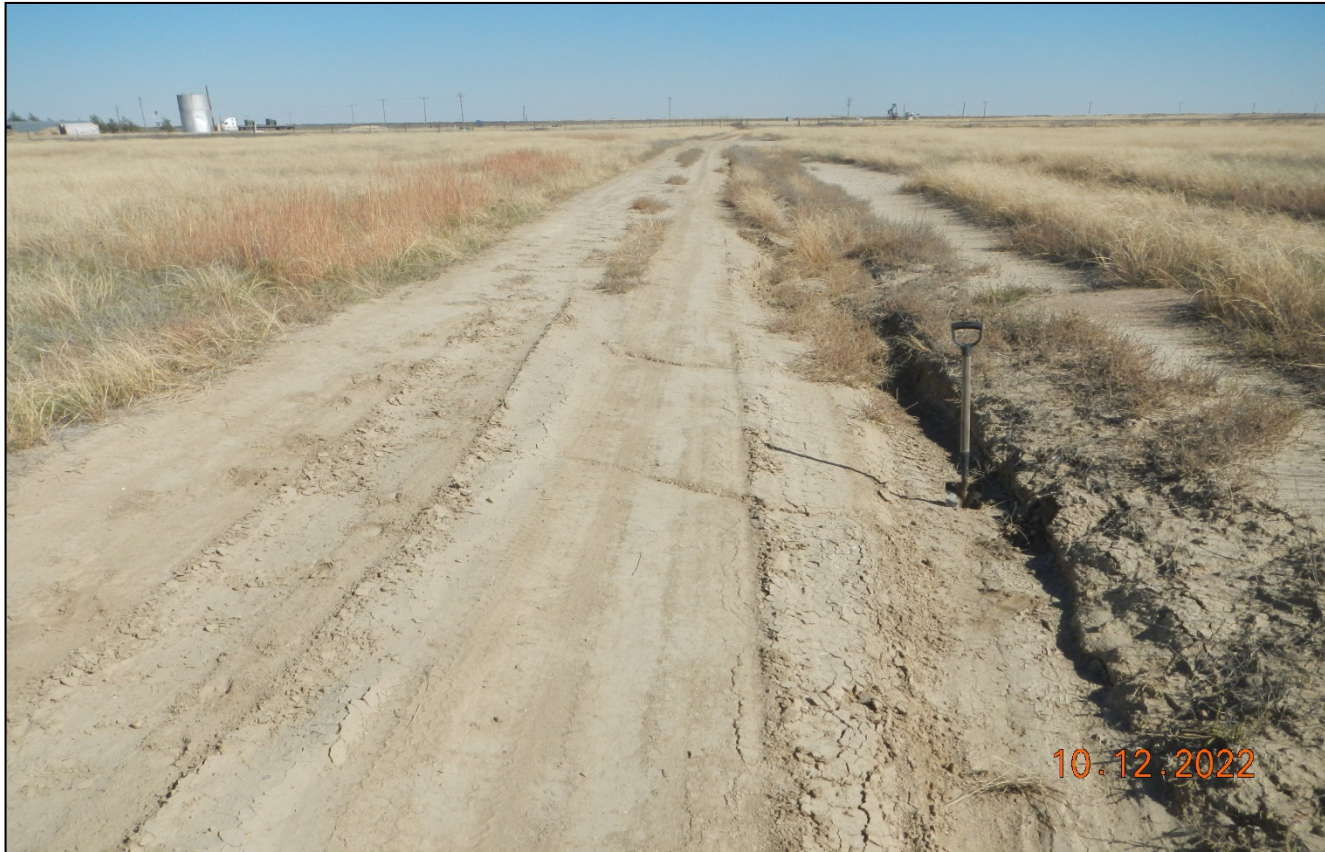
**Photo 2.** Facing northeast along the access road. There is erosion along the road that needs to be repaired. Vehicles are avoiding this area causing widening of the road.

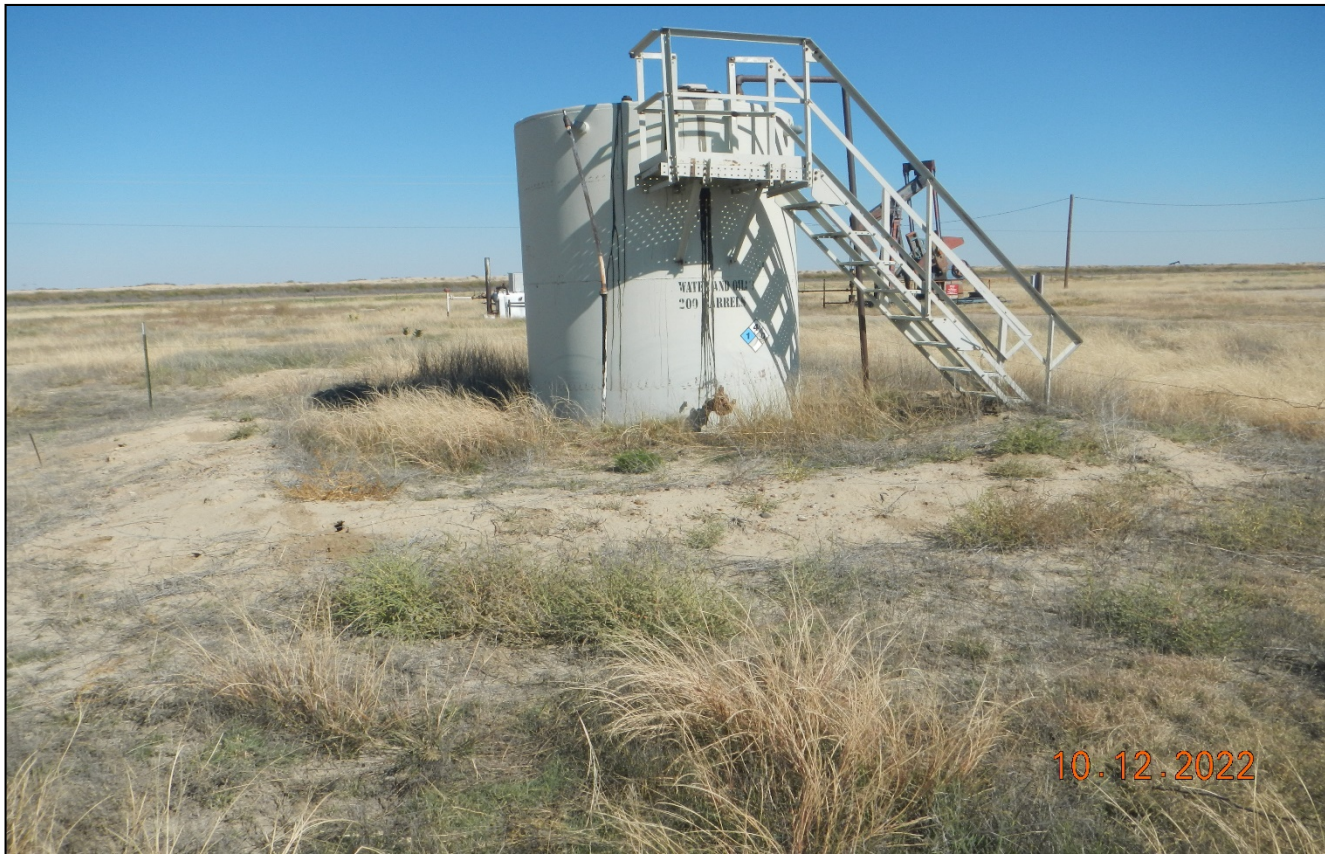
**Photo 3.** Facing toward the tank battery. The area inside the berm needs to be kept free of vegetation. The fence around the tank needs to be repaired to prevent livestock entry. The berm around the tank needs to be rebuilt to contain a spill.

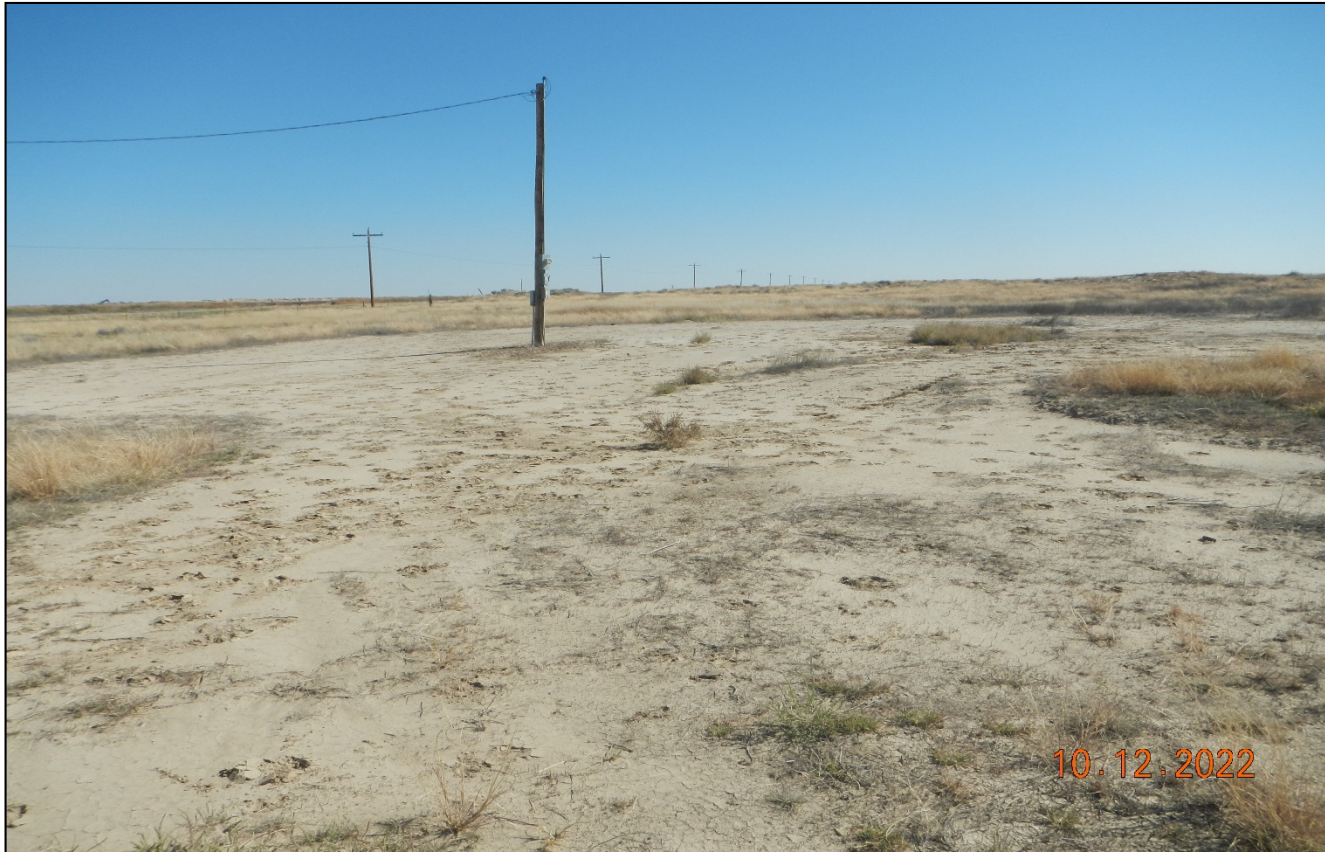
**Photo 5.** Facing west at the north side of the location. This is the area of impacted soils at the PA wellsite. A Remediation Project #22282 has been started.

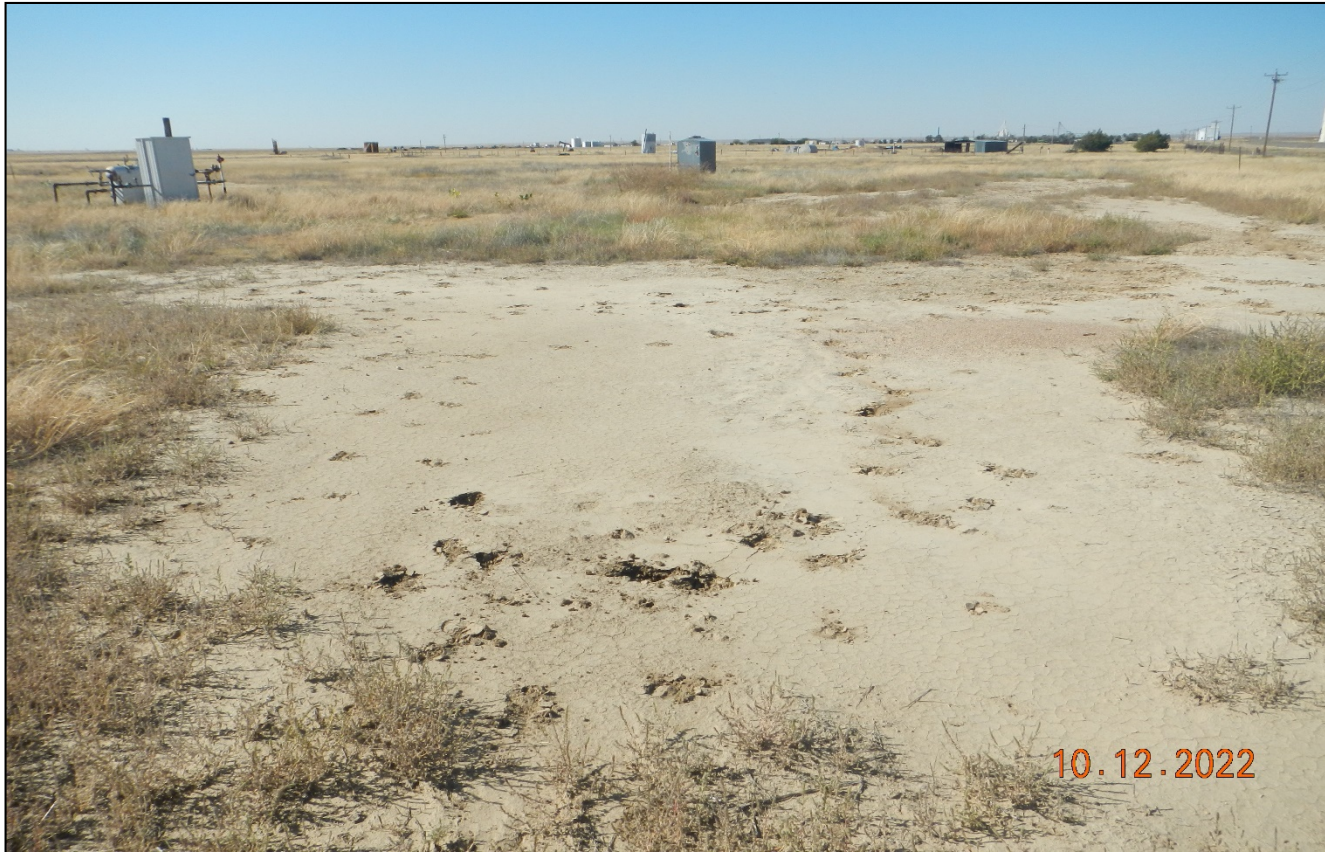
**Photo 6.** Facing west at the north side of the location. This is the area of impacted soils. A Remediation Project #22282 has been started.

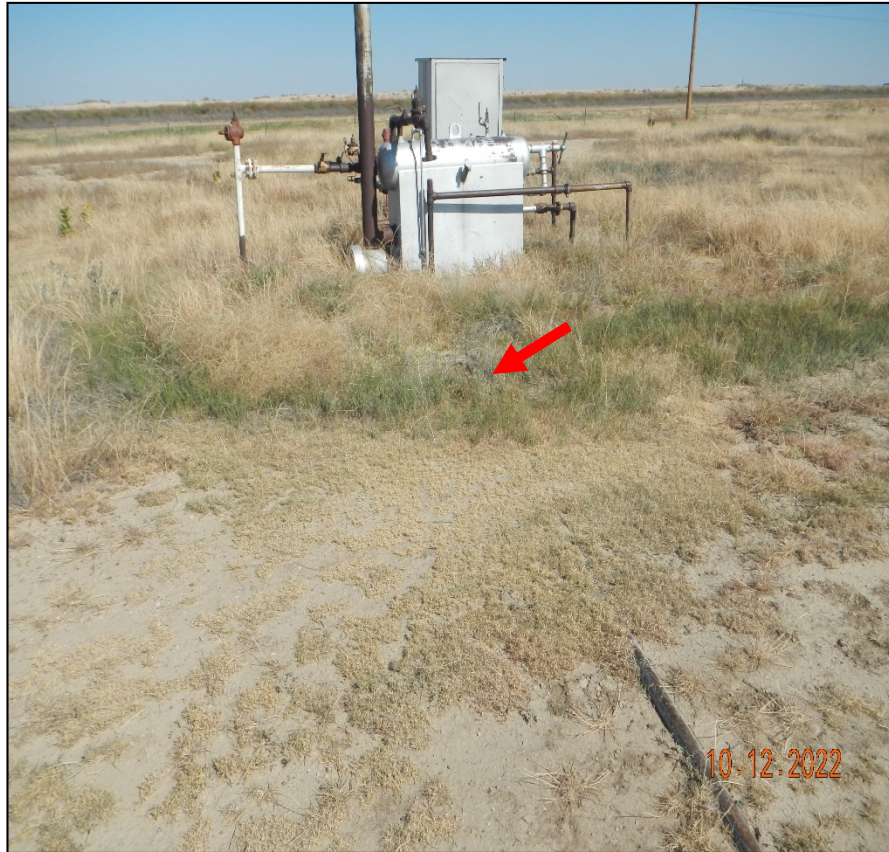
**Photo 7.** This flowline had previously leaked at red arrow.

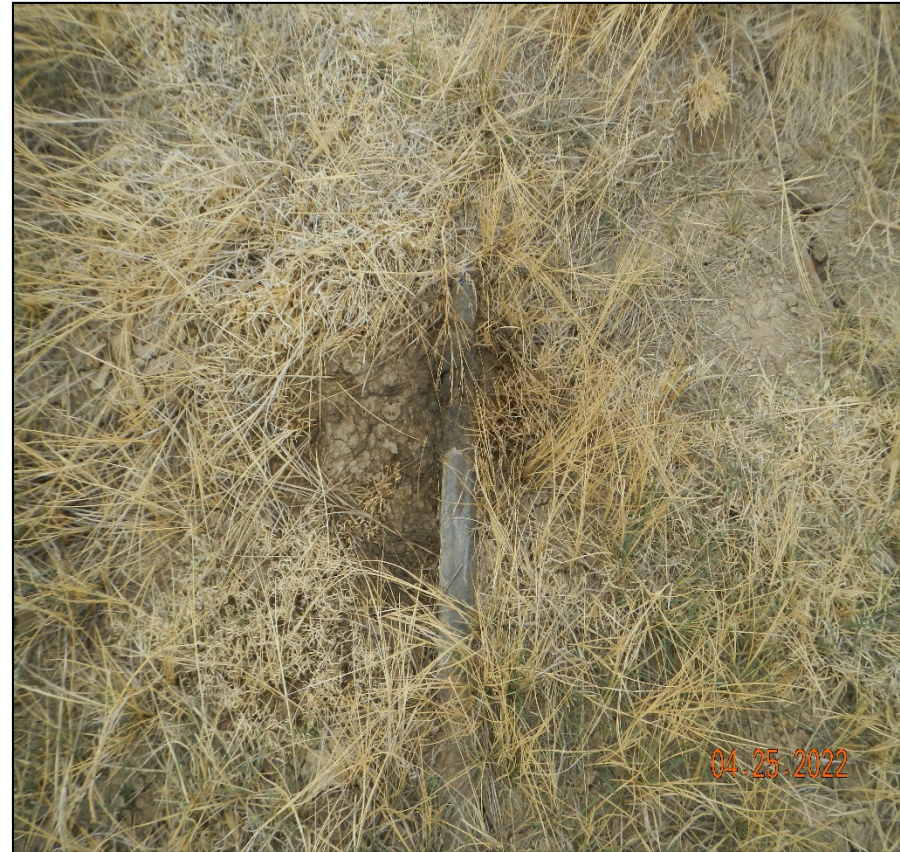
**Photo8.** The impacted soils need to be cleaned up and the pipe inspected.
