Reclamation and Stormwater Inspection

Operator: EXTRACTION OIL & GAS INC - 10459

Location ID: 319807

Inspection Document #: 696105720

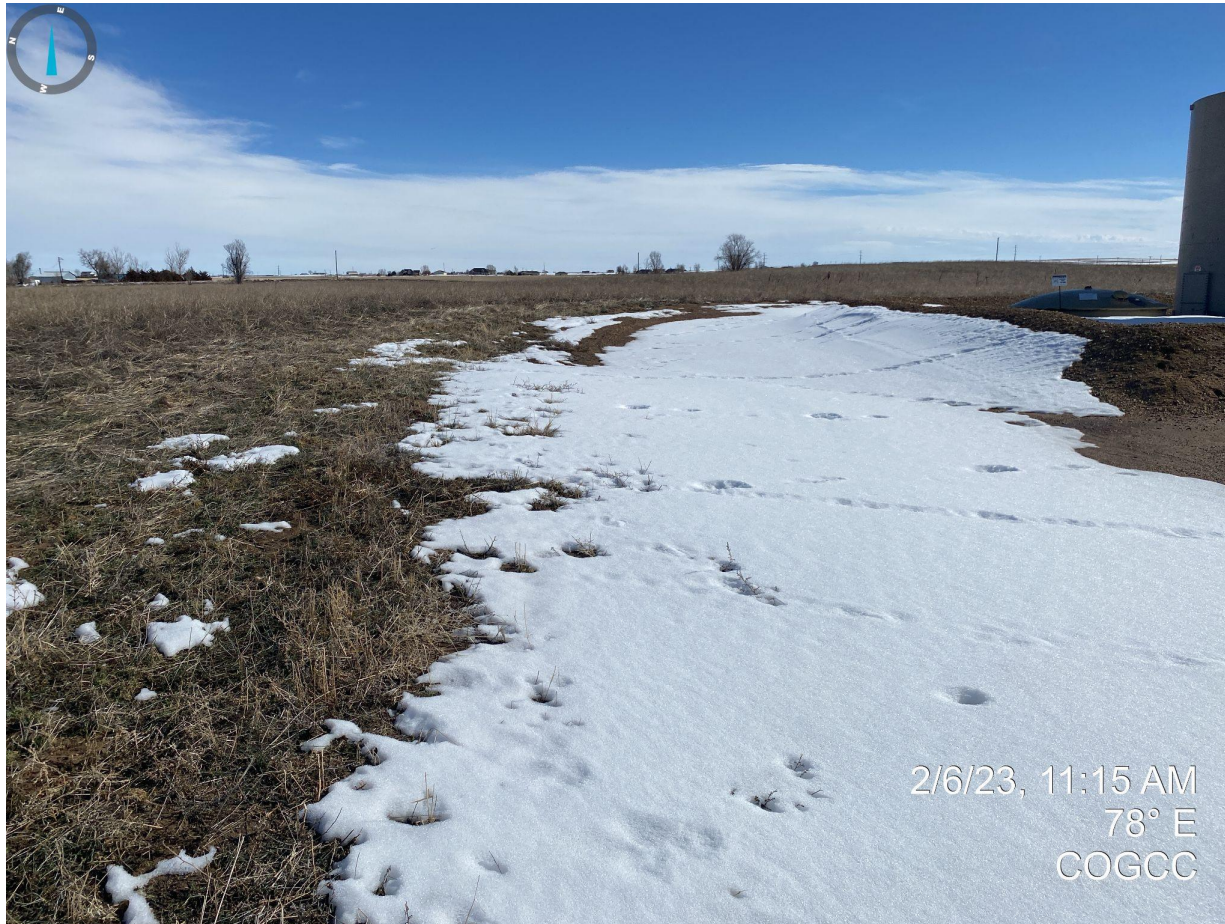
Photo 1. Facing east near the tank battery. It appears the operator has mowed the undesirable vegetation as identified in the previous inspection.

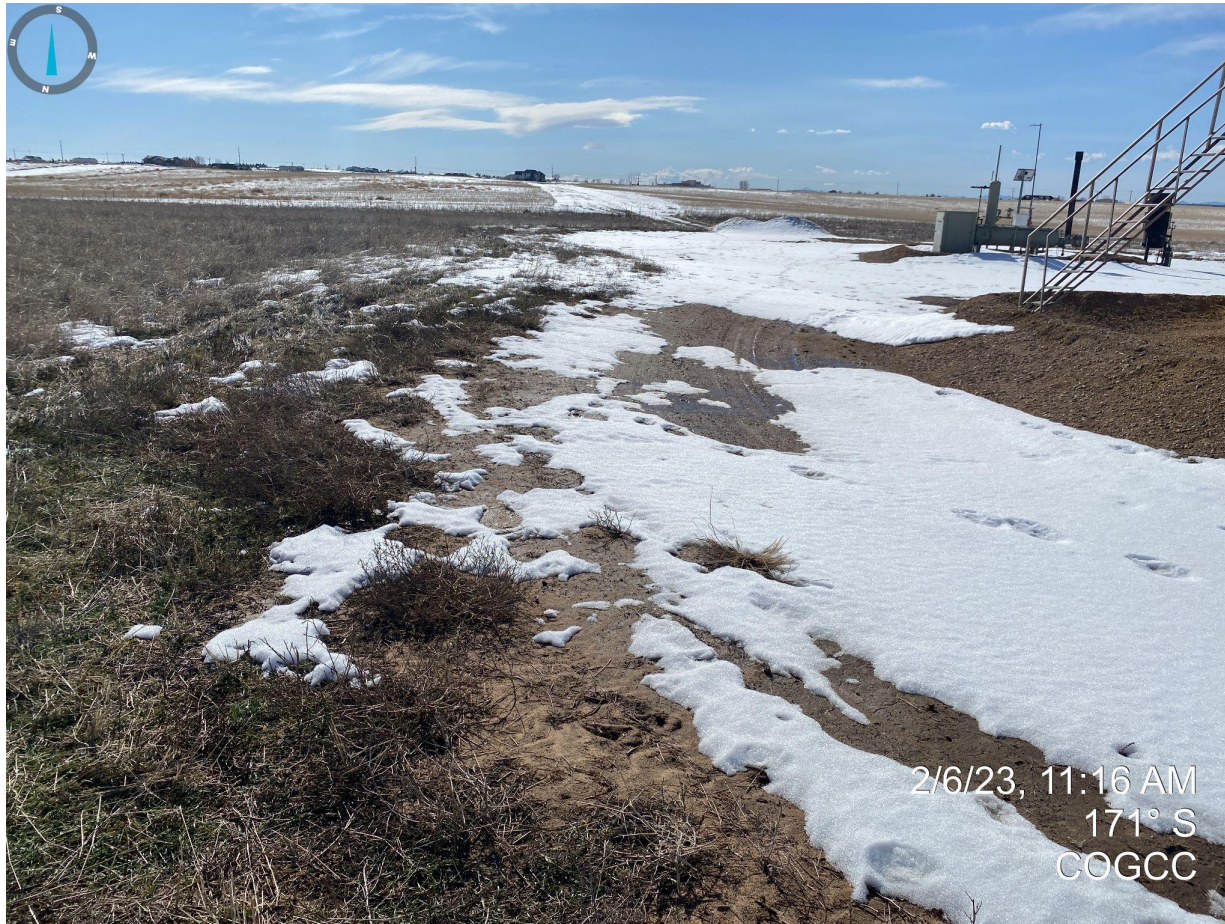
Photo 2. Facing south from tank battery. Some remnants of undesirable vegetation were observed during this inspection that the operator will have to manage for in the future. However, it does appear the operator has mowed around the perimeter of the location.

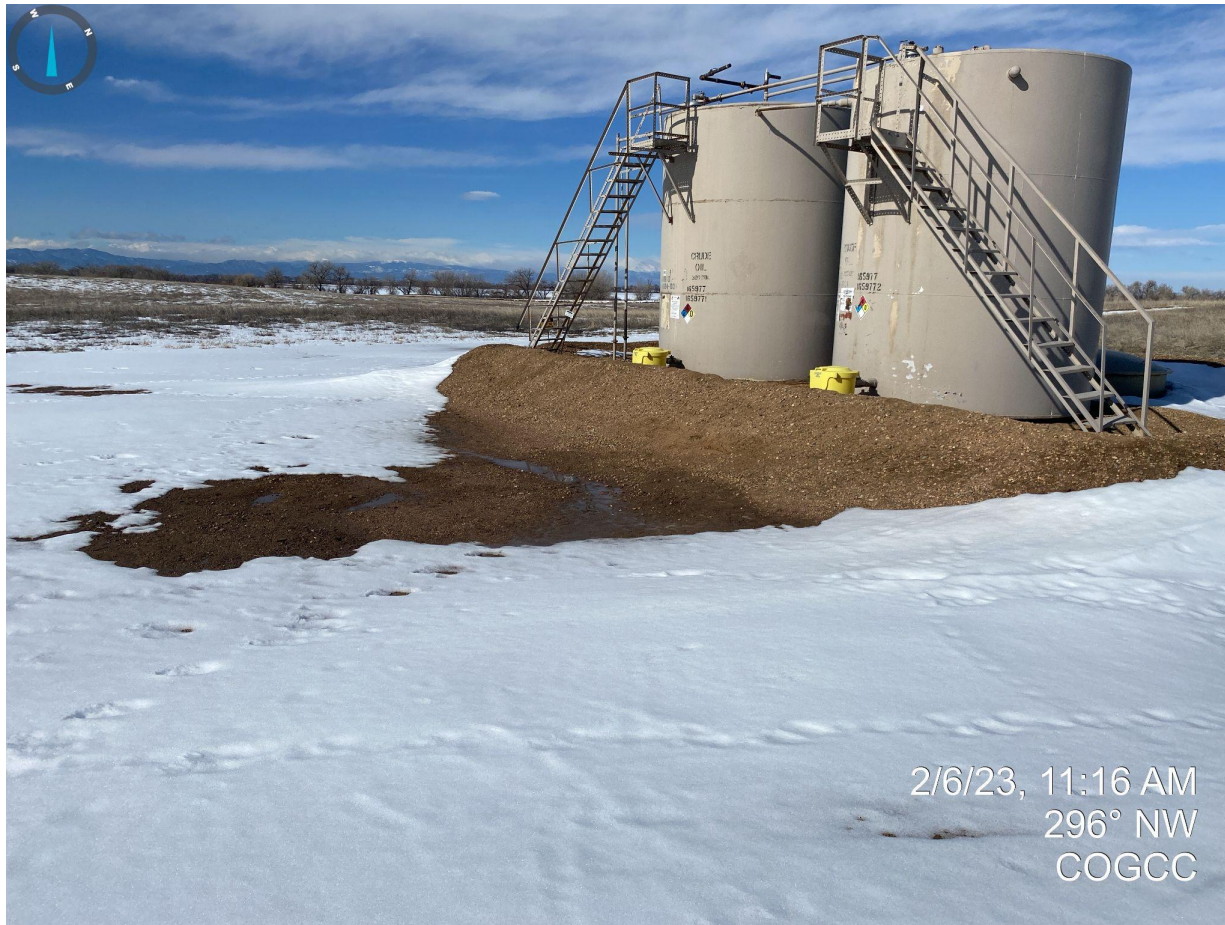
Photo 3. Facing northwest at the tank battery. Operator has completed the corrective action and removed the unused equipment previous identified.

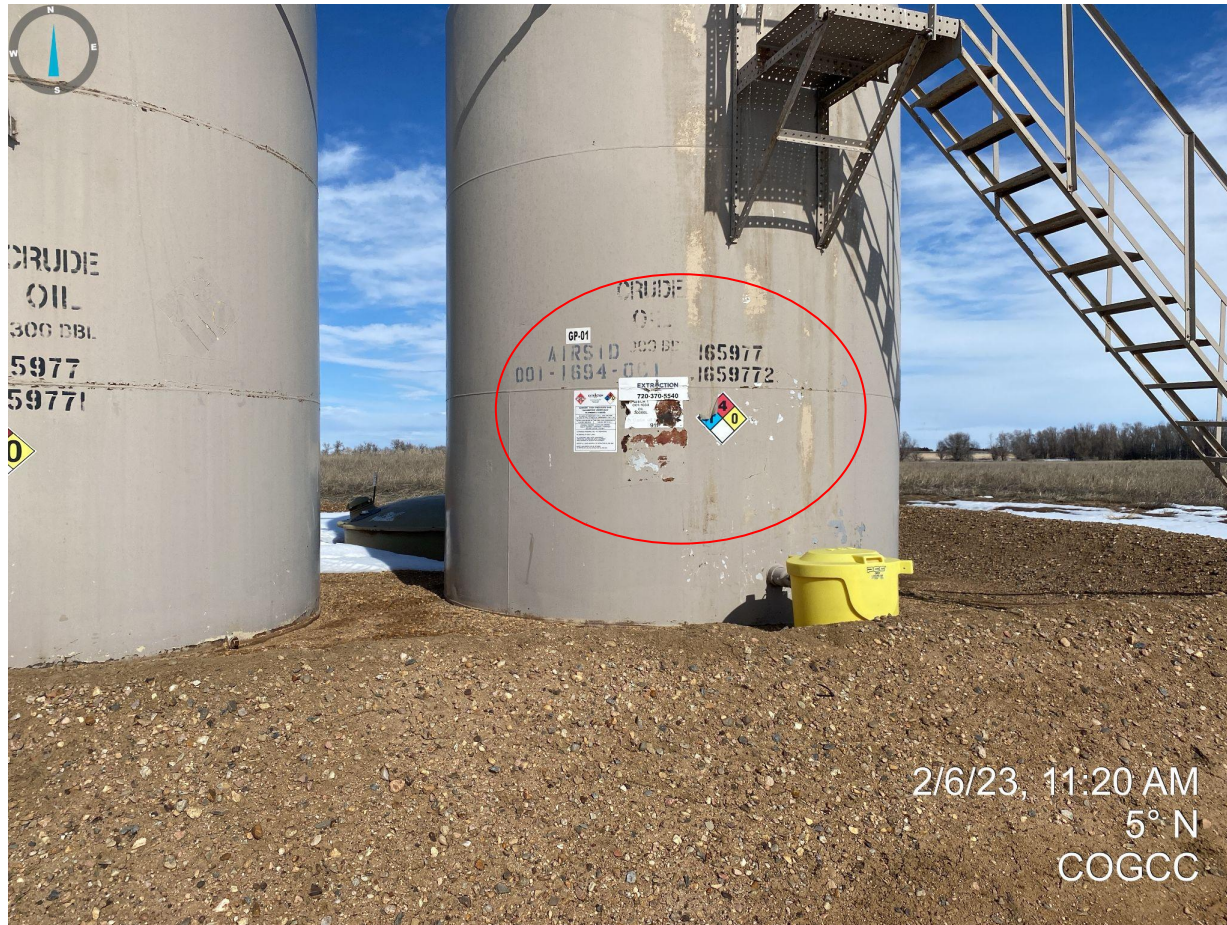
Photo 4. Facing north at the tank battery; photo illustrates that the NFPA placards and other labels on the tank are peeling, cracked, and not legible.
