Inspection Photos

Operator: CAERUS PICEANCE LLC #10456

Location #335581

Garfield County, CO

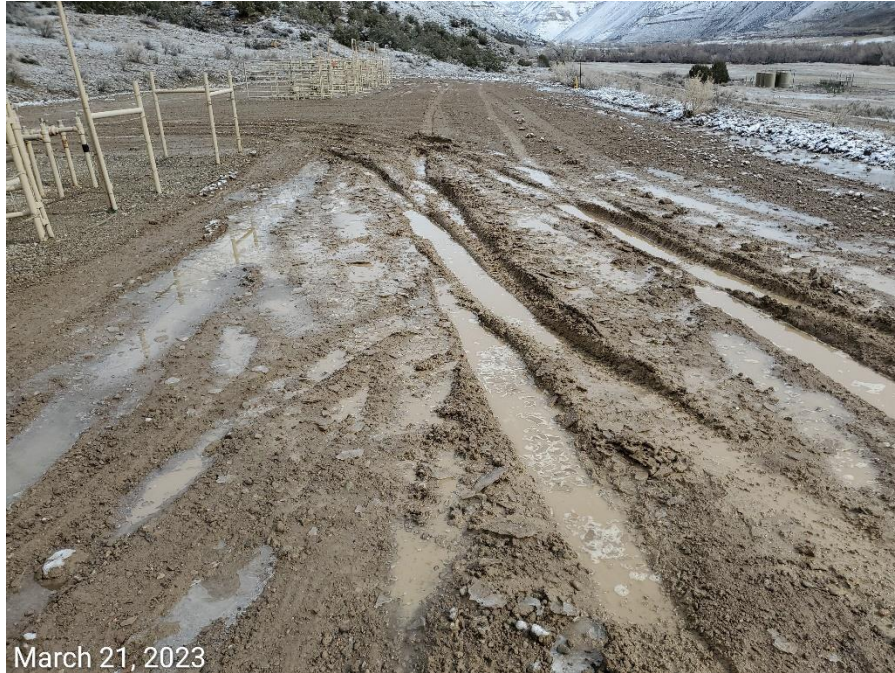
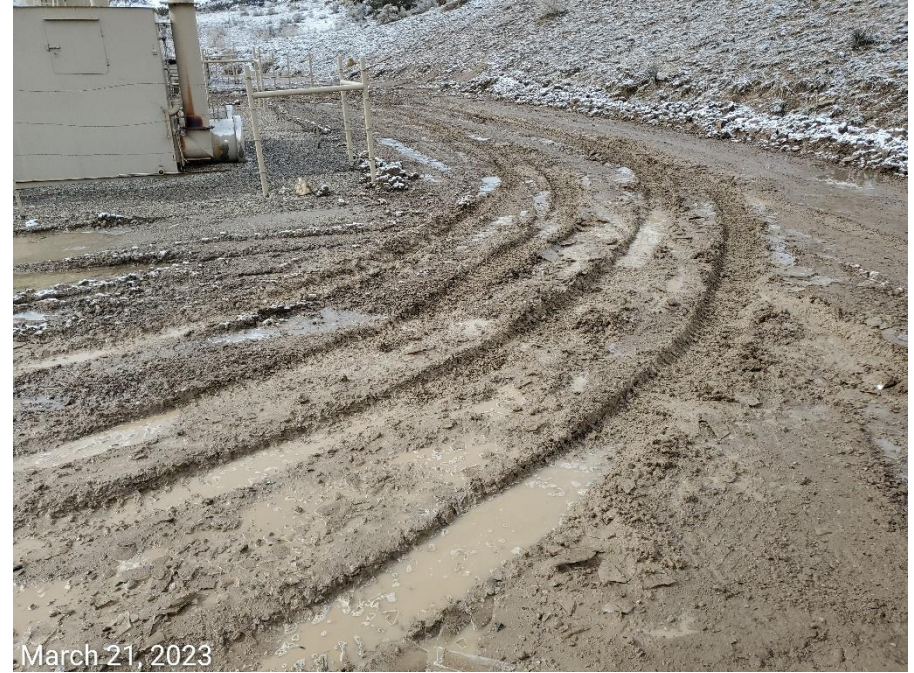
Photo 1: Photos 1-2 taken from the working pad areas of the Location and access road. Photos show that there are areas that appear to have been graded, however vehicle tracking and degradation have persisted; repairing only by grading is not sufficient. BMPs to minimize erosion, degradation, tracking and sediment transport remain missing or insufficient at the Location and access road.

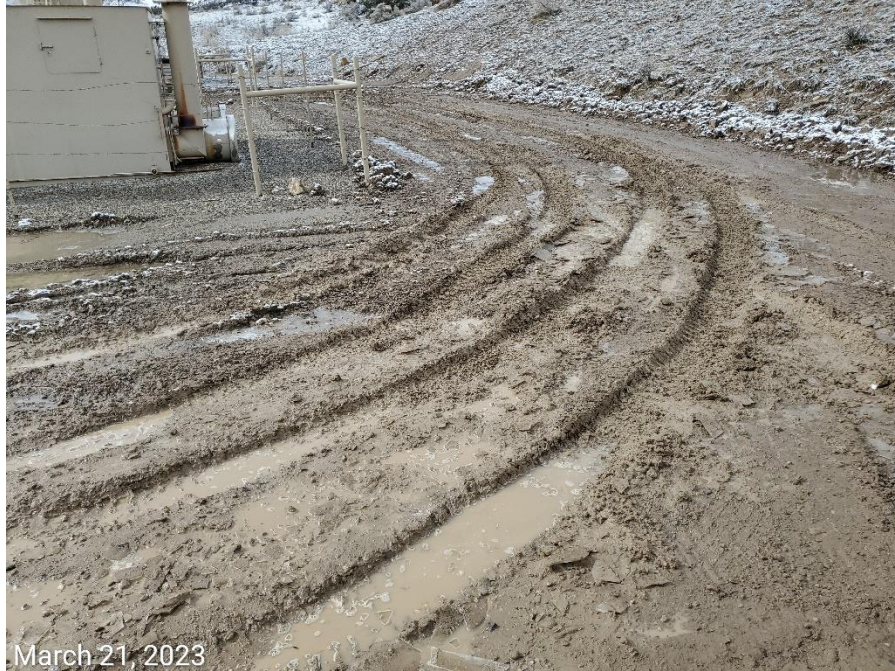
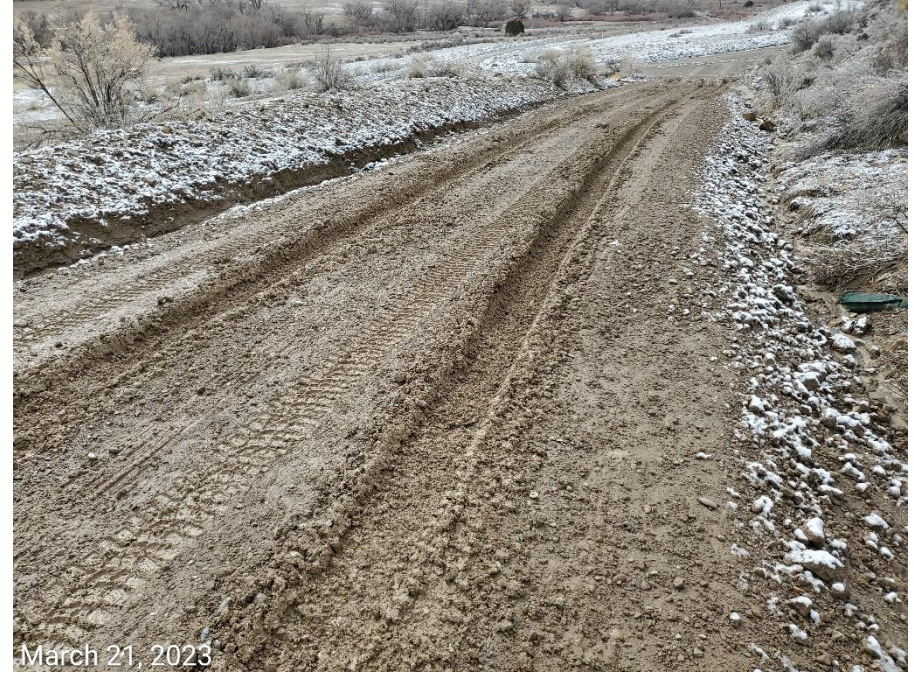
Photo 2: See comments under photo 1.

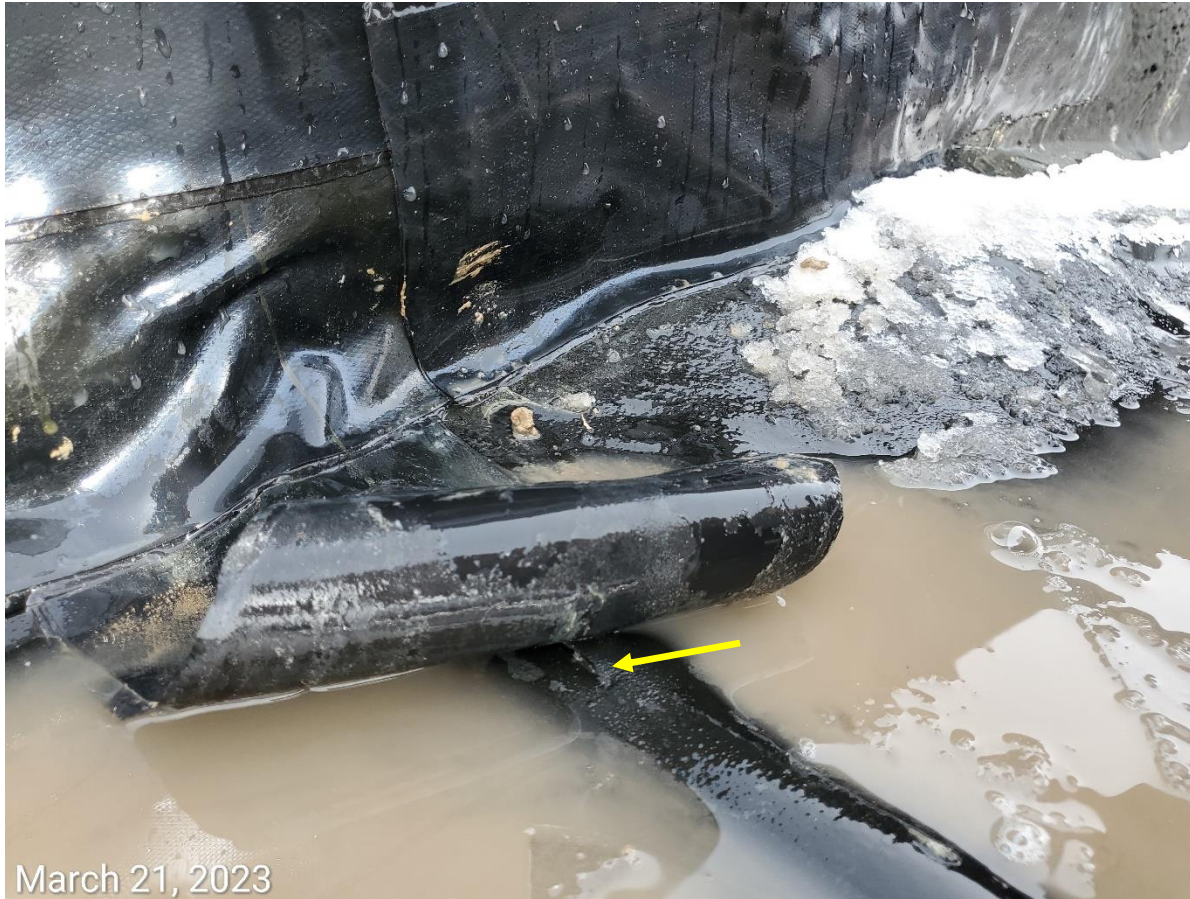
Photo 3: Photo shows repair work at secondary containment liner is inadequate.

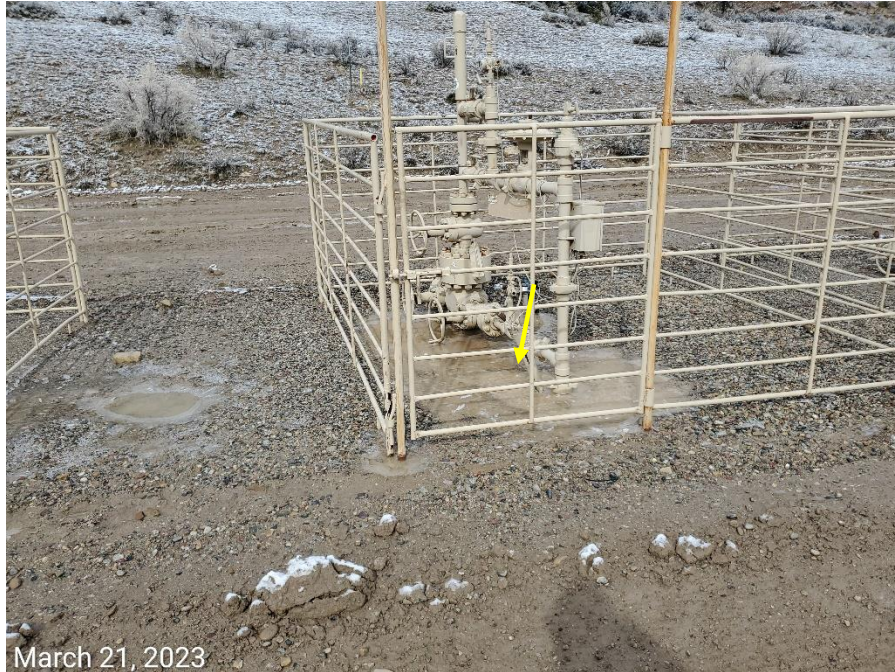
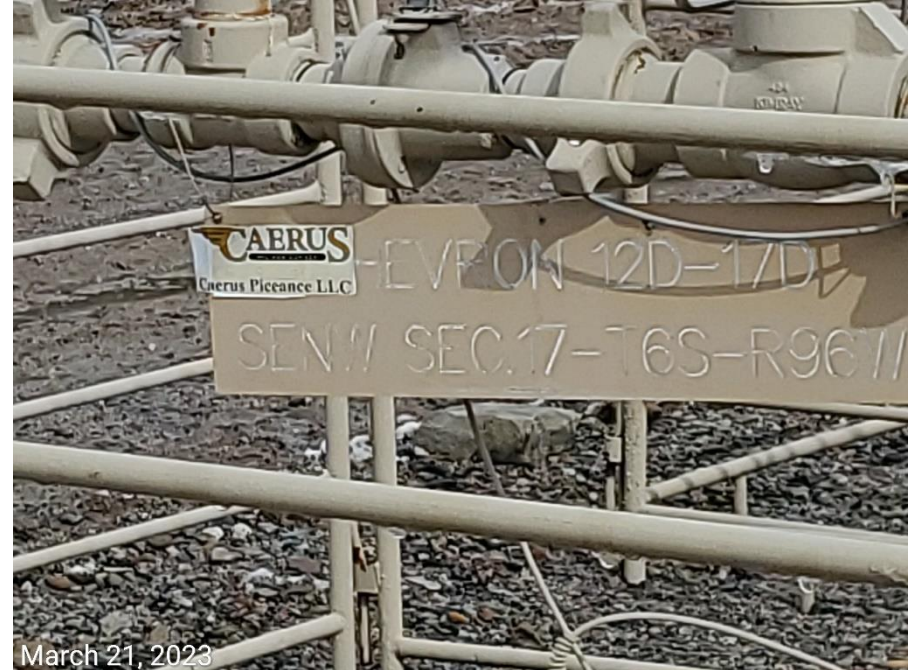
Photo 4: Gas observed bubbling from the Chevron 12D-17D. Operator (pumper) on site was notified of the leak, and provided 24 hour notice to stop leak and ensure good mechanical condition.
