Final Reclamation Inspection

Operator: HIGHPOINT OPERATING CORPORATION - #10071

Location ID: 305223

Inspection Photos
Location Name: DOW LAURA 14-27
Location ID: 305223

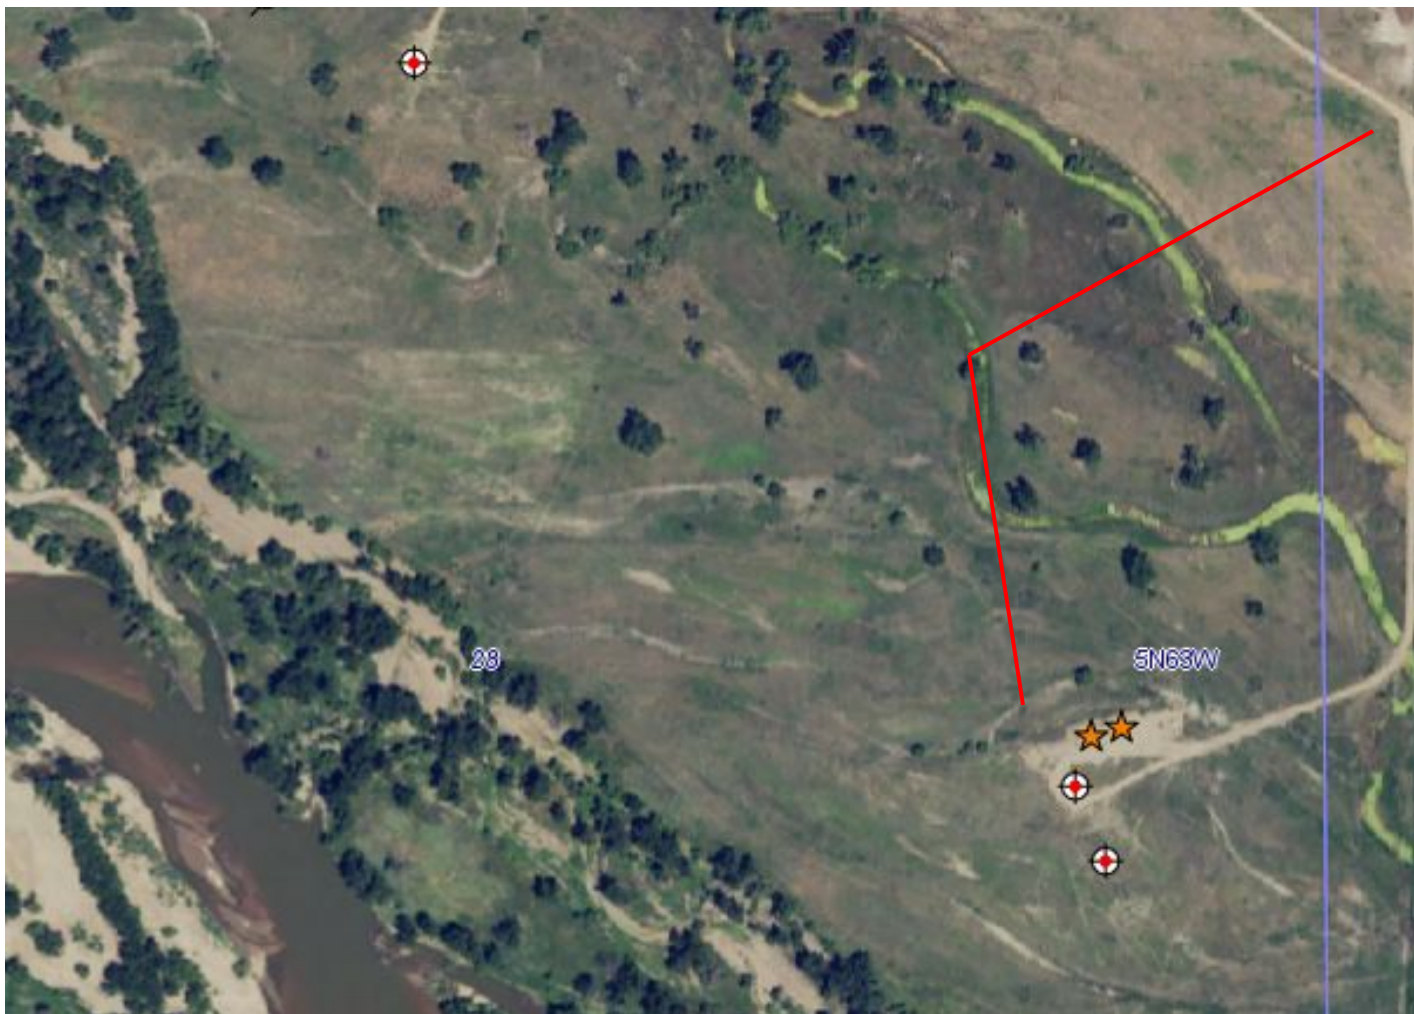
Photo 1. COGCC GISOnline aerial imagery from 2015. This inspection covers the well location/tank battery and access roads.

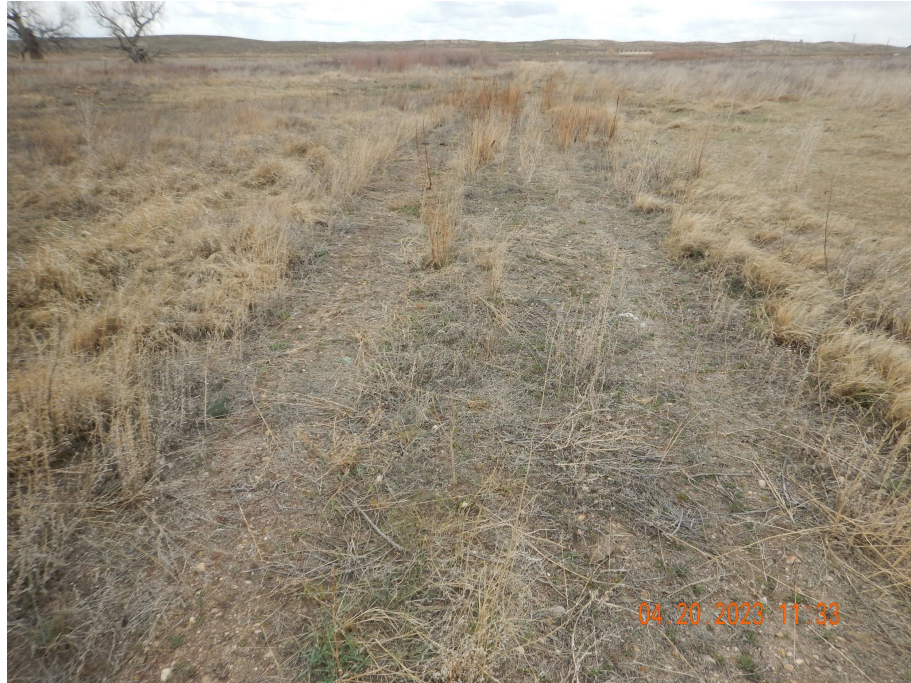
Photo 2. Photo taken from a portion of the access road, facing North. Photo illustrates the access road consists mostly of weeds with little perennial vegetation that is not reflective of reference areas.

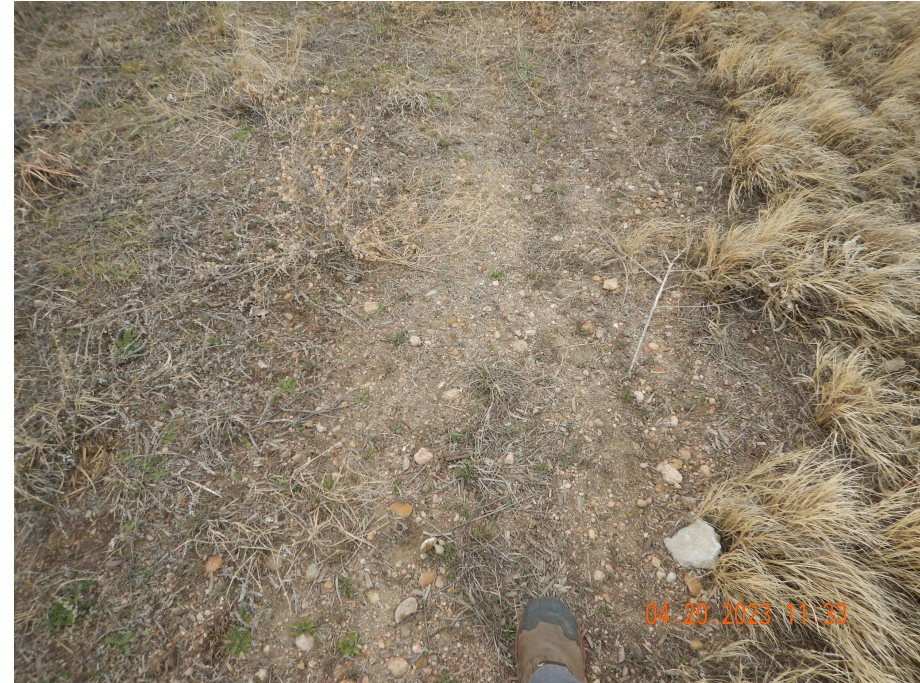
Photo 3. Close up photo taken from a portion of the access road. It does not appear all the gravel has been removed.

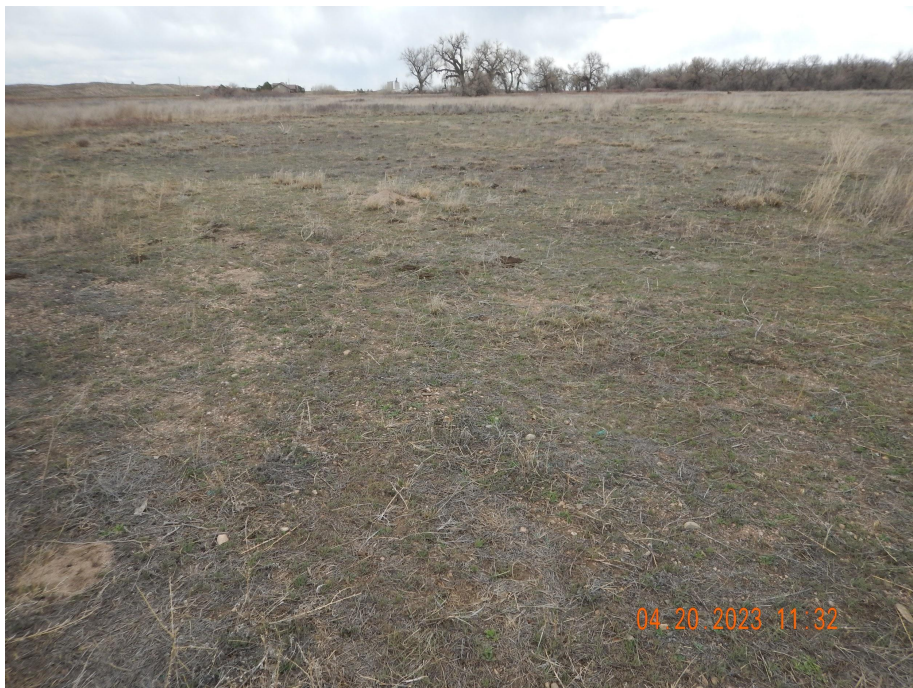
Photo 4. Photo taken from the well/tank battery location, facing East. Photo illustrates the location consists mostly of weeds with little perennial vegetation that is not reflective of reference areas.

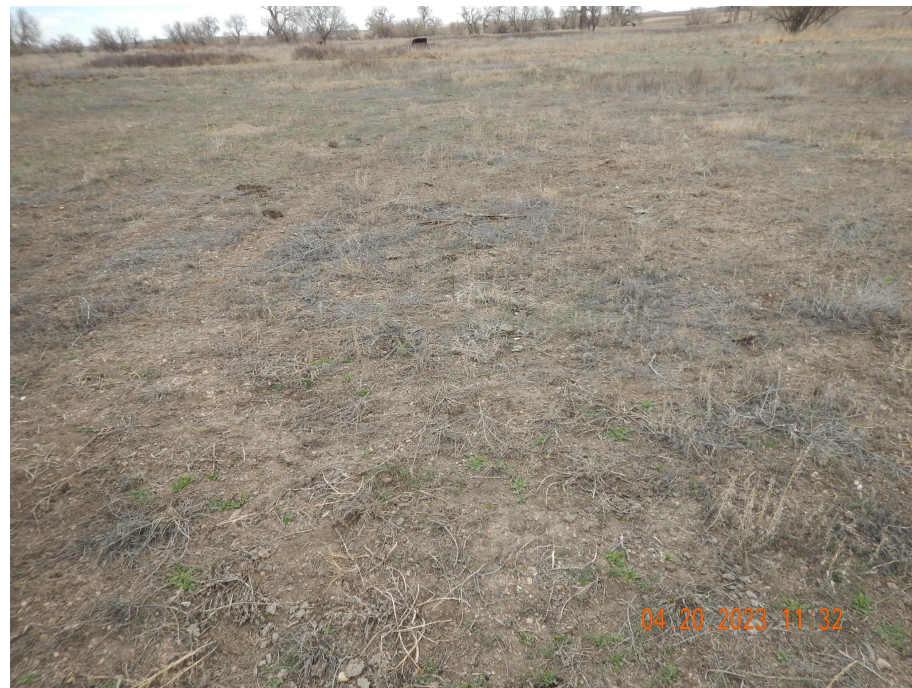
Photo 5. Photo taken from the well/tank battery location, facing North. See comments under Photo 4.

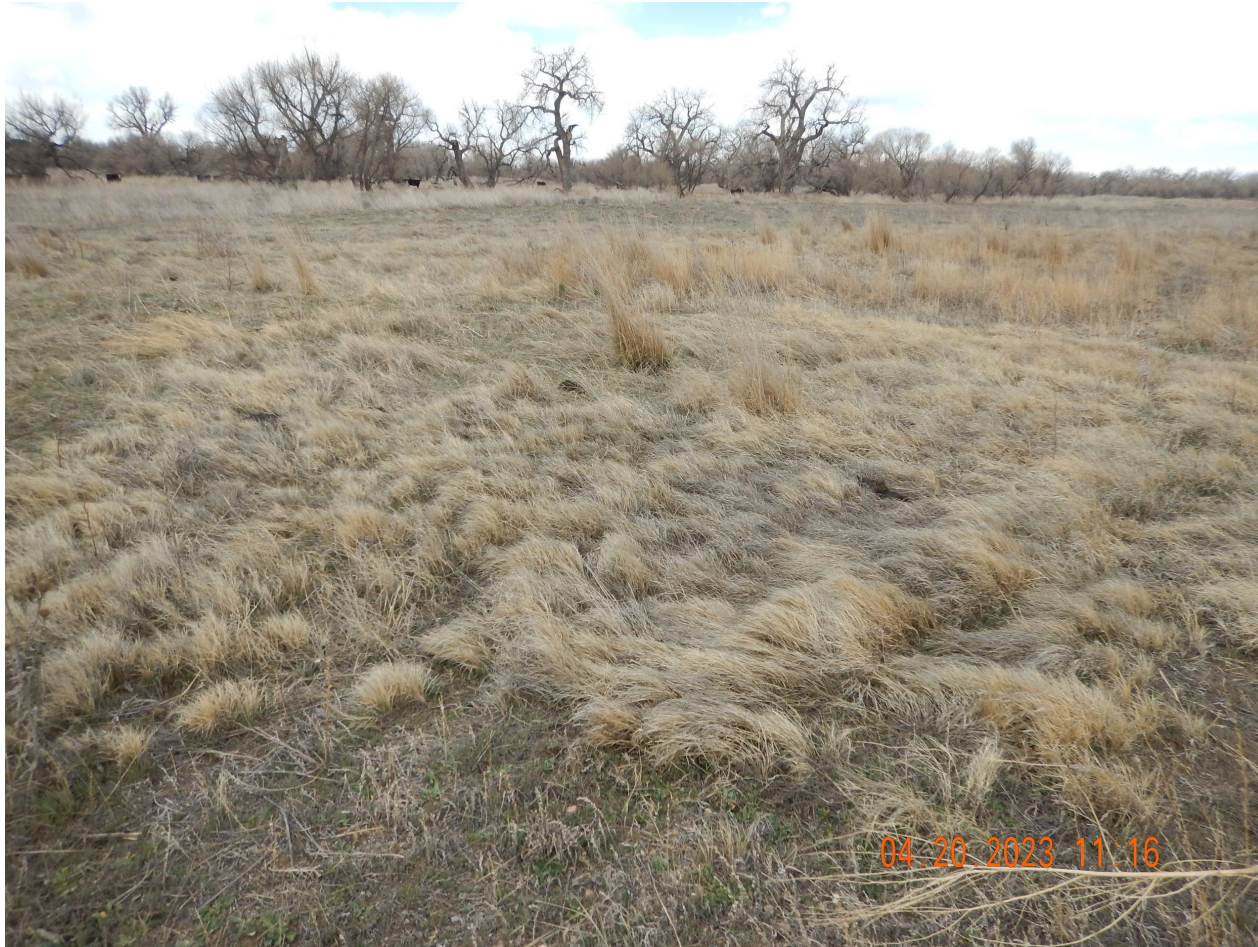
Photo 6. Reference photo taken from one of adjacent locations.
