Final Reclamation Inspection

June 2nd, 2023

Operator: PDC ENERGY INC - 69175

Location ID: 322959

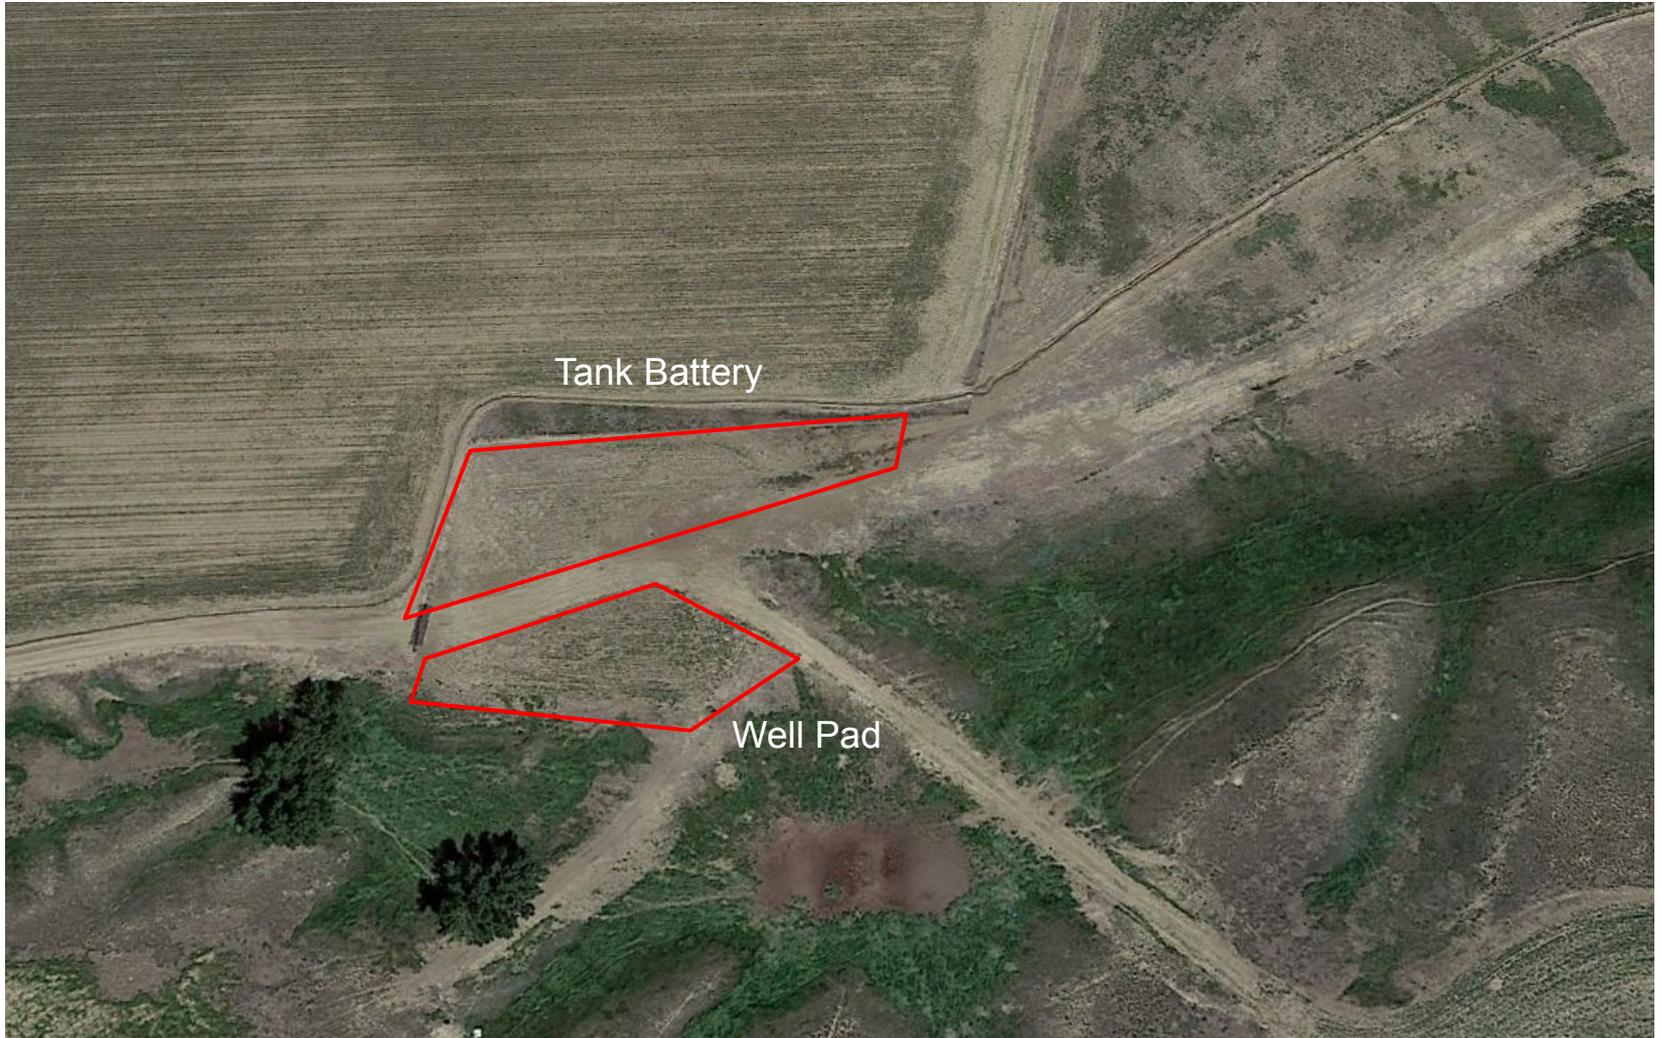
Photo 1. 2022 aerial imagery of the well pad and tank battery.

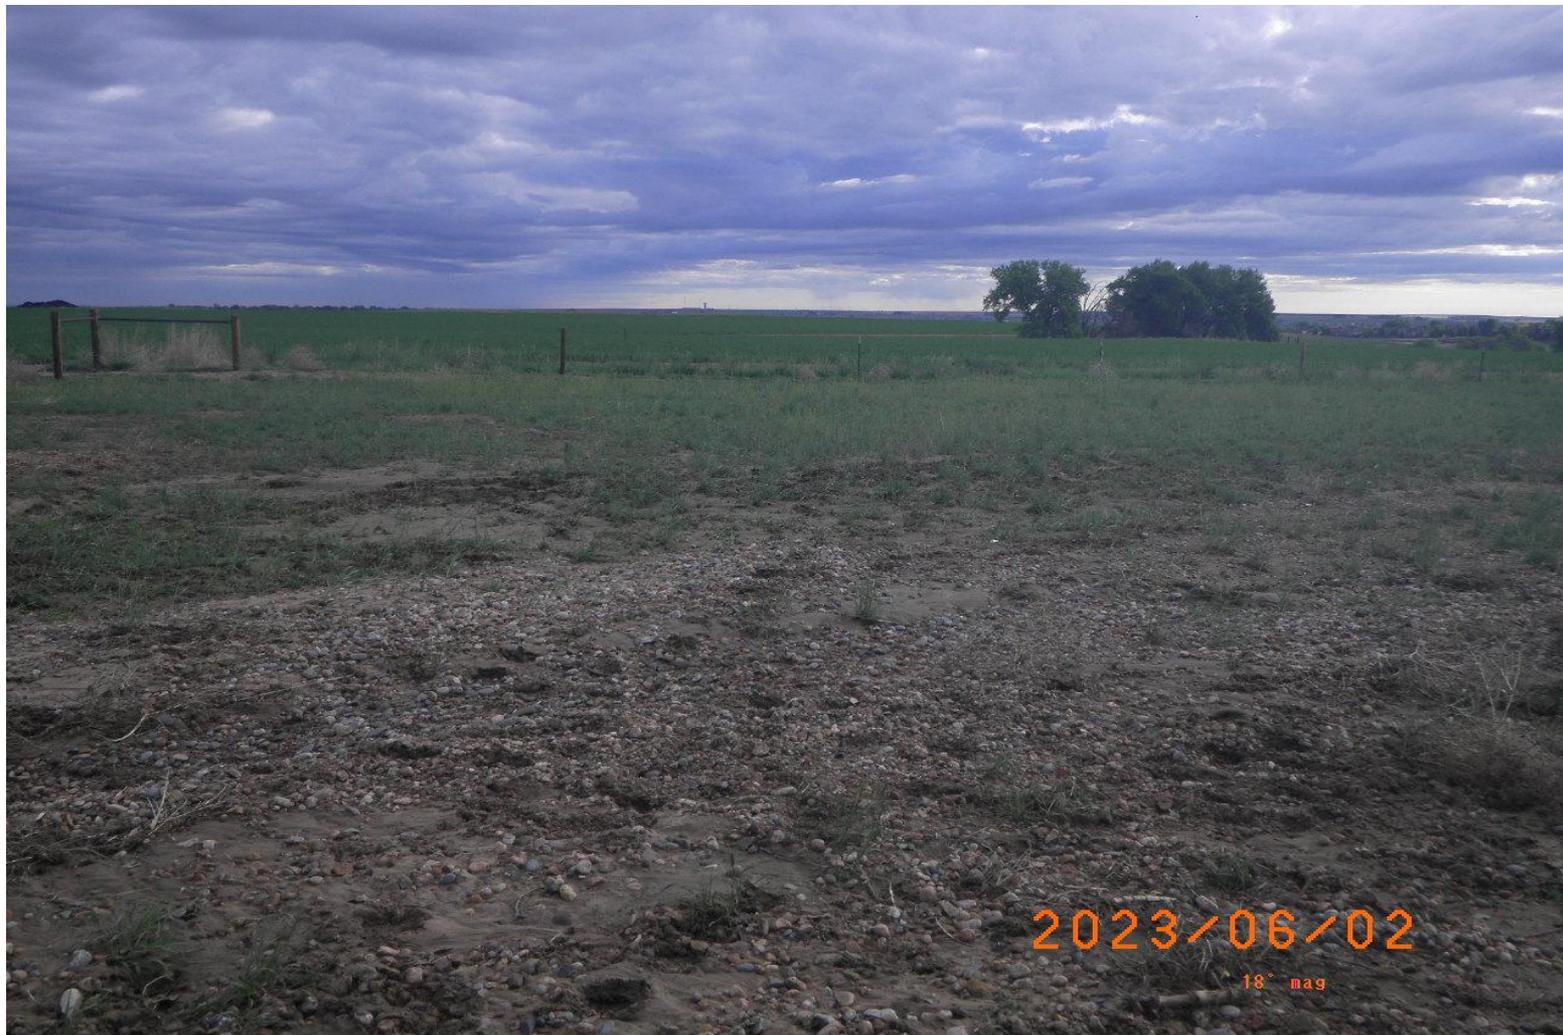
Photo 2. Overview photo of the tank battery taken at ground level from the southern edge facing north. Note: cattle have moved into the disturbance and grazed the area.

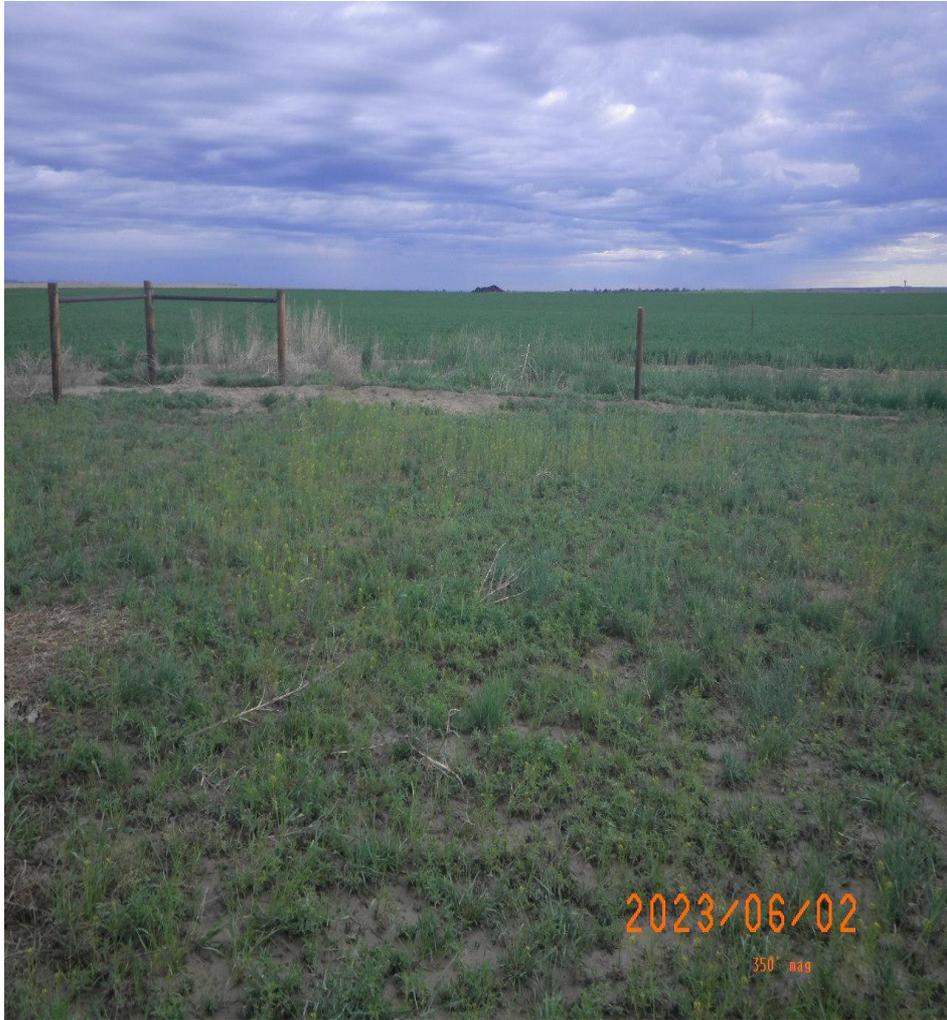
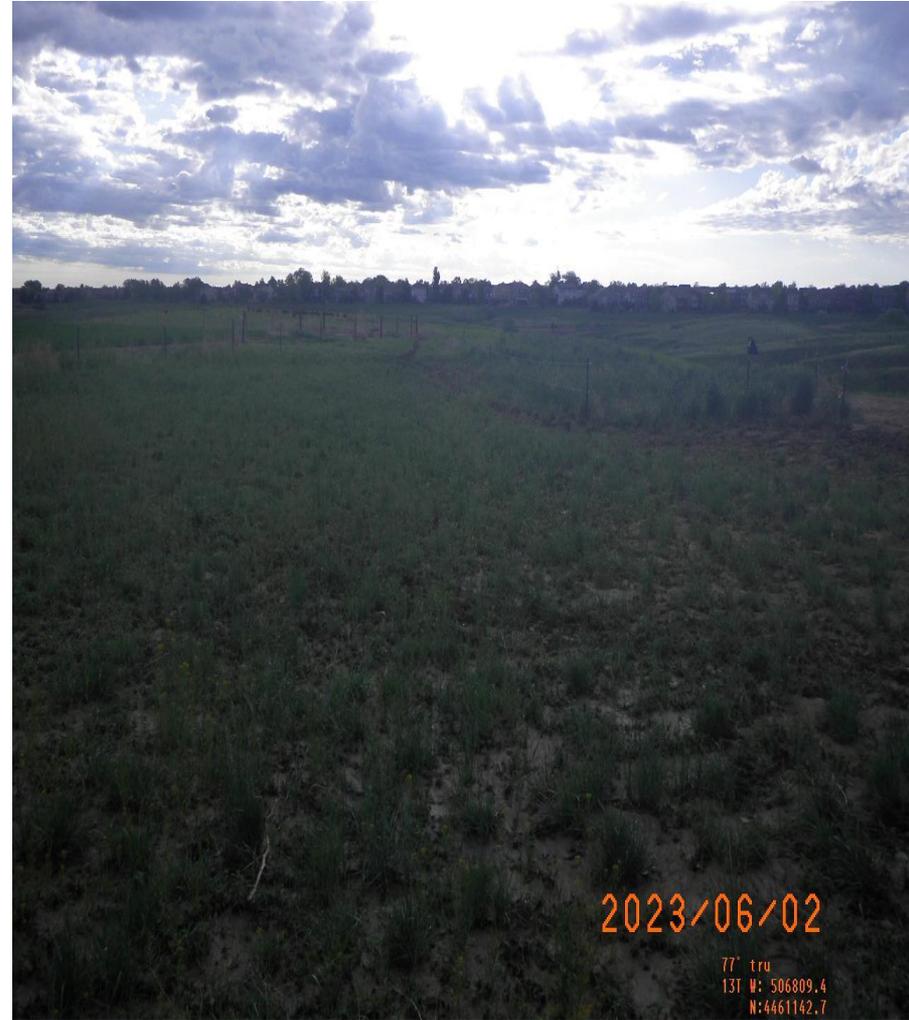
Photo 3. Cardinal photos taken at ground level from the middle of the tank battery. Left photo facing north, right photo facing east.

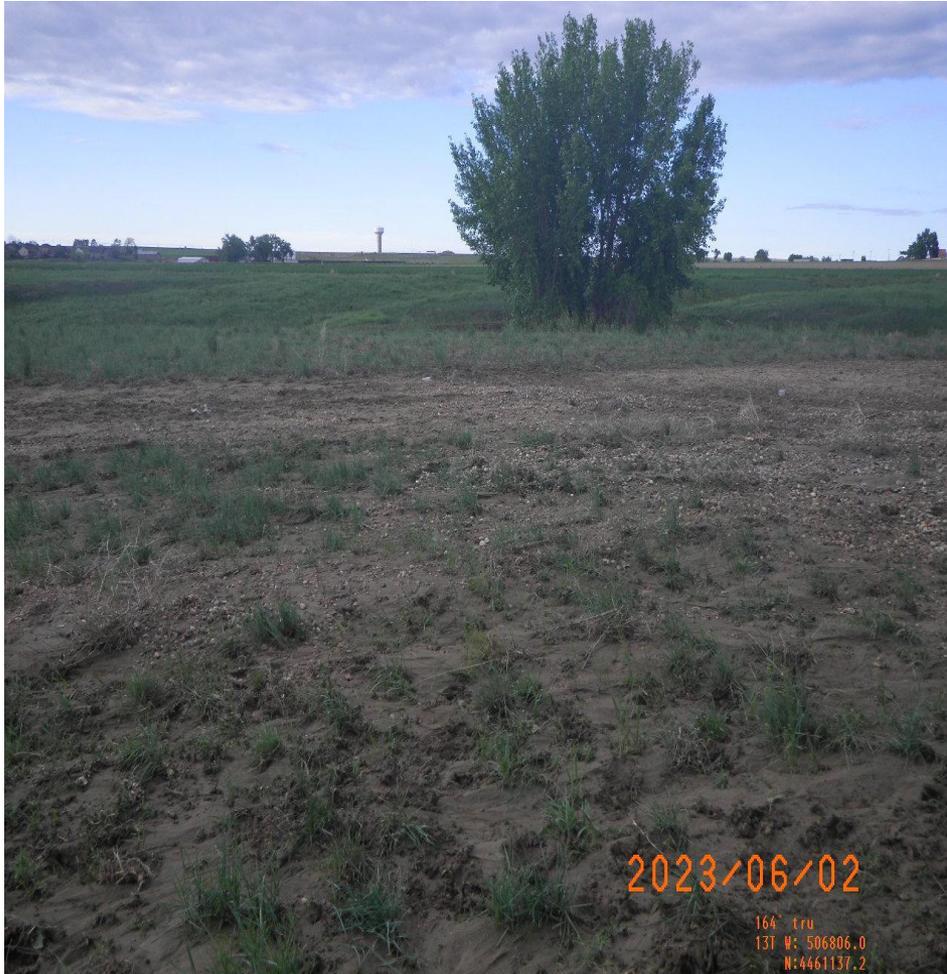
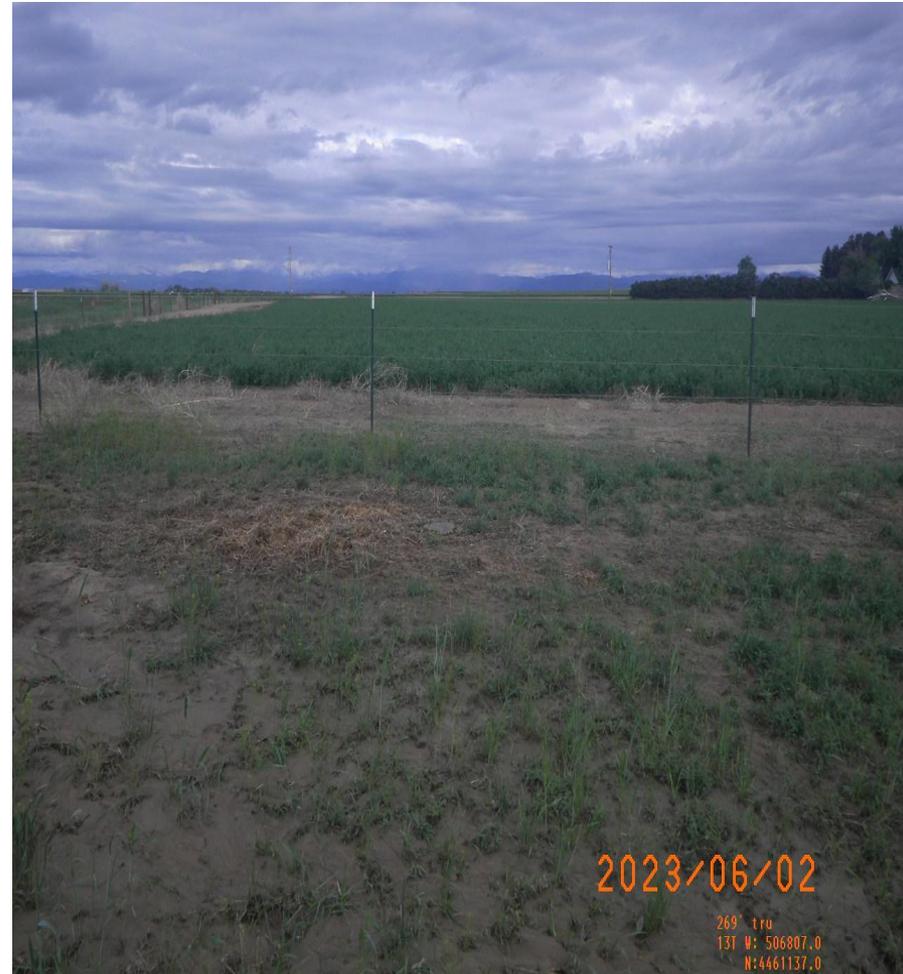
Photo 4. Cardinal photos taken at ground level from the middle of the tank battery. Left photo facing south, right photo facing west. Note: tank battery vegetation density does not appear consistent with adjacent reference area (See photo #9) and has a large amount of sediment/gravel covering the disturbance. Sediment is moving in from a recently added drainage ditch to the south side of the alfalfa field located to the west of the disturbance (see photo #5).

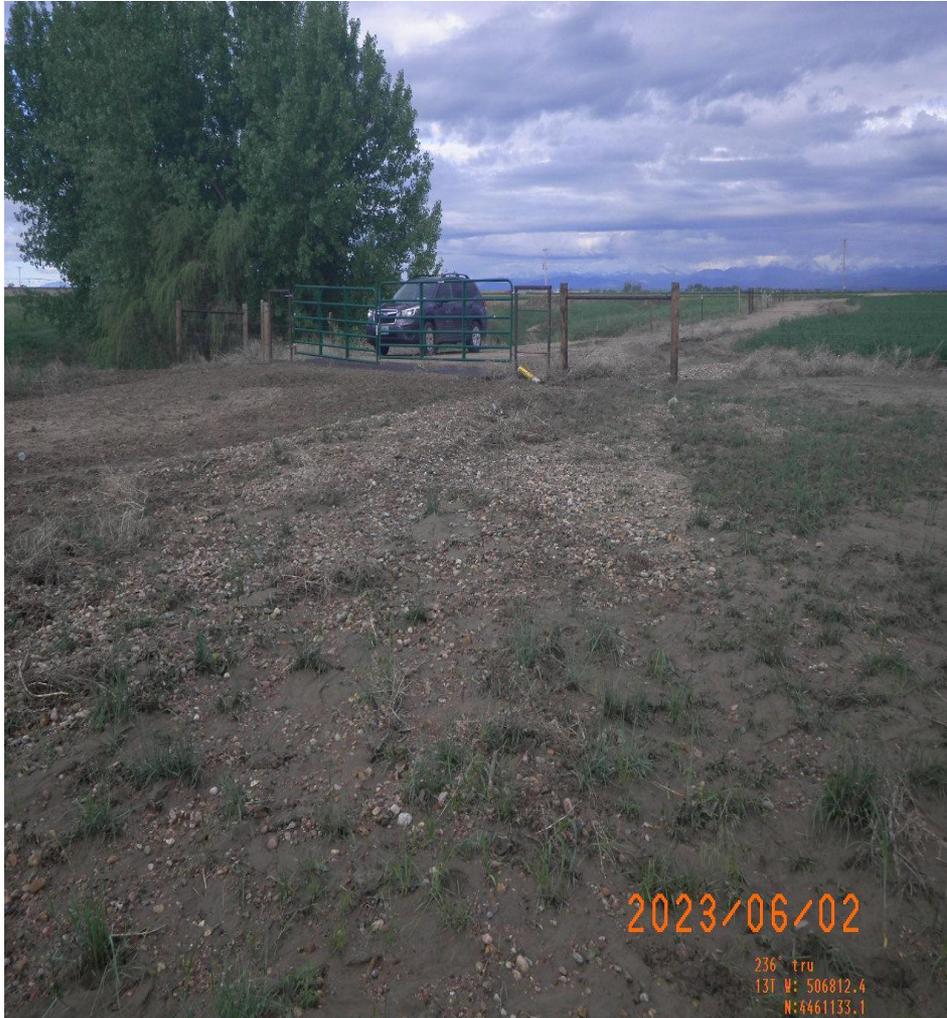
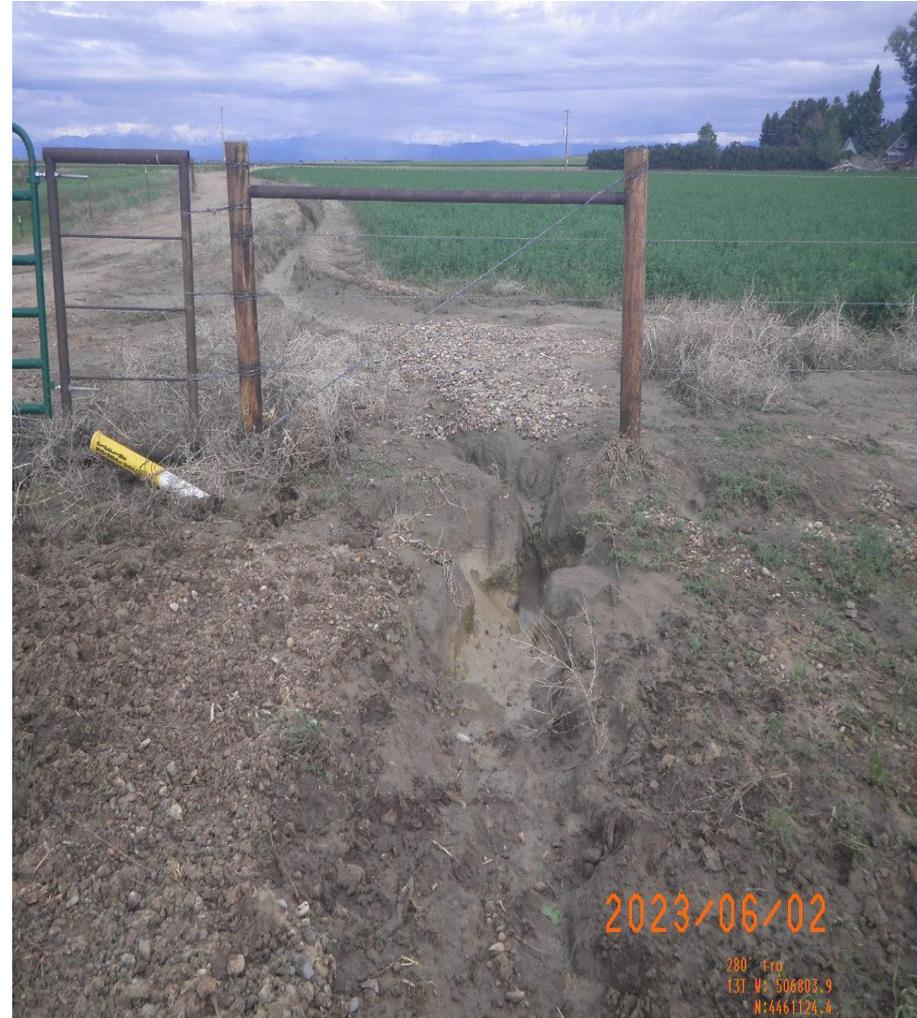
Photo 5. Photos of sediment moving into tank battery disturbance from adjacent alfalfa field.

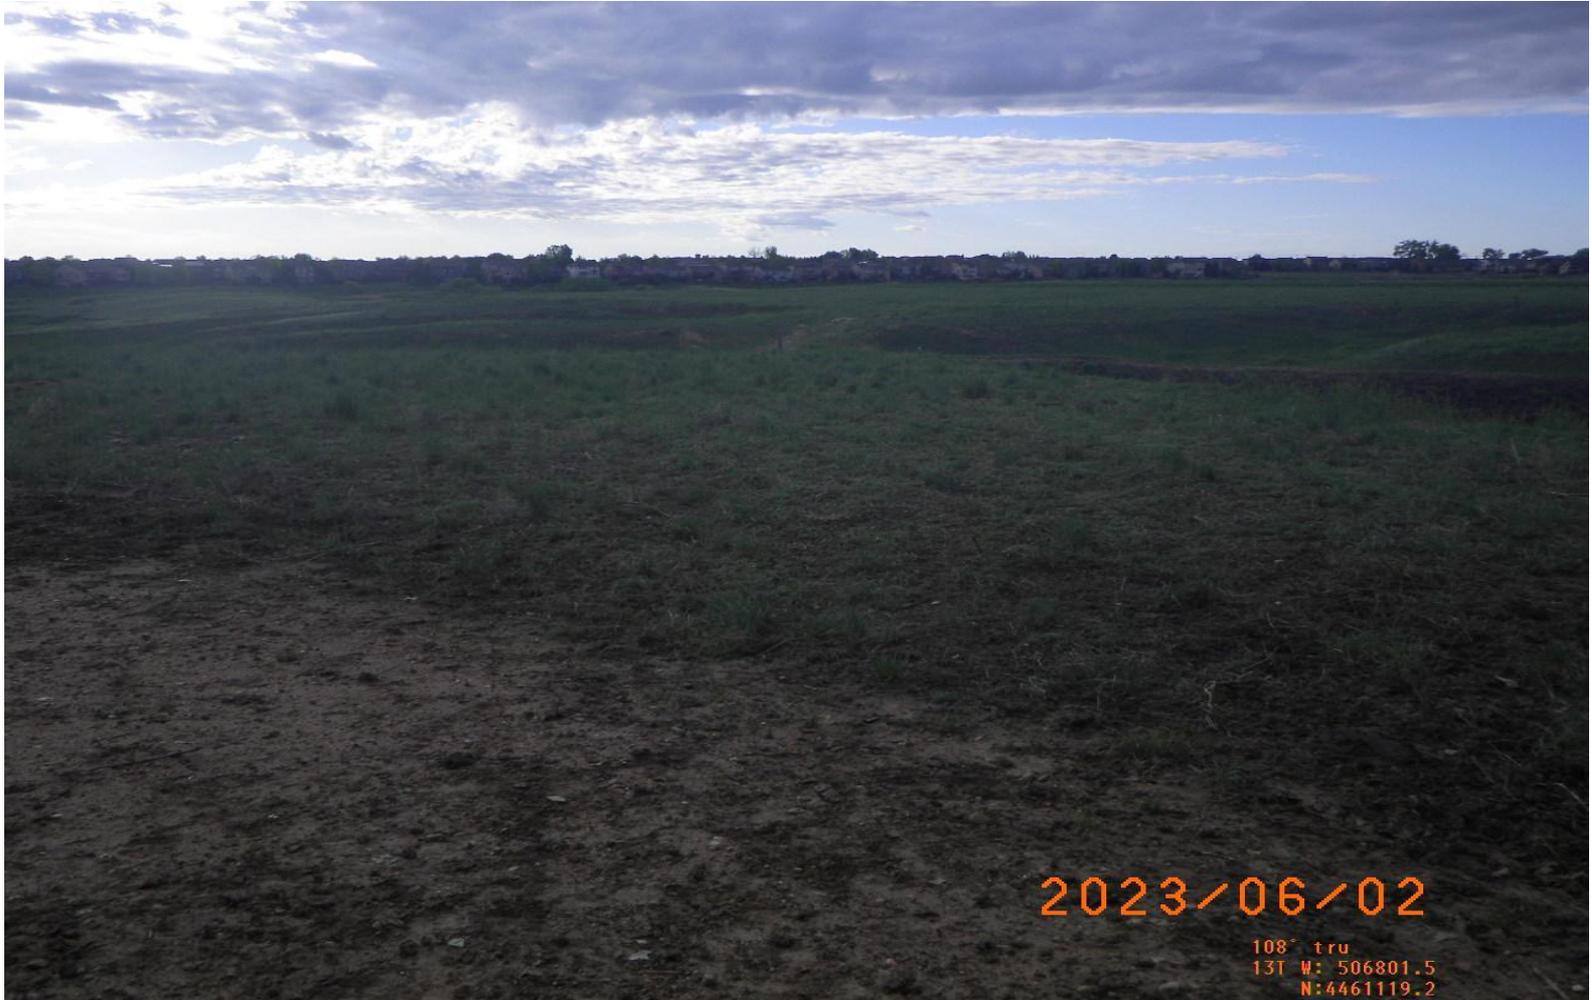
Photo 6. Overview photo of the well pad taken at ground level from the northern edge facing southeast.

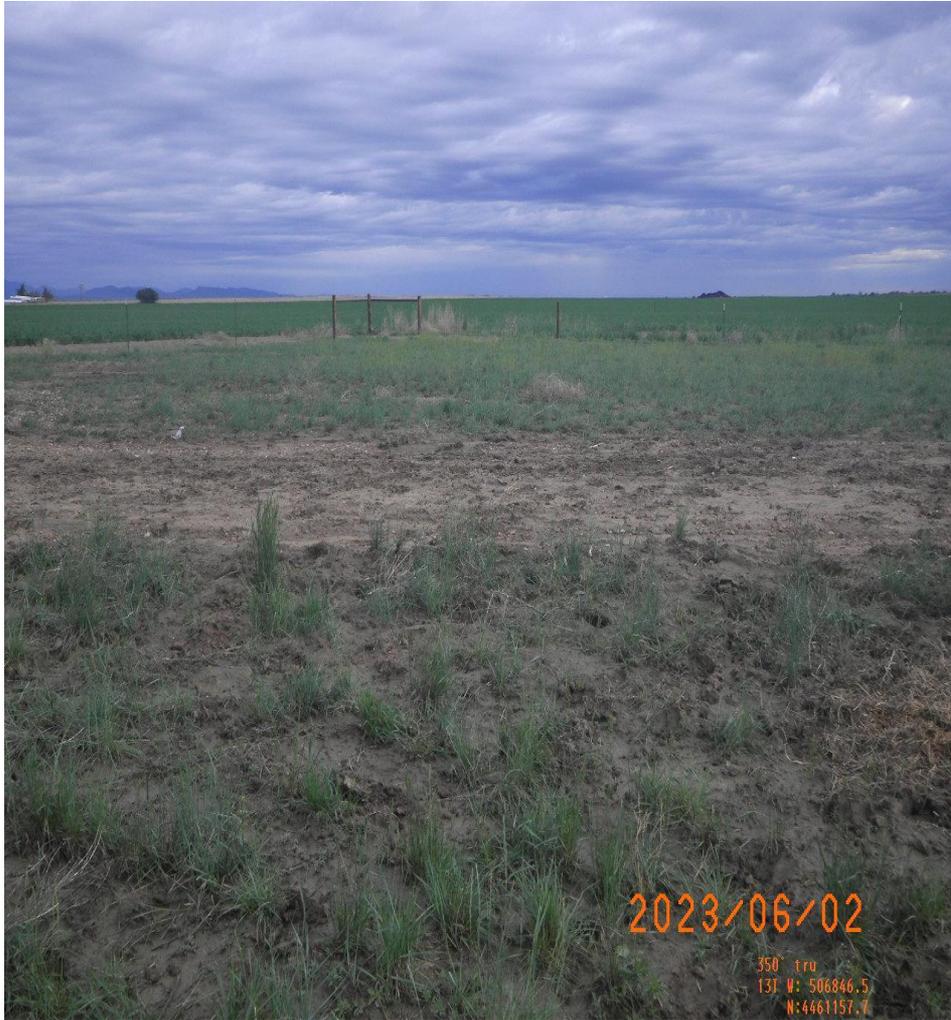
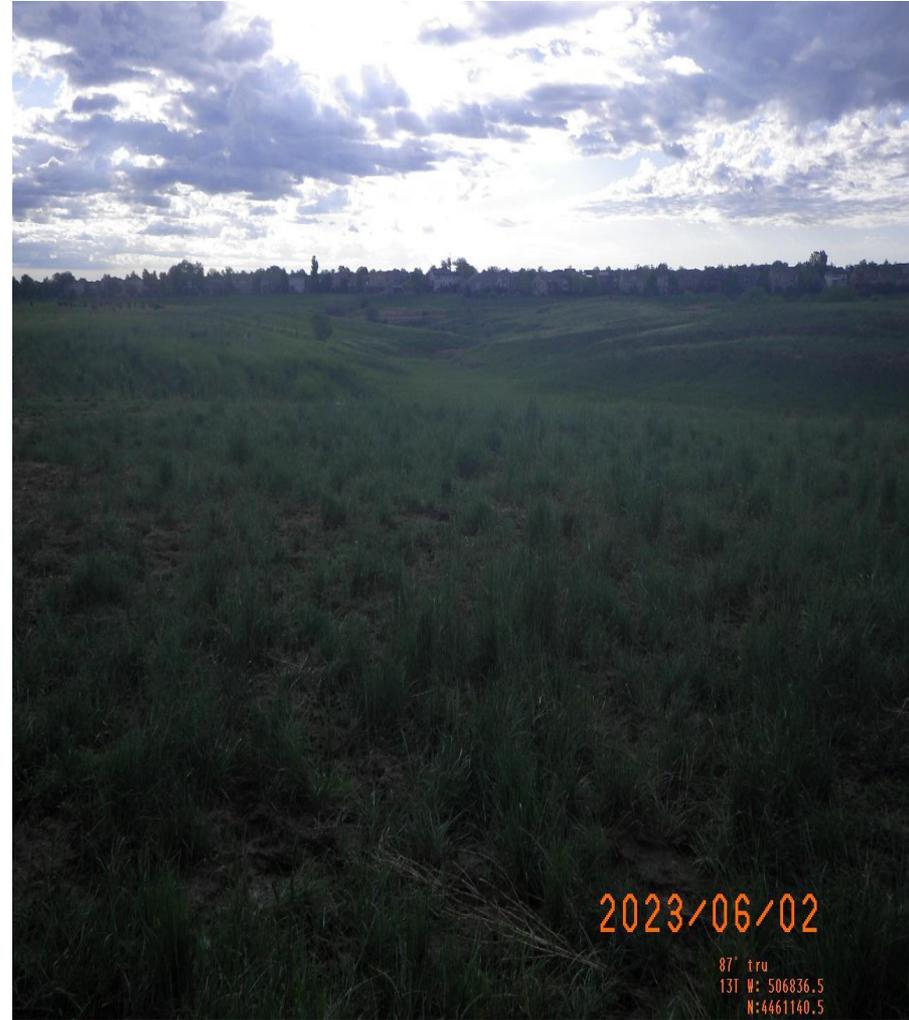
Photo 7. Cardinal photos taken at ground level from the middle of the well pad. Left photo facing north, right photo facing east.

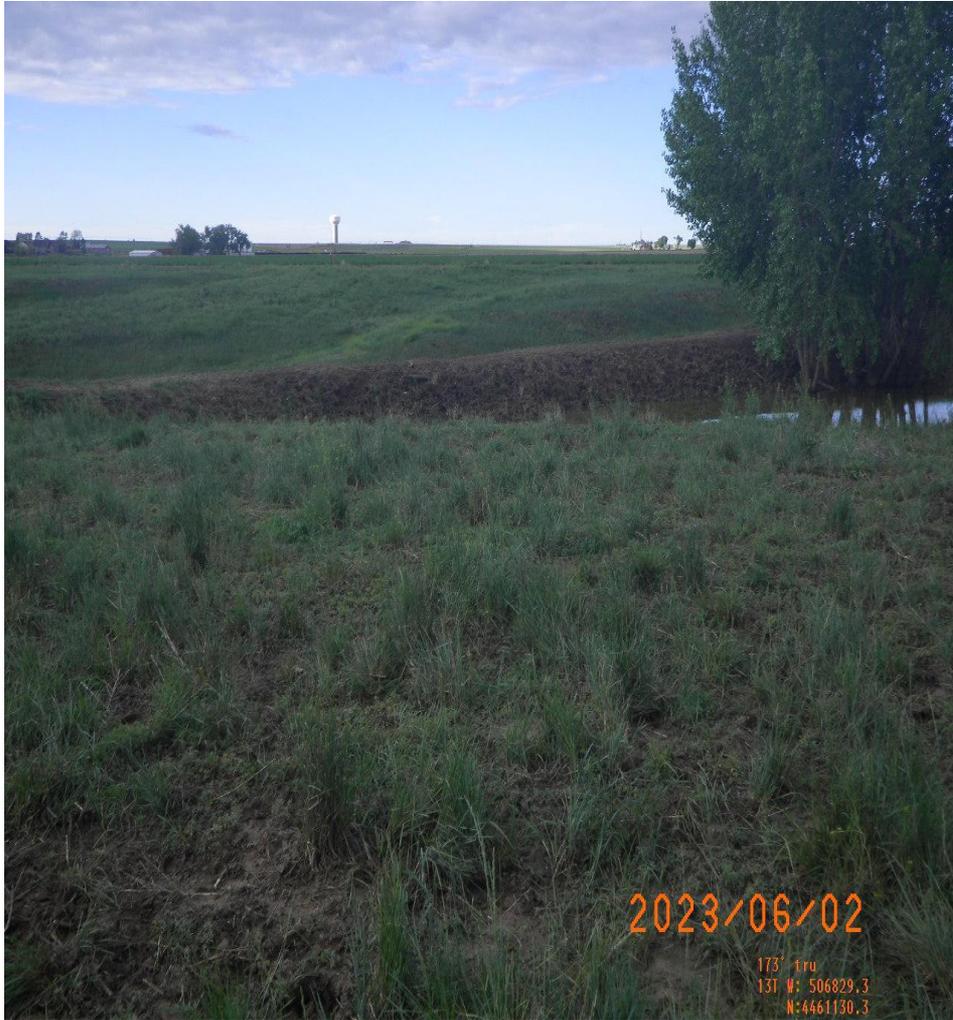
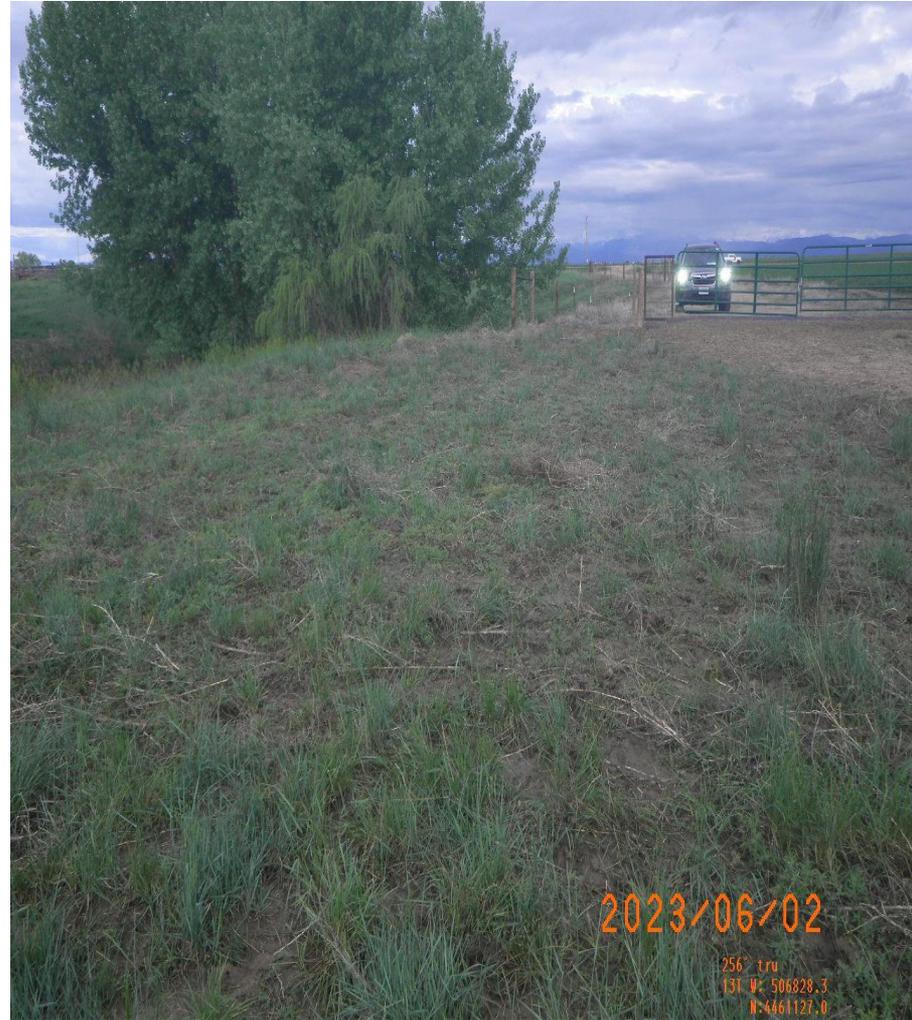
Photo 8. Cardinal photos taken at ground level from the middle of the well pad. Left photo facing south, right photo facing west. Note: well pad has higher vegetation cover than the tank battery and appears consistent with reference area (see photo #9) but has residual sediment moving in from the north. Well pad was also grazed recently.

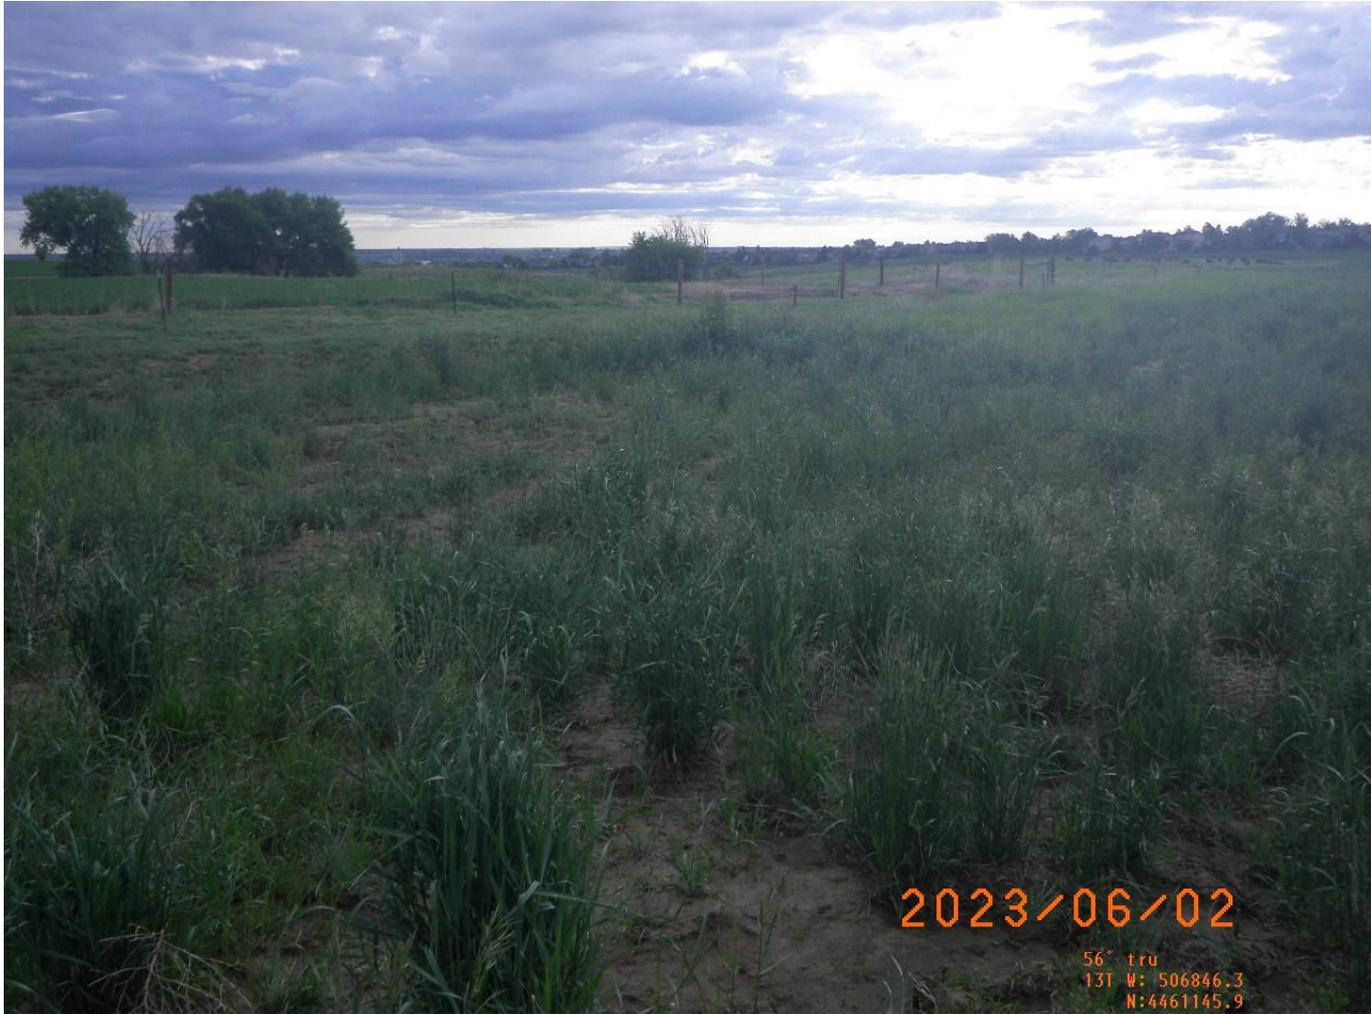
Photo 9. Well pad and tank battery reference area.
