Inspection Photos

8/14/2023

Operator: GENESIS GAS & OIL COLORADO LLC
- 10384

Location Number: 413497
Rio Blanco County, CO

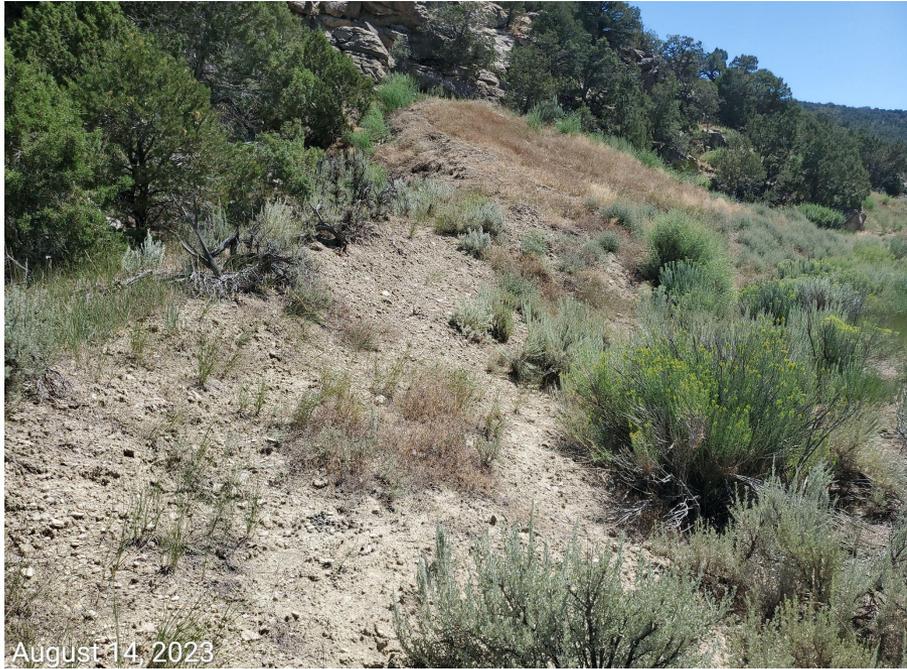
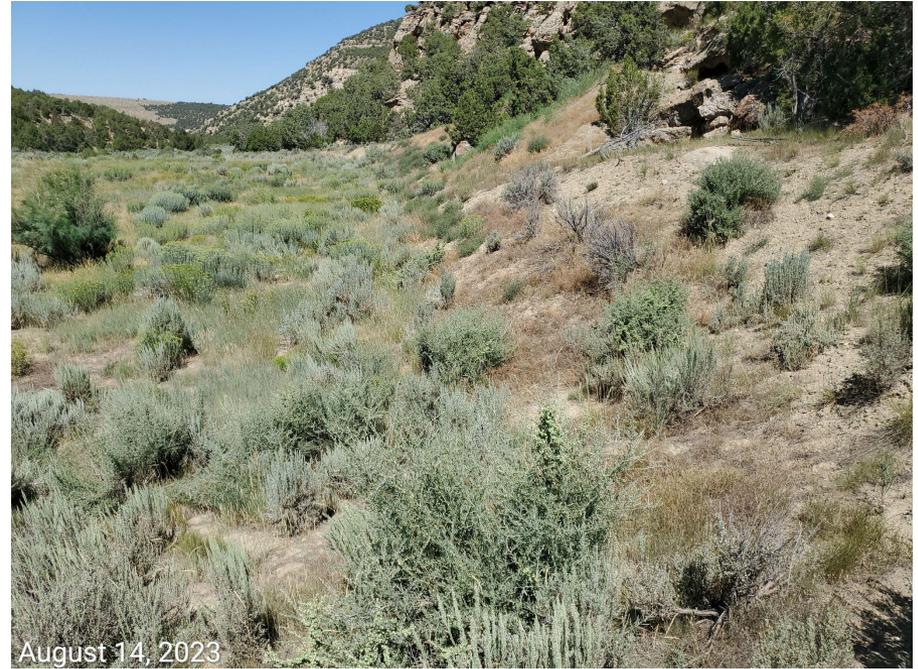
Photo 1: Photo shows cut slopes of the Location; Location has not been decompacted, recontoured, regraded and reclaimed in accordance with 1004 Rules. Cut slopes lack stabilization.

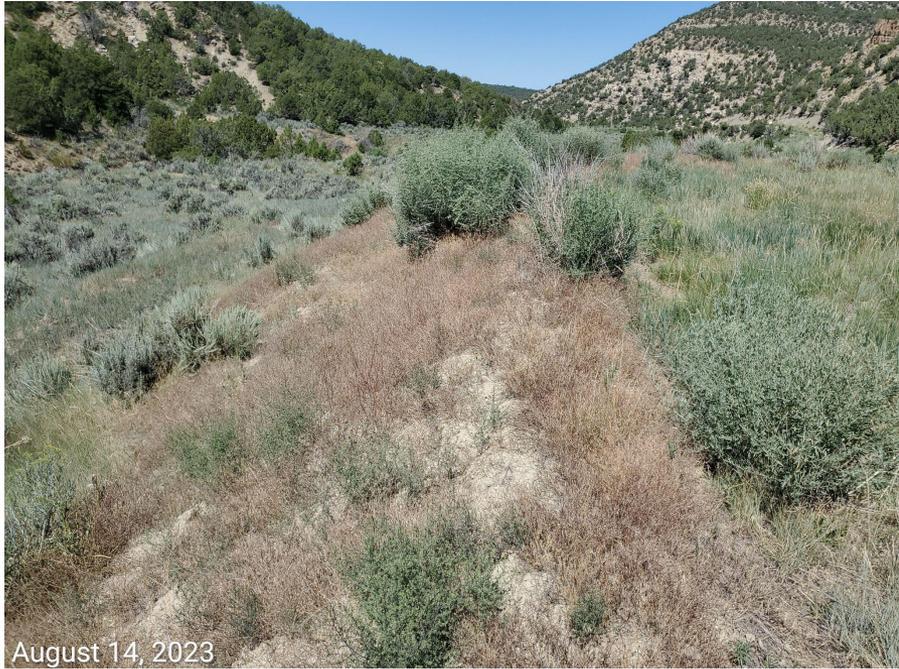
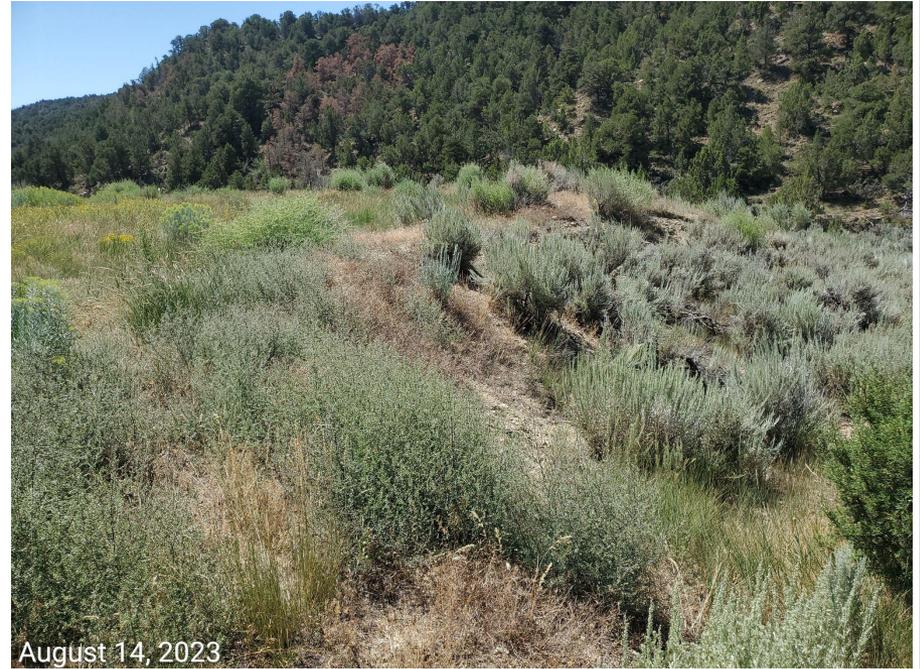
Photo 2: Fill slopes on the Location; photo show Location has not been decompacted, recontoured, regraded and reclaimed in accordance with 1004 Rules.

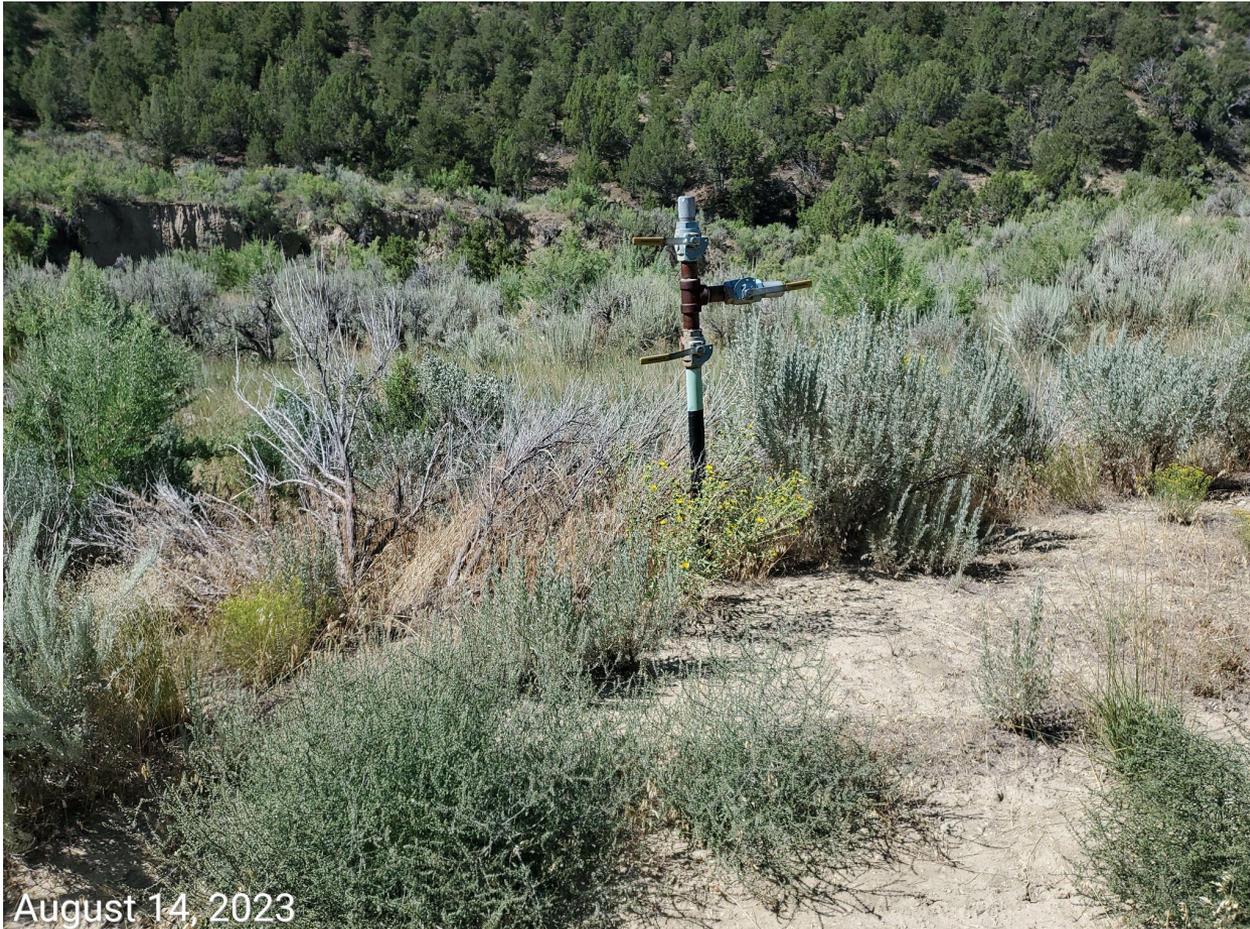
Photo 4: Equipment remaining along access road.

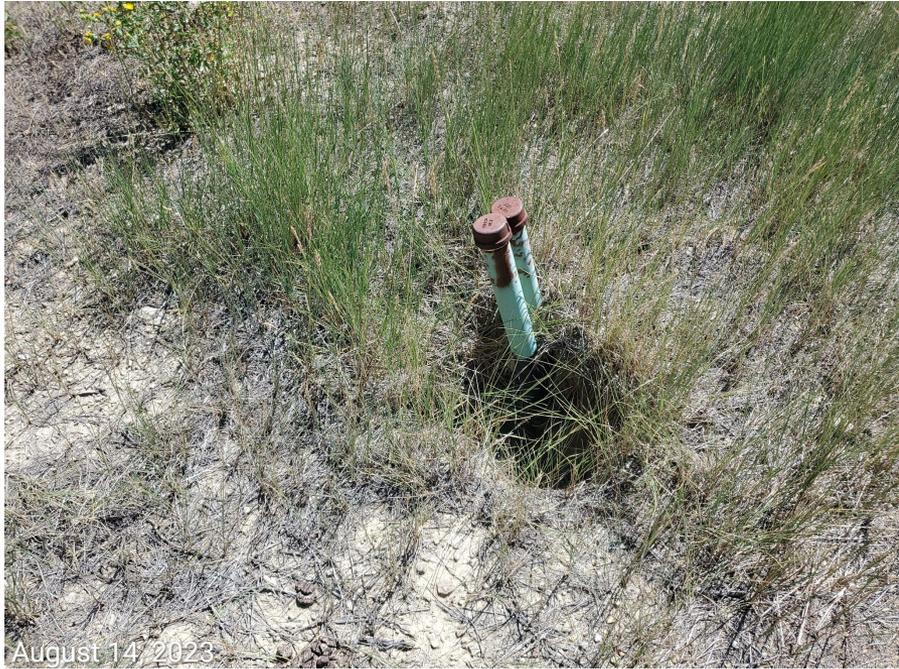
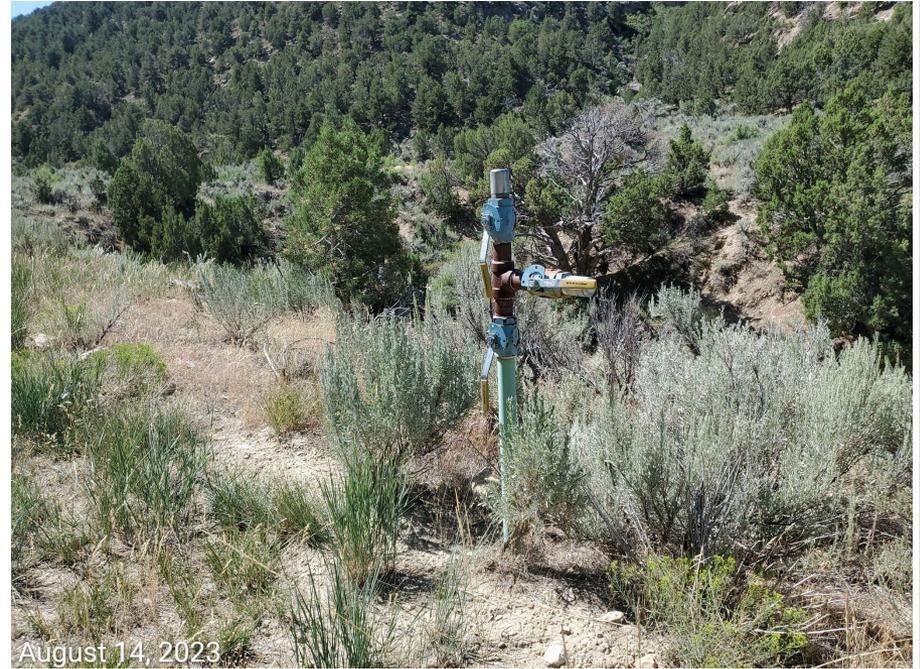
Photo 5: Equipment remaining on Location and access road.

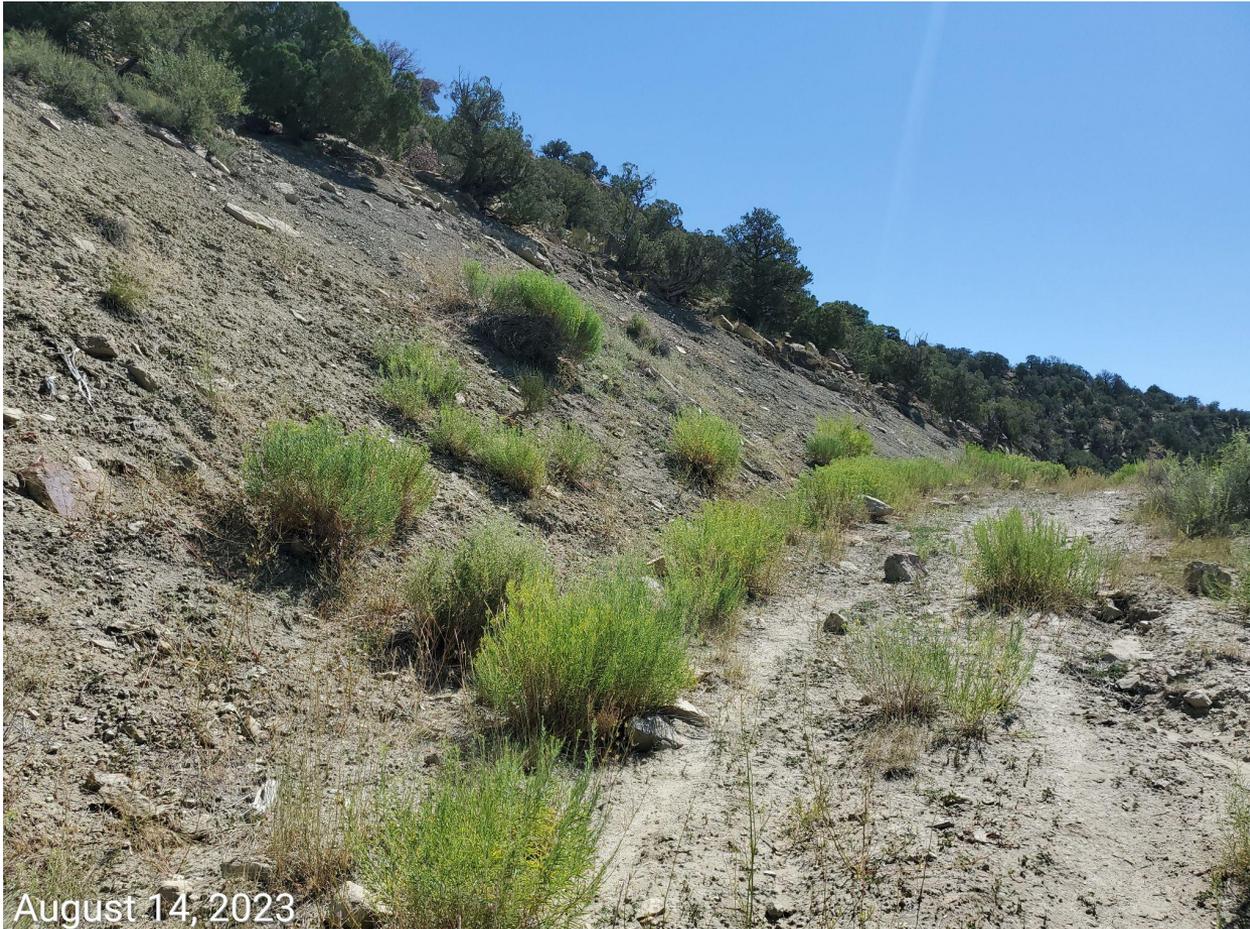
Photo 6: Photo example showing erosion degradation along access road. Stormwater and erosion control measures remain inadequate. Access road has not been decompacted, recontoured, regraded and reclaimed in accordance with 1004 Rules.

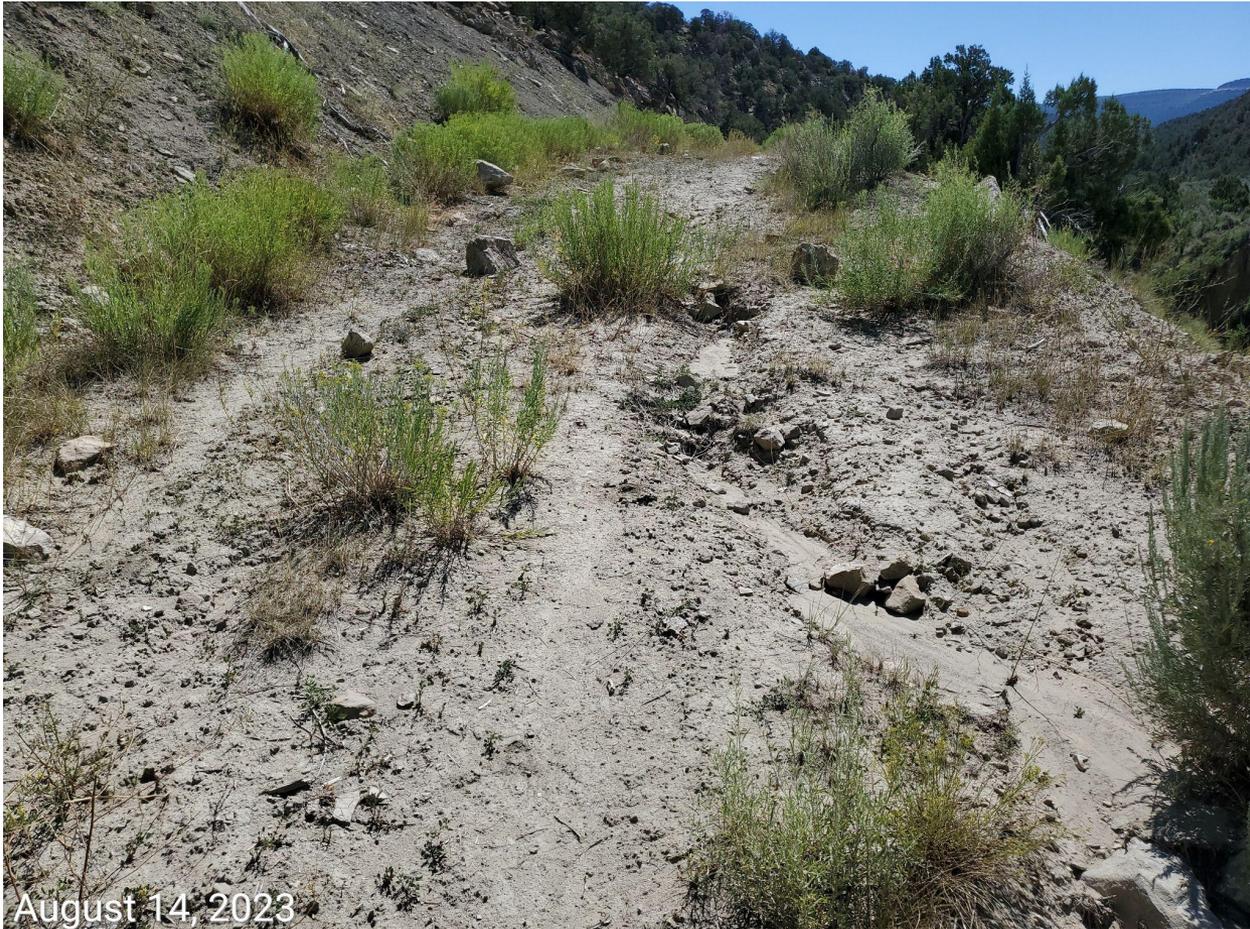
Photo 7: Photo example showing erosion degradation along access road. Stormwater and erosion control measures remain inadequate. Access road has not been decompacted, recontoured, regraded and reclaimed in accordance with 1004 Rules.

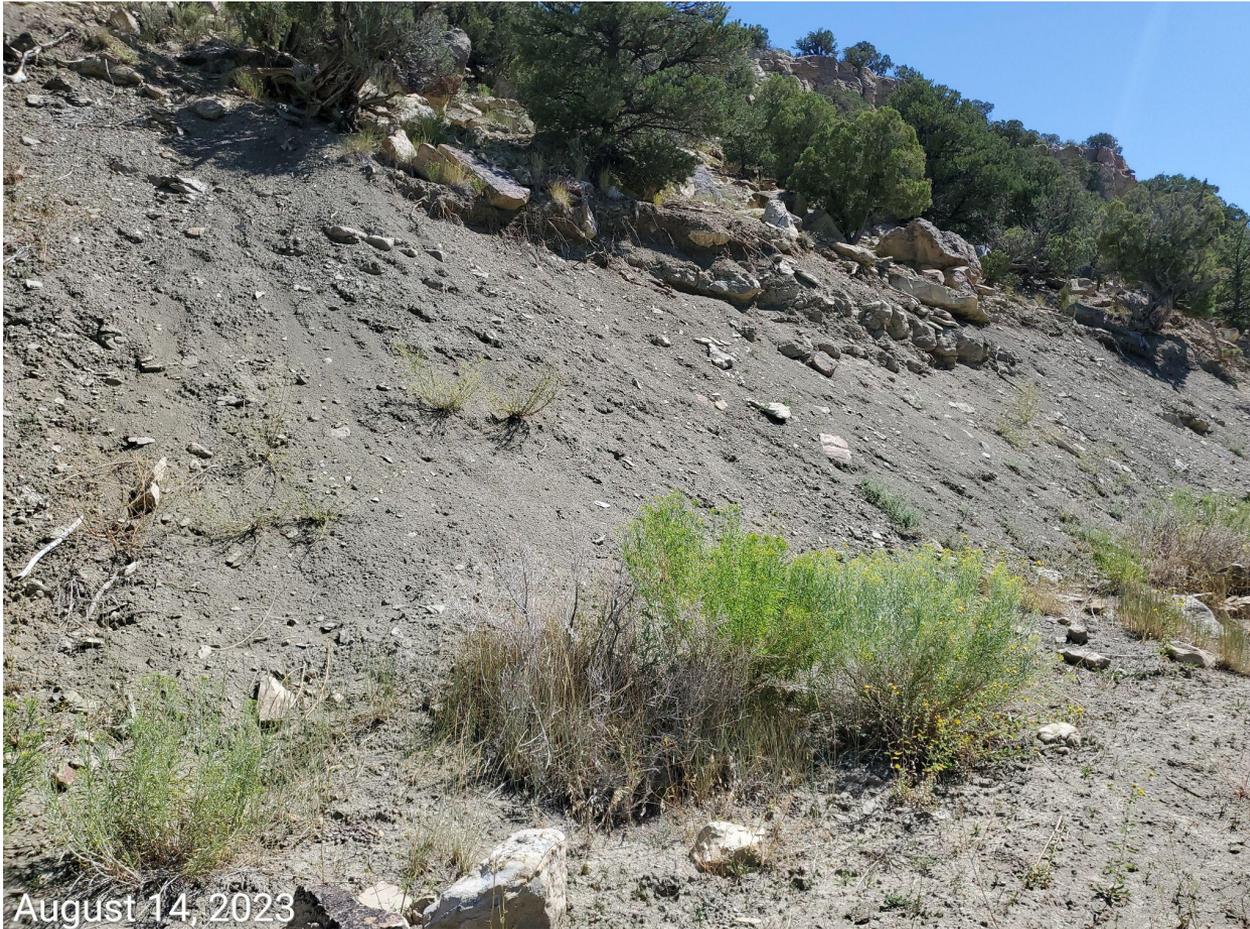
Photo 8: Photo example showing erosion degradation along access road. Stormwater and erosion control measures remain inadequate. Access road has not been decompacted, recontoured, regraded and reclaimed in accordance with 1004 Rules.

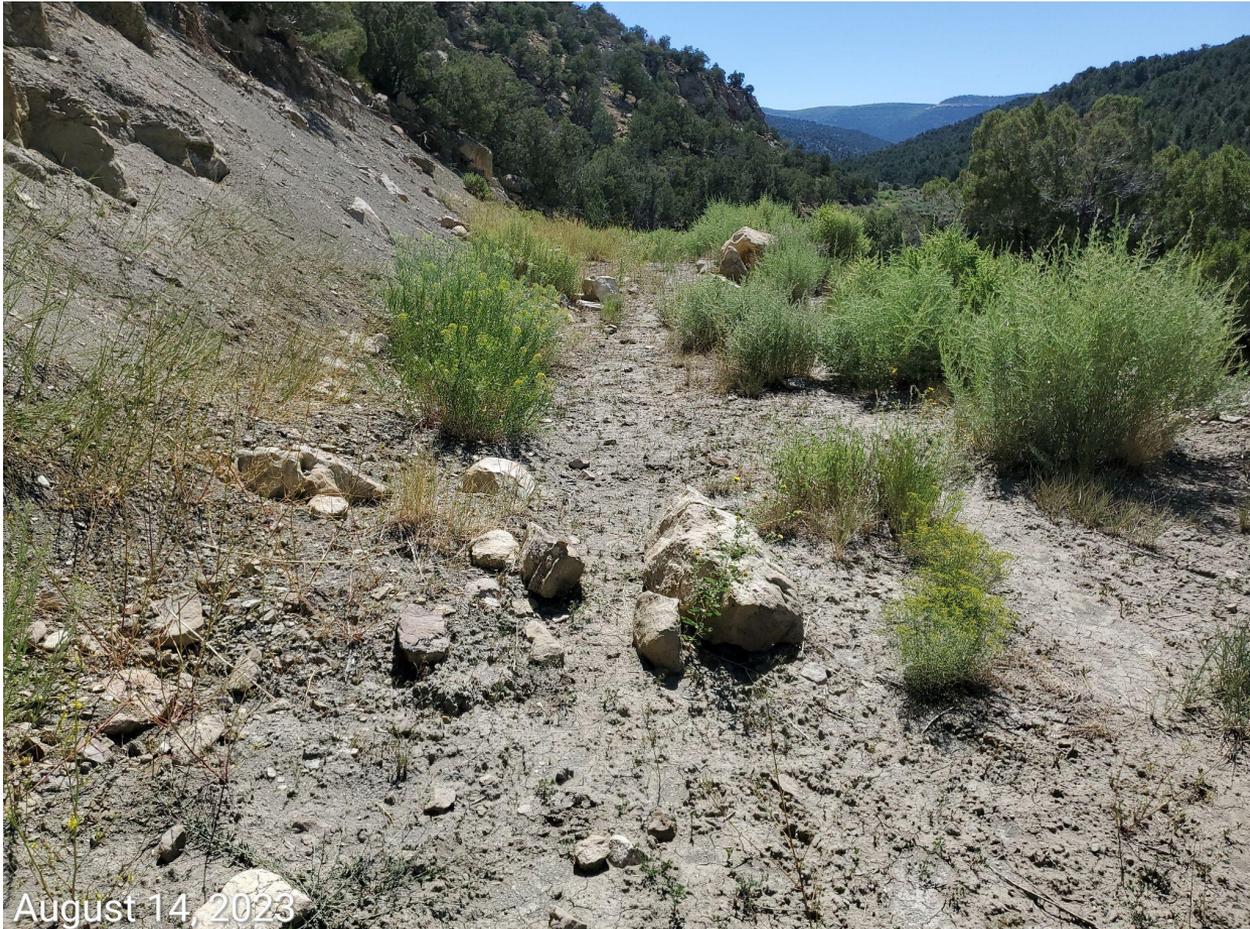
Photo 9: Photo example showing erosion degradation along access road. Stormwater and erosion control measures remain inadequate. Access road has not been decompacted, recontoured, regraded and reclaimed in accordance with 1004 Rules.

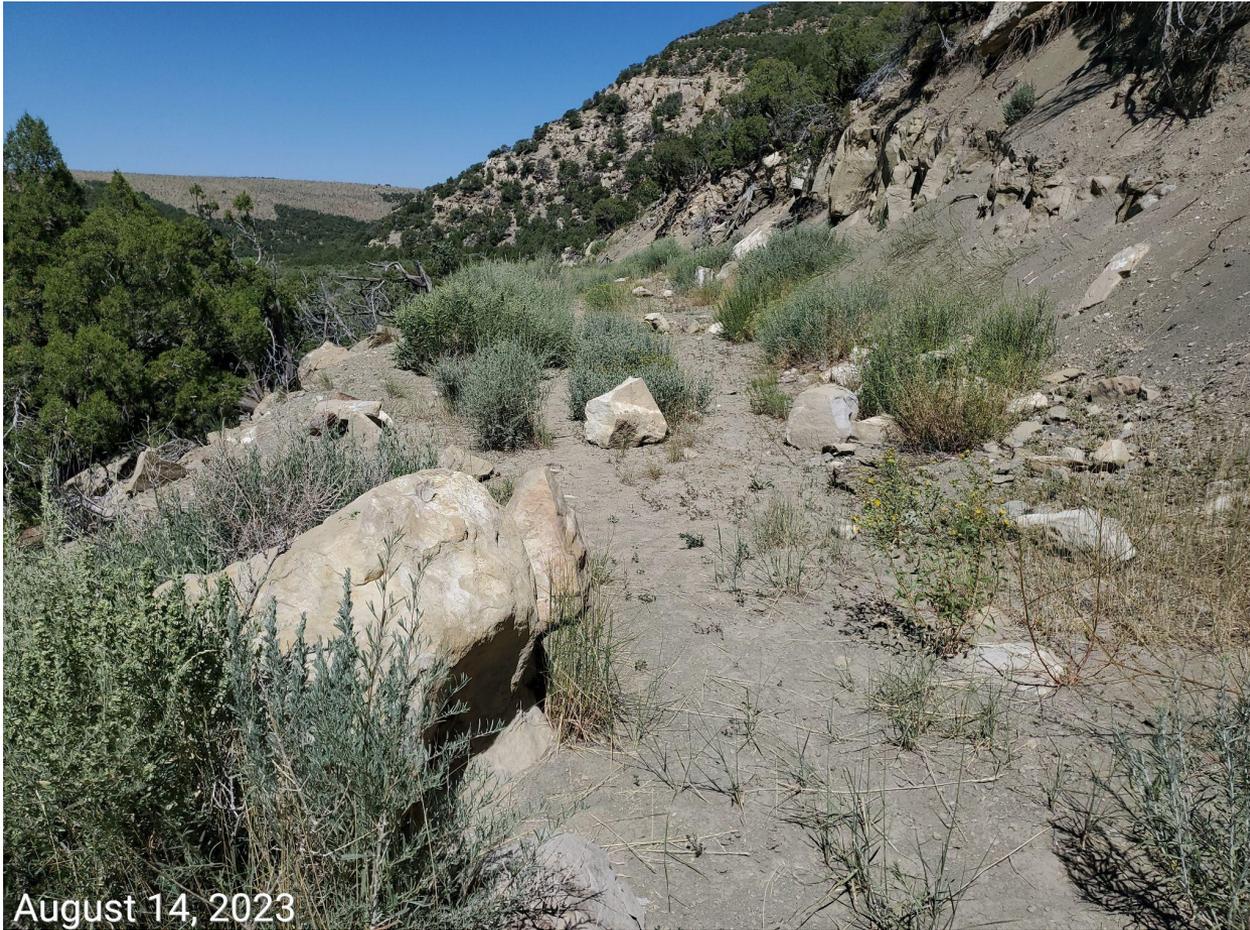
Photo 10: Photo example showing erosion degradation along access road. Stormwater and erosion control measures remain inadequate. Access road has not been decompacted, recontoured, regraded and reclaimed in accordance with 1004 Rules.

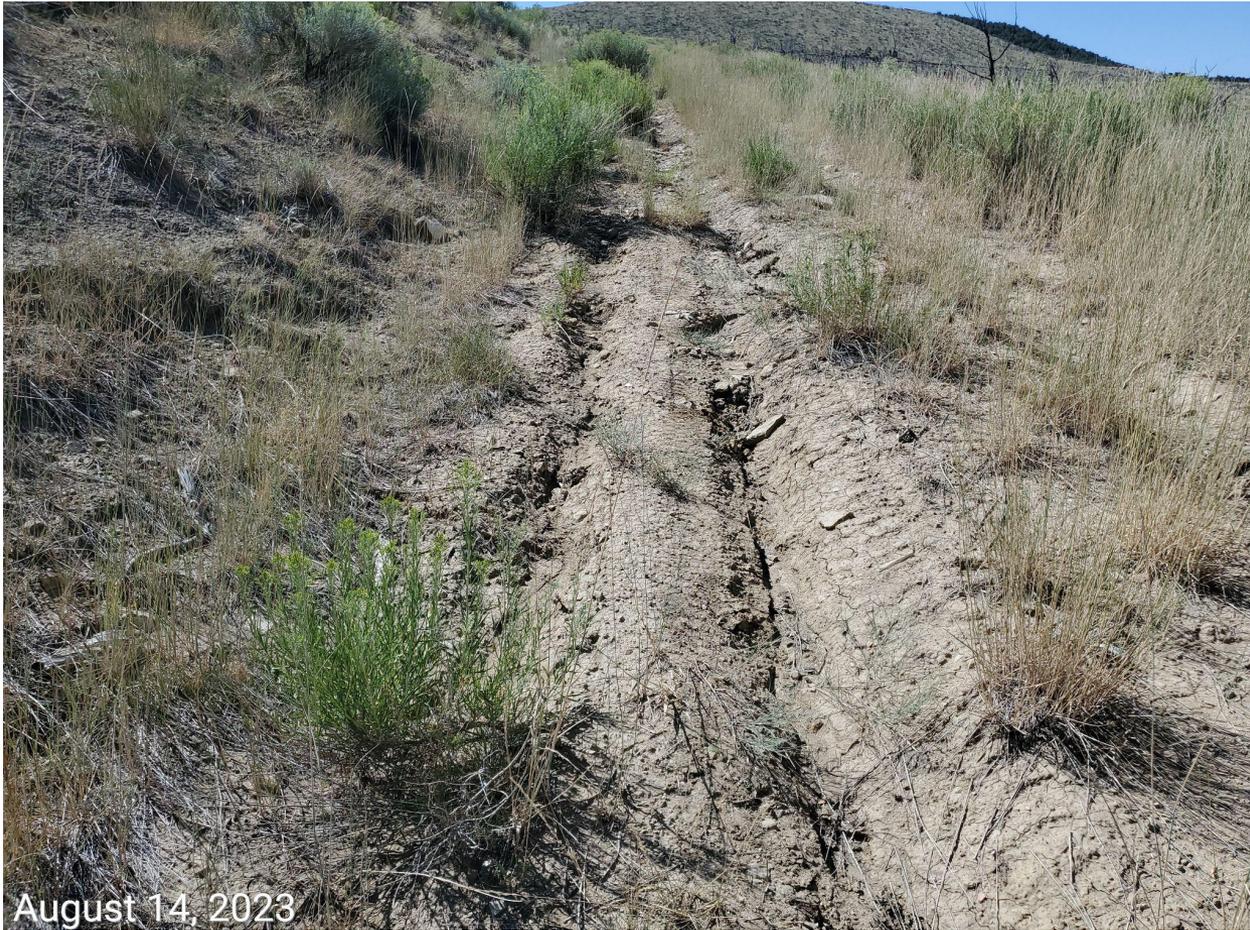
Photo 12: Photo example showing erosion degradation along access road. Stormwater and erosion control measures remain inadequate. Access road has not been decompacted, recontoured, regraded and reclaimed in accordance with 1004 Rules.
