# Interim Reclamation and Stormwater Inspection

Operator: CCRP OPERATING INC - #10665

Location ID: 443490

Inspection Photos  
Location Name: Meader 5-N Pad  
Location ID: 443490

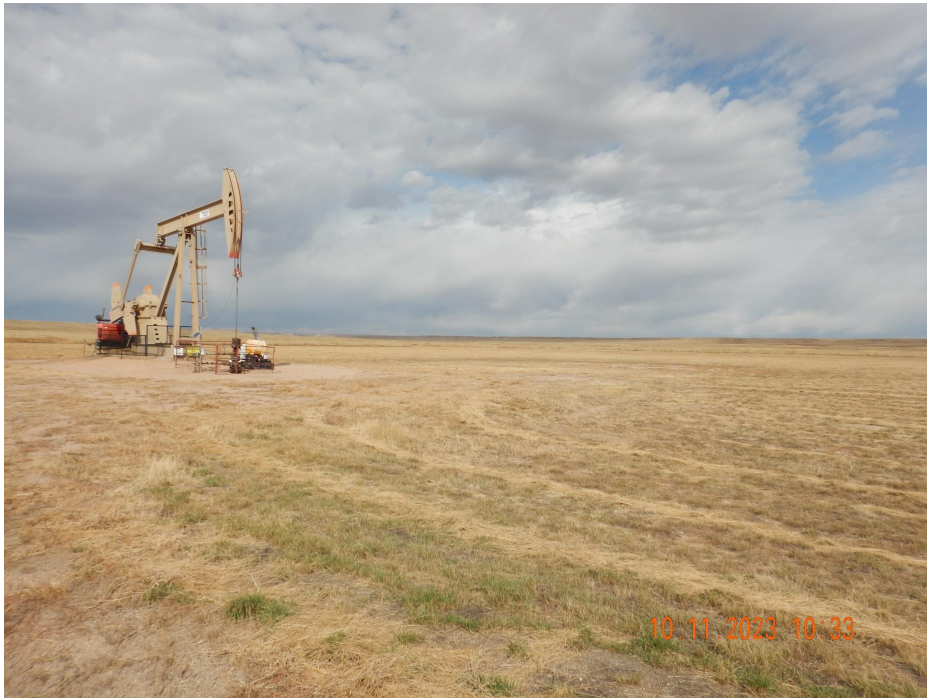
**Photo 1.** Photo taken from the location, facing West. Photo illustrates interim reclamation has been performed and perennial vegetation was observed and meets Rule 1003 standards.

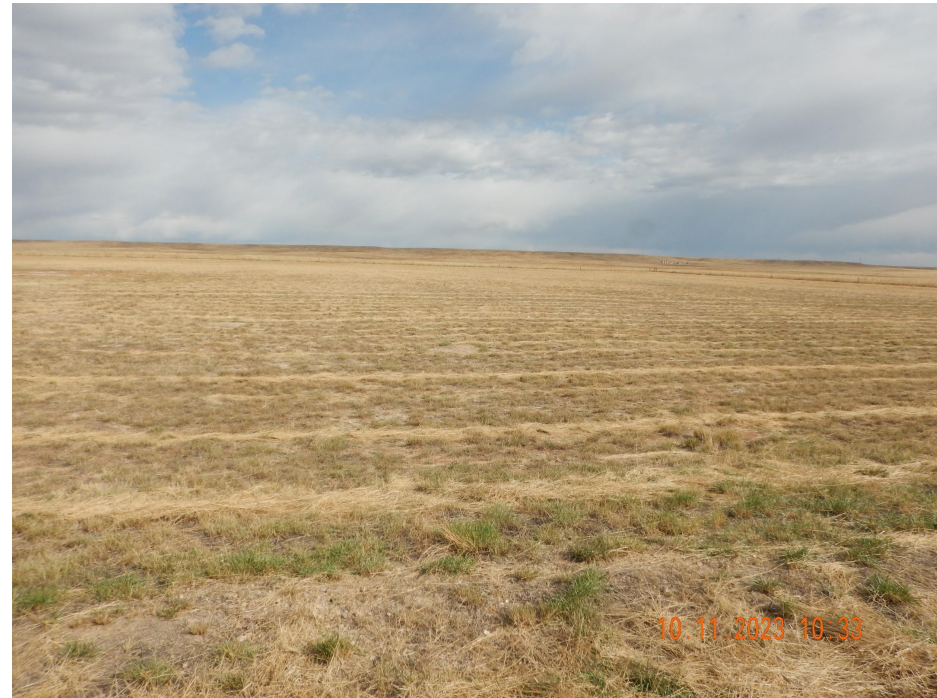
**Photo 2.** Photo taken from the location, facing North. See comments under Photo 1.

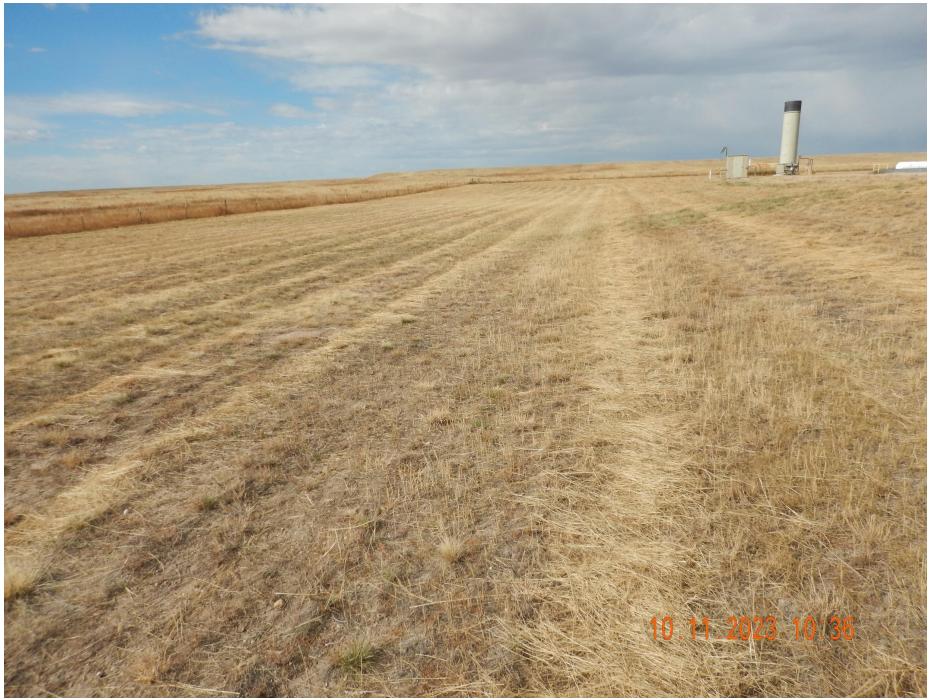
**Photo 3.** Photo taken from the southeastern interim area, facing West. See comments under Photo 1.

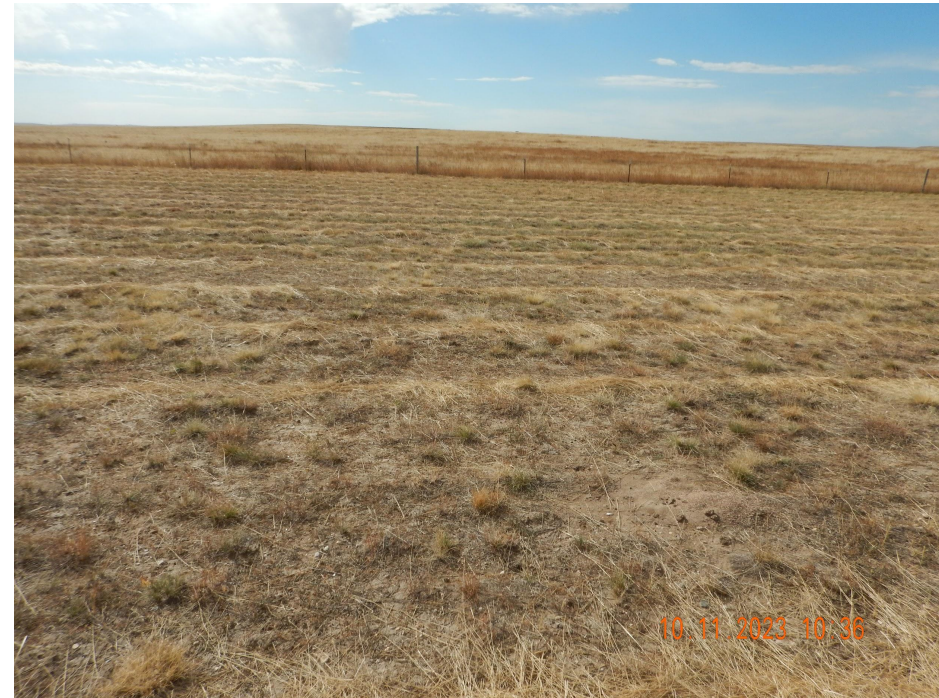
**Photo 4.** Photo taken from the southern interim area, facing South. See comments under Photo 1.

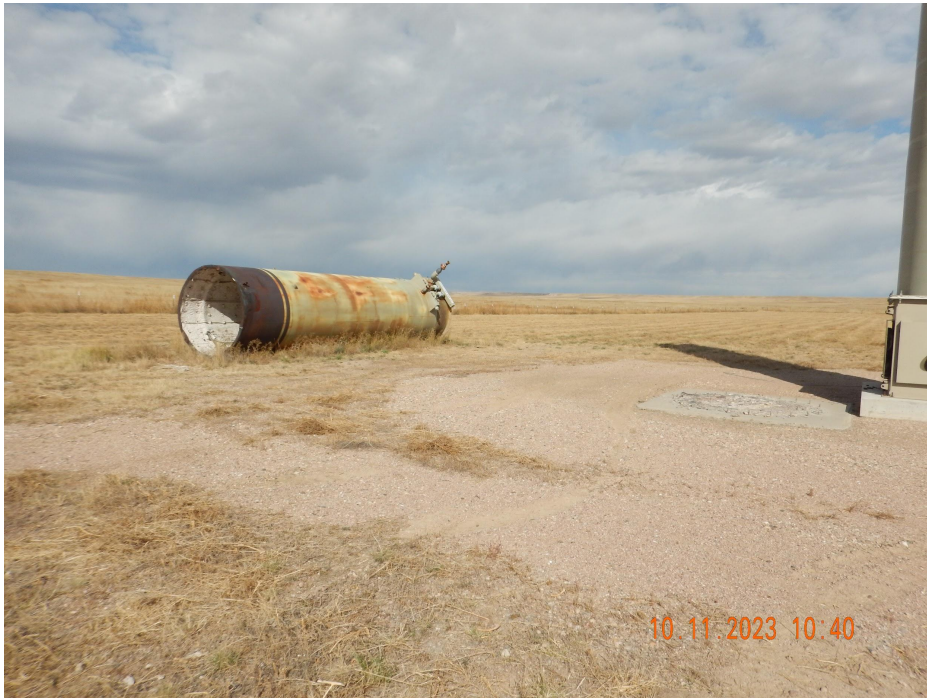
**Photo 5.** Photo taken from the western interim reclamation area, facing West. Photo illustrates unused equipment (ECD) that needs to be removed.

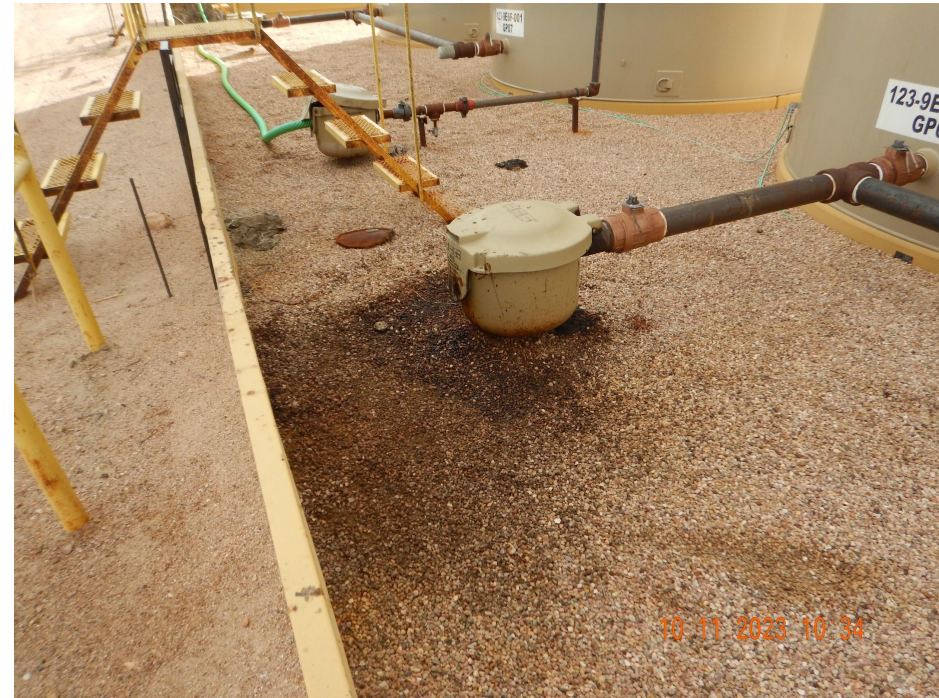
**Photo 6.** Photo taken from the secondary containment area. Photo illustrates stained soil that needs to be cleaned up and removed. Also, load out lines were observed being stored inside secondary containment. This would be considered unused equipment.

Note- Operator has a load out line hanger located outside of the eastern secondary containment that should be used.
