Inspection Photos

Loc: 320959

Operator: **PONCHO PRODUCTION COMPANY**

Inspection Date: 10/31/2023

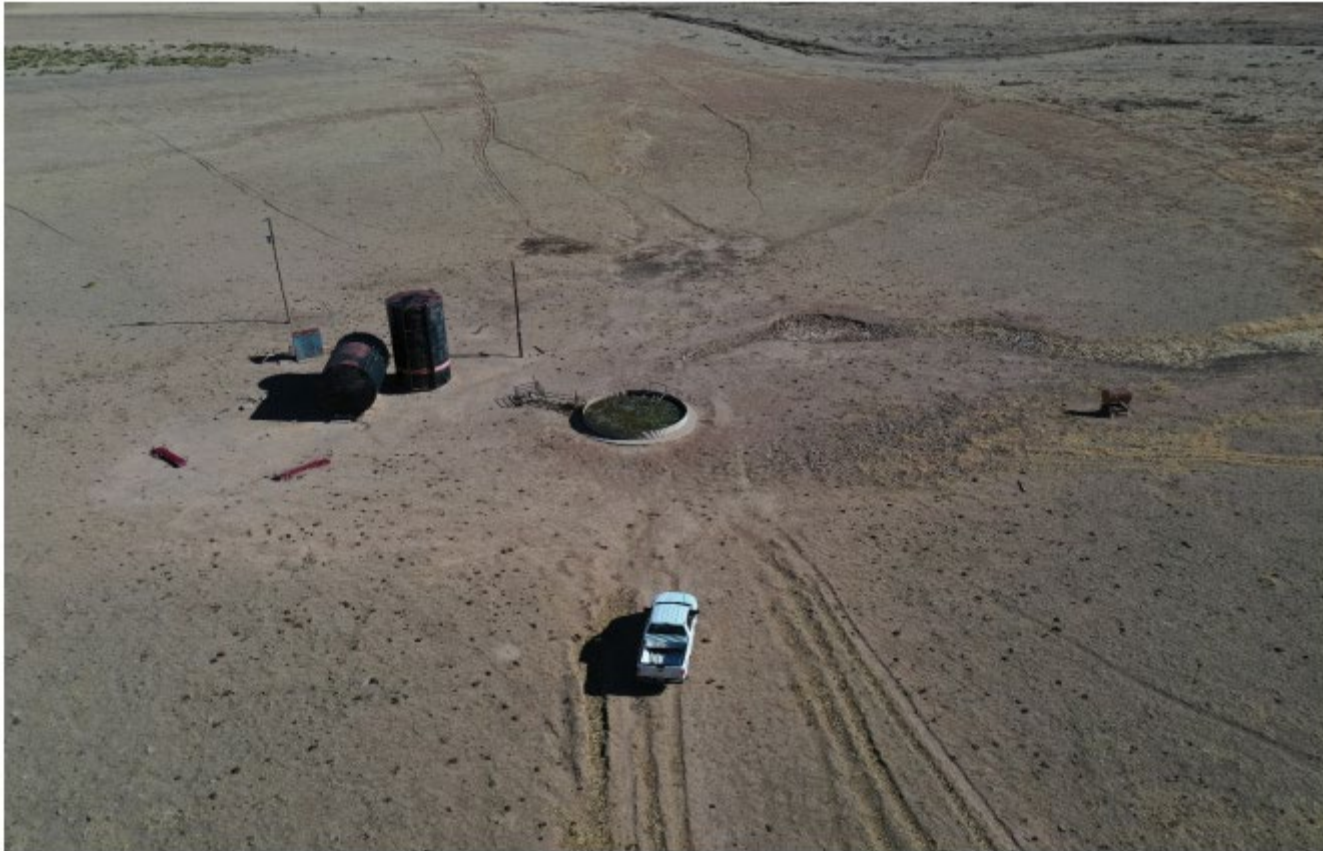
Photo 1. Drone aerial photo facing southeast toward the abandoned well site.

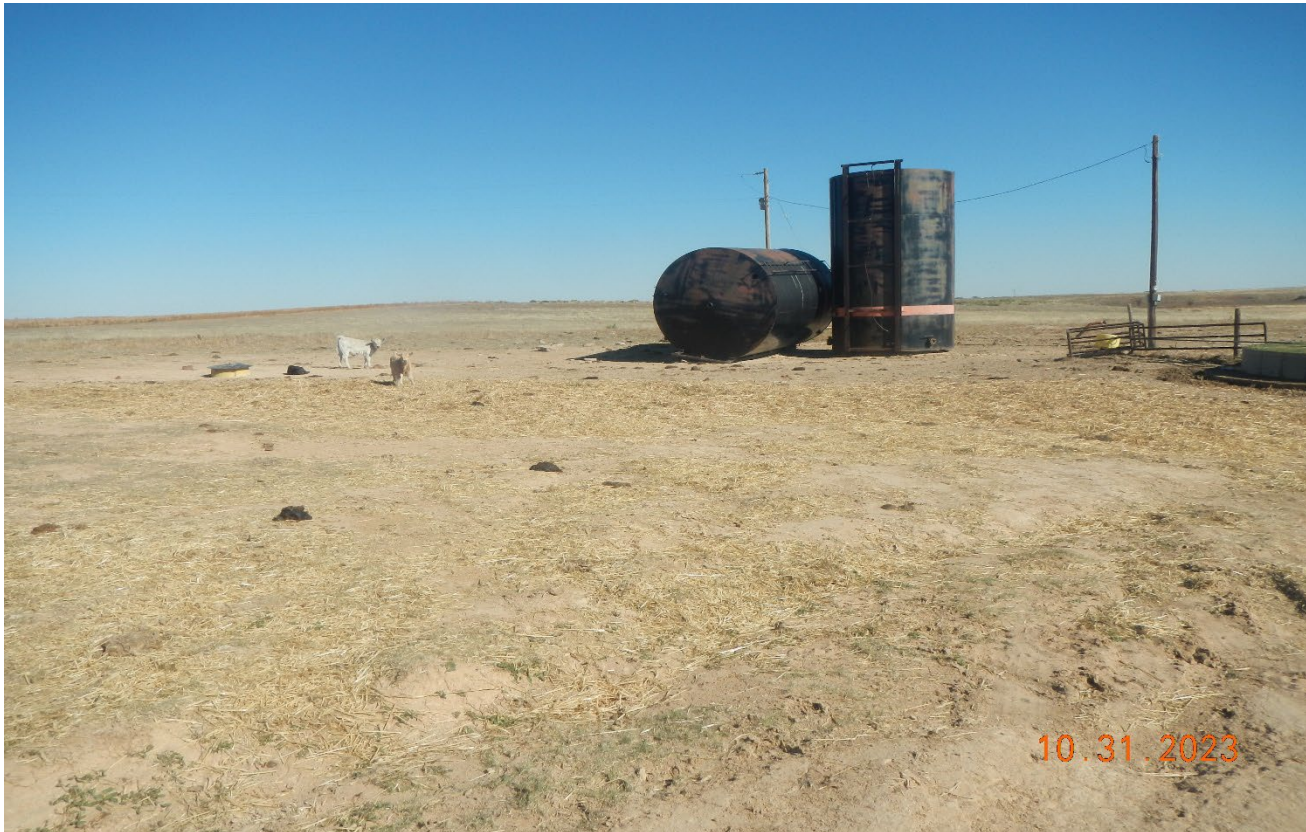
Photo 2. Facing southeast toward the location. There is a water well and stock tank at the location belonging to the landowner. The 2 black tanks shown are associated equipment from the well site that must be removed.

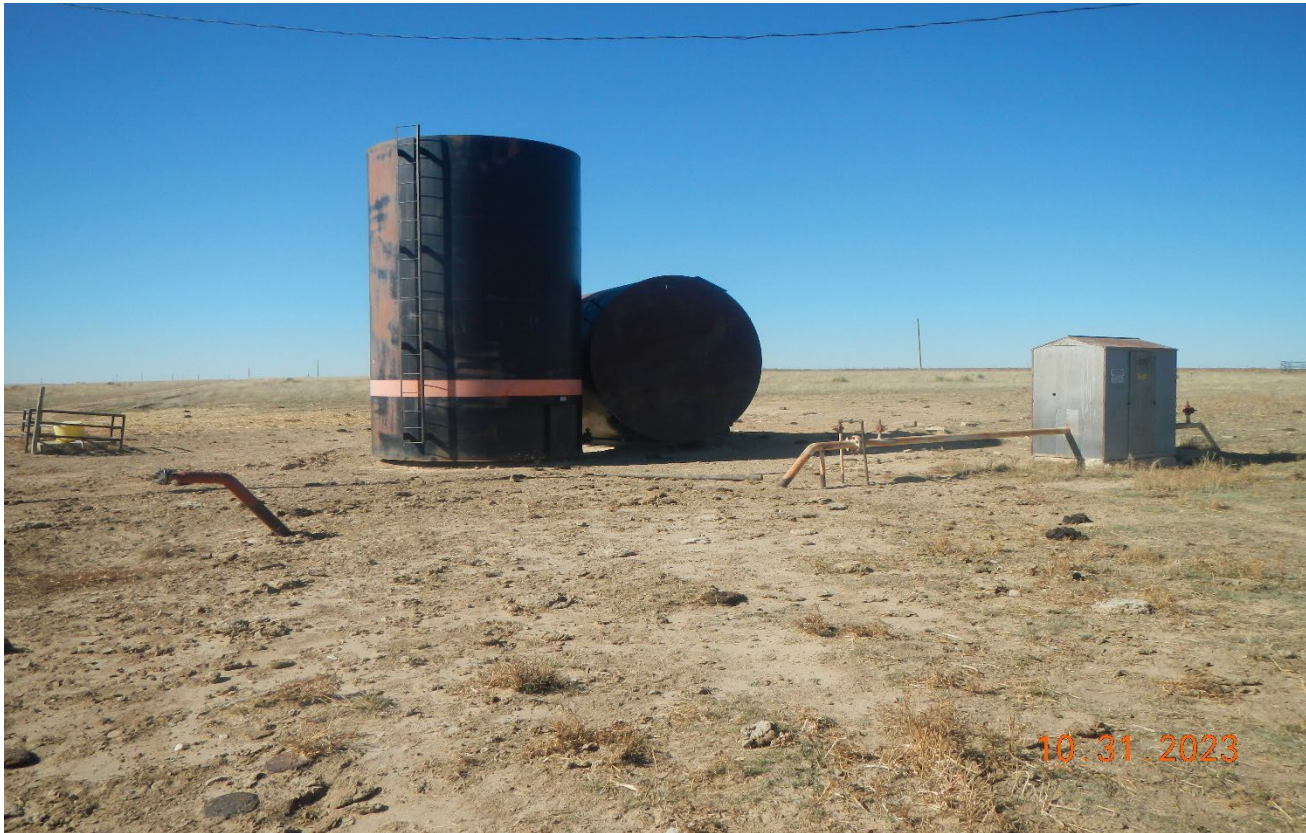
Photo 3. There are two tanks, pipe riser, meter run, and cement debris that remain. All equipment should have been removed within 3 months of well abandonment.

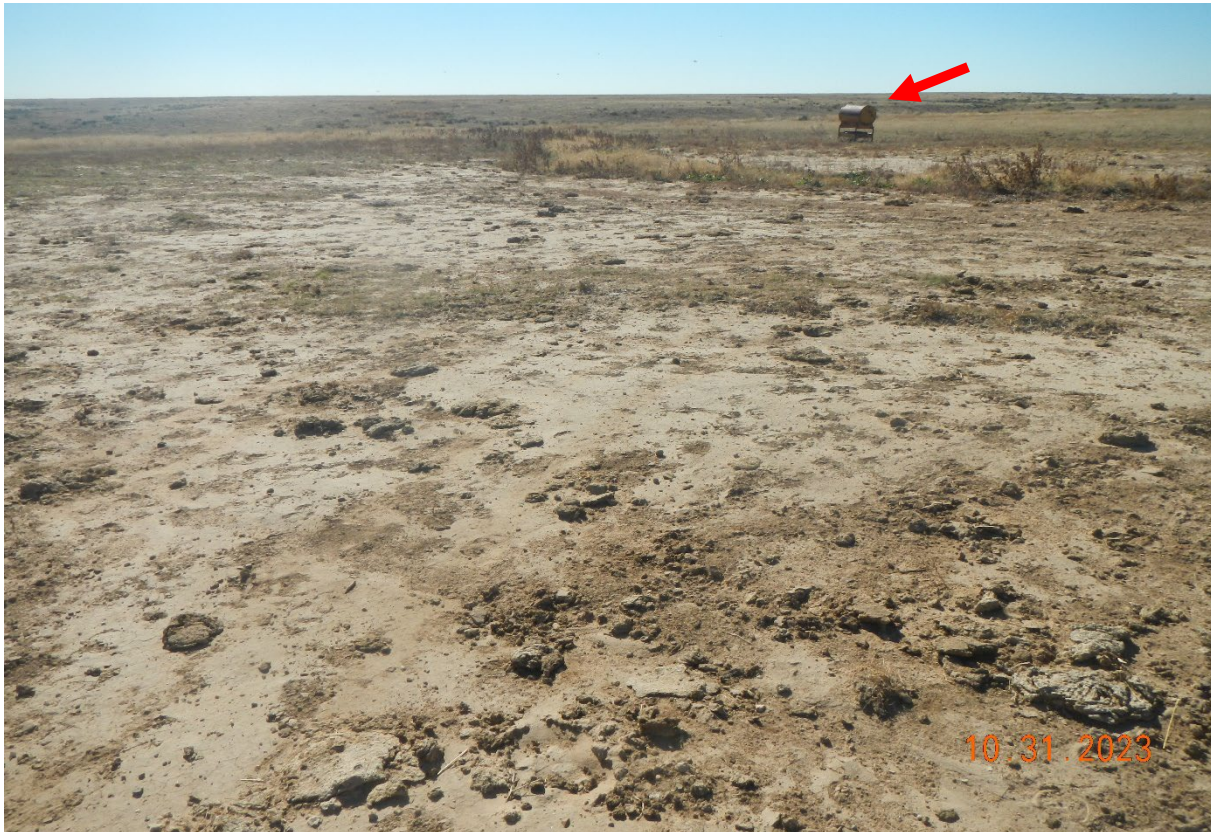
Photo 4. Facing southwest at the location. There are areas of the location with no vegetation growth which will need to be reclaimed. There is a yellow tank that remains at the southwest side of the location.

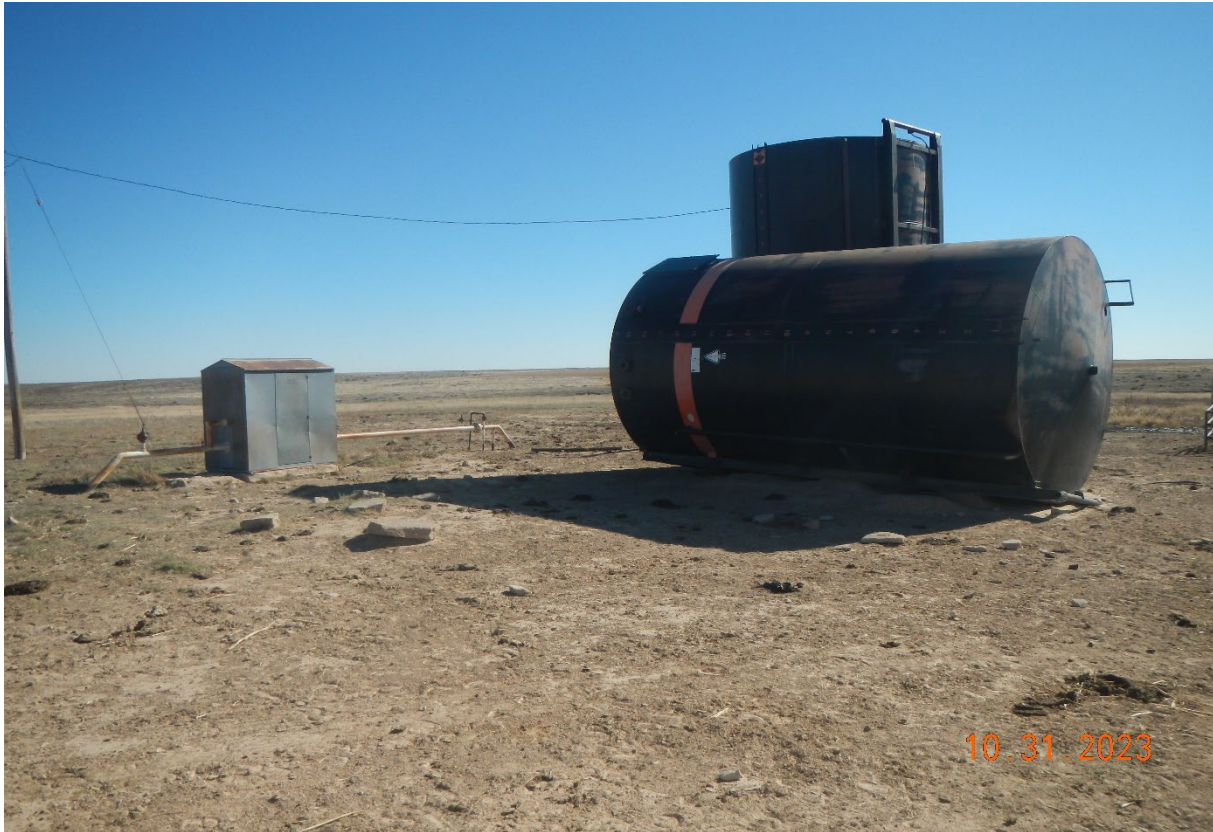
Photo 5. Facing southeast at the location. There are concrete debris scattered around the tanks.

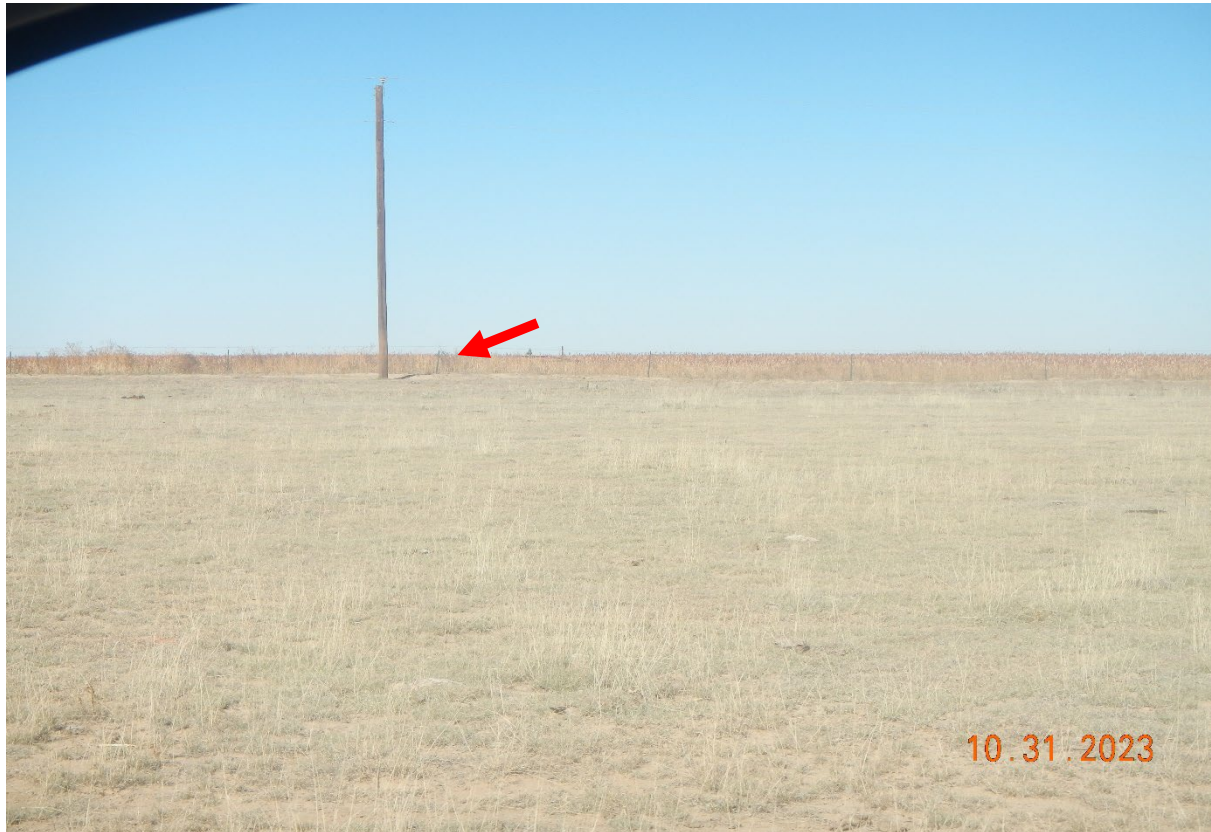
Photo 6. Facing north toward the surrounding reference area which consists of native Blue grama, Sand drpseed, ect. There are abandoned pipe risers that remain 700 ft. northwest of the location.

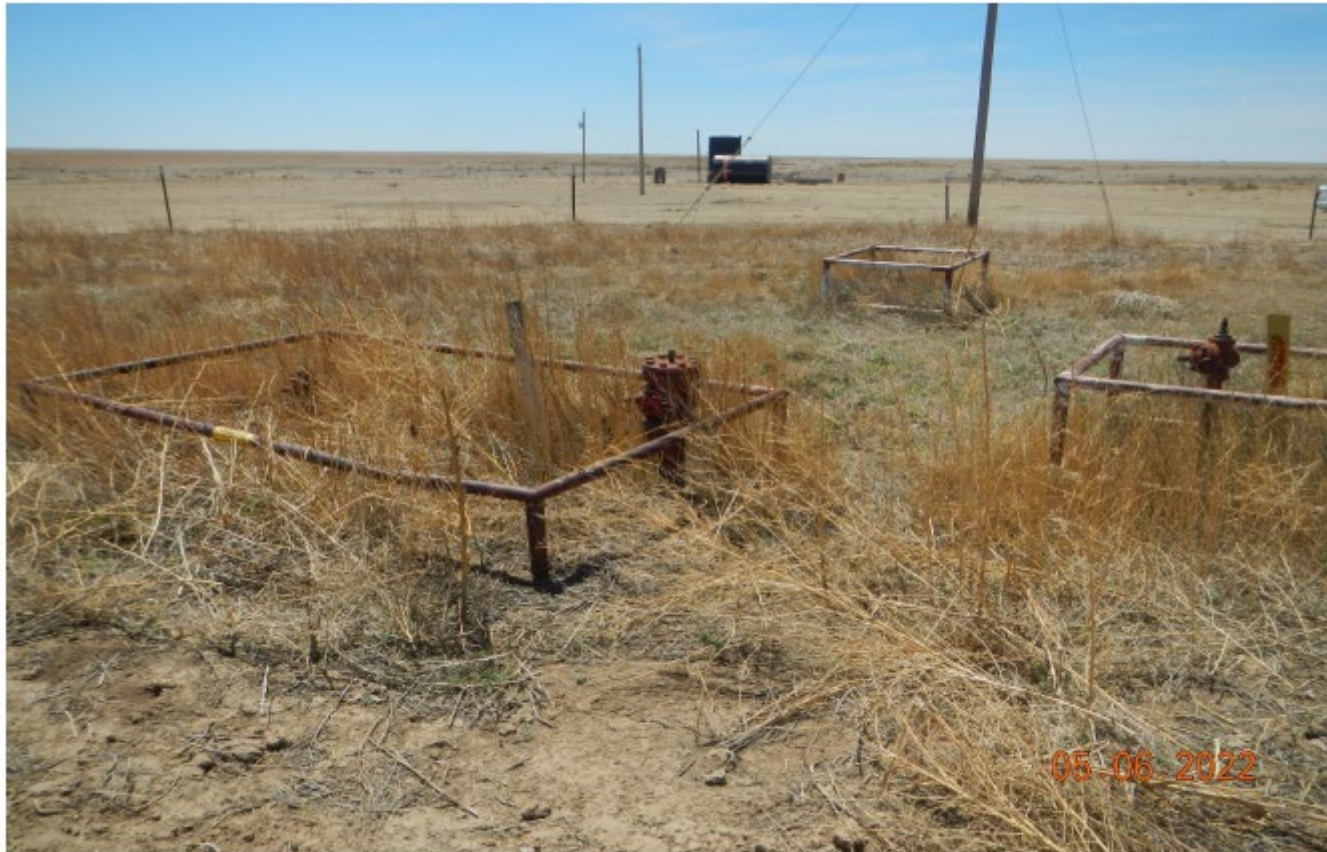
Photo 7. There are abandoned pipe risers that remain 400 ft. north of the location.
