SITE-SPECIFIC QUALITY ASSURANCE & QUALITY CONTROL AUDIT

PERMIT CLOSURE REPORT – RANGELAND

Location Name DOW LAURA-65N63W/28NESE

SITE-SPECIFIC RECLAMATION PLAN

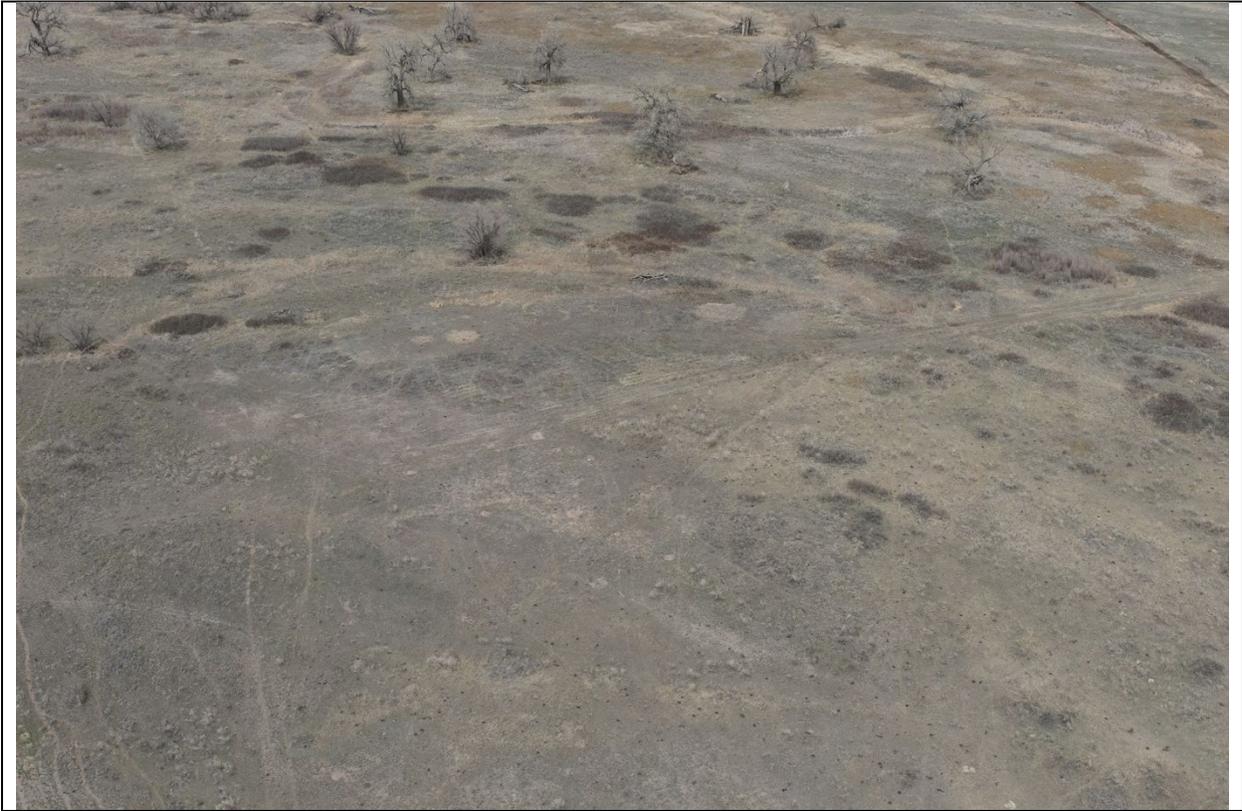
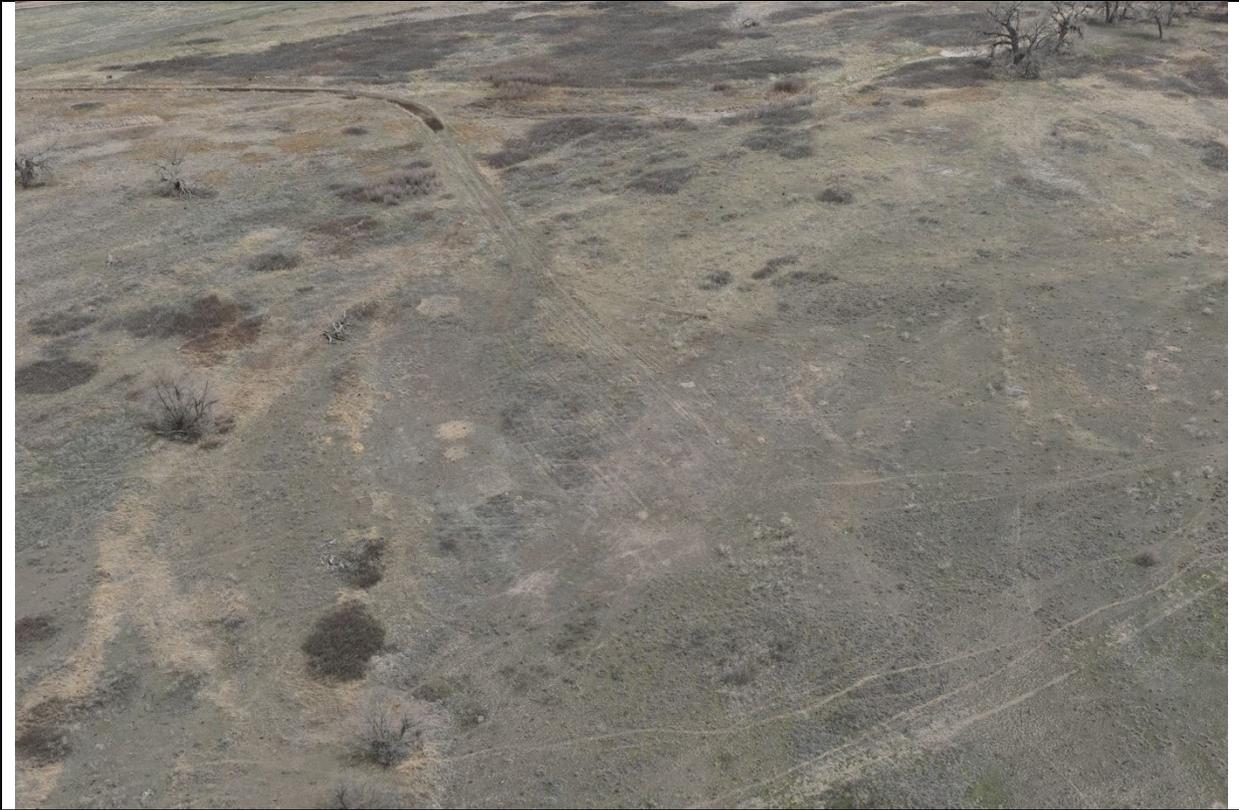
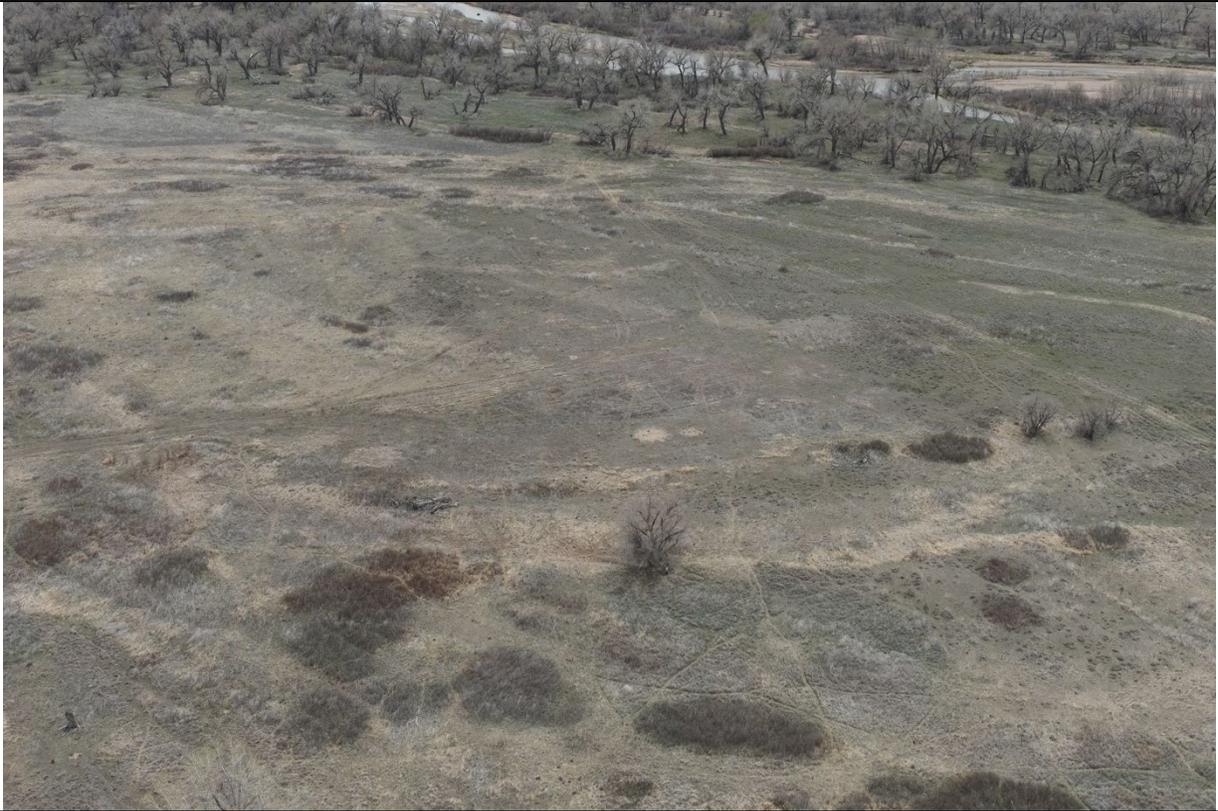
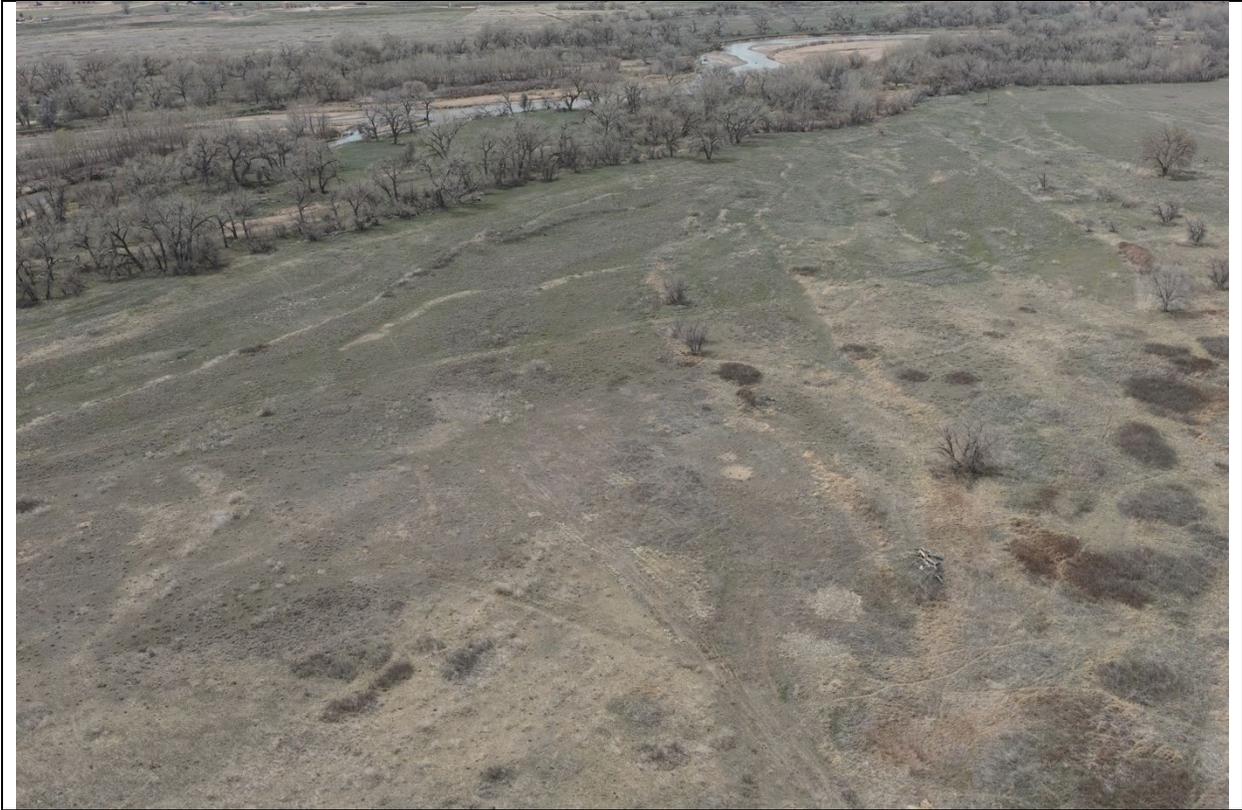
Cardinal directional photos of the site

The inspection for this Location (305223) includes plugged and abandoned Well DOW LAURA #14-27, access road, and off-site Tank Battery (435364). The inspection noted these areas consisted mostly of weeds with little perennial vegetation that is not reflective of reference areas. It also noted this is a shared location with 331381.

The Northern section is intermixed leased grazing land and “native” ecosystem along the South Platte River. The reclaimed areas have residual gravel and excessive applications of manure which have impacted the recovery of the sites.

Weed pressure has occurred along the roads and patchy areas at each site.

Debris remains along the roads and sites in the form of silt fencing, waddles and oil and gas operational equipment. Reference the observation document for specifics.

Road: 12 inches remove and replace

Pad: 6 inches remove and replace

- There are active and abandoned midstream assets in both the northern and southern parts of the reclamation area.
- Remove silt fencing, waddles and remaining oil and gas operational equipment.

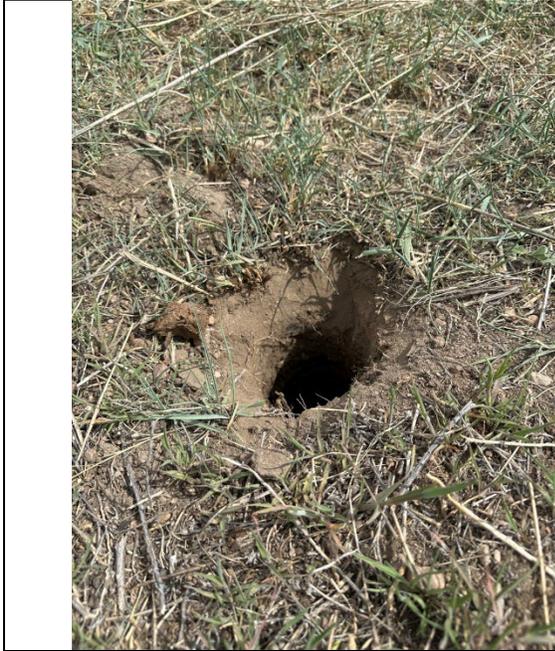
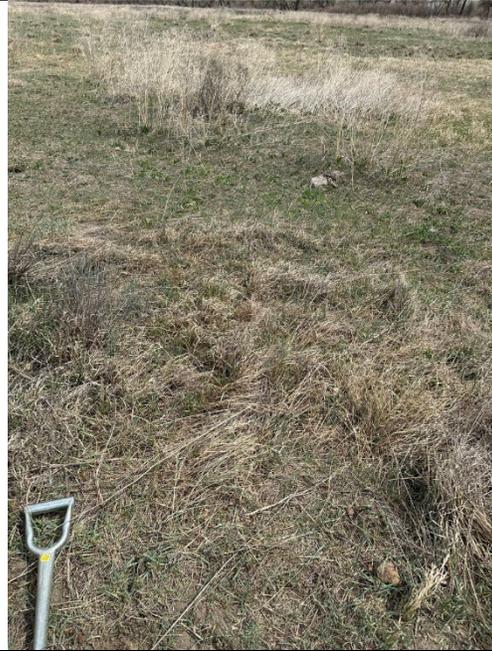
Site Photos – Soil 11 – S11

Soil Picture 1

Soil Picture 2 Vegetation at Soil Location

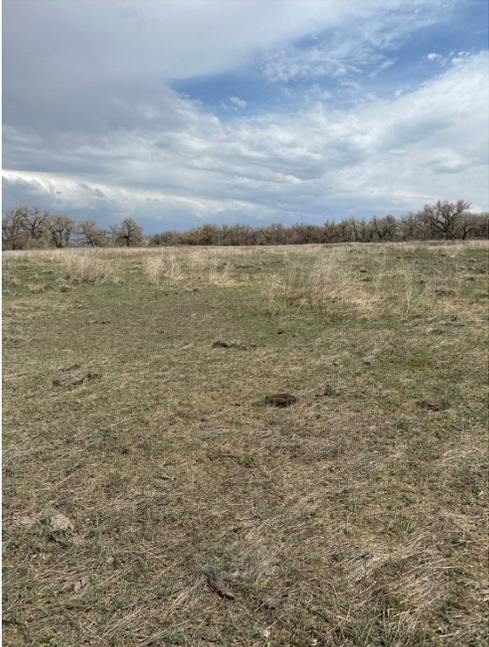
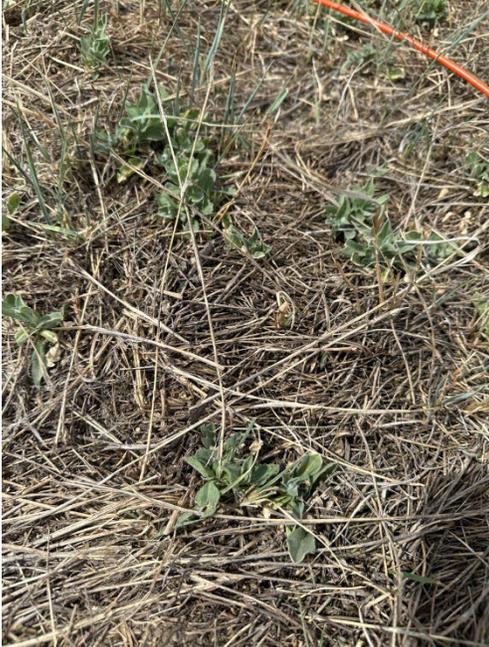
Site Photos – Vegetation 12 – V12

Sample Number	Bare Ground	Grass	Forbs	Shrubs	Litter	Weeds	Field Notes
12	5	5	0	0	85	5	Veg similar, spray for weeds

<p>Veg – West</p>	<p>Field Bindweed – <i>Convolvulus arvensis</i> – Colorado List C Noxious Weed</p>

Monitoring	Continuous	Site should be monitored post reclamation to ensure success	
Weed Management		Due to the seed bank of cheatgrass, thistle and kochia monthly monitoring is recommended with appropriate herbicide control

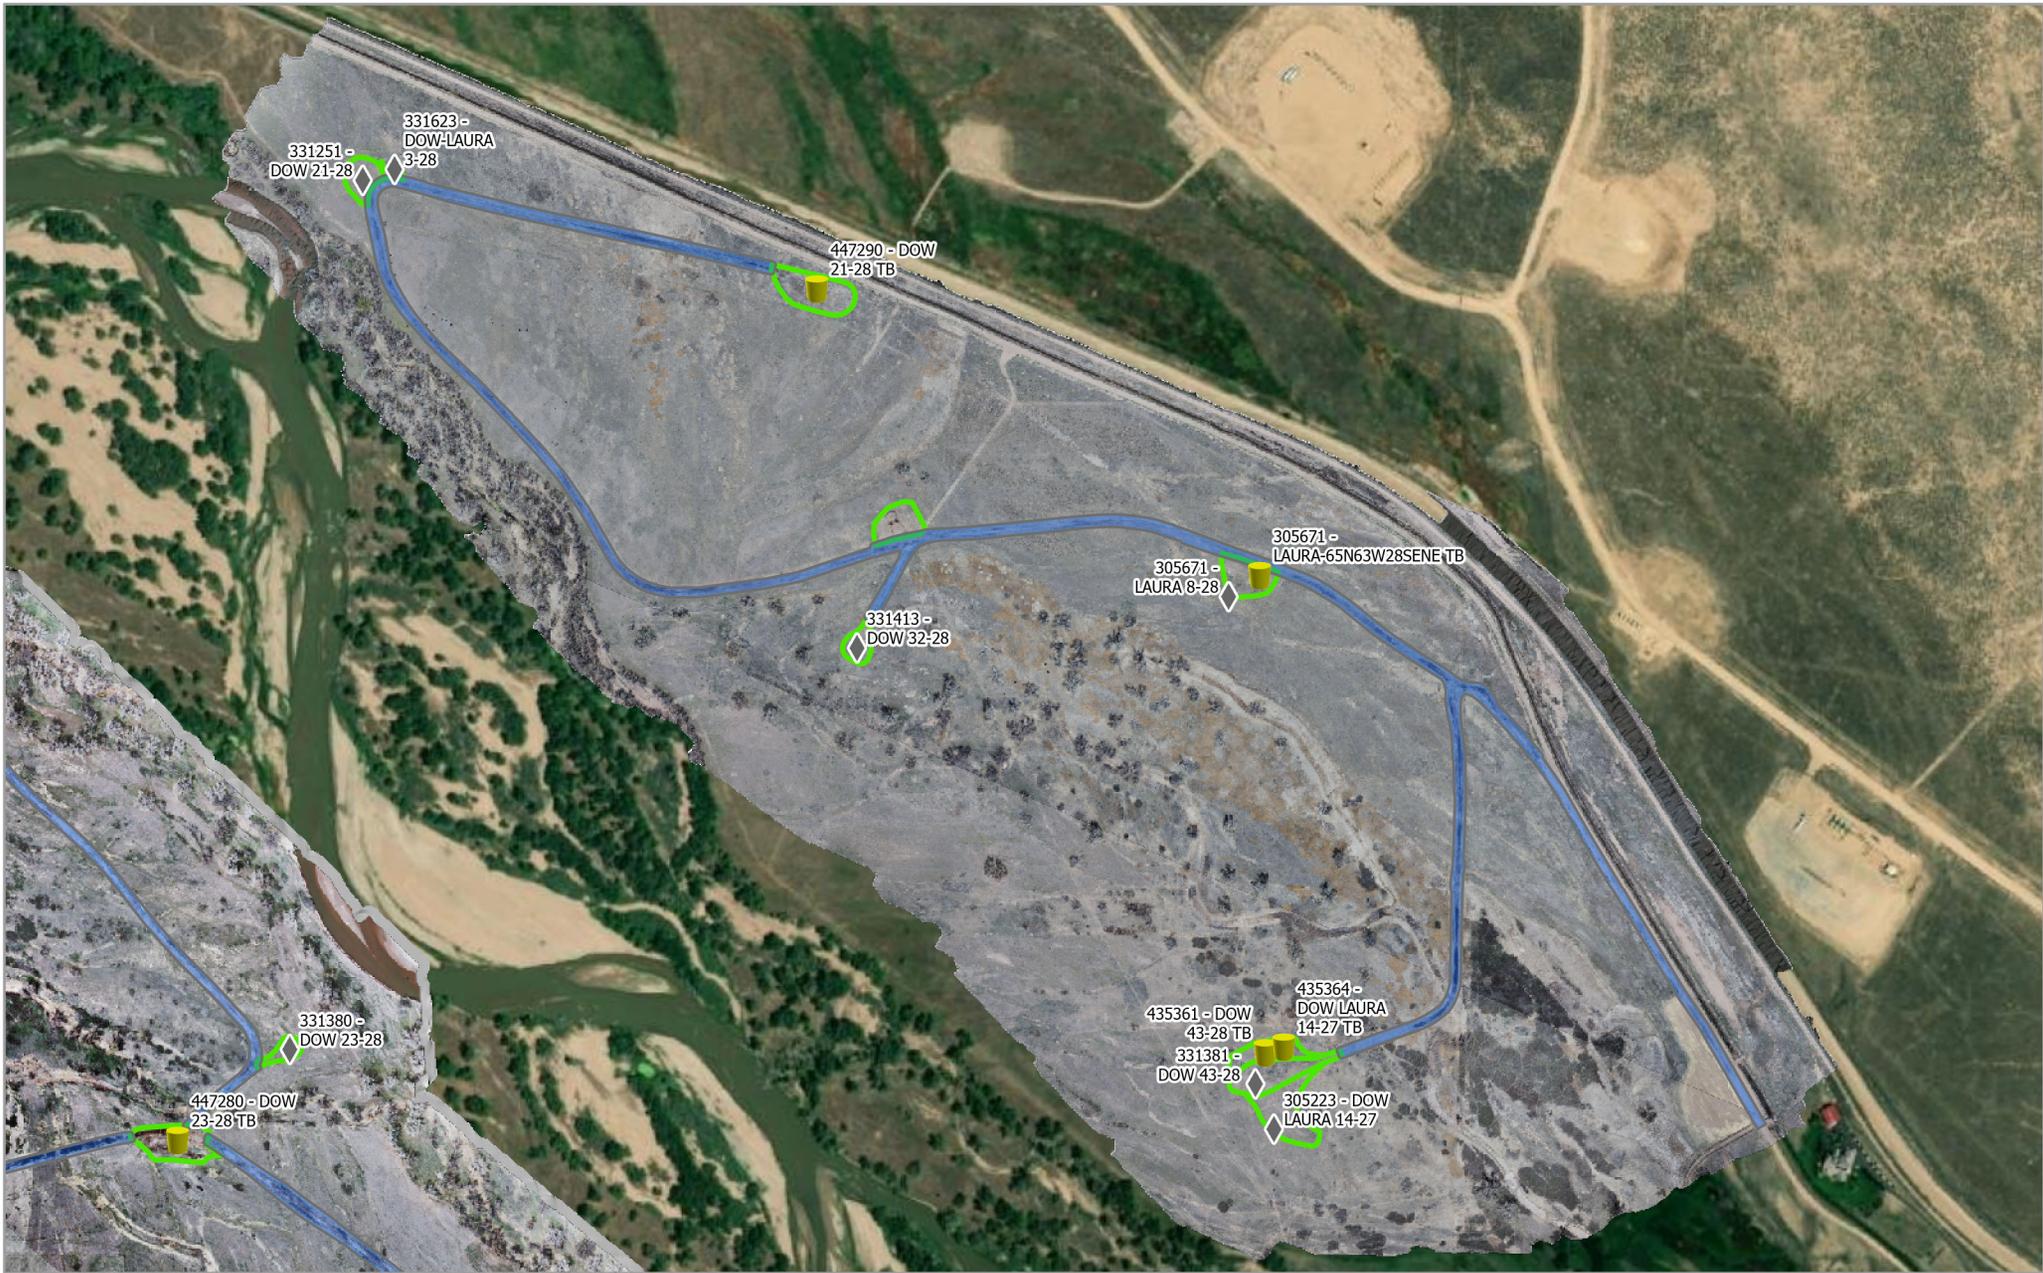
CIV - CPW North Side
Map Extent - Overview Reclaim & Road
Reclaim Extent

Description	Acres
Historic Disturbance Extent	2.65
Current Reclaim Extent	0.55
Road	*
Reference Extent	0.71

Description	Acres
Reclaim Extent	0.55

Description	Cubic Yards
Reclaim Extent remove 6 inches	148
Reclaim Extent replace 6 inches	148

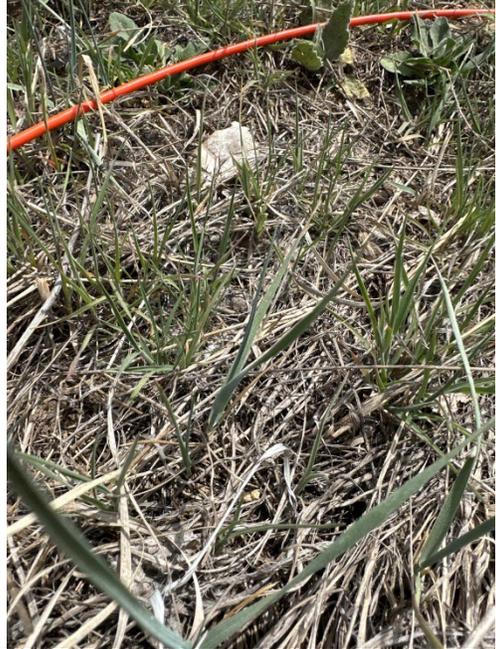
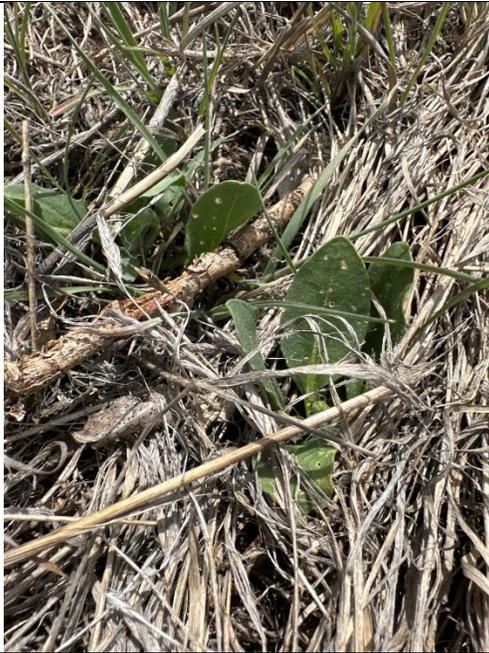
Site Photos – Vegetation 8 – V8 REF

Grass ssp.

Field Bindweed – *Convolvulus arvensis* – Colorado List C
Noxious Weed

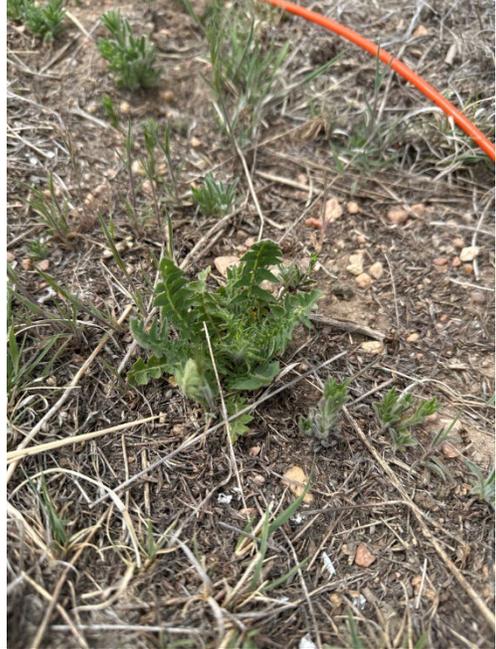
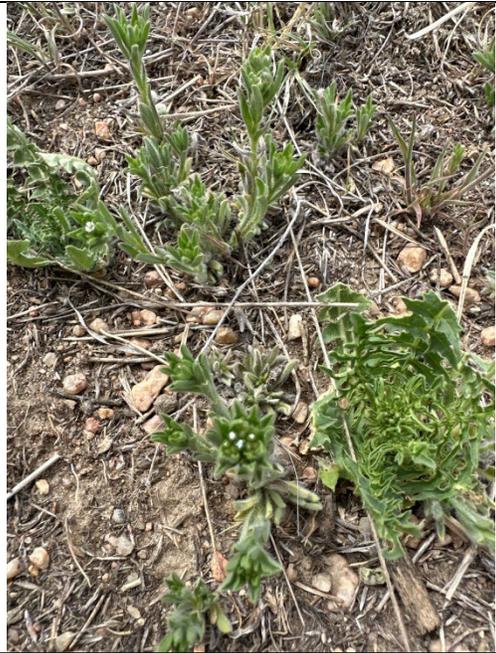
Site Photos – Vegetation 11 – V11 REF

Tansy Mustard – *Descurainia pinata* – Common Weed

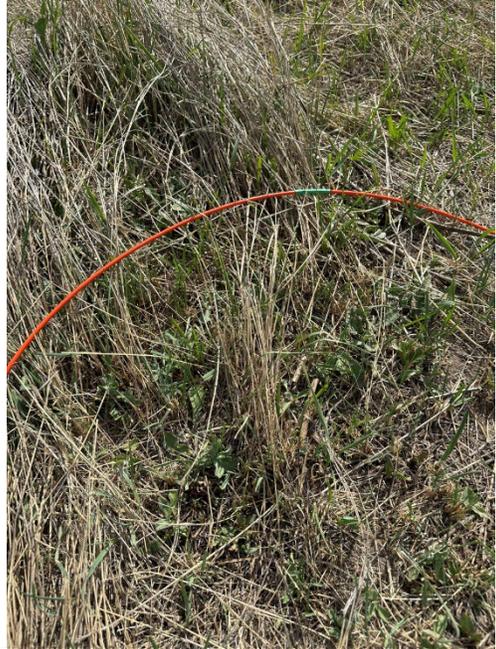
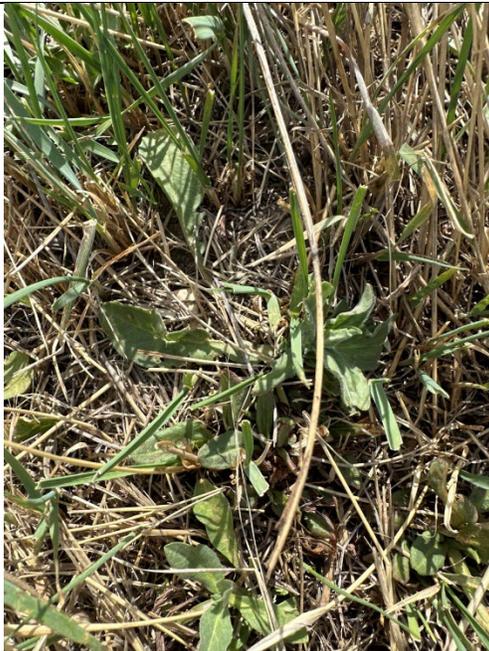
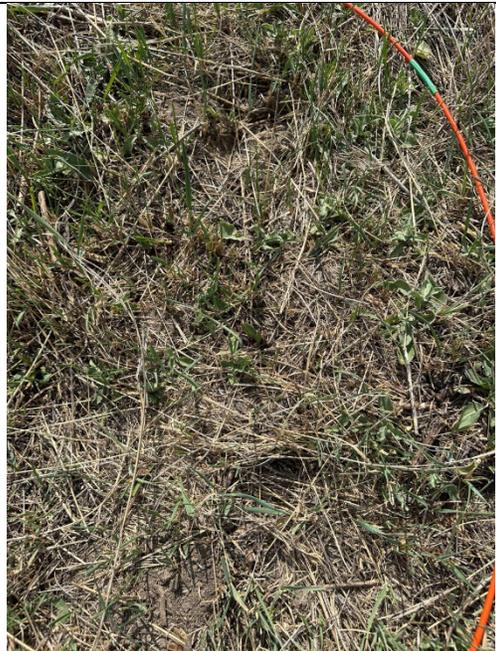
Site Photos – Vegetation 16 – V16 REF

Grass ssp. and Field Bindweed – *Convolvulus arvensis* – Colorado List C Noxious Weed
