Inspection Photos

Location Name: TEP ROCKY MOUNTAIN LLC SPECIALTY # 3 Pad

Location ID: 335147

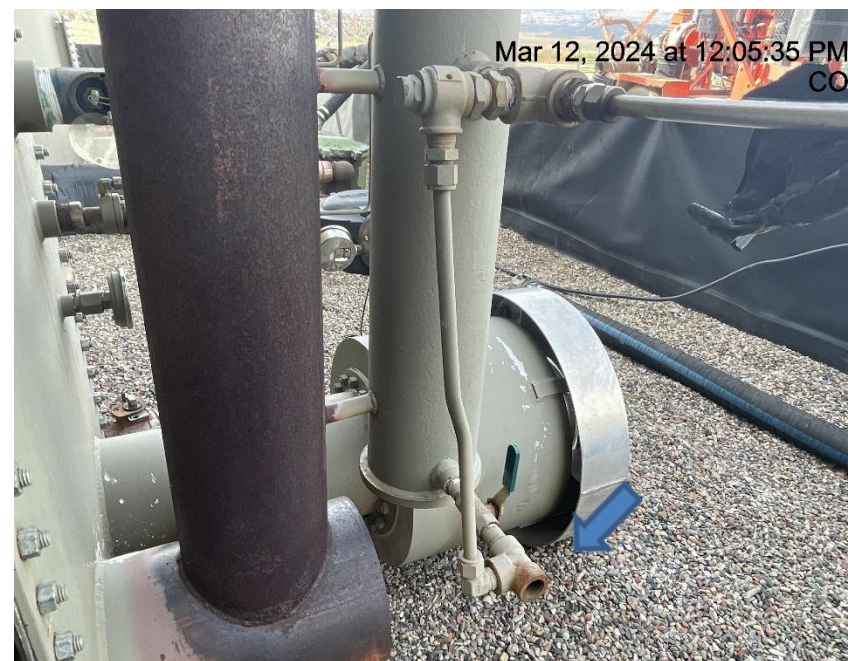
Photo # 9510 PRV vent line on tank burner terminates in an unsafe manner/does not comply with CECMC pressure safety device rules & general safety rules.

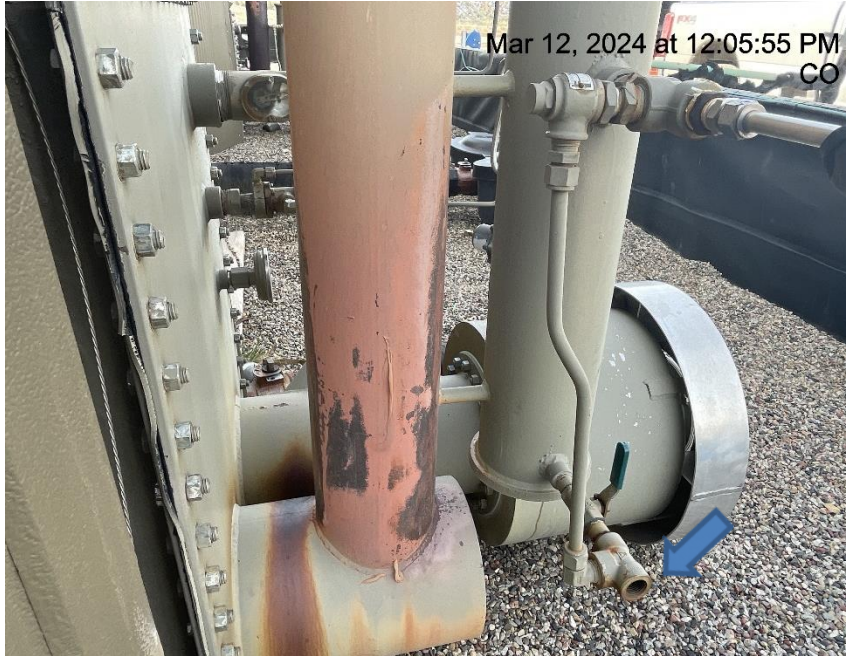
Photo # 9511 PRV vent line on tank burner terminates in an unsafe manner/does not comply with CECMC pressure safety device rules & general safety rules.

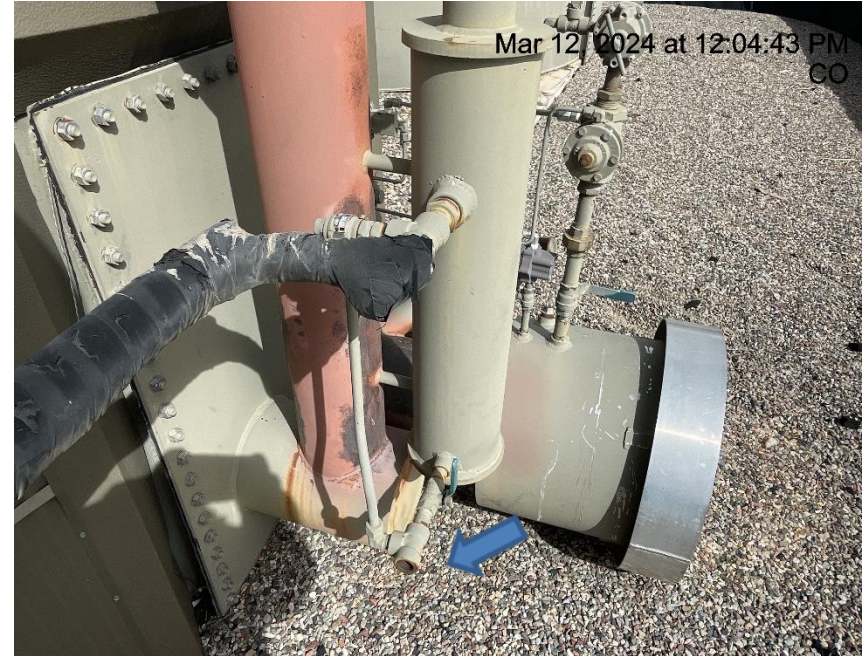
Photo # 9512 PRV vent line on tank burner terminates in an unsafe manner/does not comply with CECMC pressure safety device rules & general safety rules.

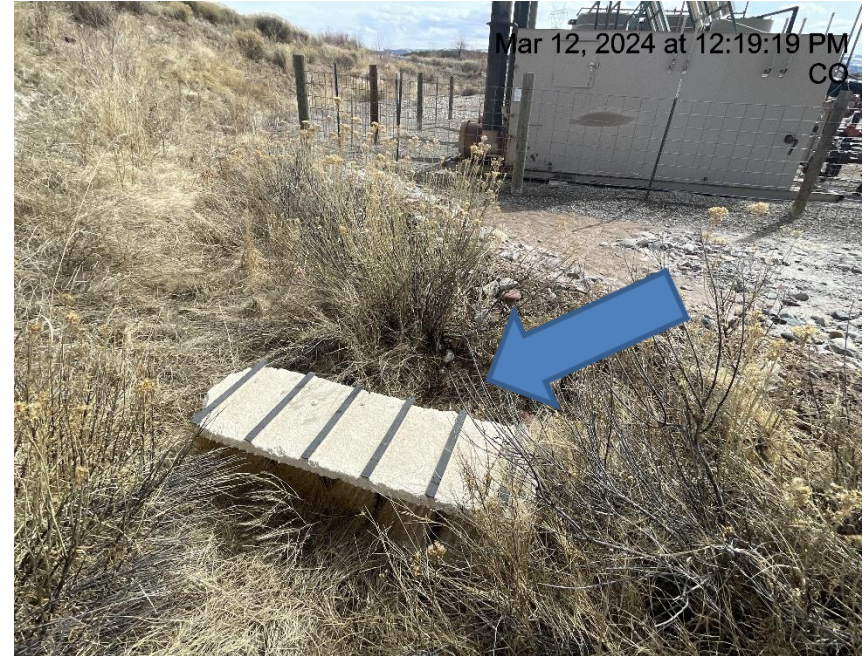
Photo # 9514 Debris

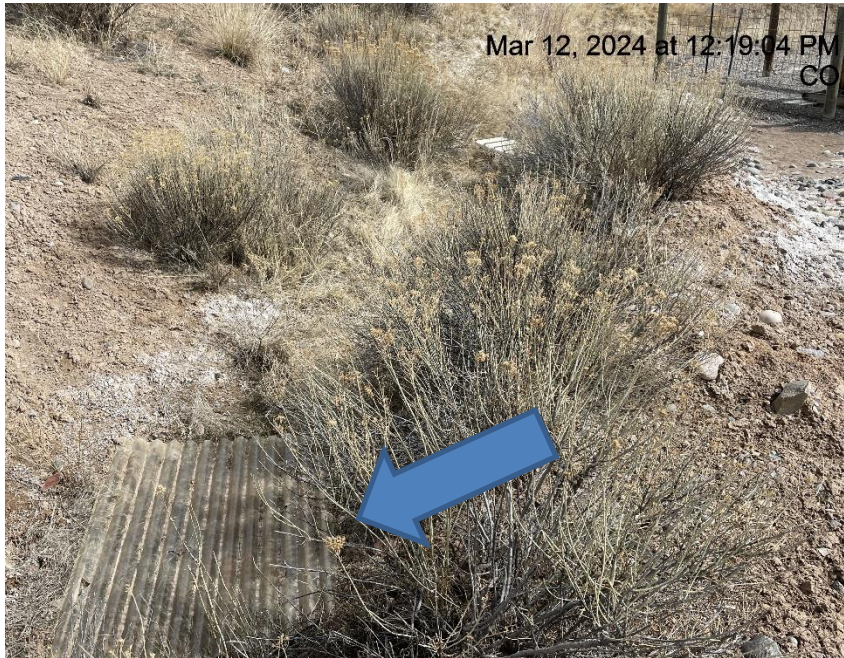
Photo # 9415 Debris
