Inspection Photos

Location Name: TEP ROCKY MOUNTAIN LLC LEFT HAND FEDERAL A Pad

Location #: 335543

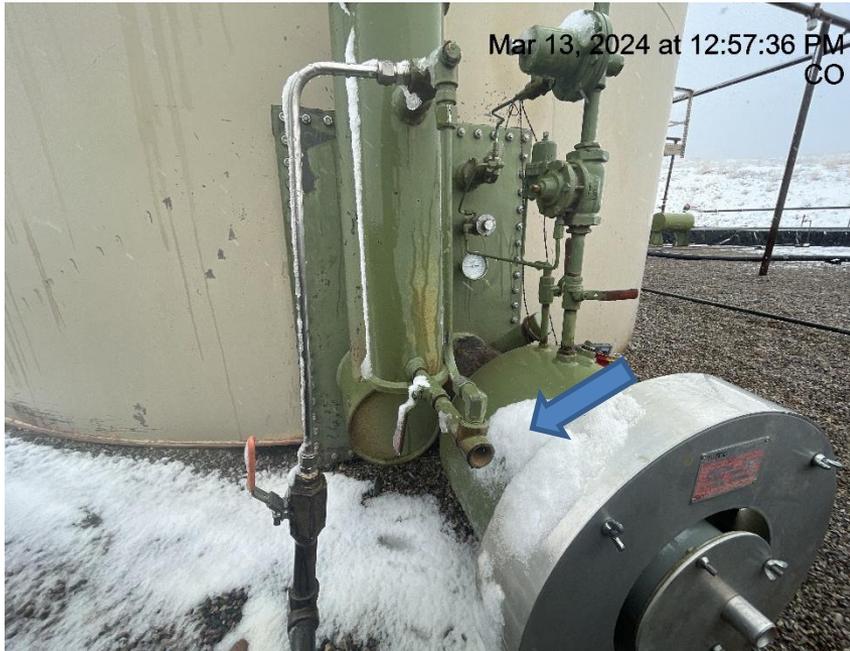
Photo # 9838 PRV vent line for tank burner does not comply with CECMC pressure safety device rules & also terminates in an unsafe manner

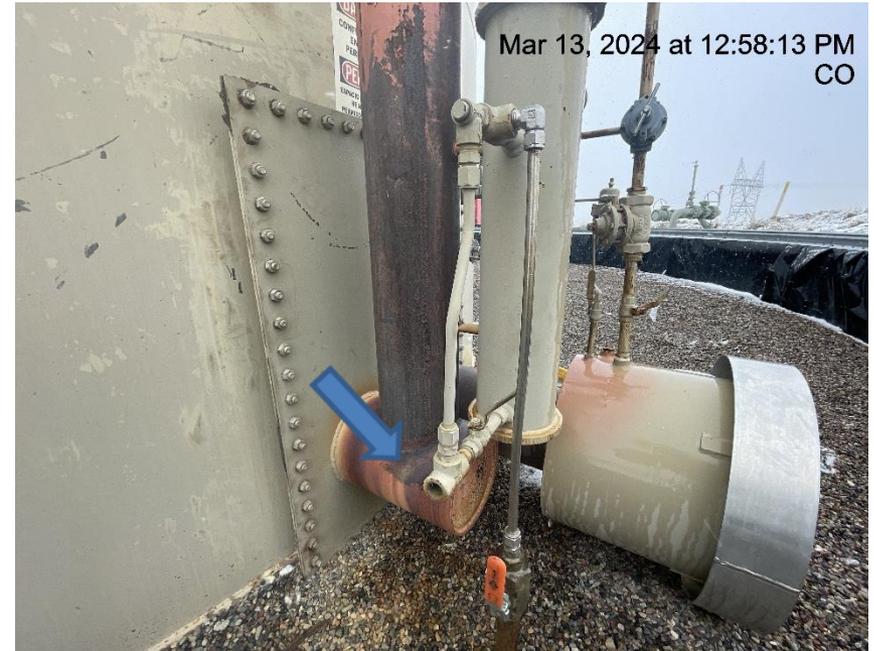
Photo # 9839 PRV vent line for tank burner does not comply with CECMC pressure safety device rules & also terminates in an unsafe manner

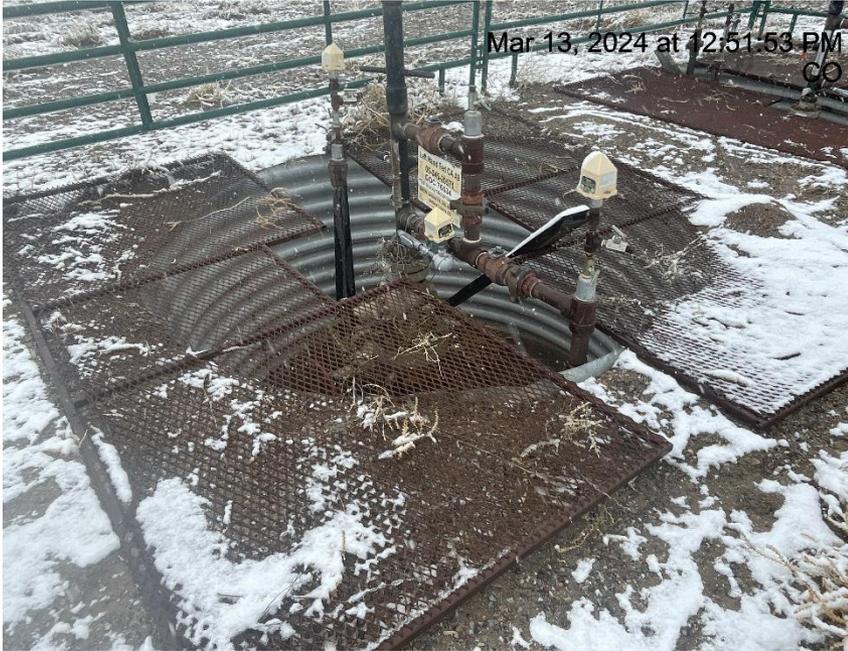
**Photo # 9840 Wellhead cellar cover not properly installed
/wildlife & personnel hazard**
