Interim Reclamation and Stormwater Inspection

March 19, 2019

Operator: EXTRACTION OIL & GAS INC #10459

Location ID: 450197

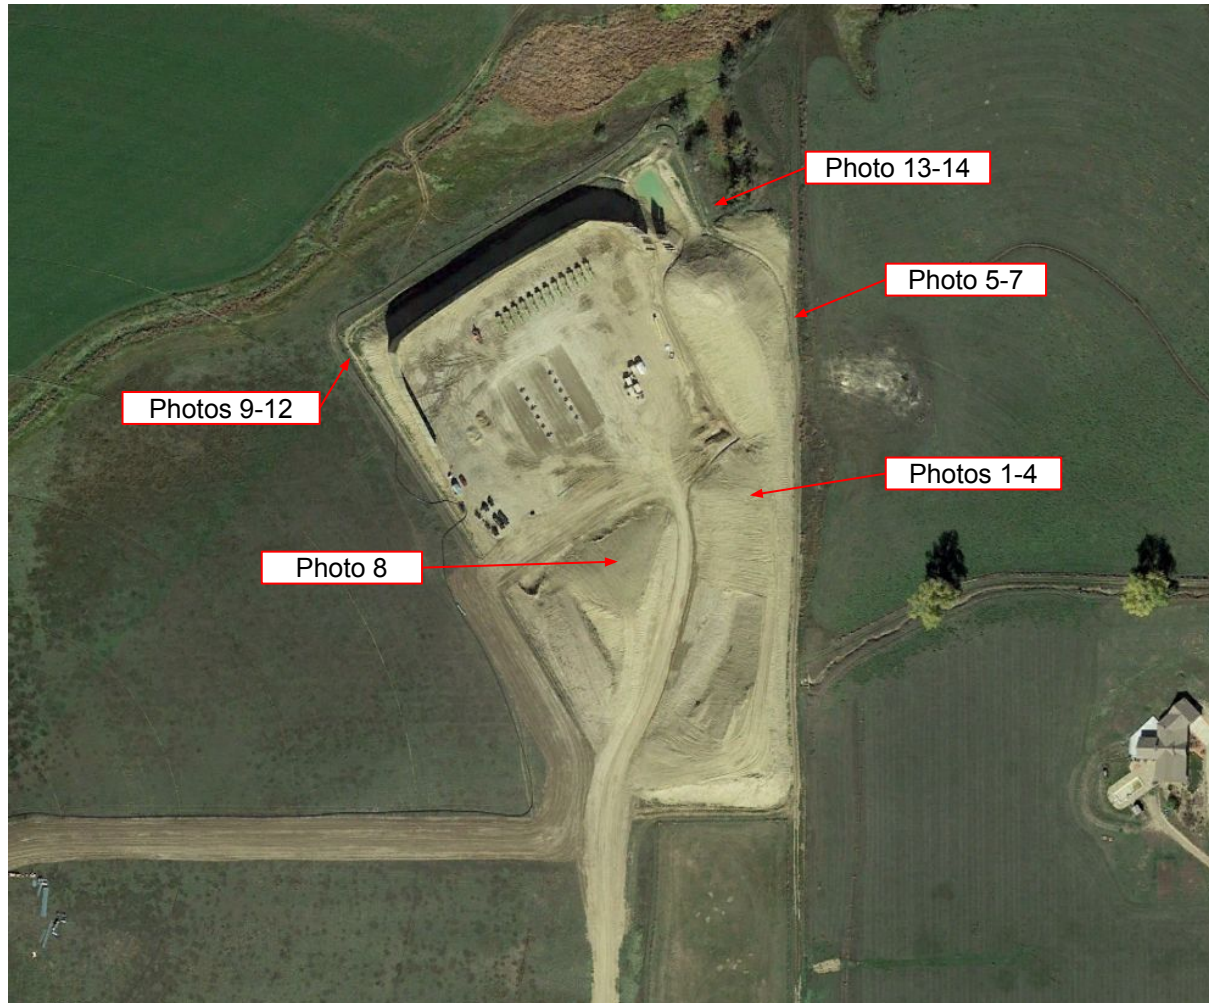
Google Earth aerial imagery taken on 10/14/2017. Photo reference points to help illustrate approximate locations of the subject photo during the January 30, 2019 and March 19, 2019 inspection.
