Inspection Photos

Operator: Hilcorp Energy
API: 067-08409
Date: 10/15/2020

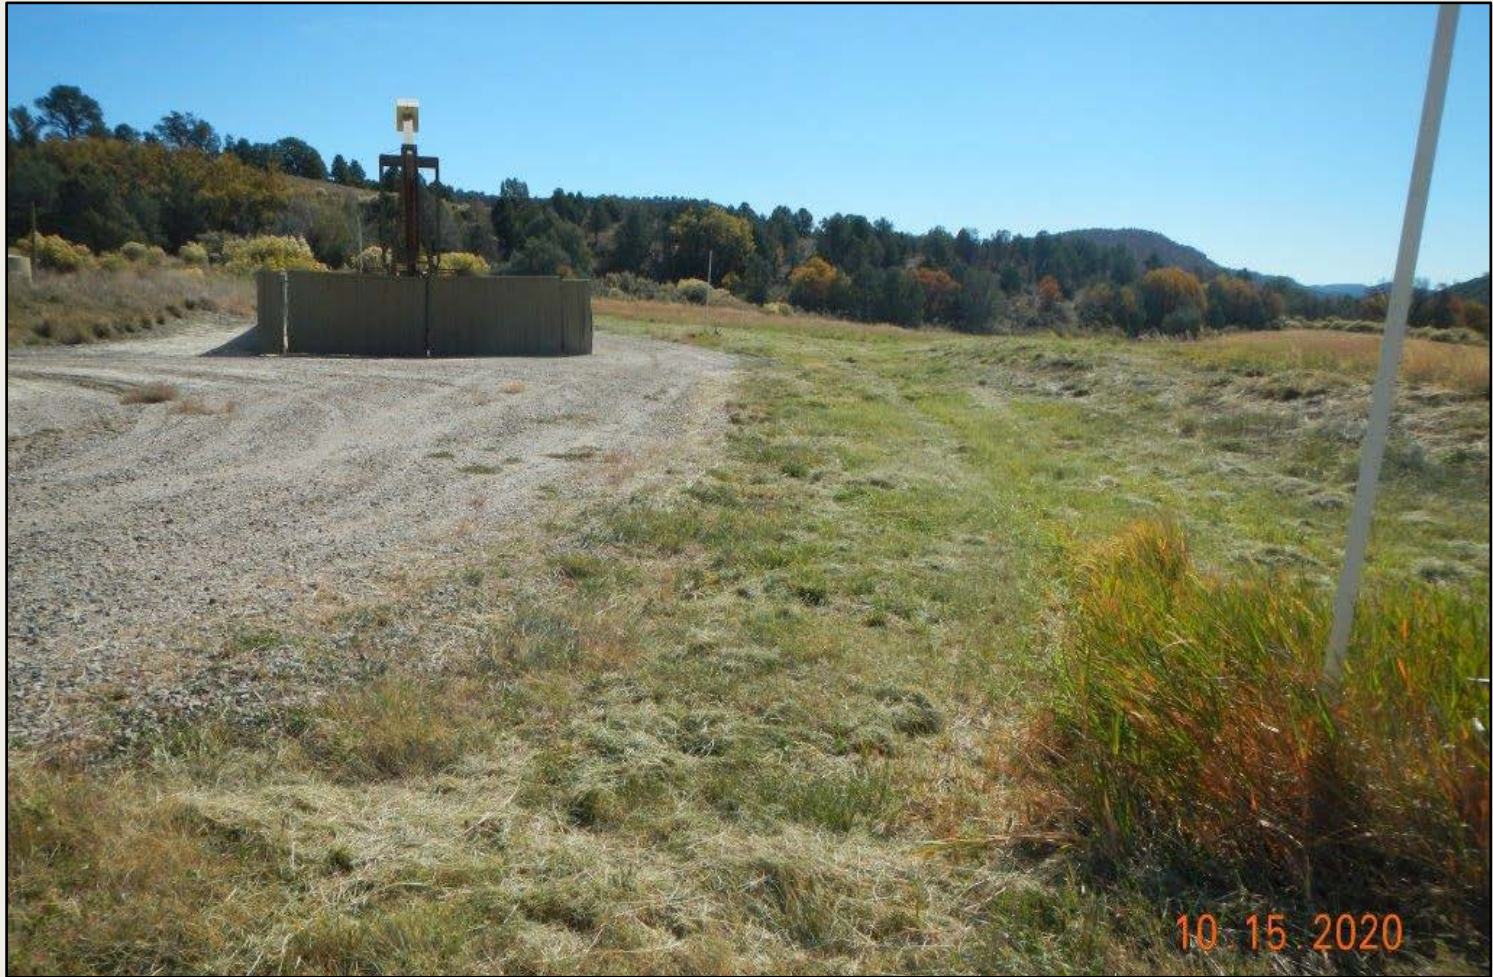
Photo 1. View of the project area from the northwestern corner facing center. Mowed pasture grasses such as smooth brome present.

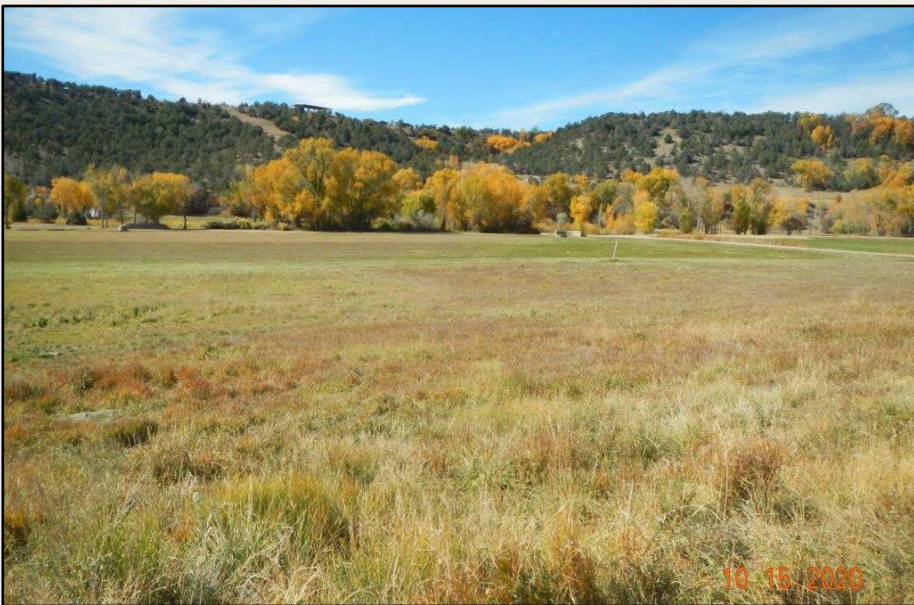
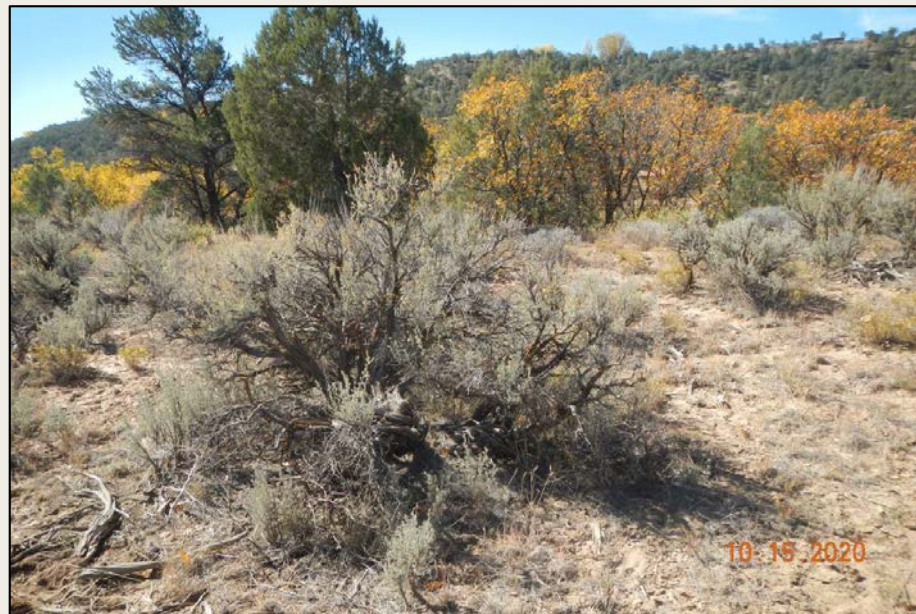
Photos 6/7. View of the reference area situated at the edge of the sagebrush, pinyon and juniper woodland with blue grama and sand dropseed, as well as irrigated grass field with grasses such as smooth brome.

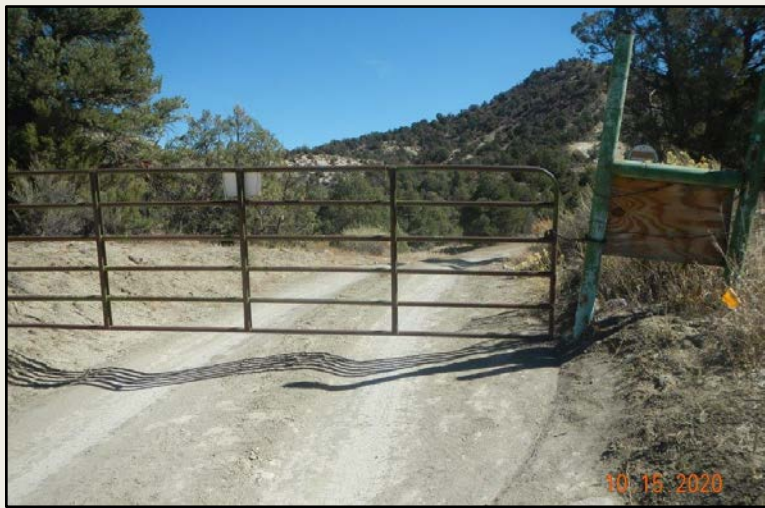
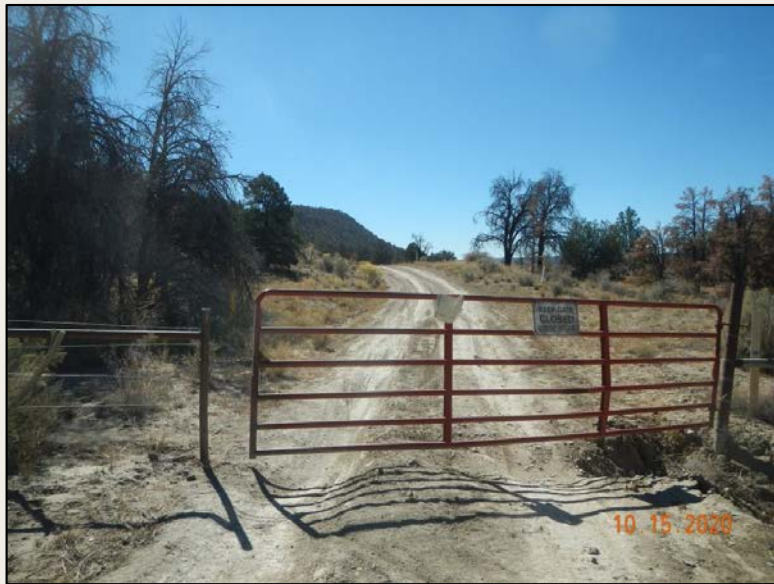
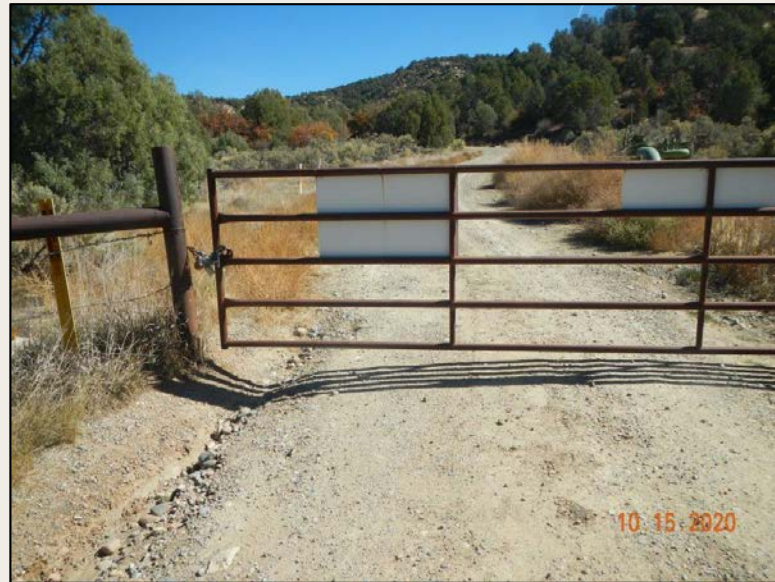
View of closed gates used to access location.
