FREMONT ENVIRONMENTAL INC.

Subject: **Flow Line Closure Submittal**
 Heinze 31-44 Flow Line
 API # 05-123-24929
 SESE Sec 31, T7N, R63W
 Weld County, Colorado
 Facility #465757, Remediation #16818
 Fremont Project No. C021-016

Flowline Closure Checklist

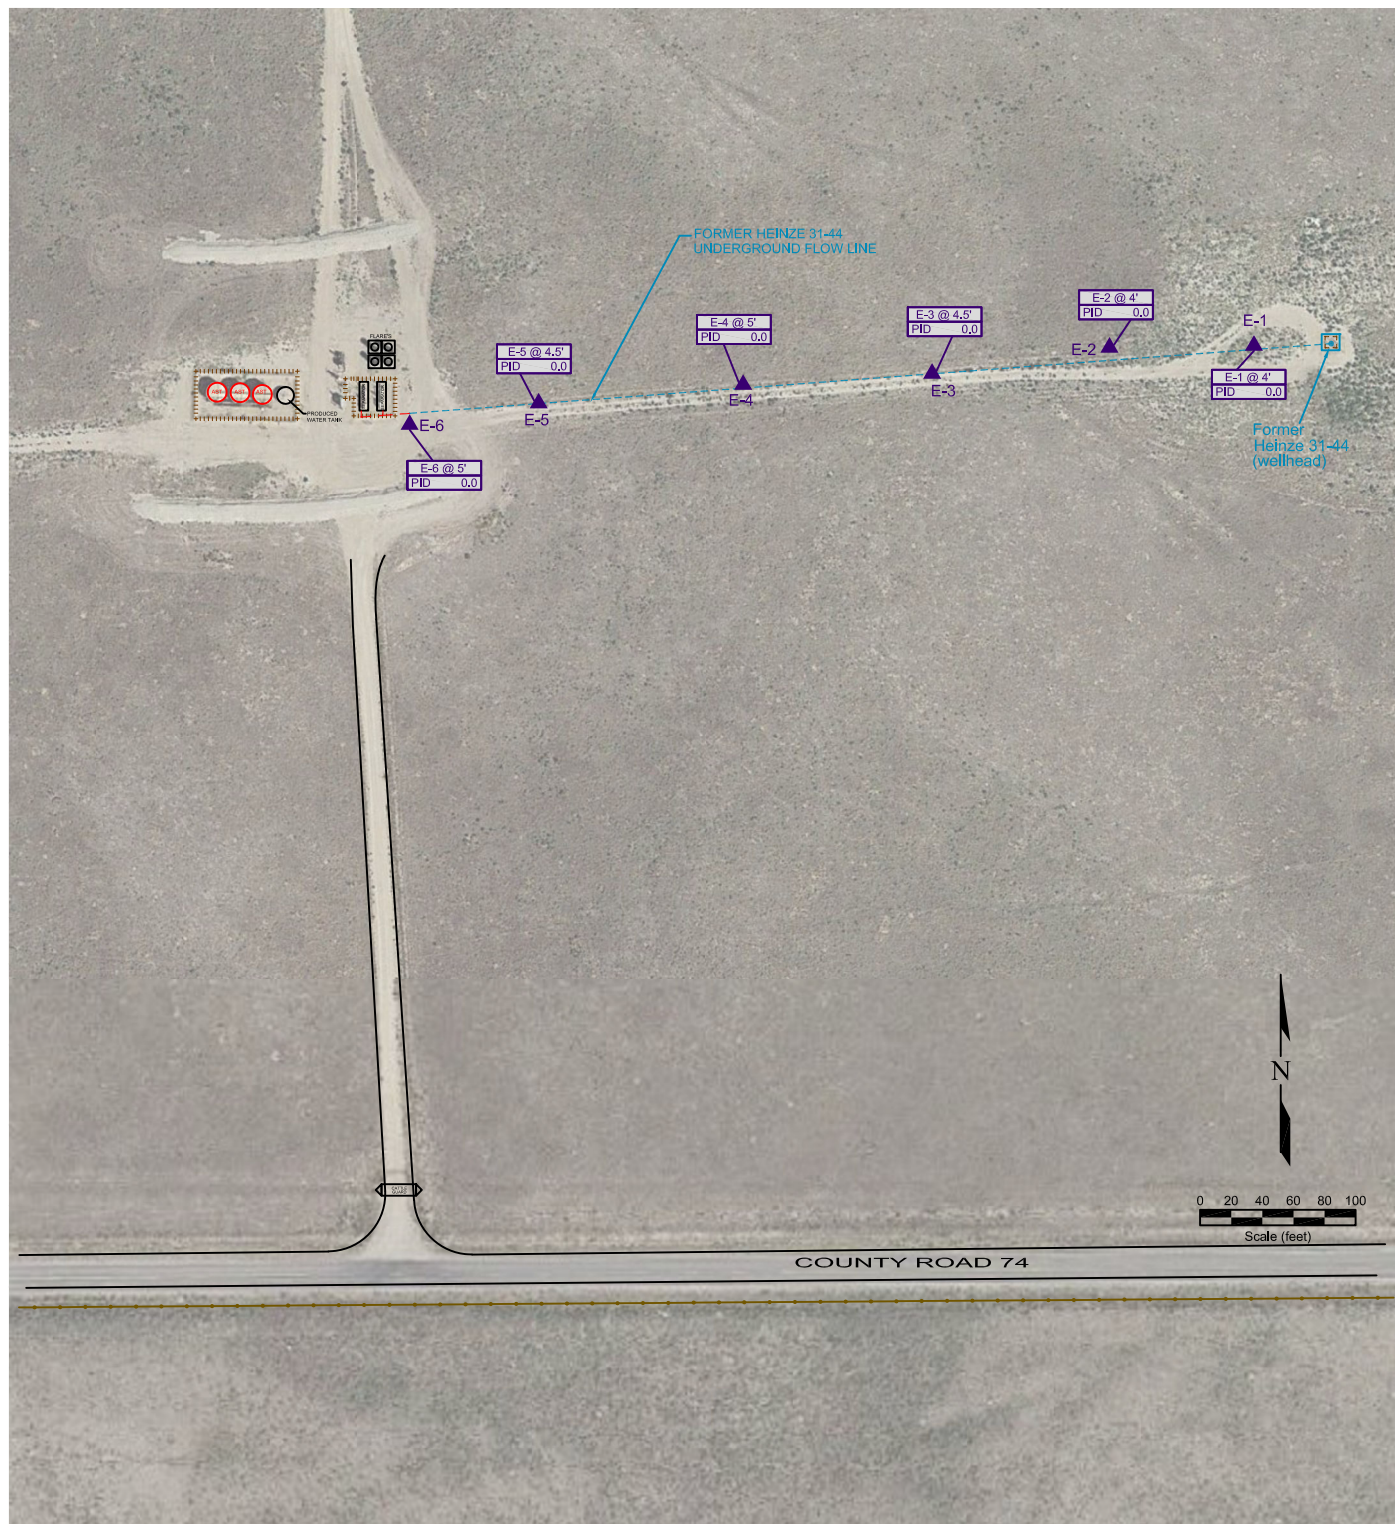
The flow line was observed to be in good condition and hydrocarbon impacts were not observed. Please see the attached Flow Line Facility Closure Check List and Photo Documentation.

Due to the proximity to operating facilities at the production site. A short section of the flow line was left in place beneath the existing separator and associated facility lines. That section will be removed during facility closure activities at a later date. Approximately 65 feet of flow line remains in the subsurface beneath.
